**NATIONAL REGISTER OF HISTORIC PLACES
PROPERTY PHOTOGRAPH FORM**

COMMON: Starr House
AND/OR HISTORIC: Michael VanKirk House

STREET AND NUMBER: 1310 King Street
CITY OR TOWN: Wilmington
STATE: Delaware CODE: 10 COUNTY: New Castle CODE: 003

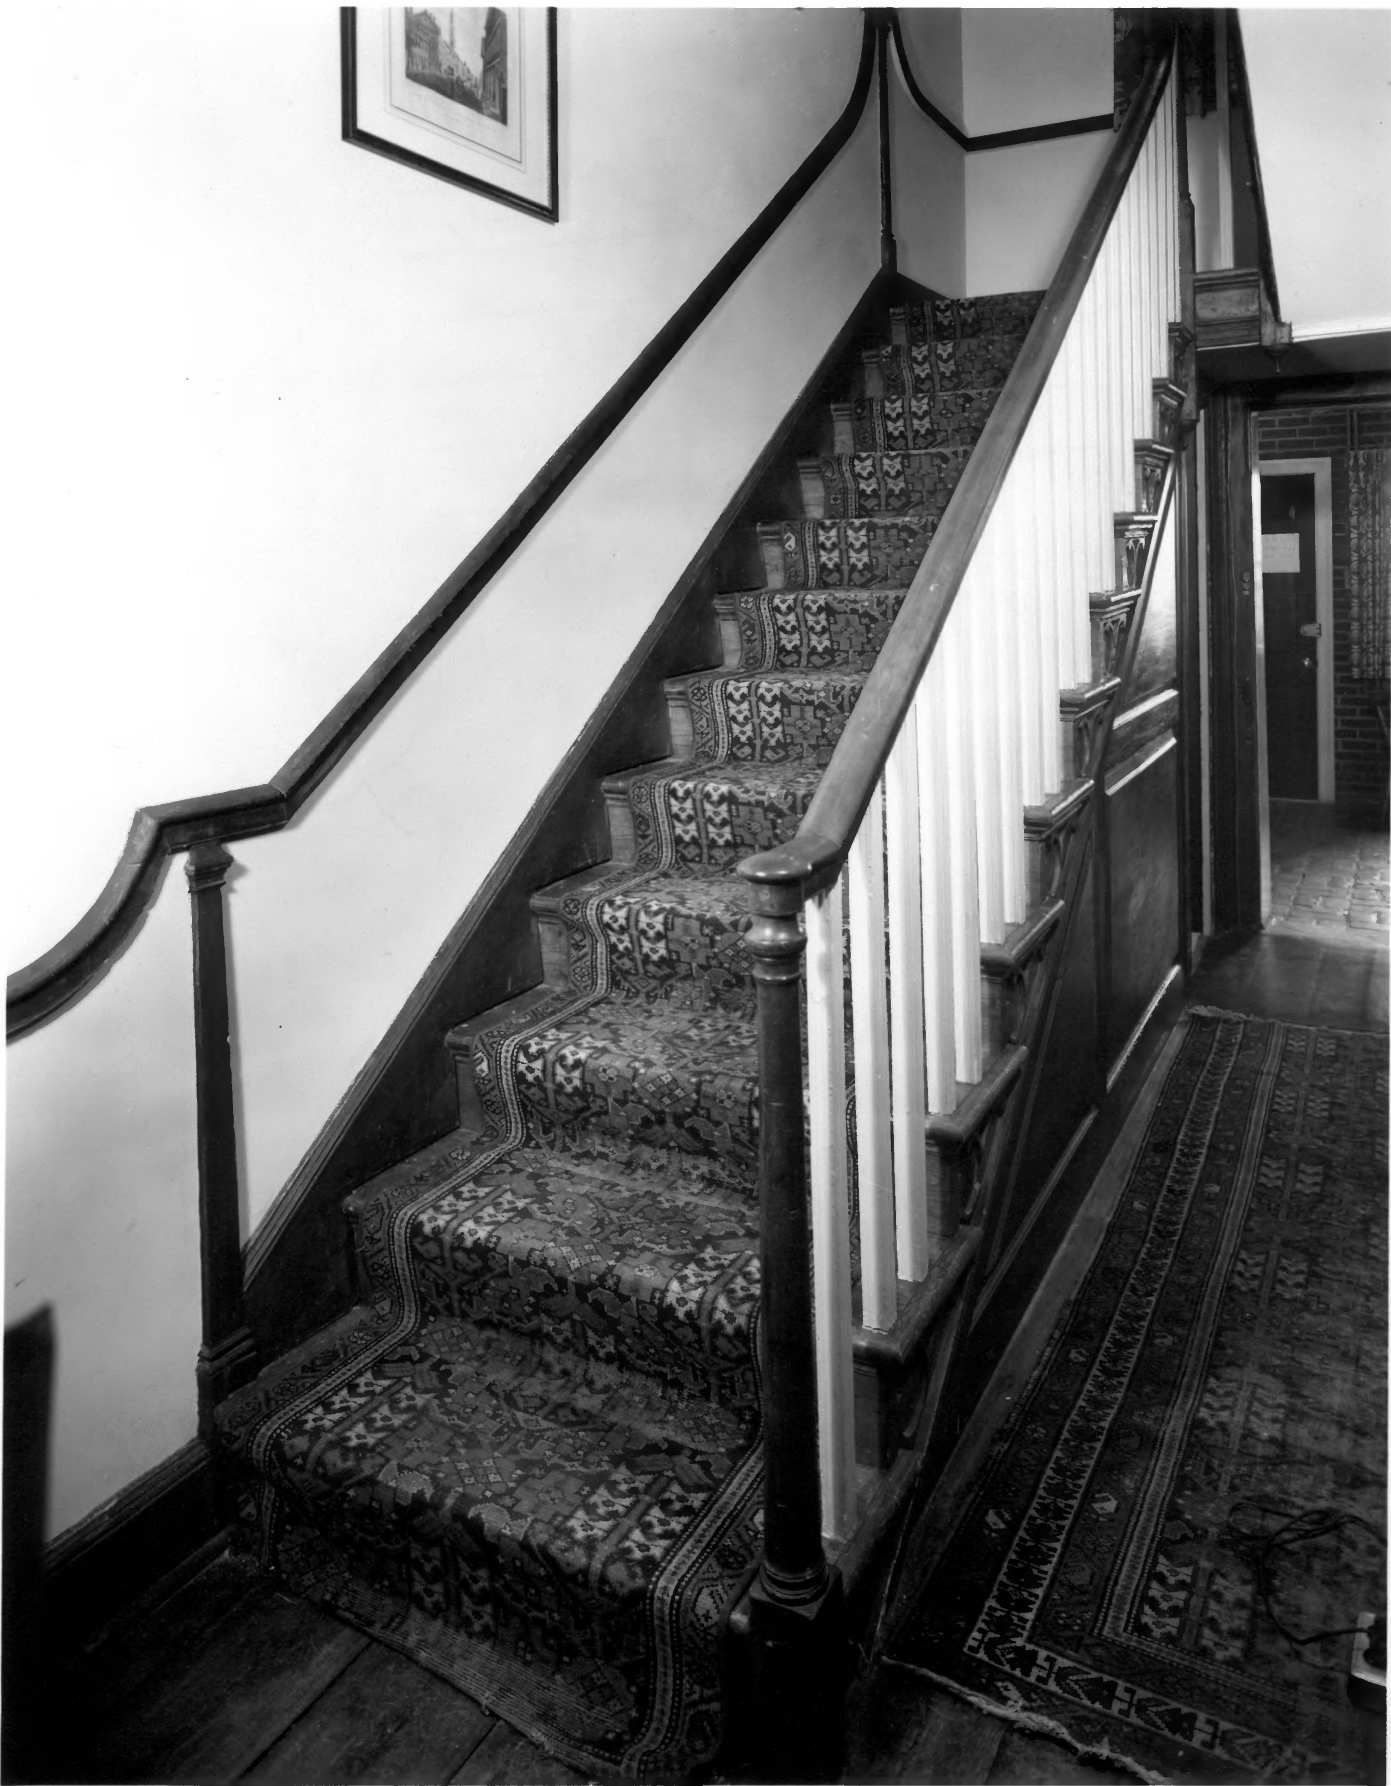
#1
SEE INSTRUCTIONS

DESCRIBE VIEW, DIRECTION, ETC.
The openstring staircase is a very fine example of Wilmington
woodwork during this period. It is well proportioned with a good
concern for detail. The stair is two run with a landing at the
top of the first run. Note the grace of the ramp and ease, the
simple newel post, the pendant at the base of the newel beginning
the second run, and the carving at the step ends.

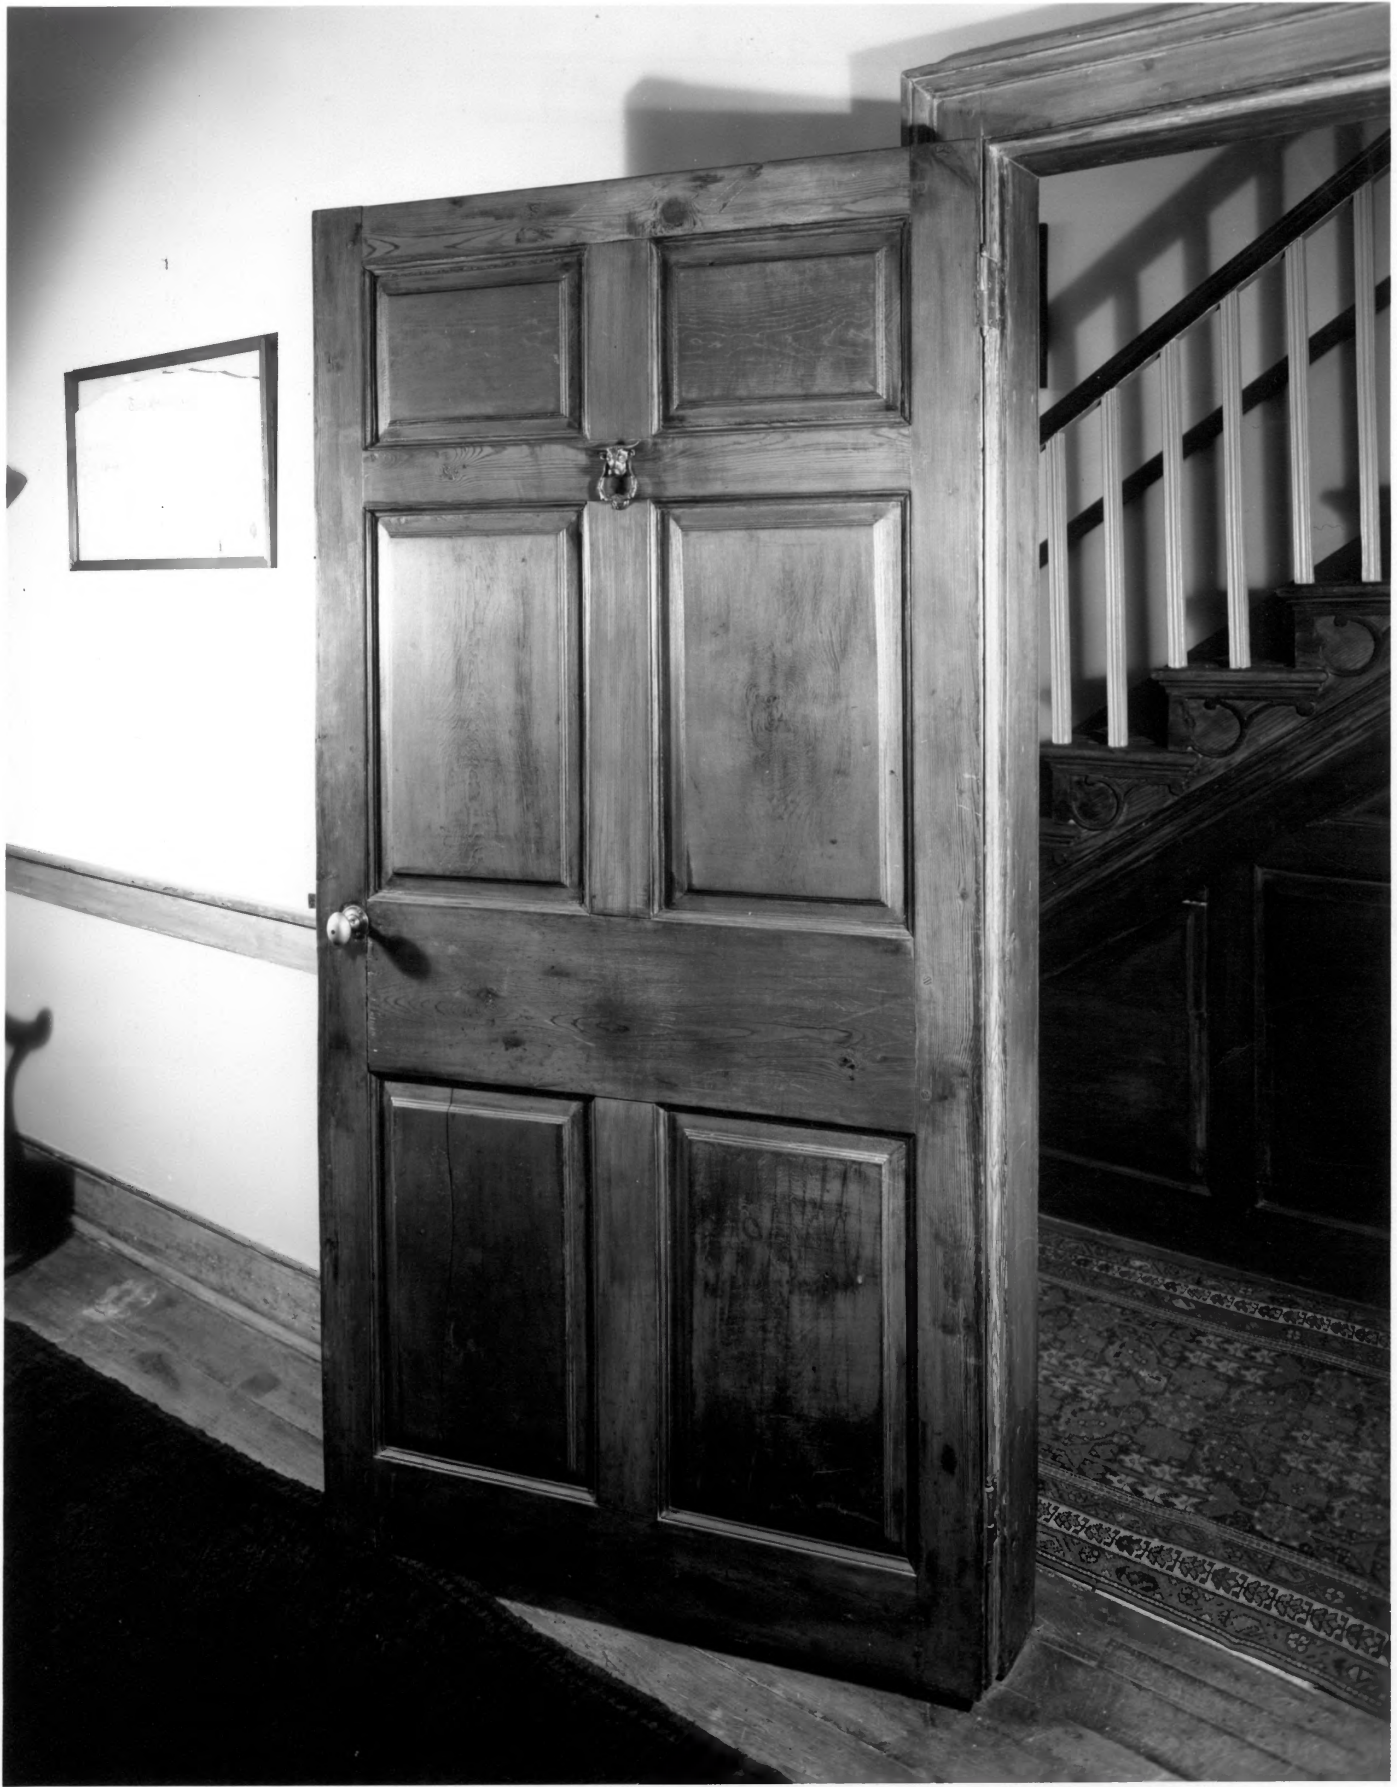
#2
SEE INSTRUCTIONS

1. NAME			
COMMON:		Starr House	
AND/OR HISTORIC:		Michael VanKirk House	
2. LOCATION			
STREET AND NUMBER: 1310 King Street			
CITY OR TOWN: Wilmington			
STATE: Delaware	CODE 10	COUNTY: New Castle	CODE 003
3. PHOTO REFERENCE			
PHOTO CREDIT:		George Eisenman	
DATE OF PHOTO:		February 1970	
NEGATIVE FILED AT:		In possession of the owner.	
4. IDENTIFICATION			
DESCRIBE VIEW, DIRECTION, ETC. Door and door frame connecting the hall and dining room. The yellow pine woodwork is original. The crack in the lower left hand panel is attributed to a powder explosion on King Street in 1854.

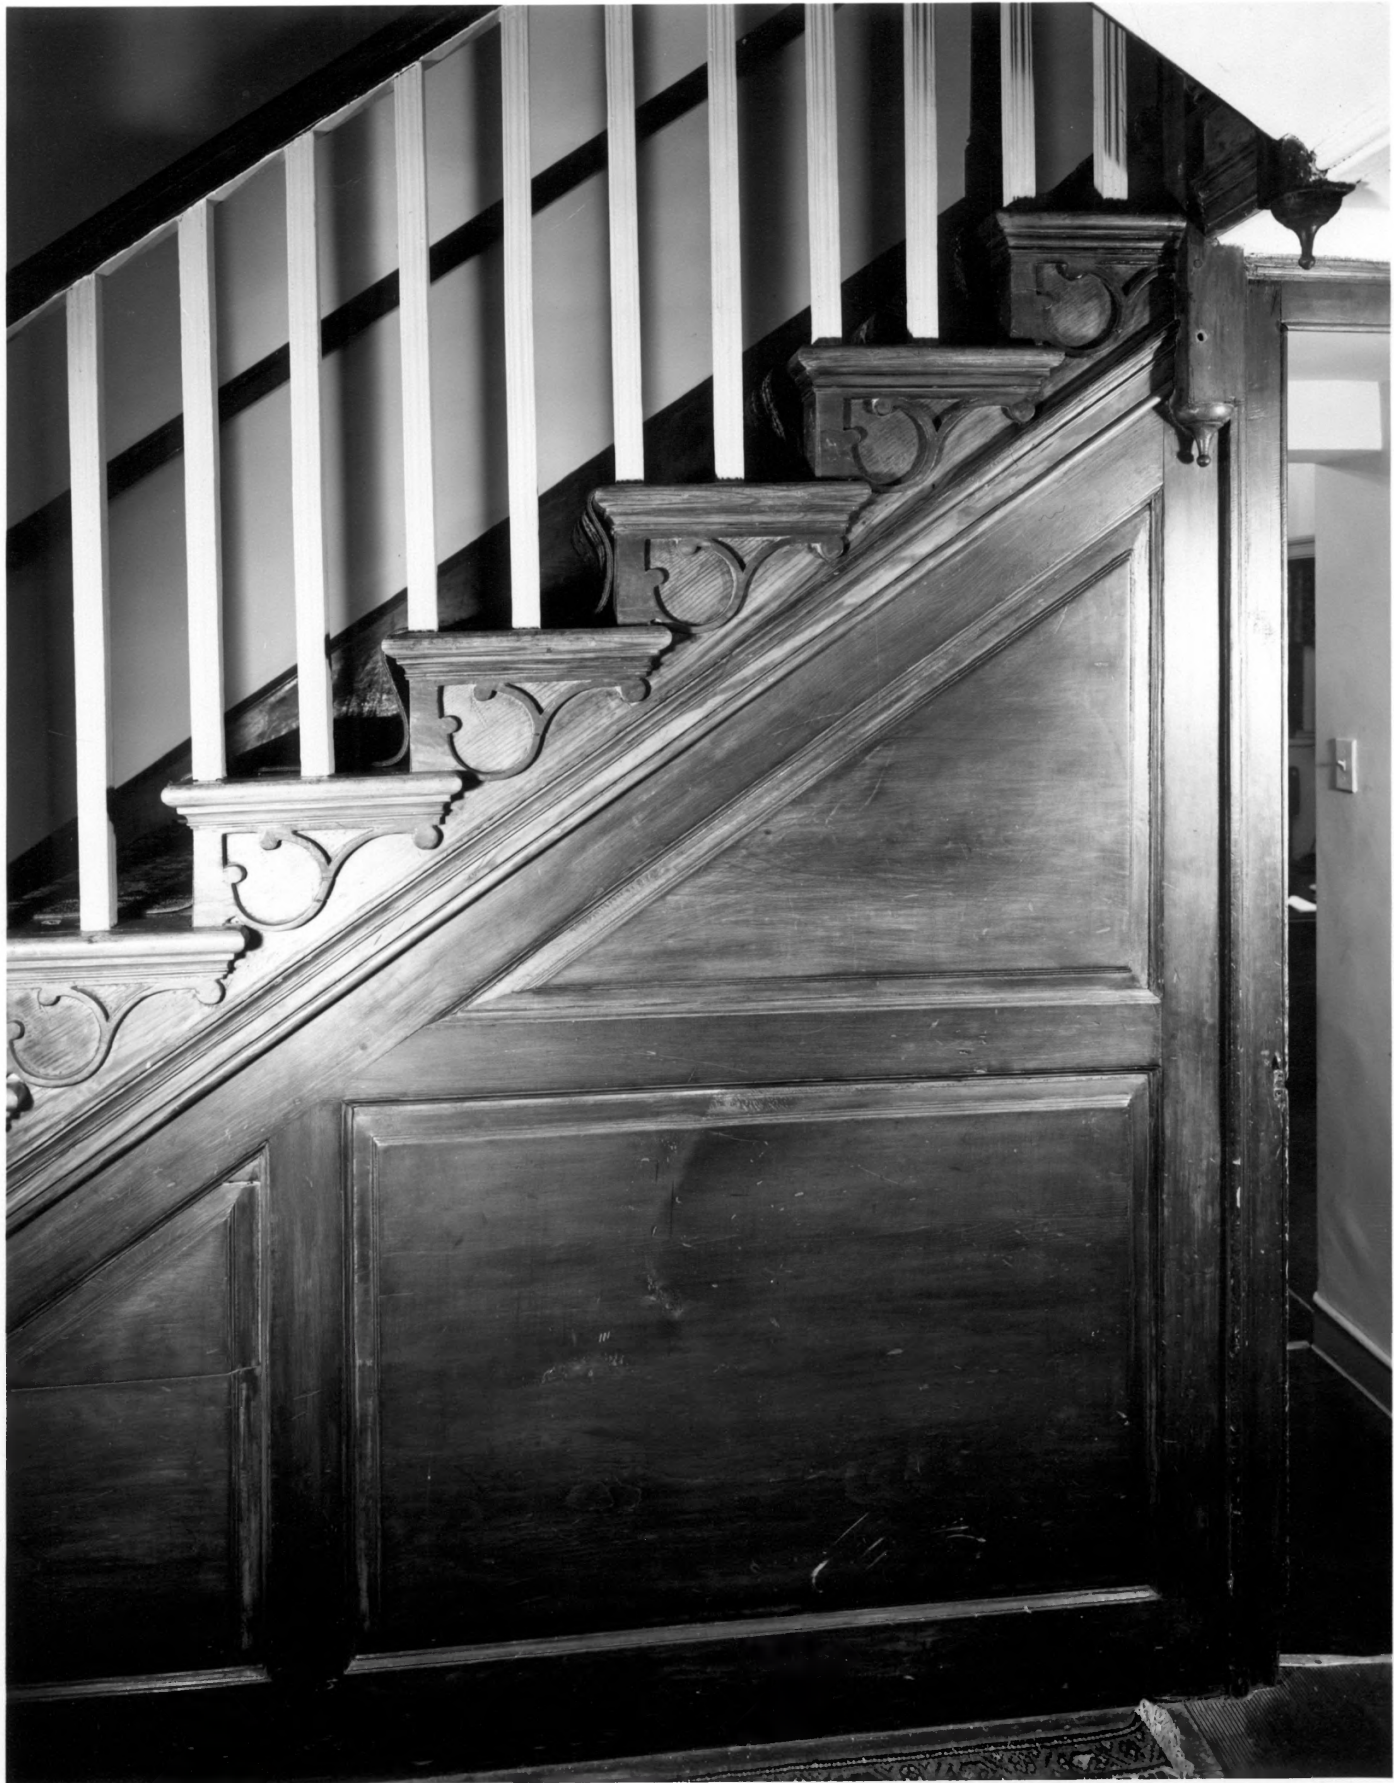
#3
SEE INSTRUCTIONS

1. NAME			
COMMON:		Starr House	
AND/OR HISTORIC:		Michael VanKirk House	
2. LOCATION			
STREET AND NUMBER: 1310 King Street			
CITY OR TOWN: Wilmington			
STATE: Delaware	CODE 10	COUNTY: New Castle	CODE 003
3. PHOTO REFERENCE			
PHOTO CREDIT:		George Eisenman	
DATE OF PHOTO:		February 1970	
NEGATIVE FILED AT:		In possession of the owner.	
4. IDENTIFICATION			
DESCRIBE VIEW, DIRECTION, ETC. Detail of the yellow pine paneling and step ends. craftsmanship of the early nineteenth century work is displayed at its best.

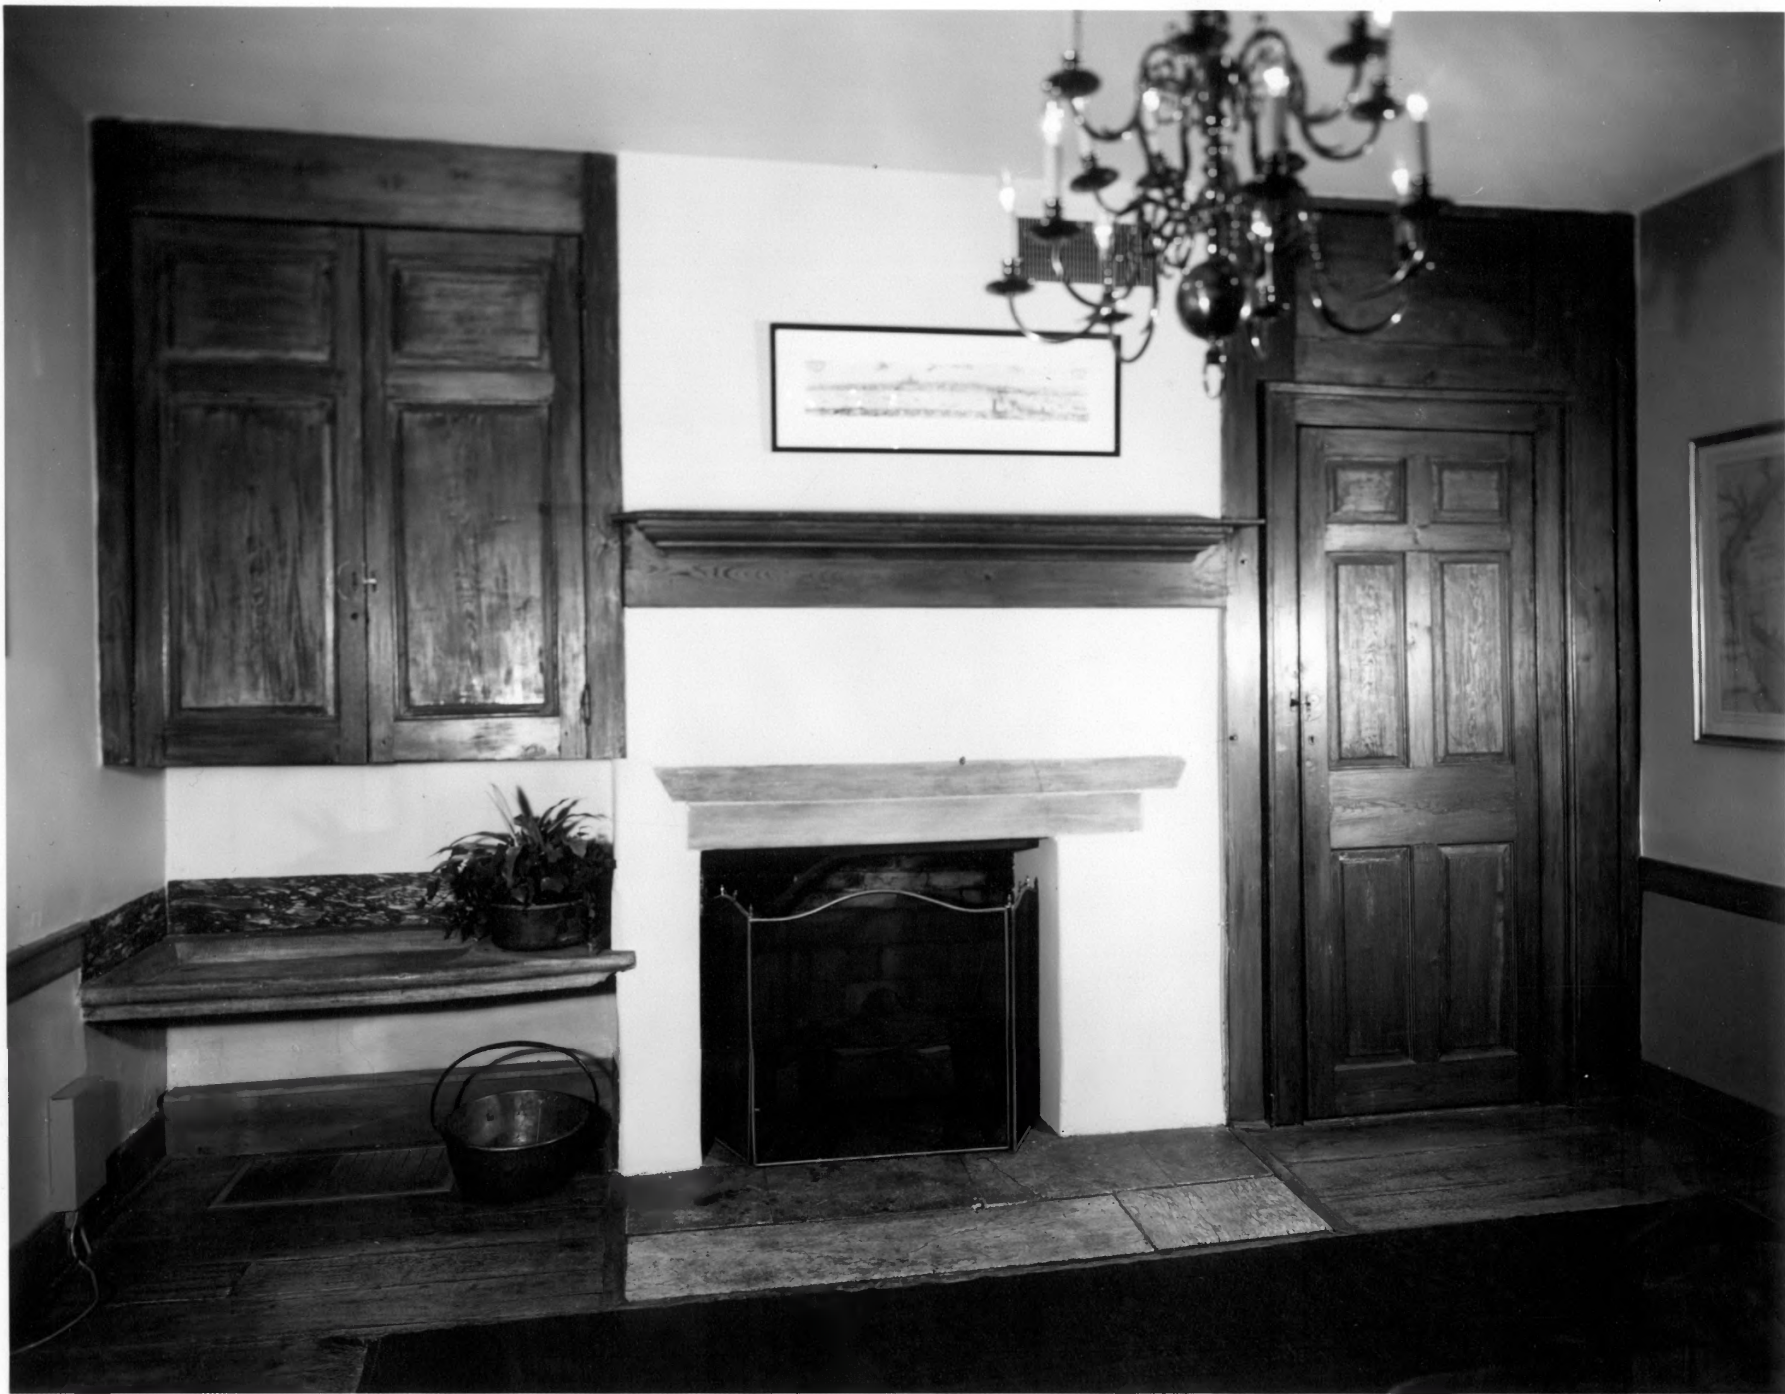
DESCRIBE VIEW, DIRECTION, ETC.
Dining Room Fireplace Wall. The manteltree is stone instead of wood. The shallow soapstone sink with its marble backboard is unusual. The simplicity of the room provides a vivid contrast with the parlour.

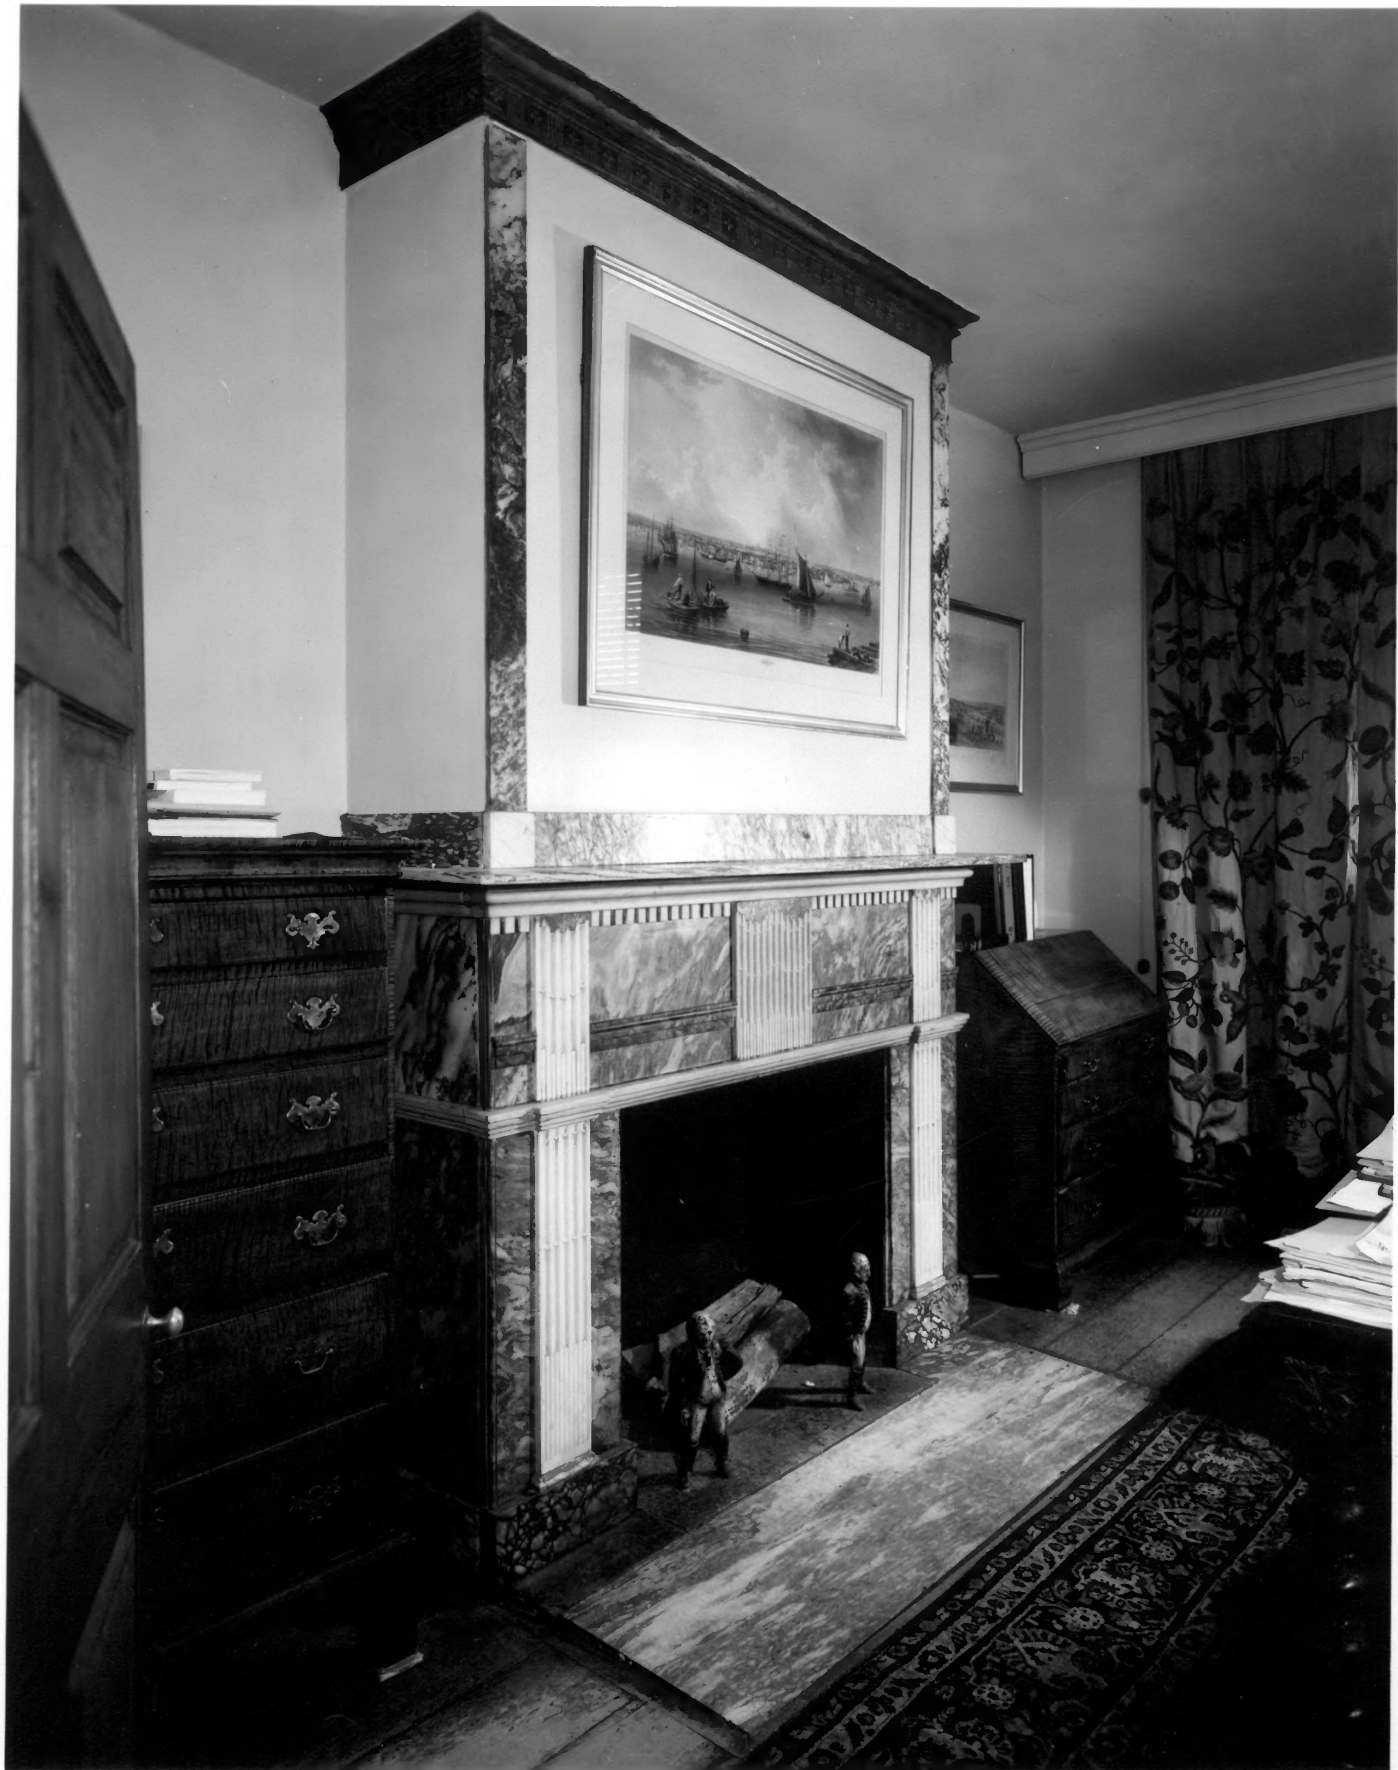
Title: Starr House - #5

1. NAME			
COMMON: <u>Starr House</u>			
AND/OR HISTORIC: <u>Michael VanKirk House</u>			
2. LOCATION			
STREET AND NUMBER: <u>1310 King Street</u>			
CITY OR TOWN: <u>Wilmington</u>			
STATE: <u>Delaware</u>	CODE <u>10</u>	COUNTY: <u>New Castle</u>	CODE <u>003</u>
3. PHOTO REFERENCE			
PHOTO CREDIT: <u>George Eisenman</u>			
DATE OF PHOTO: <u>February 1970</u>			
NEGATIVE FILED AT: <u>In possession of the owner.</u>			
4. IDENTIFICATION			
DESCRIBE VIEW, DIRECTION, ETC. <u>Parlour Fireplace. The parlour of the Starr House is to the right of the entrance hallway. The room has not been changed since Michael VanKirk built it. The most outstanding feature of the room is the carved marble mantel illustrated in the photograph. Also note the Chinese motifs in the cornice.</u>

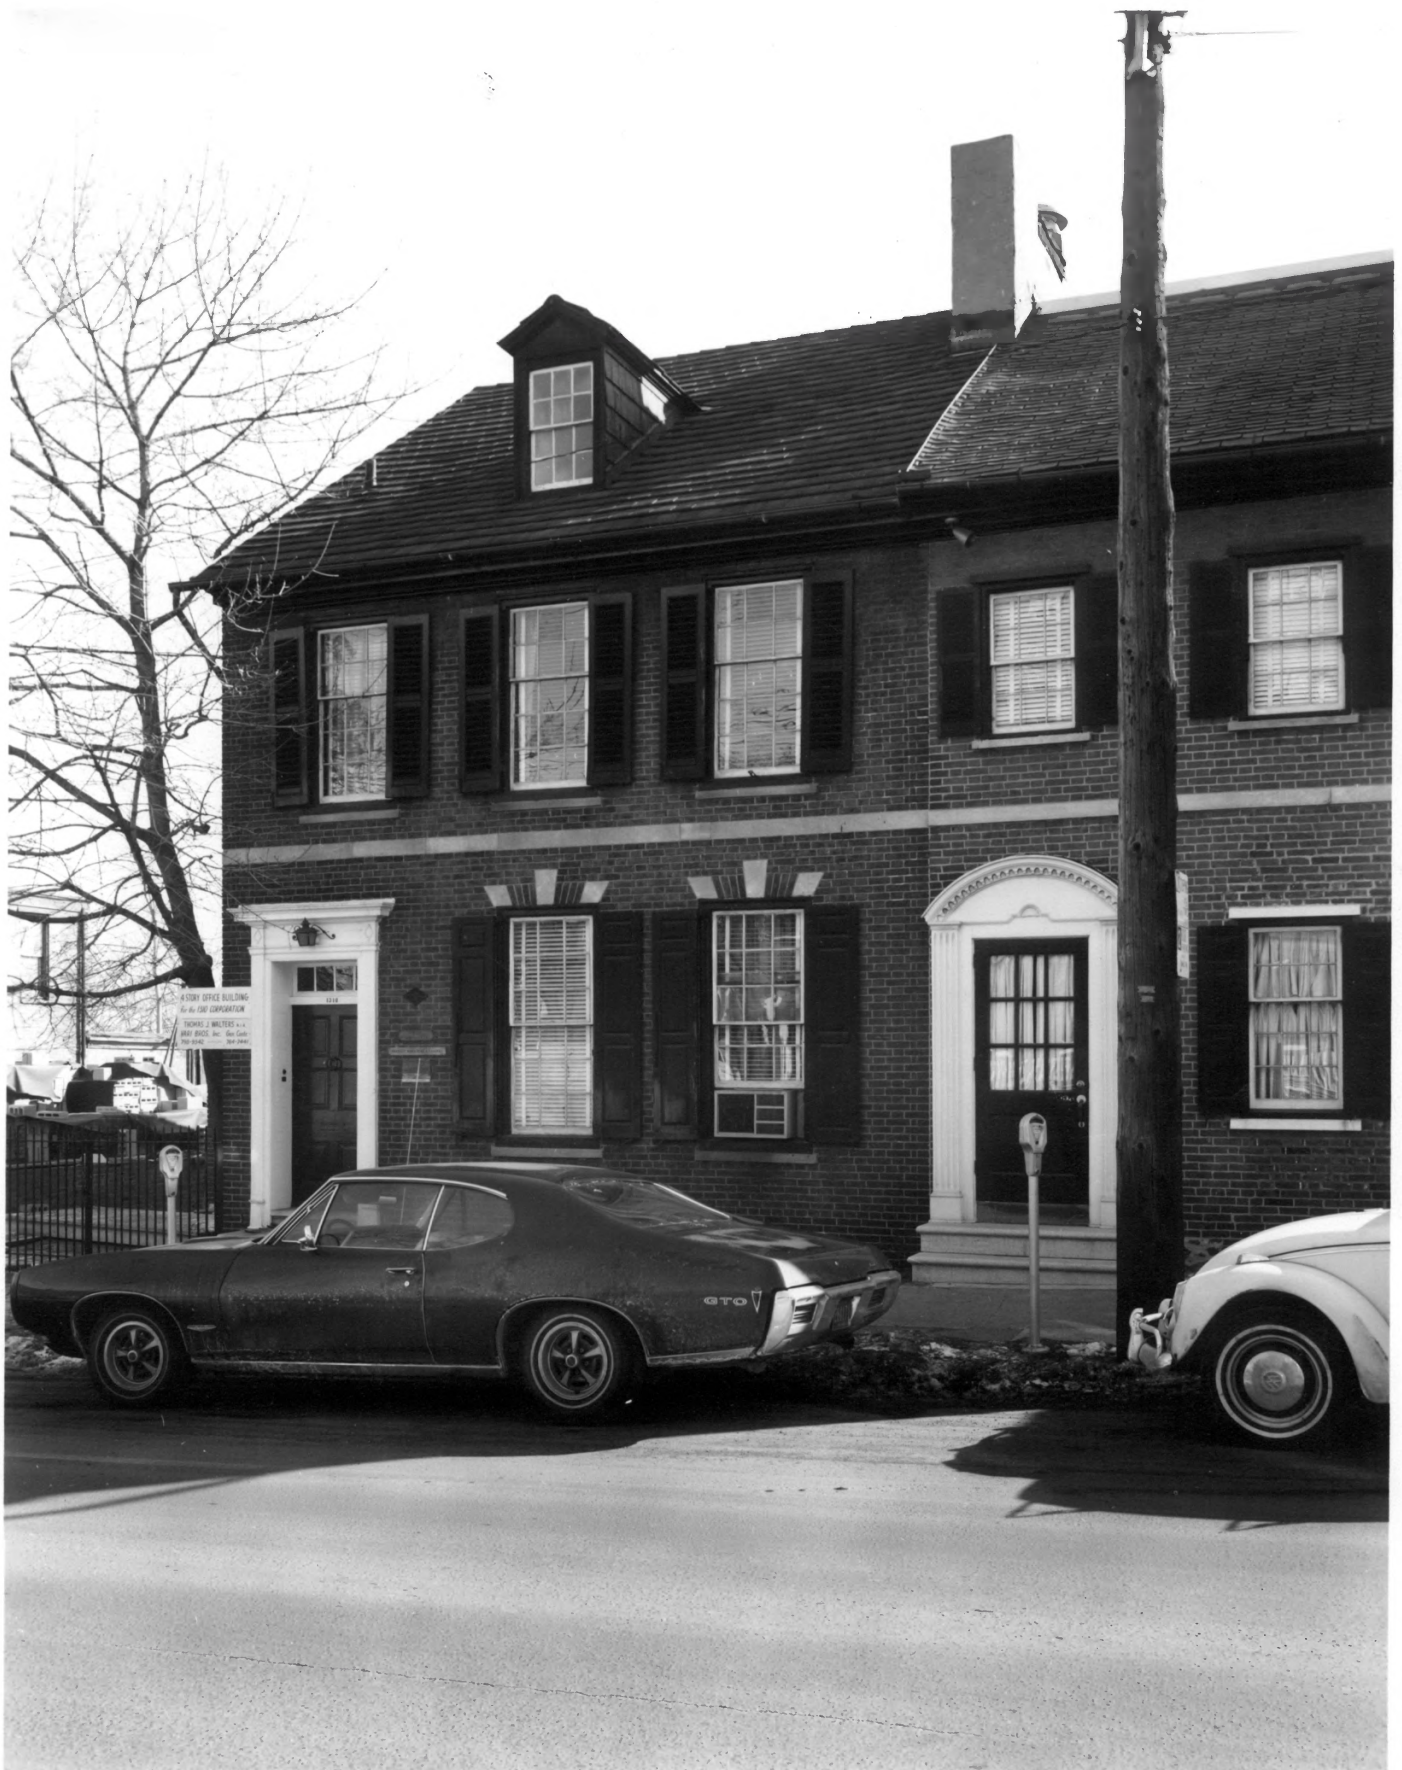
Title: Starr House #6

Exterior View, street elevation. The doorway, shutters and window frames are original. The roof is not. Note the change in the way the bricks are laid between the 14th and 15 courses.
