KENTUCKY HISTORIC RESOURCES INVENTORY

Site No. Oh-207

1. Historic Name(s) <u>Bayless quarters</u> Original Owner <u>Mrs. Nathan Bayless?</u>		22. ADD/County <u>Bluegrass / Bourbon</u>	
2. Present Name		23. U.S.G.S. Quadrant (15'/75') <u>N. Middletown Vic.</u> G.I.S. Mod.

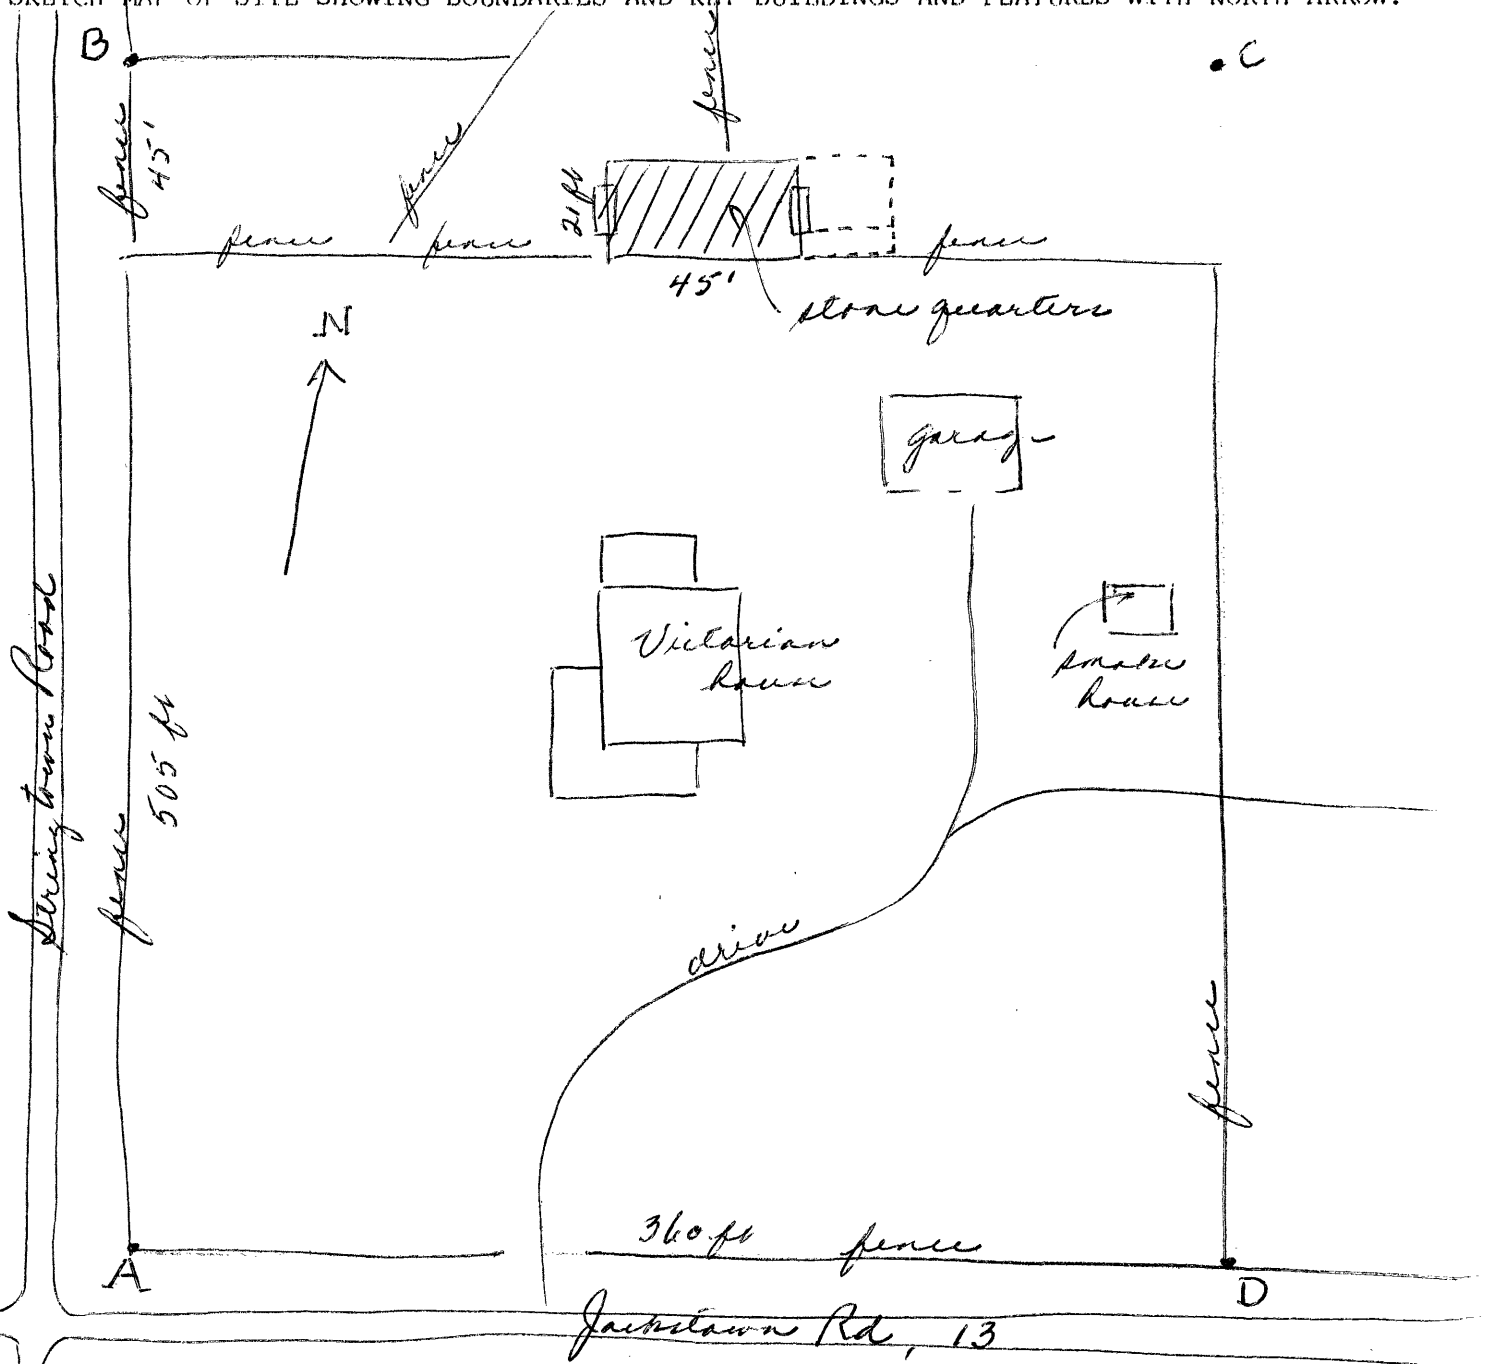
SKETCH MAP OF SITE SHOWING BOUNDARIES AND KEY BUILDINGS AND FEATURES WITH NORTH ARROW.

Beginning at A at the fence corner to Jackstown Rd and Springtown Road, thence N with fence and passing corner of yard, a total of 550 ft, thence E parallel to stone quarters 360 ft E B C, thence S, meeting fence & with fence a total of 550 ft to D at the Jackstown Road, thence with road 360 ft W to the beginning, containing the stone quarters, Victorian

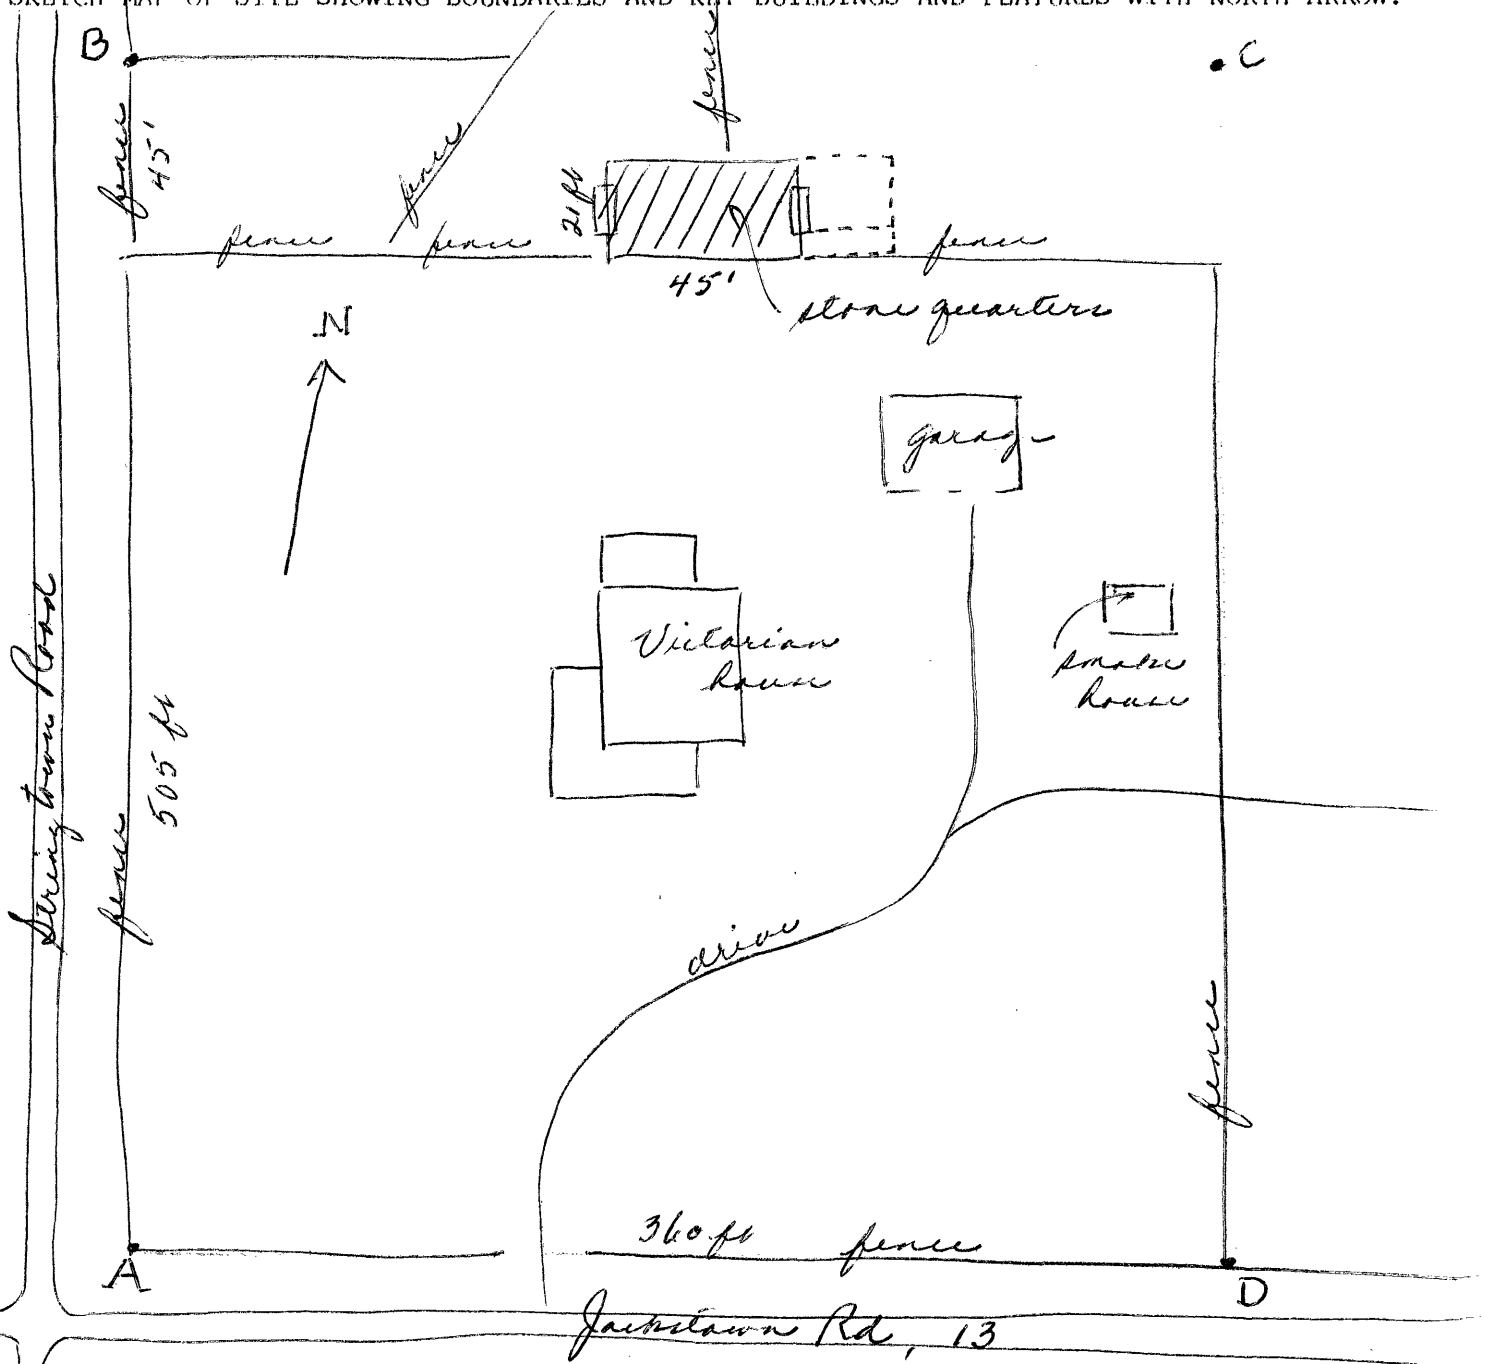
SKETCH MAP OF SITE SHOWING BOUNDARIES AND KEY BUILDINGS AND FEATURES WITH NORTH ARROW.

Beginning at A at the fence corner to Jackstown Rd and Springtown Road, thence N with fence and passing corner of yard, a total of 550 ft, thence E parallel to stone quarters 360 ft E B C, thence S, meeting fence & with fence a total of 550 ft to D at the Jackstown Road, thence with road 360 ft W to the beginning, containing the stone quarters, Victorian
