United States Department of the Interior
National Park Service
National Register of Historic Places
Registration Form

historic name Pyramid Guard Station

other names/site number 5RB.2882

Pyramid Guard Station
Rio Blanco County/ Colorado

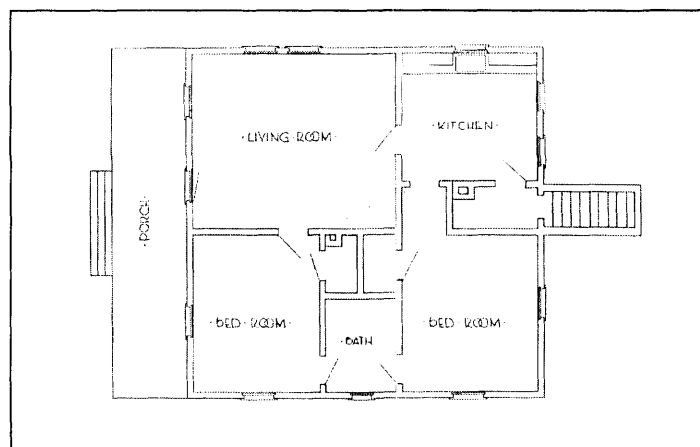
Typical Dwelling Footprint

The 1934 Dwelling (also referred to as the Guard Station and the Residence) was the first building completed. Rectangular in plan, the one-story building is covered by a wood shingled front gabled roof. Overhanging eaves shelter exposed rafters on the front and rear porches as well as the sides of the building. Two brick chimneys pierce the roof ridge at the center and the rear east side slope. Walls are composed of logs with saddle notching at the corners. On the north façade, a hipped roof porch is supported by four wood posts and shelters an off-center entrance and two 6/6 double-hung windows, one flanking each side of the door. All windows are original wood sash with wood trim. Of the three on the west wall, two are 6/6 double-hung while the central window is a shorter fixed 6 light. On the rear (south), two of three windows and an entry door are protected by a hipped roof entry hood supported by large triangular braces. The door is off center and is flanked by one 6/6 double-hung and one short fixed 6 light window. A second 6/6 double-hung window is off towards the west end of the wall. A wood door lifts up from the ground beneath the fixed window to provide cellar access. The east wall consists of paired 6/6 double-hung windows towards the north end, a 6/6 slider window (for the kitchen), and a small shed roof projection over a concrete framed opening towards ground level under the kitchen windows. The purpose of this projection is unknown.

James L. Brownlee, then District Head Engineer in Denver, developed the Dwelling design. Brownlee produced much of the Region's design work prior to creation of the Architectural Division in 1936. Brownlee's designs before 1934 were strongly influenced by the Bungalow. However, his design for the Pyramid Dwelling included the use of relatively simple materials, substantial construction (with heavy log walls), and a high degree of hand craftsmanship. These elements were characteristic of Rustic style architecture and mark the first formal use of the style within the Region. Regional designers would refine these stylistic elements throughout the early 1940s to develop their own interpretation of the Rustic Style. No plans for the Wood Shed, Blacksmith Shop, Combination Office Building or Barn at Pyramid are known to exist, but several are based upon standardized plans or building types.

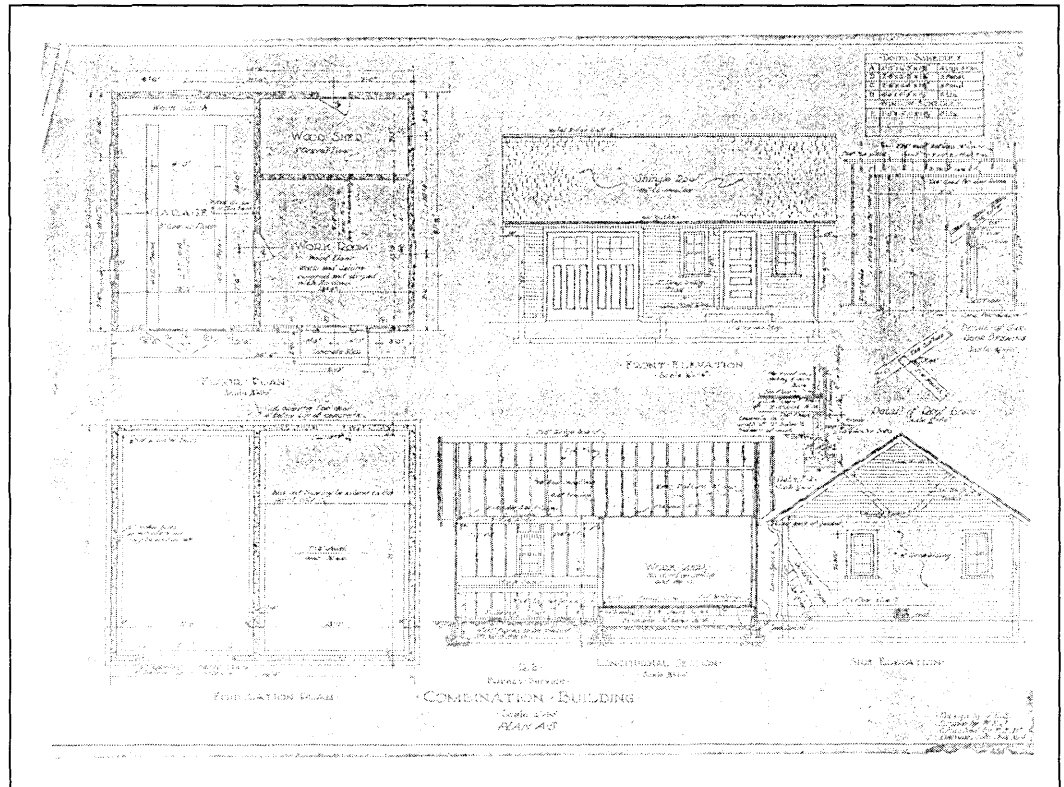
A5 Plan (Combination Building) Dated December 18, 1930

Though a standard plan for the Forest Service, when actually constructed, the Combination Building could be modified based upon the topography of the site and local materials available.

The one-story combination office building, also completed in 1935, was simply an A5 combination building constructed of logs. Sitting on a concrete foundation, the building is rectangular in plan with a side gabled roof covered by wood shingles. Overhanging eaves shelter exposed rafters. Walls are log with saddle notching at the corners. All casement windows and screens are original with wood trim. The building faces east and stands somewhat north of the Blacksmith Shop. The east façade contains a triple panel garage door that opens outward at the south end. The three garage windows are four light fixed. Towards the north end of the façade is the main entry wood door with a fixed four light window. Flanking the door are six-light rectangular windows. The north wall contains a paired six-light window at the eastern side, and, at the other end, a wood entry door without a stoop. This door was originally a window. The west (rear) wall contains a single six-light window to the north and a paired six-light window to the south. A brick chimney can be found along the western roof slope. The south wall contains two sym-metrically placed six-light windows. Interior chinking consists of exposed saplings.

The Combination Office Building was simply an "A5" constructed of logs. The A5 was part of a set of standardized administrative plans developed by the Regional Engineering Division in the late 1920s. This Bungalow-influenced series of frame buildings incorporated an office, small fuel or work room, and a single stall garage. Several administrative buildings from the "A" Series were completed within the Region during the late 1920s and early 1930s. The building's triple paneled garage door was a prototype which proved insufficient. A Regional Forest Inspector in 1937 noted that outward swinging doors were difficult to operate in the winter, due to heavy snow buildup around buildings. Later garage doors on these buildings were modified so that they either swung inward or folded upwards.

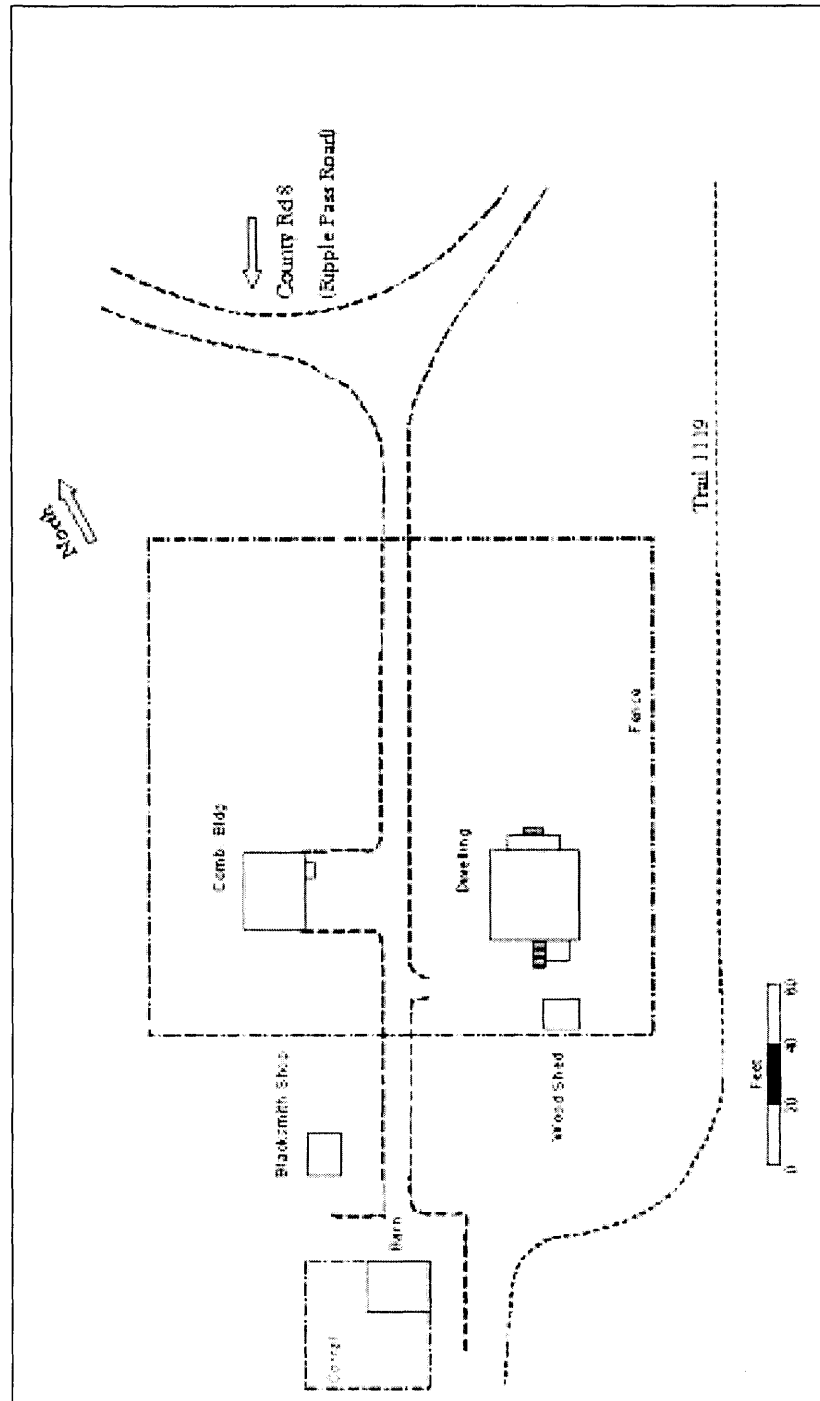
Site Plan

The buildings are clustered together in a small clearing within the Routt National Forest: the Dwelling and Combination Building sit across from each other, separated by the road/ driveway; the driveway terminates at the Barn after passing the Blacksmith Shop and Wood Shed. (See site plan) For ease in description, the façade of the dwelling will be referred to as north. All buildings are contributing.

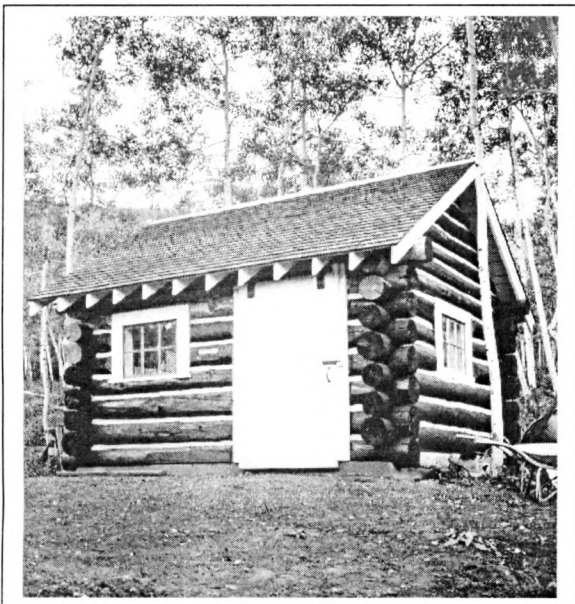
Completed in 1936, the Blacksmith Shop faces east towards the driveway and Wood Shed. Rectangular in plan, the one story building also has a wood shingled side gabled roof with exposed rafters. Walls consist of saddle notched logs that rest upon a concrete foundation. All windows are fixed six-light framed by wood trim. There is one window on the east façade, one on the north wall, one on the south wall, and none on the west (rear) wall. The entry door is a replacement and consists of a wood panel on a sliding track. Interior chinking consists of exposed saplings.

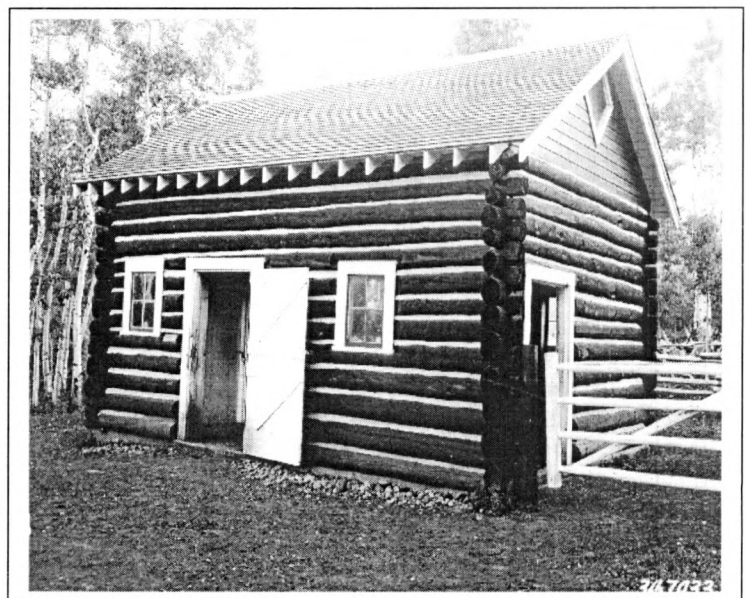
Barn

Constructed in 1935, the barn sits on a concrete foundation facing north. The one-and-a-half story rectangular plan building is covered by a side gabled, wood shingled roof with walls of log and exposed rafters. It stands at the terminus of the road into the complex. All windows in the barn are original 2/2 with wood framing. The diamond loft window in the apex of the west wall was a trademark element in early James Brownlee barn designs and is not seen in late CCC-era construction. A board and batten door with hinges provides pedestrian access on the north façade. One window stands immediately east of the door while the window to the west appears to be open without any glazing. The west wall contains the aforementioned diamond window, allowing for some light in the loft. A board and batten door is the only other opening on this wall. The south (rear) wall contains three asymmetrically placed windows. Chinking is seen towards the bottom of the wall. The east wall consists of two symmetrically placed windows and a rectangular hay loft door in the gable face. It is noted by a Forest Service archaeologist that the barn was thought to be moved in from another station and re-assembled at its current location, but nothing has been found to confirm that information at this time. A rebuilt corral consisting of a wood fence in a rectangular plan attaches to the west and south walls of the barn. It is made up of three horizontal wood rails connected at regular intervals to vertical wood poles.
