# National Register of Historic Places Registration Form

Historic name: Lampe, Wilhelm & William, Ranch

Other names/site number: Jacobs Family Berry Farm

Agriculture on the Carson River in Nevada's Douglas and Ormsby Counties

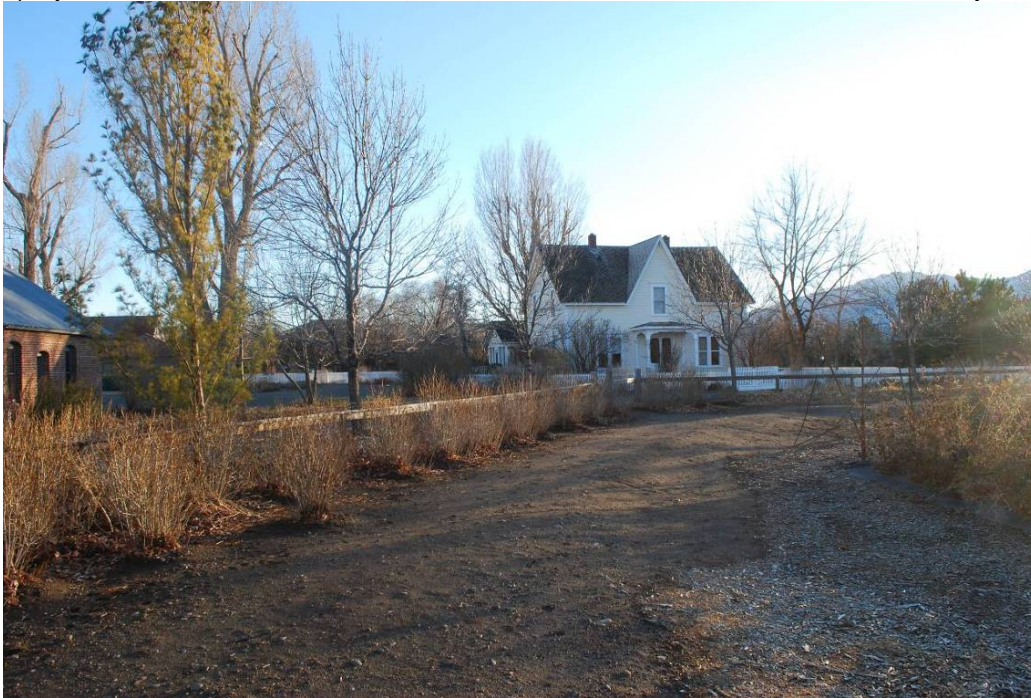
Photograph 1 – Fields, Ranch House, and Creamery (far left), looking southwest.

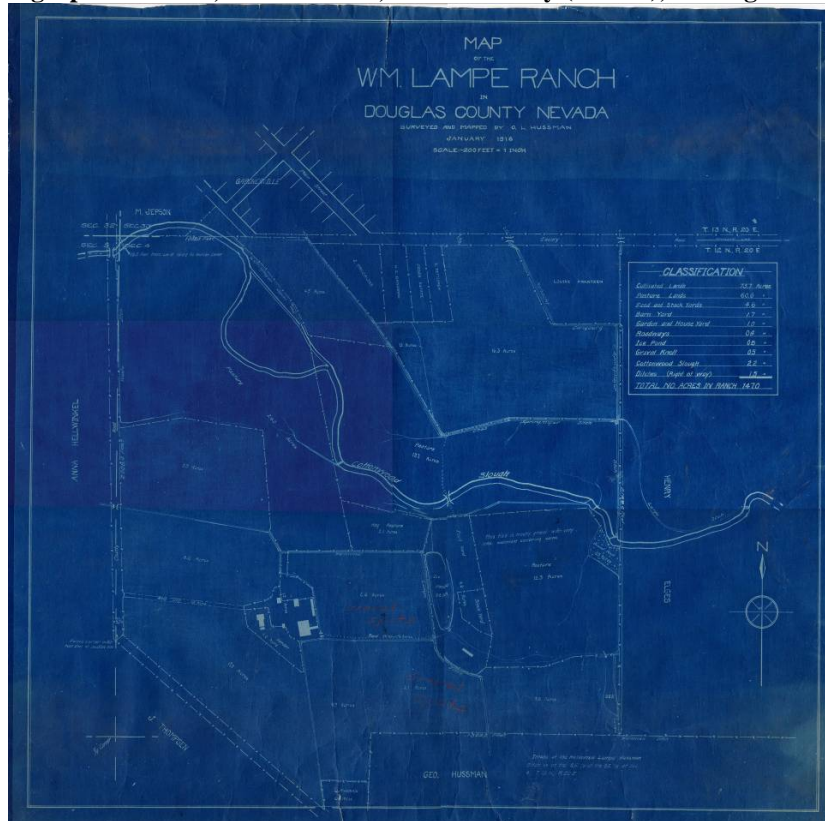
Lampe Ranch Plat Map, 1918 with 147 acres (Courtesy of Jacobs Family Berry Farm).

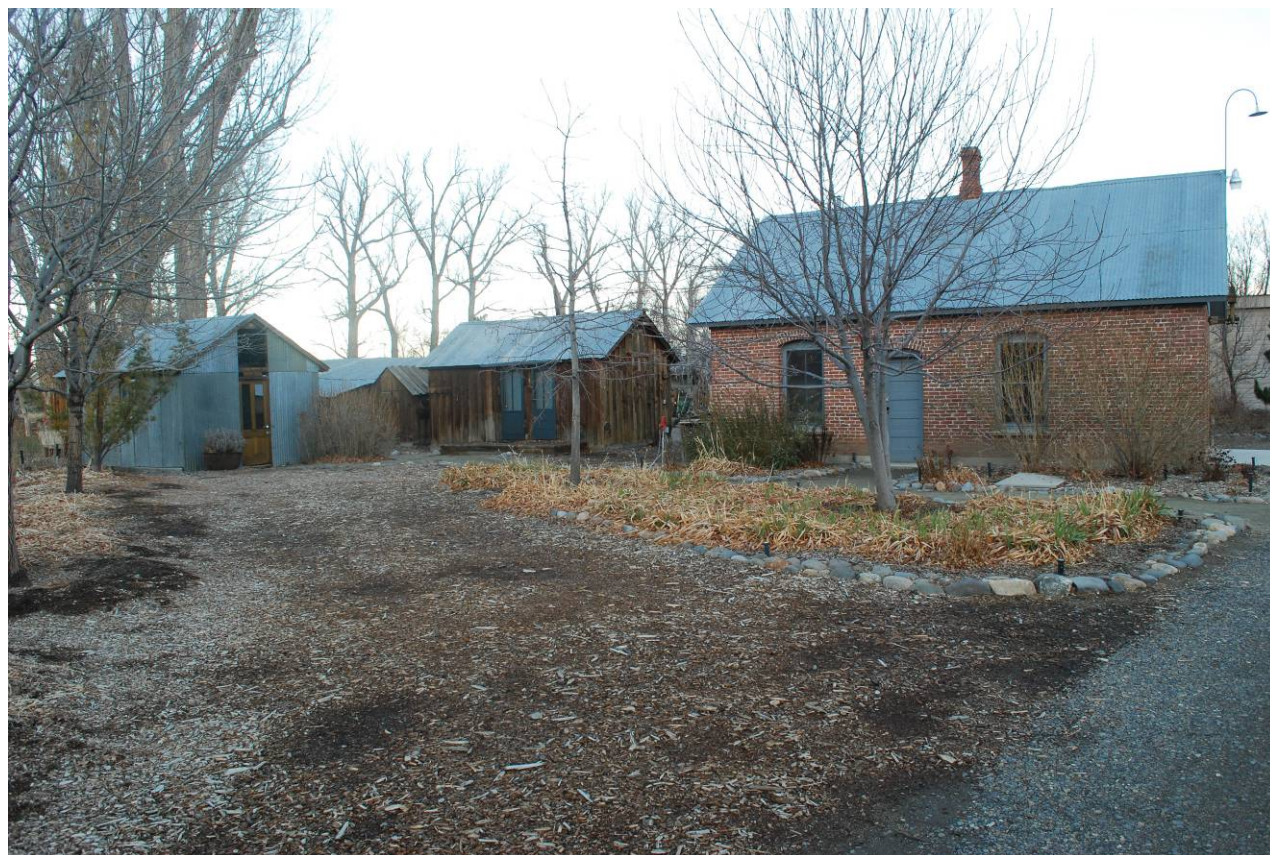
Photograph 2 – Example of cluster arrangement, showing Creamery (right), Bunk Shed (center), and Workshop (left), looking northeast.

The main Ranch House anchors the development's southwest corner, with the Barn at the southeast corner and a large open parking turnabout and dirt yard in between. Secondary buildings, mostly north of the turnabout space, are scattered to the north, including the Garage, Creamery, Chicken House, Workshop, Privy, Bunk House, and two loafing sheds. The two main non-contributing elements are the Warehouse and the Guest House, which were constructed amid the historic buildings. Although they are compatible with the historic use and setting of the ranch, the Warehouse does represent an obviously modern disruption of the otherwise nineteenth and twentieth century character of the ranch. Running along the east side of the property is the former Lampe Ranch Canal which provided water from the East Branch of the Carson River, which is diverted approximately 1.25 miles southeast of the property. Although the fields are mostly developed, the canal system is still active and is used to irrigate some parts of the property. The embankments, culverts, bridges, and diversion boxes remain. Historic trees, mostly cottonwoods (*Populus* sp.) remain throughout the property, providing shade and windbreaks.

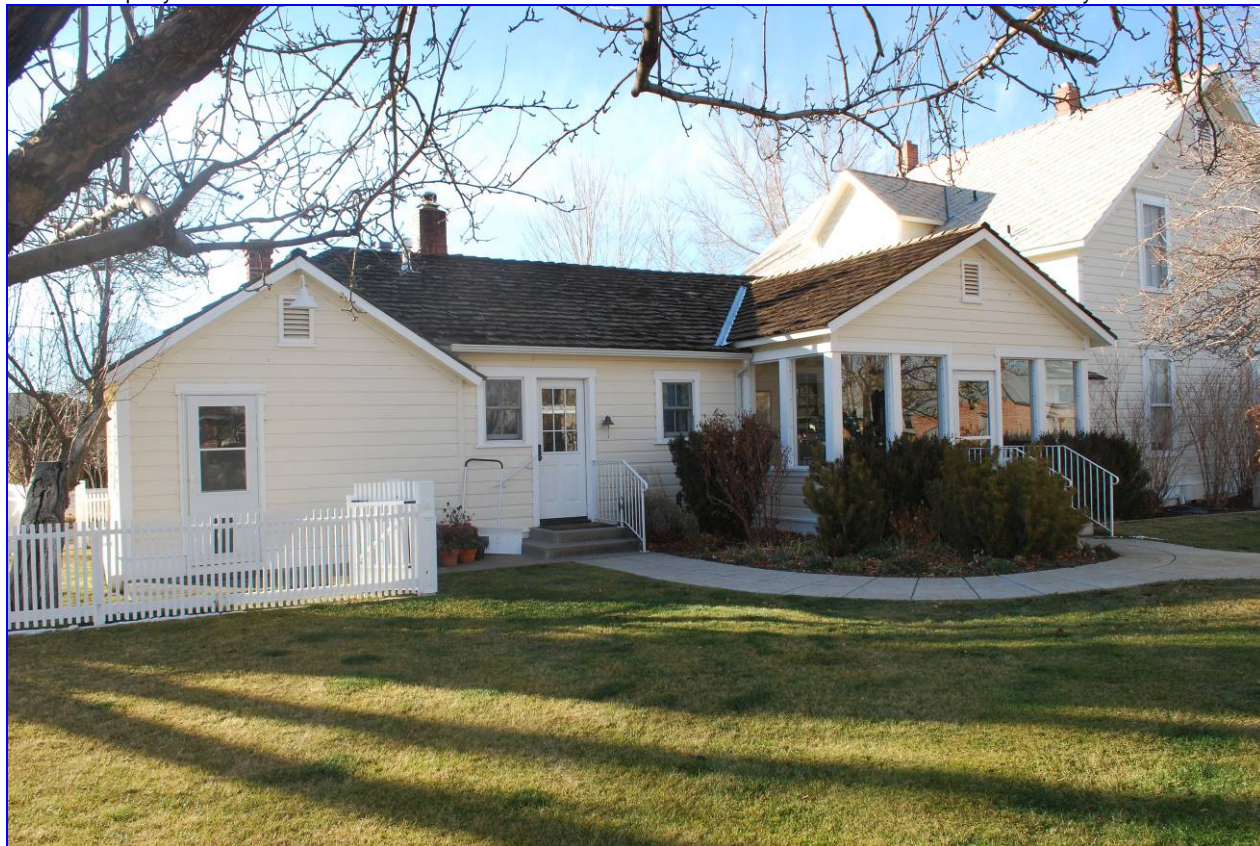
**Photograph 4 - Lampe Ranch House, east elevation, looking west, showing additions to rear of the main house including historic Cold Storage building. (left).**

The Lampe Ranch House, constructed in 1898 by Wilhelm and Maria Lampe, is an extremely late example of the Gothic Revival-style. It is a two-story home following the Centered Gable variety of residences in this style. The main section of the house on the north end has a moderately-pitched, side-gabled roof with a steeply-pitched intersecting gable centered on its north façade and a second-story, centered, gabled dormer breaking the rear (south) roofline. The roof is asbestos tile, added in approximately 1915 after a fire burned away a portion of the historic wood shingle roof. Two red brick chimneys break the roof crest. Extending from the north section to the south was a single-story extension, with a red brick chimney near its southern terminus. All siding is wood, dropboard, and all foundations are concrete perimeter, in some cases reinforcing historic rock pilings with lime grout, or slab. This extension received an addition in 1965 that in-filled space between a storage building and the main house. The storage building, also present by 1918, is a single-story front-gabled frame building with dropboard siding and heavily insulated walls, having served as a cool storage room for produce prior to the electrification of the ranch. Records and observation suggest that the 1918 storage building was initially the first residence for the family, built in 1872, but the historical record is not clear. The practice of expanding relatively simple homesteads into larger, architecturally extravagant dwellings was not uncommon in western agricultural areas. However, the two-over-two wood sash windows and dropboard siding matching that on the main Gothic Revival house suggests that regardless of the date of construction, the building was heavily remodeled in or after 1898 along with the construction of the main portion of the house. In 2007, the owners made a gable-roof extension from the 1962 addition to the east, creating a new entry and glassed in sunroom on the elevation.<sup>1</sup>

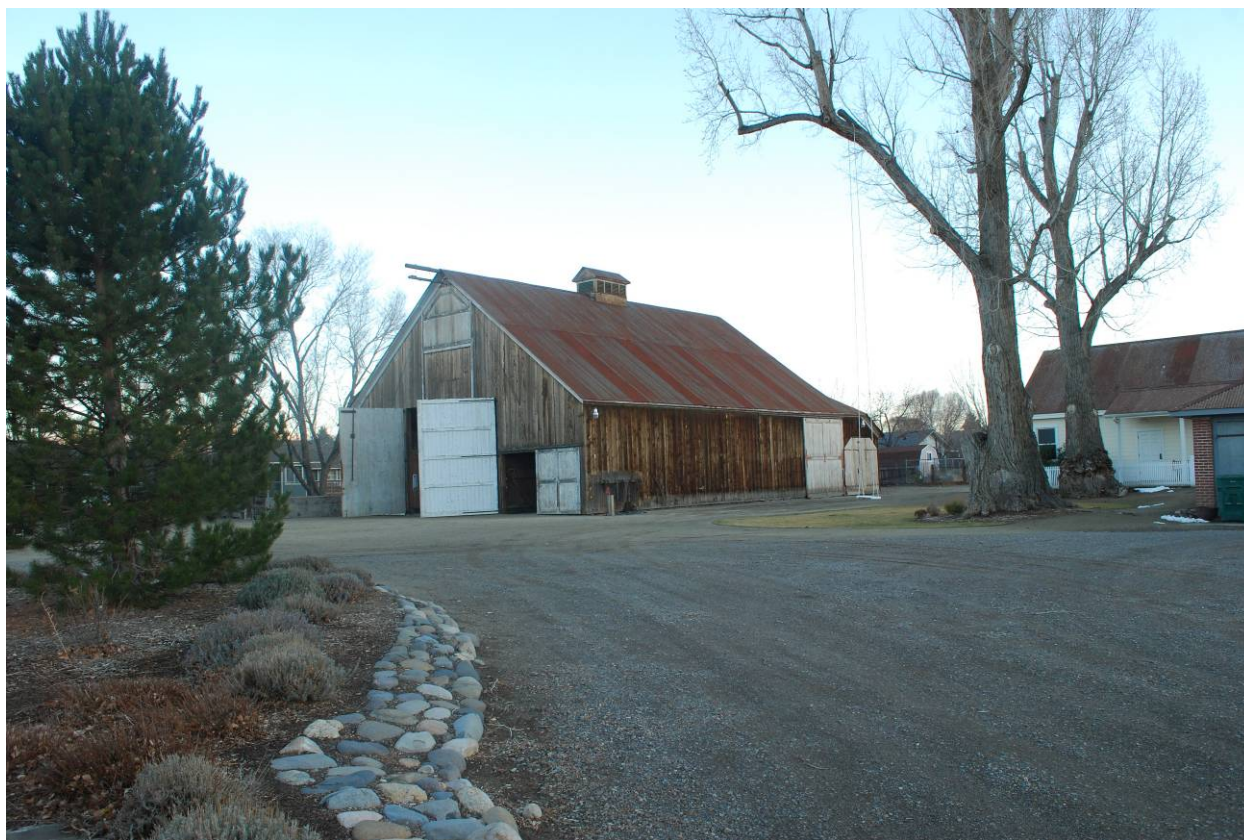
Photograph 5 – Barn, viewed from central driveway, looking southeast.

2. Barn, 1901, (w/ addition c.1920s), contributing building

The barn is approximately 55' wide and 82' long with four bays and three aisles, two large lofts, and two large granaries. It has a moderately-pitched, corrugated steel, front-gabled roof that faces north, with an extended monitor breaking the roof crest at its center. The barn has a single-entry center hall with side-aisle configuration. Side walls along the east and west elevations are roughly two-stories tall. The north façade is dominated by large, two-story swinging panel doors providing access to the barn's center aisle. The side aisles have single-story heavy sliding doors mounted on steel tracks on the façade. A shed roof extension was made onto the rear of the barn, either constructed originally or added onto the barn later to house small grain bins. Exterior walls are all flush 2"x10" unfinished boards.

The barn has heavy timber, mortise-and-tenon framing with selective reinforcement with steel bolts and straps, resting on embedded foundation stones. Oatman provides a detailed description of the barn's structure:

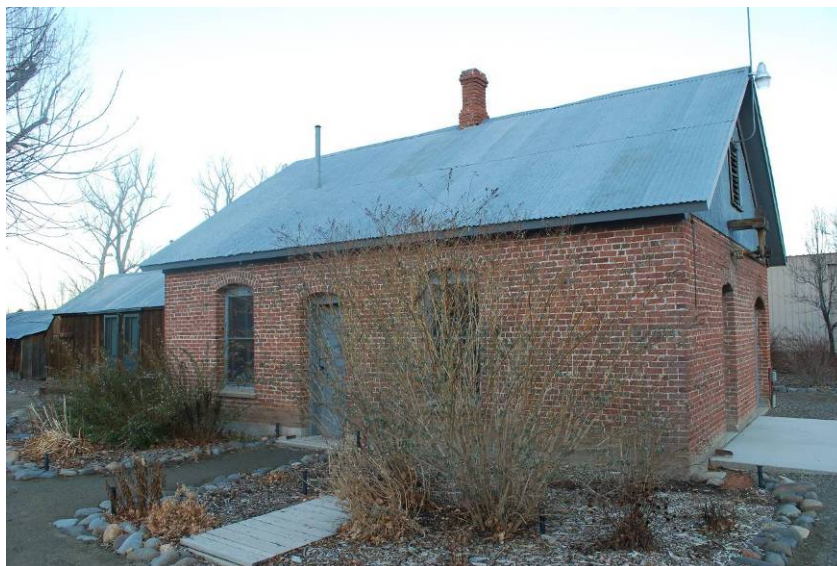
The Creamery, referred to as the Tank-house by William Lampe, is a one-and-one-half story red brick masonry building with a moderately-pitched, corrugated steel, front-gabled roof built by Wilhelm Lampe in 1909. It sits on a concrete slab foundation, its brick outer walls are common bound, and the gable ends are sheathed in corrugated steel, broken by large attic vents. A tapered, concave brick chimney breaks the roof crest near the center of the building. Entries and window ports have concrete sills and arched brick lintels, with wooden jambs. Windows are two-over-two wooden sash windows, and doors are un-lit wood panel doors. There are a total of four entries, including two on the south façade, one on the east elevation near the northeast corner, and one on the west elevation near its center. Along the north elevation, two small window ports are present, one being a divided wood casement and the other being boarded over with 1"x2" paneling. On the west elevation, two one-over-one windows are present along with an un-lit wood panel door. A line shaft, likely providing belt driven power to the ranch complex, remains on both the interior and south façade of the building, although the gas engine generator is no longer present.<sup>6</sup>

The interior is divided into three primary spaces divided by secondary, plastered red brick walls. The southwest corner of the building is the primary separator room, that is now the retail space for the Jacobs Family Berry Farm. The northwest corner is storage space. Running the east length of the building is the storage room, dominated by a large, blackened steel tank. Although its use remains in question, it is possible that the tank served as milk storage during the ranch's height as a dairy operation.

**Photograph 9 – Creamery, west elevation, looking northeast. Note the belt-driven assembly in the gable end above the entrance (far right). The bunk shed can be seen at the far left behind (north of) the Creamery.**

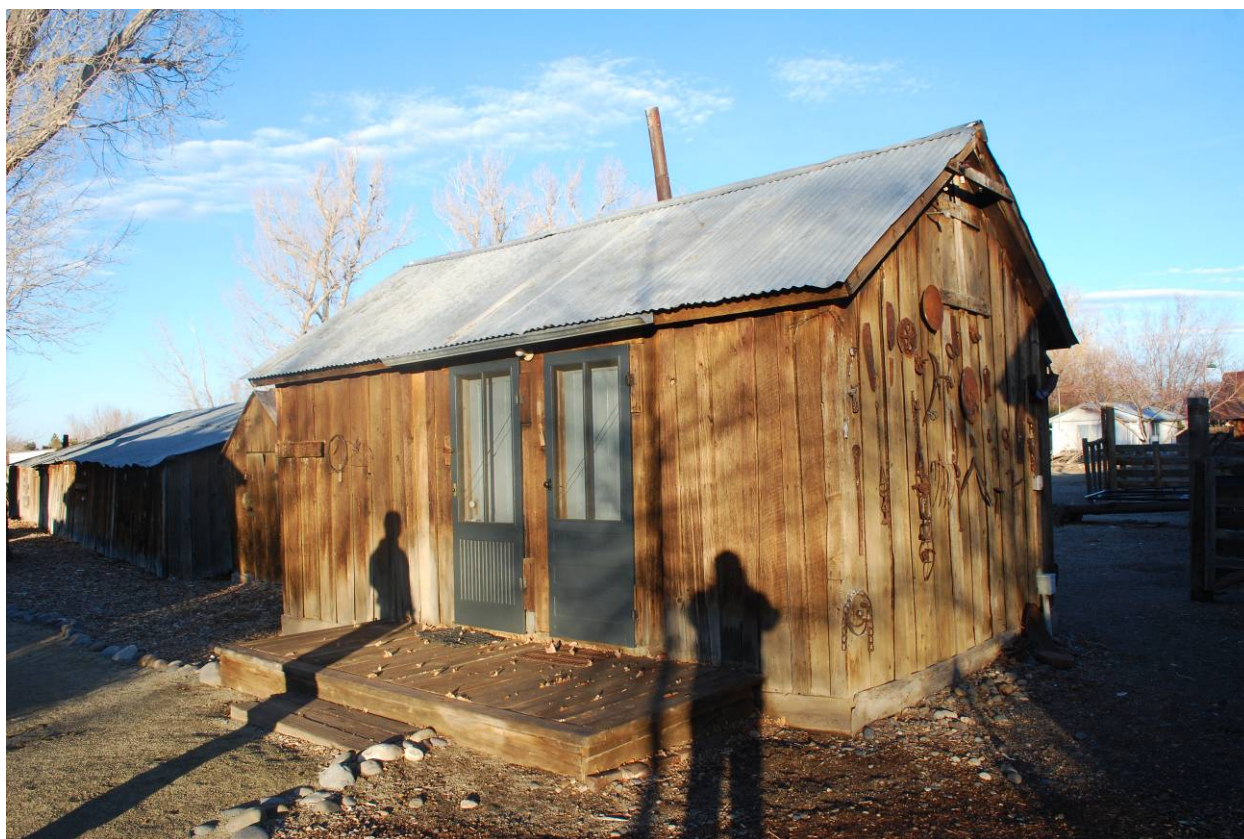
The bunk shed is a small, side-gabled building with a moderately-pitched, corrugated steel roof and board-and-batten siding. It does not have a foundation, but rests on a wooden sill laid on grade. There are two horizontal sliding windows on the north and east elevations, and a third vertical sliding window on the east elevation. There is an access door to the attic on the south side. A wall divides the interior space into two living units, with separate entrances on the west façade. The doors are unlit wood panel doors. The interiors retain strong integrity to the early-twentieth century, with interior walls lined with flush 2"x6" paneling, as well as built-in wood shelving. Although the wiring of the building has been upgraded, the original push-button light switches remain. Carved graffiti from ranch workers remain on the interior walls.

Photograph 10 – Bunk Shed, west façade and south elevation, looking northeast.

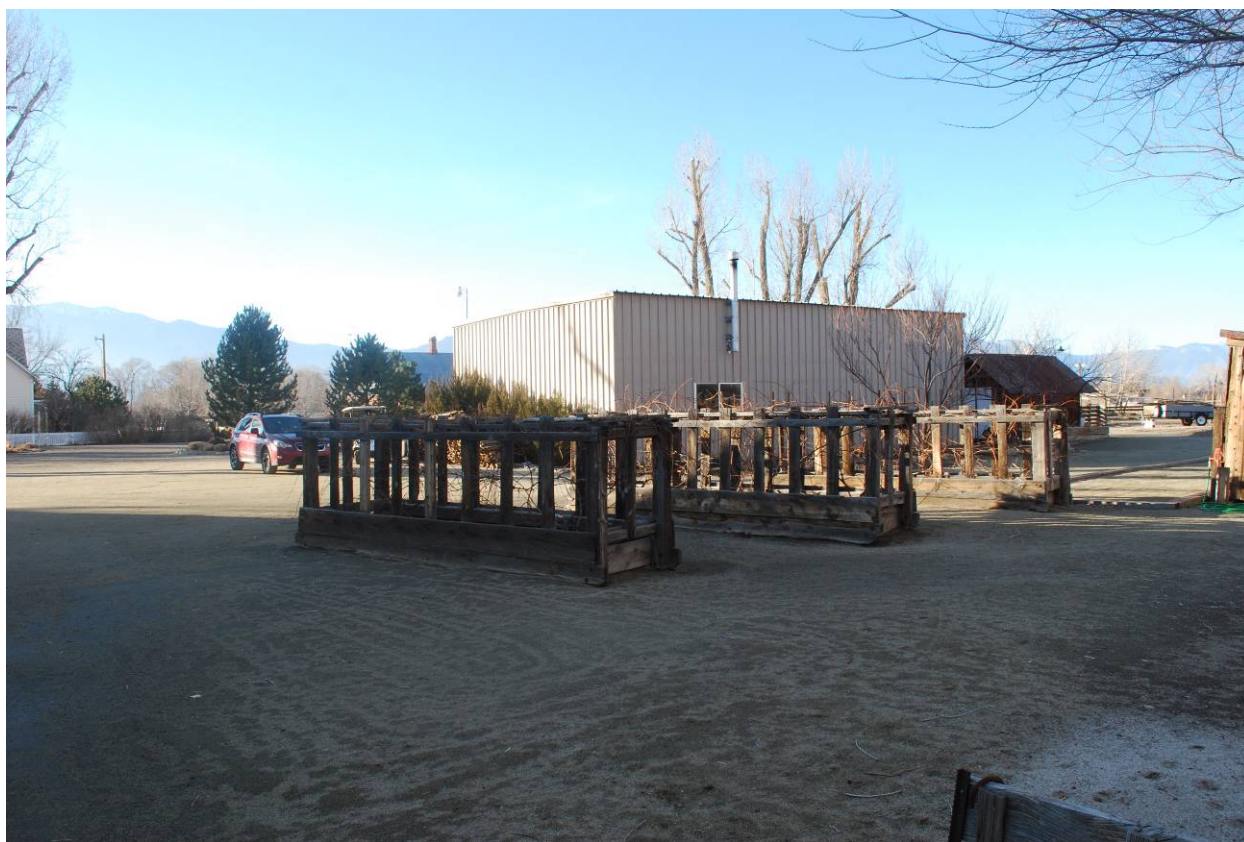
The Warehouse is a two-story building on a concrete slab foundation with standing-seam steel walls and a very slightly pitched, gabled roof, also of standing-seam steel. The exterior walls are relatively unbroken, except for a single-view double window on the east elevation near the southeast corner, a simple panel door on the south elevation near the southwest corner, and a large track garage door on the west elevation near the southwest corner. A ventilation stack vents above the east entry, and a security light breaks the roofline above the garage door. Historic photos indicate that a smaller, one-and-one-half story livestock and equipment barn, as well as an adjacent equipment shed or pig barn, had been on this location, but either burned down or was demolished sometime after the 1950s, and was replaced in 1965 with the current building. A farm and asset inventory series sent from Lampe to the University of Nevada, Reno notes three barns, two sizeable and one small in 1930 but only two barns, one small and one large in 1931.

**Photograph 11 – Warehouse, and grape arbors, looking northwest from northeast corner of the Barn.**

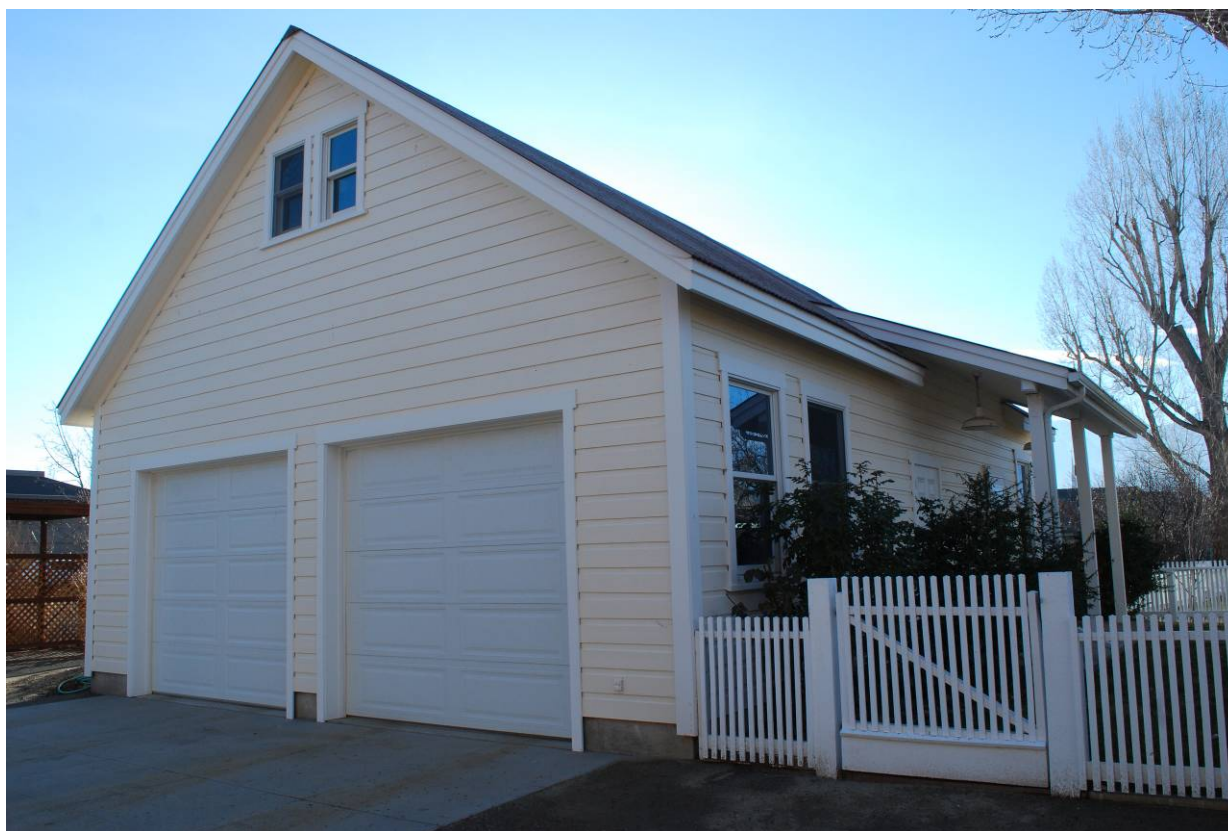
The Guest House is a small, one-and-one-half story residence and garage near the southern end of the property. It has a moderately pitched, side-gabled roof of corrugated steel and wood drop-board siding, allowing it to be stylistically compatible with the historic Ranch House to its northwest. It sits on a concrete slab foundation, and has a pair of large garage doors with a driveway breaking its east elevation. There is a shed porch with squared posts on the north façade, with a simple panel door. Windows on the façade and in the gable ends are vinyl one-over-one windows, both single and paired, of varying sizes. A modern wood picket fence encloses a small yard space around the building's north façade, and is designed in the same style as the fence surrounding the Ranch House.

**Photograph 12 – Guest House, east and north elevations, looking southwest.**

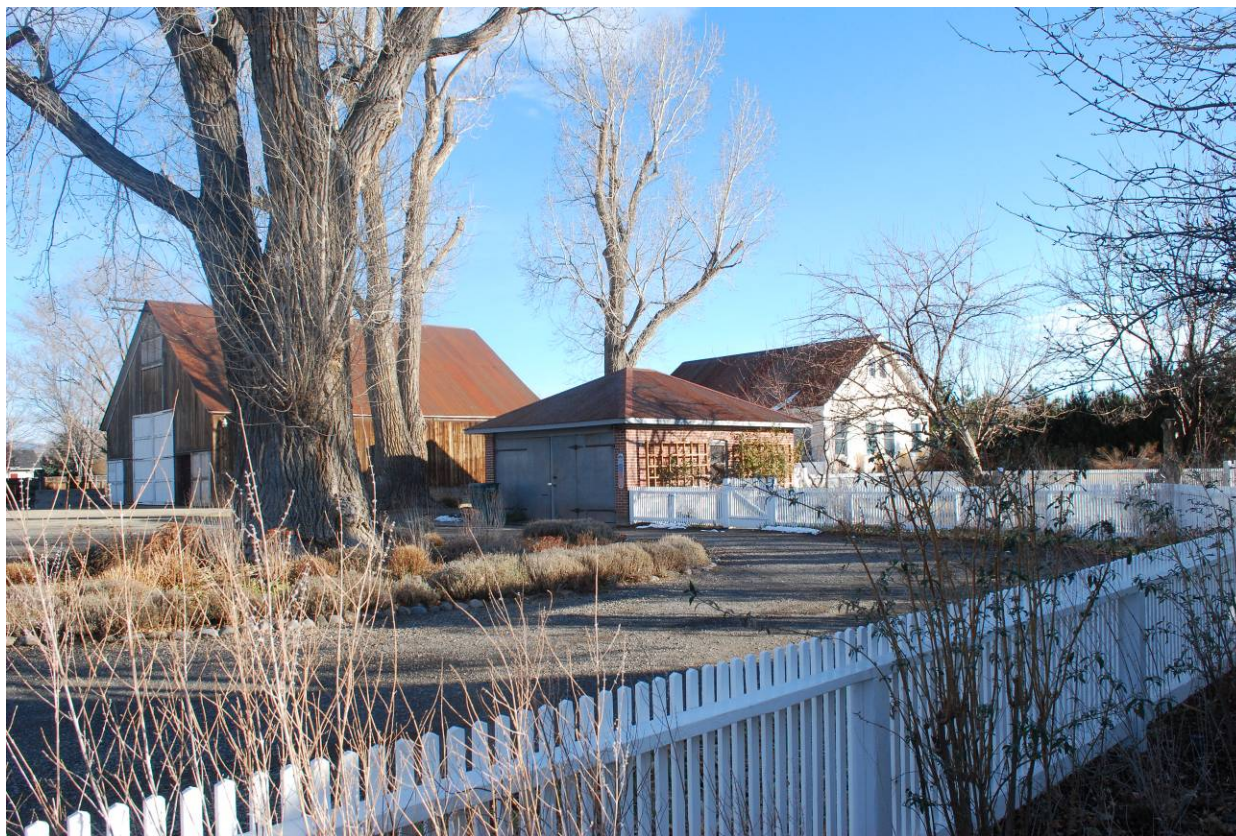
The Garage is a single-story, frame structure with a red brick veneer and sits on a concrete slab foundation, and has a hipped roof with boxed eaves and corrugated steel sheathing. Its north façade is dominated by paired, double-hinge, riveted steel doors, with a small man-door in the middle. The side and south elevations have wood, one-over-one sash windows with arched lintels, red brick sills, and wood screen covers. The interior includes a concrete cutaway drop on the interior for working underneath vehicle chassis. A c.1930s fuel pump and gas tank was situated at the northwest corner of the garage, but has since been removed.

**Photograph 13 – Garage (center), with Barn and Guest House in background, looking southeast.**

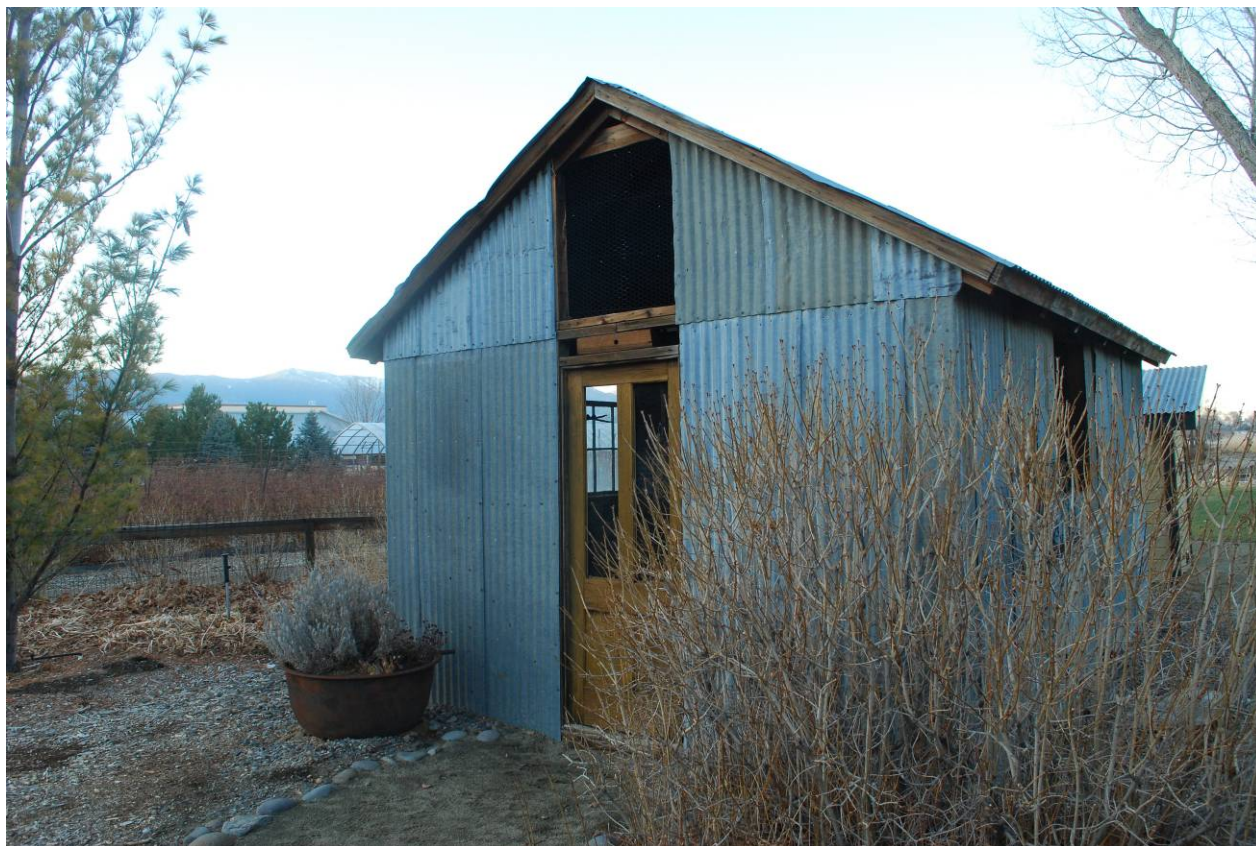
The Workshop is a small, one-story, front-gabled structure with corrugated steel walls and roof. It does not have a foundation, but sits on a wooden sill rested on grade. The building has a simple wooden frame, a salvaged entry door on its south façade, and what appear to be salvaged wood windows on all three remaining elevations, one fixed square (east), one fixed with an arched top (north), and one 2x3 (west). The gable ends above the south entry and north window are open but screened, likely as ad-hoc vents. The interior space contains late-nineteenth and early-twentieth century blacksmith equipment, indicating the structure's historic use. A panel on the rear has painted lettering on it reading:

Photograph 15 – Workshop, south façade, looking northwest.

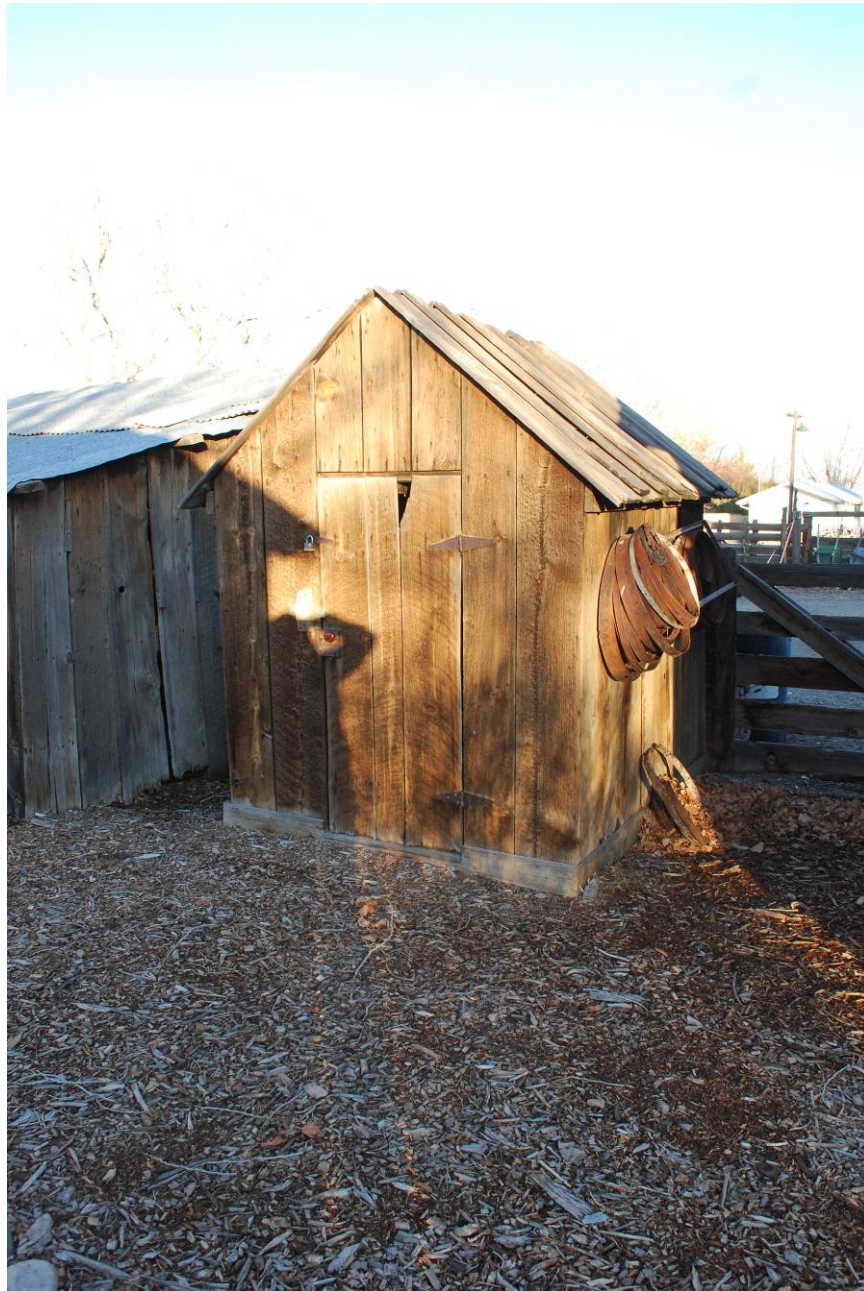
The Smokehouse is a simple, one-story front-gabled structure sitting on grade with no foundation and facing west. It has flush vertical board walls and roofing, with the roof secured with additional battens. A doorway of flush boards is on the west façade, and there do not appear to be any windows in the building. Hooks for equipment are on the north wall's exterior. It is possible the structure was built earlier than the 1920s, but it is first confirmed in records by the 1920s.

Photograph 16 – Smokehouse, west façade, looking northeast.

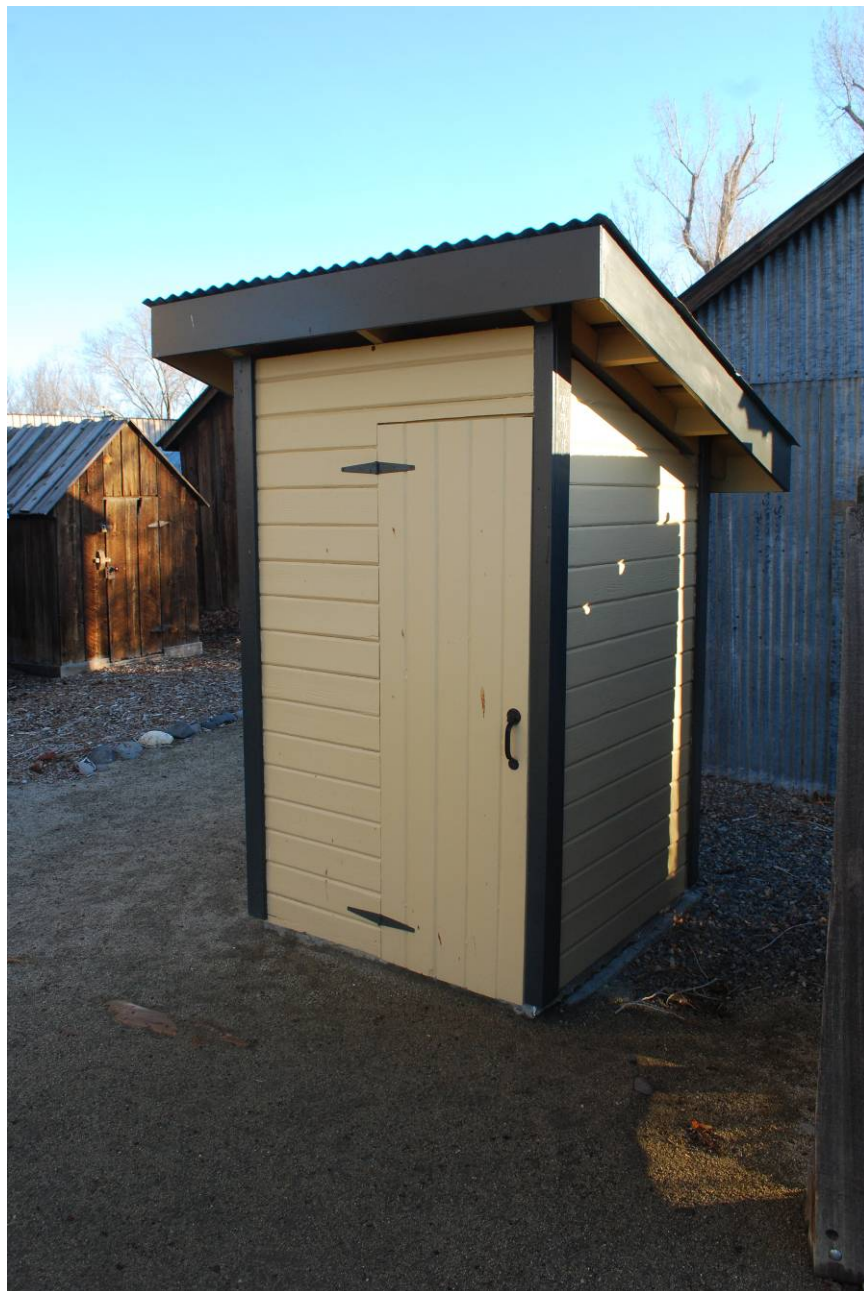
The Privy appears to be a Works Progress Administration (WPA) privy constructed as part of rural sanitation efforts during the New Deal in the 1930s. It is a simple, single-story frame structure on a concrete slab foundation and a shed, corrugated steel roof slanted upward toward the structure's north façade. It has wood, dropboard siding, and a vertical board door that appears to be re-oriented salvage dropboard. The structure has modern vents along its east, west, and south walls.

Photograph 17 – WPA Privy north façade, looking southeast.

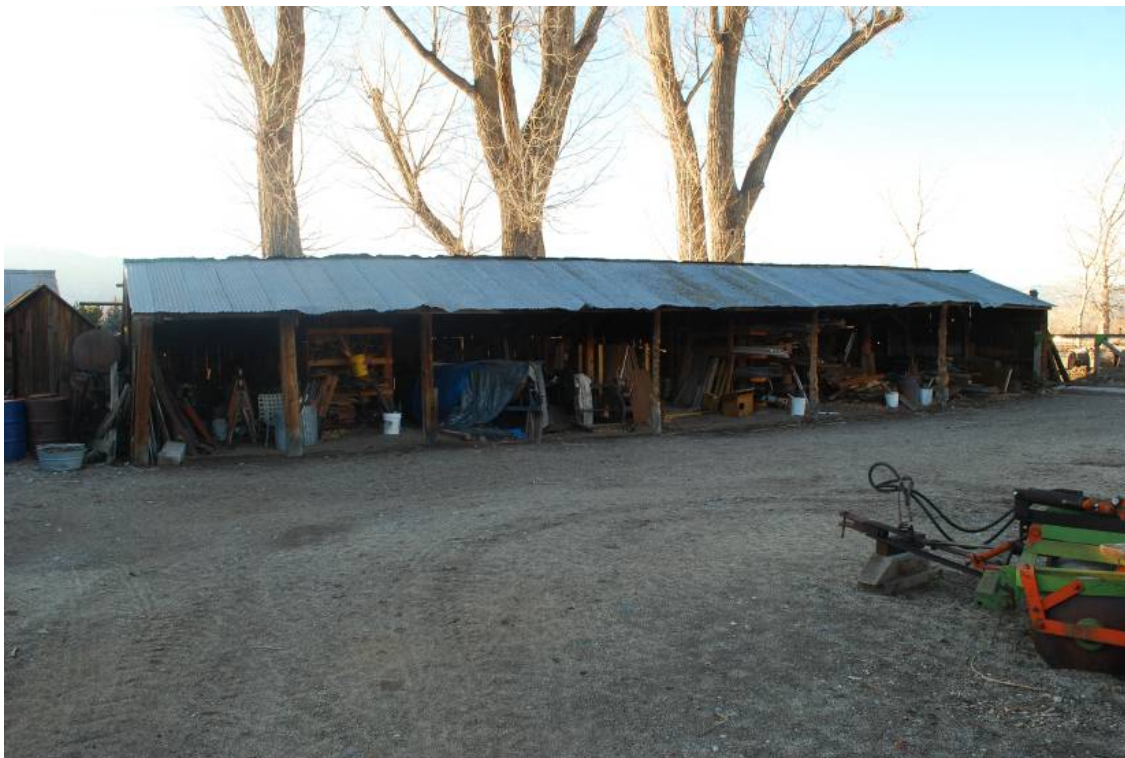
The Large Loafing Shed, which opens eastward into the Corral, is a modest, single-story, side gabled structure with a corrugated steel roof and flush vertical board paneling for its south, north, and west walls. It has no foundation, and posts along its open east façade, ranging from sawn 6"x6" timbers to salvaged rough-hewn timber poles, indicating it was likely cobbled together from scrap materials. Although it was likely used historically as a livestock shelter and milking space as it is encompassed by the Corral, it is now used for equipment and material storage.

**Photograph 18 – Large Loafing Shed, east façade, looking west.**

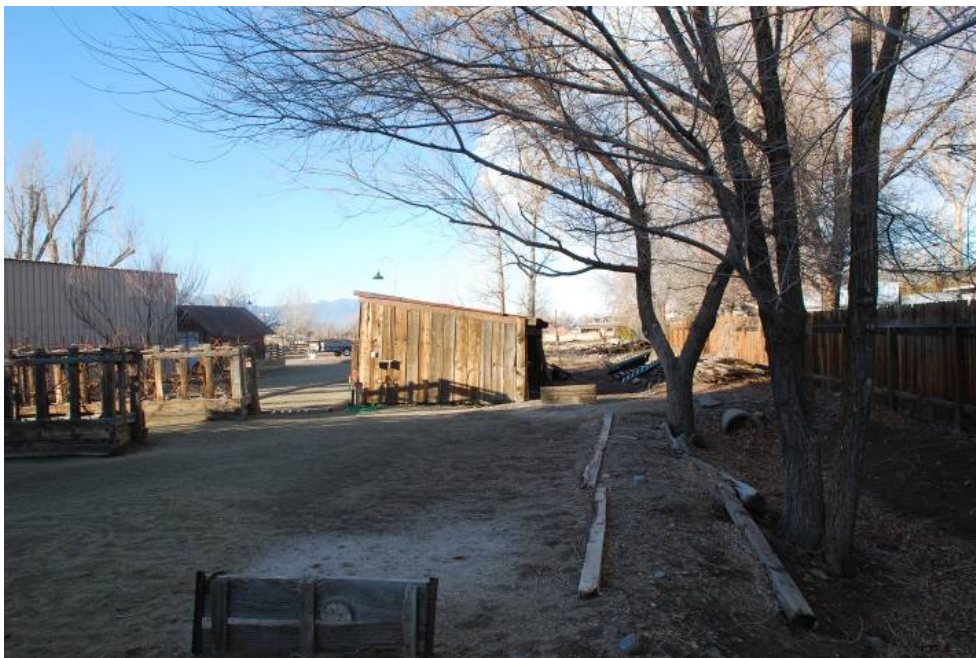
The Small Loafing Shed is a small, shed-roof structure that sits on grade with no foundation, and has flush vertical board siding. It has a corrugated steel roof that slopes downward to the eastern façade. The east façade is open to allow access to livestock historically. It is now used as a storage shelter for salvage material and equipment.

Photograph 20 – Small Loafing Shed, also showing the Hussman Company Ditch running along the fence line to the right, looking north. The Warehouse (far left) and Salvage Shed (left) are also visible.

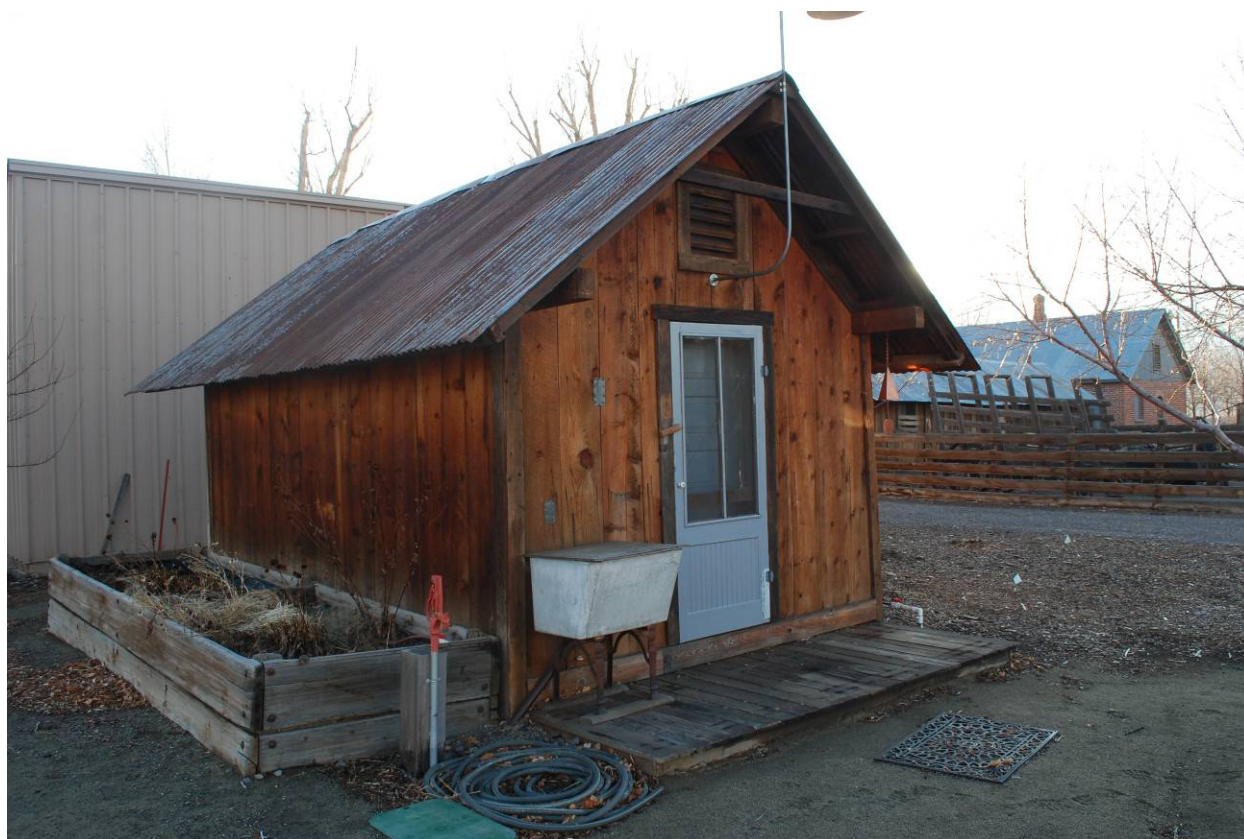
The Salvage Shed was constructed by the Jacobs family in 2007, using salvaged lumber from the ranch site, replacing the remains of a hog shed on the location. It is a single-story, one-room, front-gabled structure on grade with no foundation. It has flush vertical board siding, and a moderately-pitched gable roof of corrugated steel, with exposed beams on the gable ends and a decorative truss brace above the north entry. There are wooden vents in the gable ends. There is a small wooden deck in front of the north entry, which consists of a salvaged historic panel door with a salvaged  $\frac{3}{4}$  view screen door. The south elevation has large swinging doors to provide larger equipment access. The side elevations have salvaged two-by-three fixed wood windows. It is primarily used as a gardening shed by the Jacobs family.

**Photograph 22 – Salvage Shed, north façade and east elevation, looking southwest. Warehouse (left) and Creamery (right) can be seen in the background.**

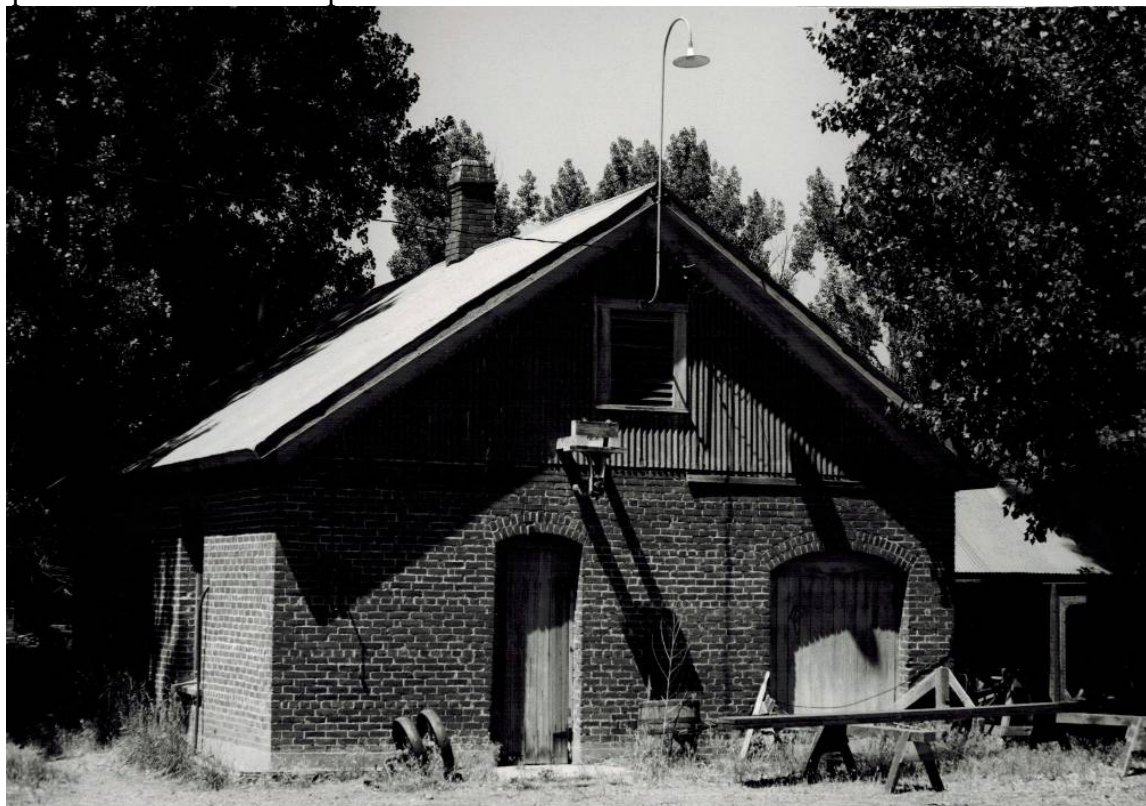
Photograph 25 – Image of the Creamery, c.1940s. Courtesy of Jon Olson.

However, with dairying becoming an important part of Carson Valley’s economy, ranchers like the Lampes took opportunities to expand production. The Lampe family added the Creamery in 1909 to provide on-demand processing of a growing amount of dairy products from the ranch. Whereas most ranchers chose to send their milk to the Minden Butter Manufacturing Company, operated by the Dangbergs in Minden, Lampe appears to be an extremely rare exception to this rule, processing milk on his own ranch. Although cold storage for dairy products was a ubiquitous feature of most ranches in the area, processing facilities appear to be extremely rare, with the Lampe Creamery being the only stand-alone processing center on a mid-sized ranch observed in a 2016 survey of the region. The reasons for establishing the Creamery are not outlined in primary sources. However, the timing of construction offers some clues. The Douglas County Creamery in Waterloo, built in 1893, was only a mile from Lampe’s main complex, and

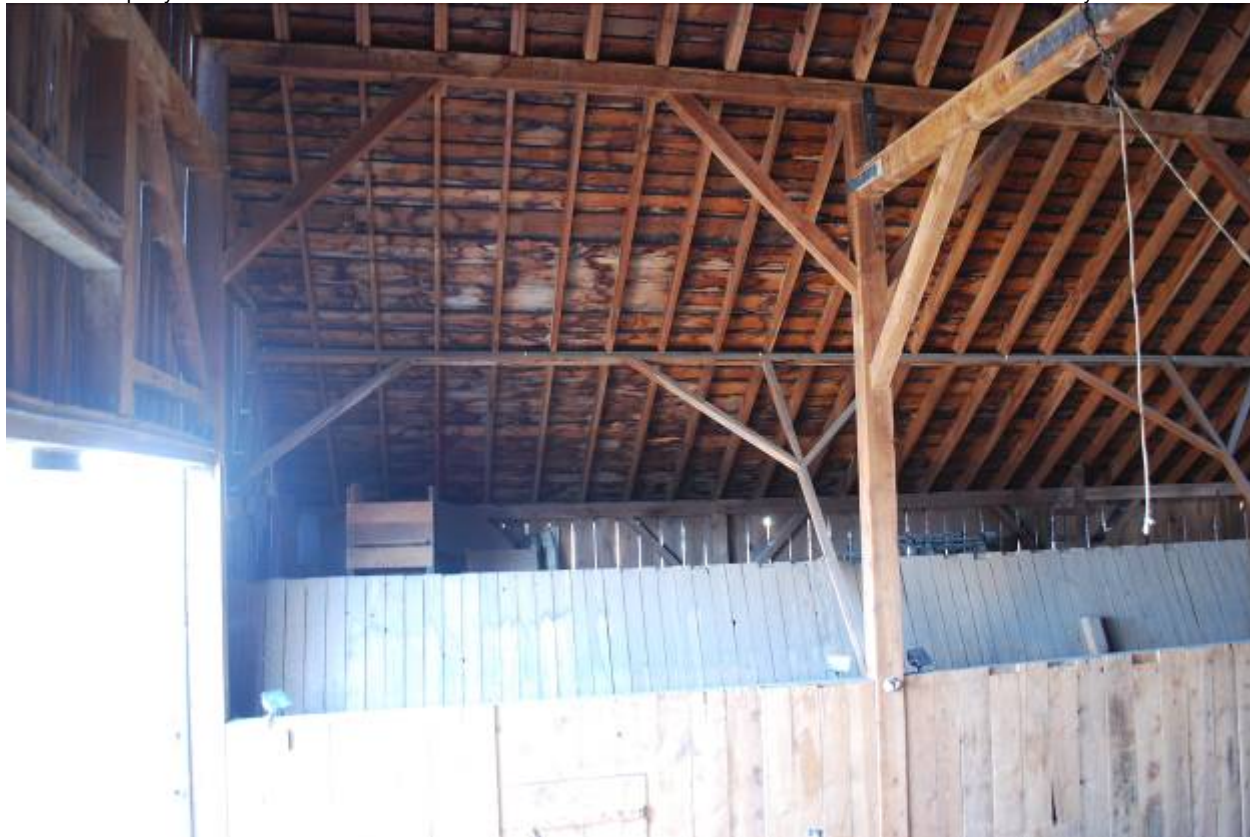
**Photograph 27 – Barn roof framing system, showing dropped tie beam (upper right and left) and unique angled truss bracing system along secondary (lower) purlin.**

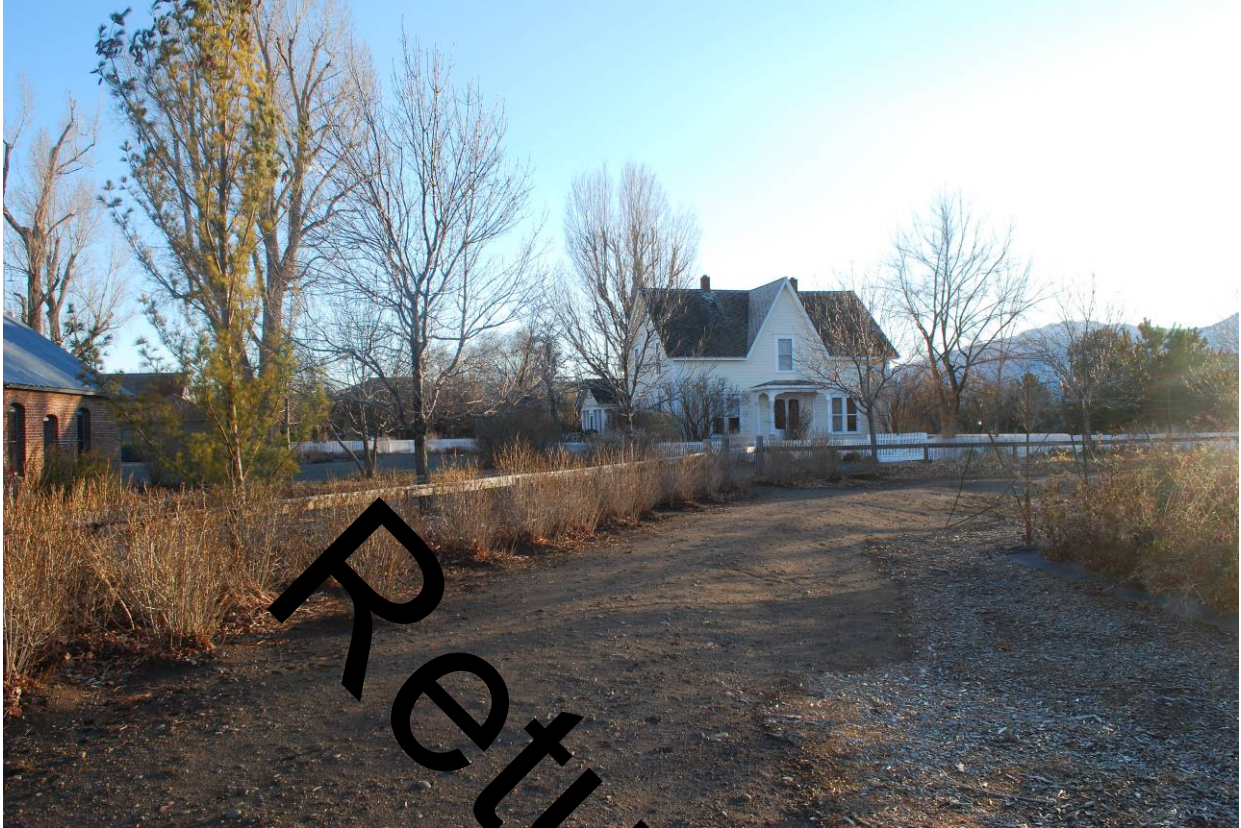
**Photograph 1 – Fields, Ranch House, and Creamery (far left), looking southwest.**
