# National Register of Historic Places Registration Form

Historic name: Lampe, Wilhelm & William, Ranch

Other names/site number: Jacobs Family Berry Farm

Agriculture on the Carson River in Nevada's Douglas and Ormsby Counties

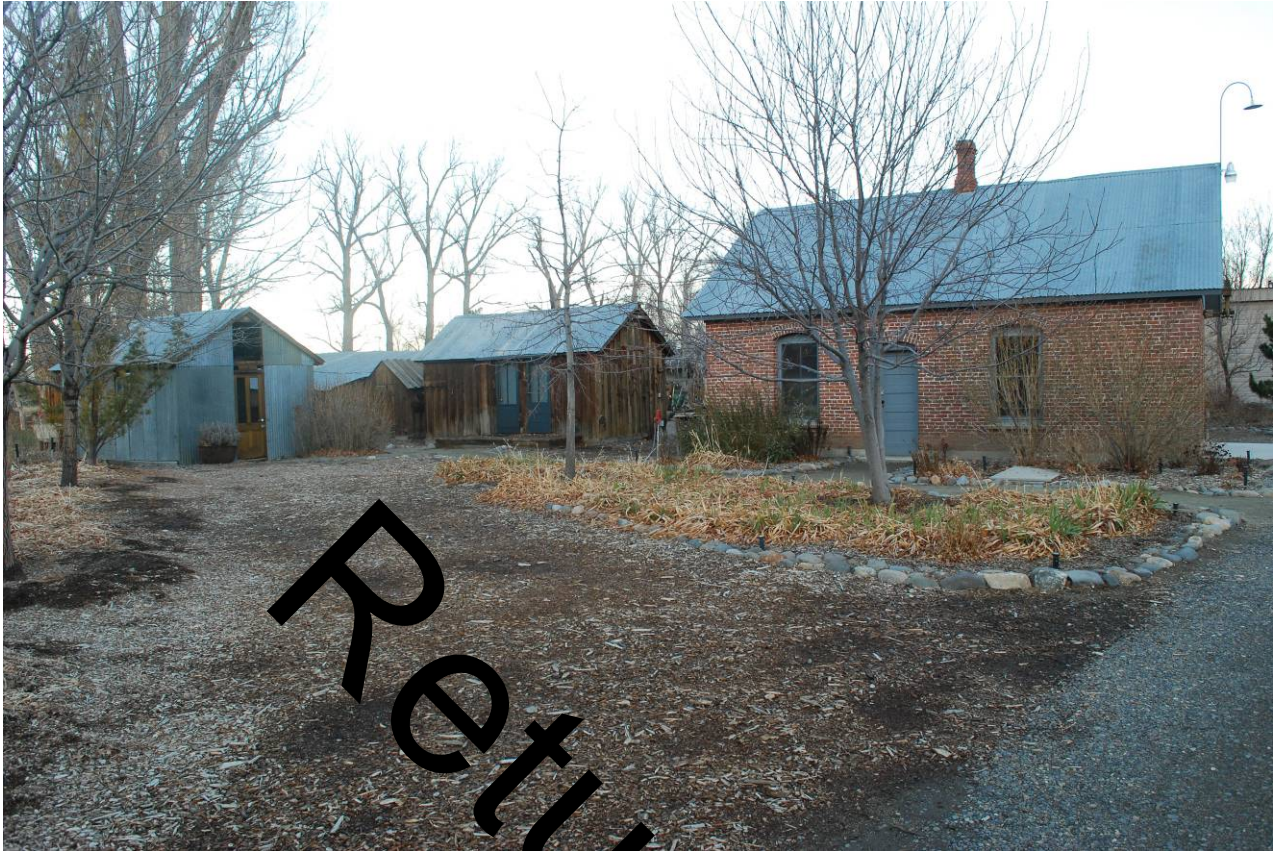
**Photograph 2 – Example of cluster arrangement, showing Creamery (right), Bunk Shed (center), and Workshop (left), looking northeast.**

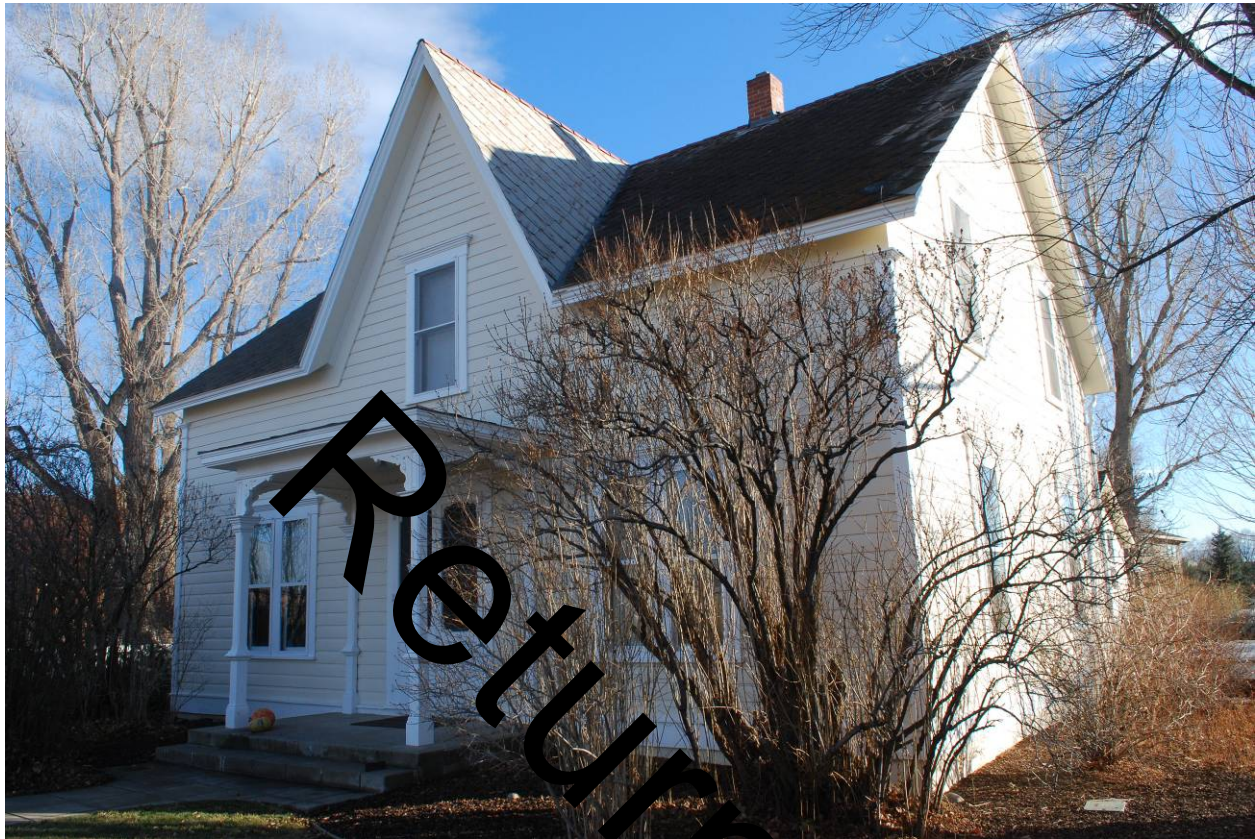
The Lampe Ranch House, constructed in 1898 by Wilhelm and Maria Lampe, is an extremely late example of the Gothic Revival-style . It is a two-story home following the Centered Gable variety of residences in this style. The main section of the house on the north end has a moderately-pitched, side-gabled roof with a steeply-pitched cross-gable centered on its north façade and a second-story, centered, gabled dormer breaking the roof (south) roofline. The roof is asbestos tile, added in approximately 1915 after a fire burned away a portion of the historic wood shingle roof. Two red brick chimneys break the roof crest. Extending from the north section to the south was a single-story extension, with a red brick chimney near its southern terminus. All siding is wood, dropboard, and all foundations are concrete perimeter, in some cases reinforcing historic rock pilings with lime grout, or slab. This extension received an addition in 1965 that in-filled space between a storage building and the main house. The storage building, also present by 1918, is a single-story front-gabled frame building with dropboard siding and heavily insulated walls, having served as a cool storage room for produce prior to the electrification of the ranch. Records and observation suggest that the 1918 storage building was initially the first residence for the family, built in 1872, but the historical record is not clear. The practice of expanding relatively simple homesteads into larger, architecturally extravagant dwellings was not uncommon in western agricultural areas. However, the two-over-two wood sash windows and dropboard siding matching that on the main Gothic Revival house suggests that regardless of the date of construction, the building was heavily remodeled in or after 1898 along with the construction of the main portion of the house. In 2007, the owners made a gable-

**Photograph 3 – Lampe Ranch House, looking southeast.**

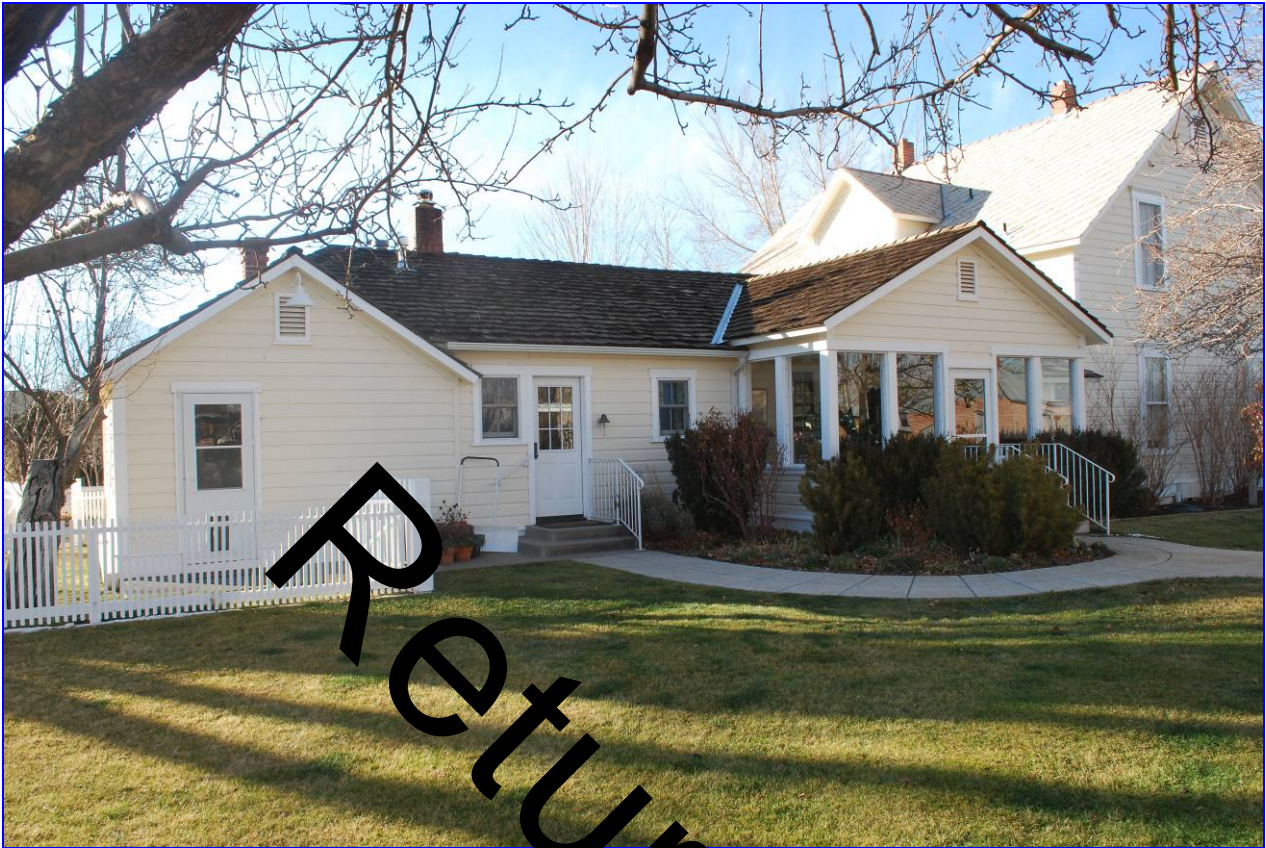
**Photograph 4 - Lampe Ranch House, east elevation, looking west, showing additions to rear of the main house including historic Cold Storage building. (left).**

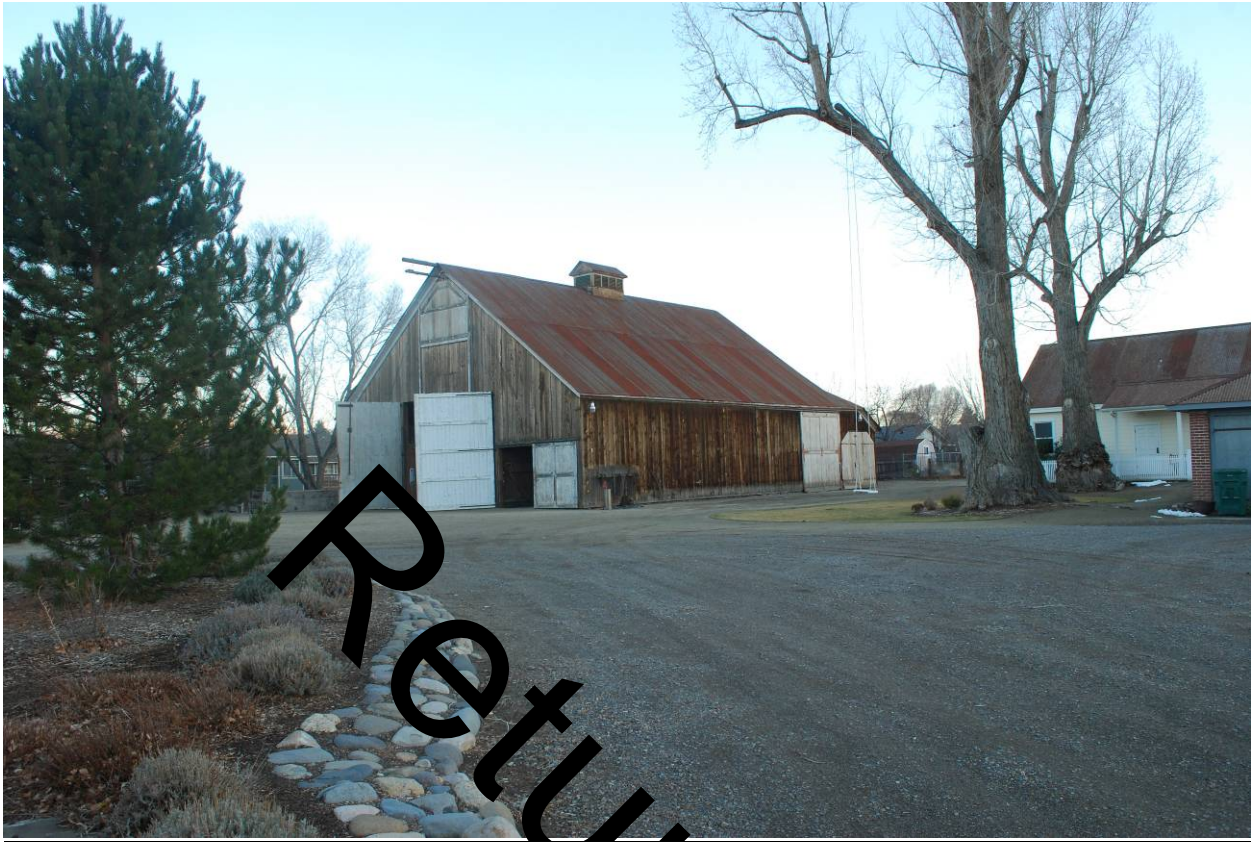
**Photograph 5 – Barn, viewed from central driveway, looking southeast.**

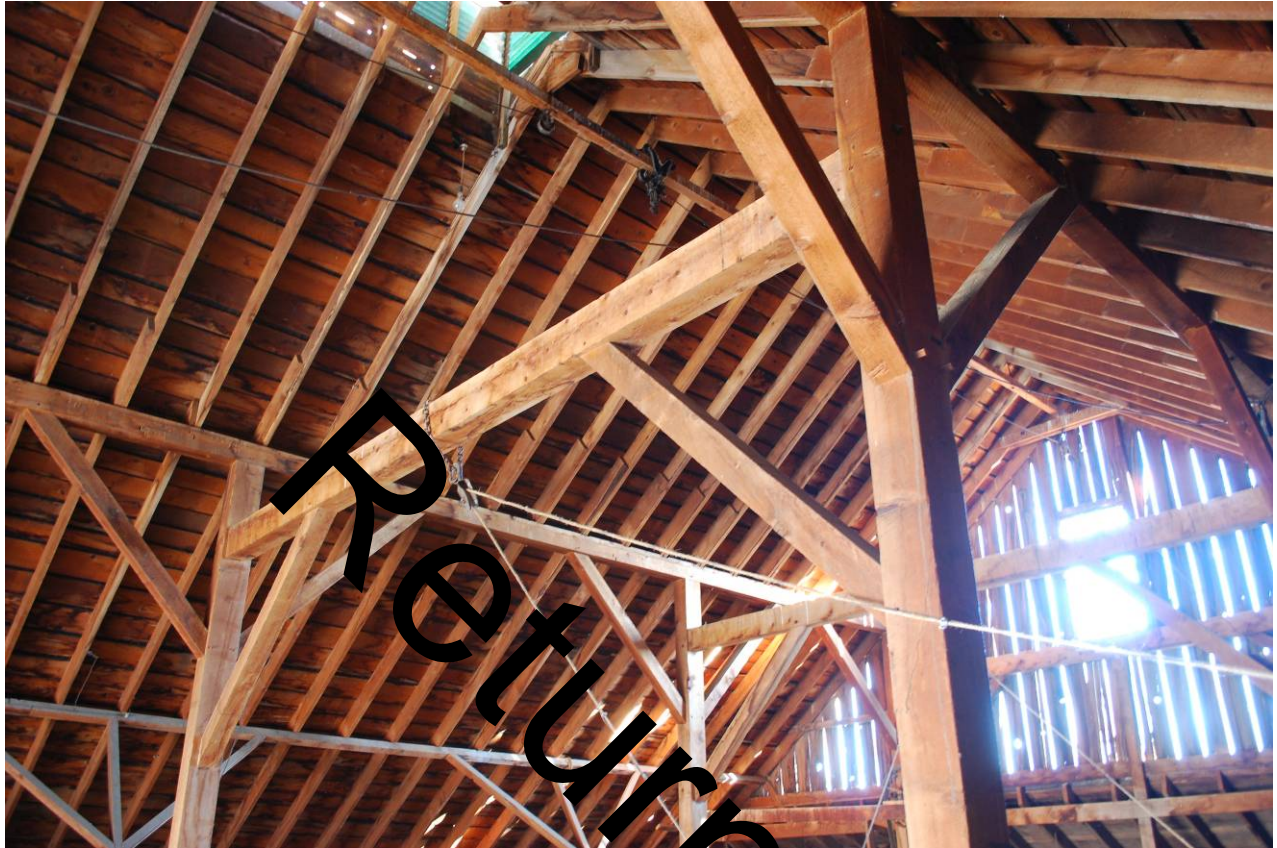
Photograph 6 – Barn interior, viewing primary framing and roof structure, looking up and southeast.

The barn has heavy timber, mortise-and-tenon framing with selective reinforcement with steel bolts and straps, resting on embedded foundation stones. Oatman provides a detailed description of the barn's structure:

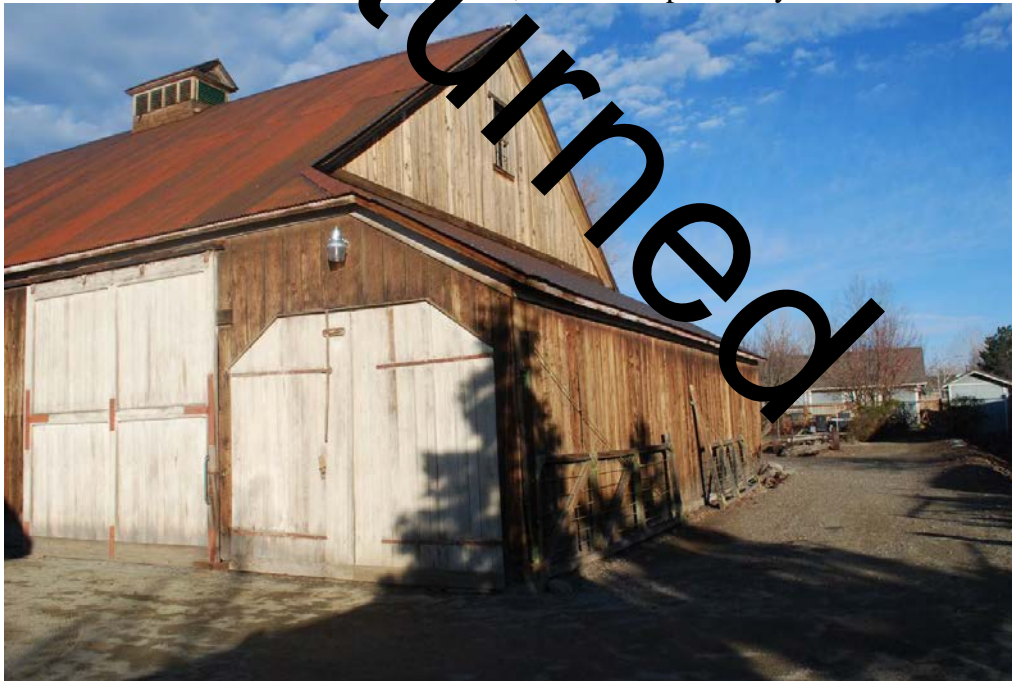
**Photograph 7 – Barn, rear elevation and southwest corner, looking northeast, showing grain bin addition.**

fastened with 1” tenons. At the rear of the barn’s center aisle, there is a raised wood floor for clean work space, leading up to the grain bins at the rear of the barn. The frame wall of the middle bin is movable to allow for adjustment based on the necessary storage space needed, and to allow the space to be used alternately for grain storage and for equipment storage. A belt driven grain elevator remains and is installed along the north wall of the grain bin area. The east side-aisle has a low ceiling and 6.5”x6.5” posts and beams framing the space, and was used historically as a feeding corral. The west side-aisle has matching posts and beams, but has a small shop crane, indicating the space had been used for loading and unloading smaller wagons. Interior framing posts and beams show circular saw marks, suggesting they were lumbered at local sawmills in the Carson Valley.

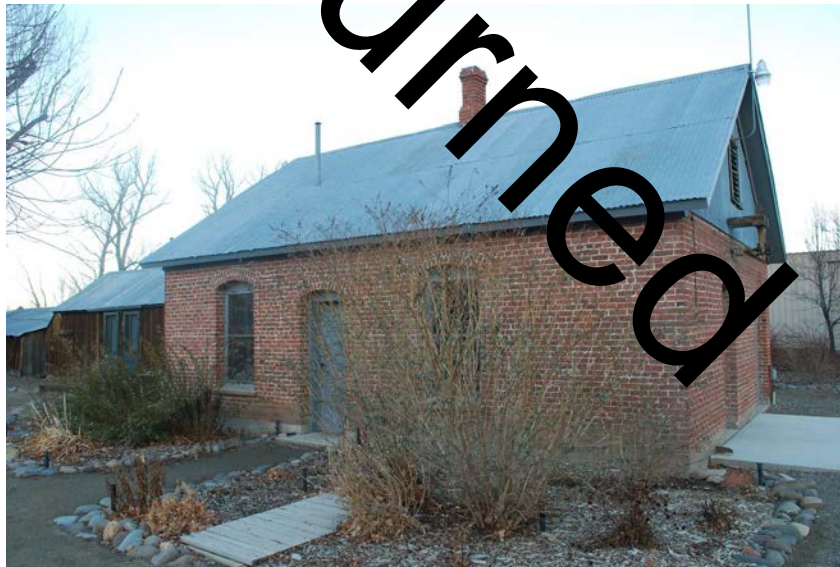
The Creamery, referred to as the Tank-house by William Lampe, is a one-and-one-half story red brick masonry building with a moderately-pitched, corrugated steel, front-gabled roof built by Wilhelm Lampe in 1909. It sits on a concrete slab foundation, its brick outer walls are common bound, and the gable ends are sheathed in corrugated steel, broken by large attic vents. A tapered, concave brick chimney breaks the roof crest near the center of the building. Entries and window ports have concrete sills and arched brick lintels, with wooden jambs. Windows are two-over-two wooden sash windows, and doors are un-lit wood panel doors. There are a total of four entries, including two on the south façade, one on the east elevation near the northeast corner, and one on the west elevation near its center. Along the north elevation, two small window ports are present, one being a divided wood casement and the other being boarded over with 1"x2" paneling. On the west elevation, two one-over-one windows are present along with an un-lit wood panel door. A line shaft, likely providing belt driven power to the ranch complex, remains on both the interior and south façade of the building, although the gas engine generator is no longer present.<sup>6</sup>

The interior is divided into primary spaces divided by secondary, plastered red brick walls. The southwest corner of the building is the primary separator room, that is now the retail space for the Jacobs Family Berry Farm. The northwest corner is storage space. Running the east length of the building is the storage room, dominated by a large, blackened steel tank. Although its use remains in question, it is possible that the tank served as milk storage during the ranch's height as a dairy operation.

**Photograph 9 – Creamery, west elevation, looking northeast. Note the belt-driven assembly in the gable end above the entrance (far right). The bunk shed can be seen at the far left behind (north of) the Creamery.**

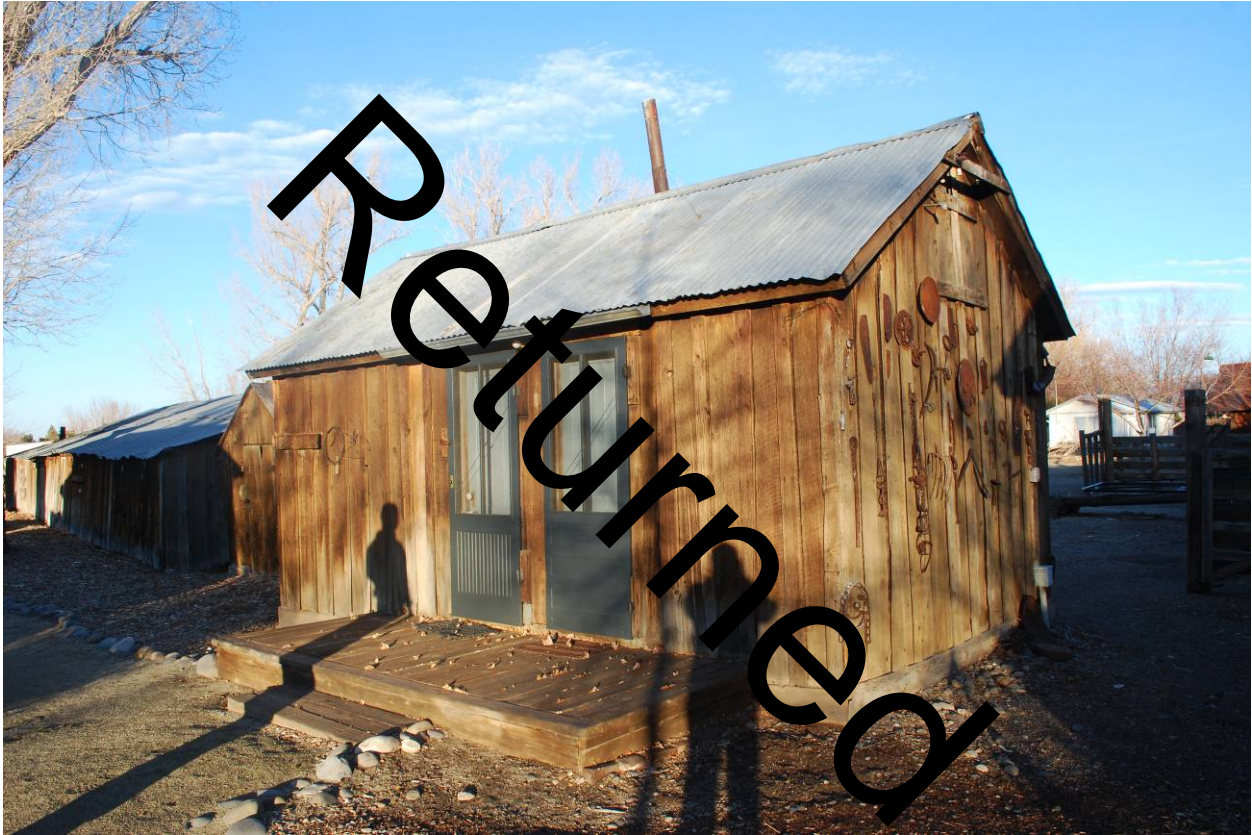
The bunk shed is a small, side-gabled building with a moderately-pitched, corrugated steel roof and board-and-batten siding. It does not have a foundation, but rests on a wooden sill laid on grade. There are two horizontal sliding windows on the north and east elevations, and a third vertical sliding window on the east elevation. There is an access door to the attic on the south side. A wall divides the interior space into two living units, with separate entrances on the west façade. The doors are unlit wood panel doors. The interiors retain strong integrity to the early-twentieth century, with interior walls lined with flush 2"x6" paneling, as well as built-in wood shelving. Although the wiring of the building has been upgraded, the original push-button light switches remain. Carved graffiti from ranch workers remain on the interior walls.

**Photograph 10 – Bunk Shed, west façade and south elevation, looking northeast.**

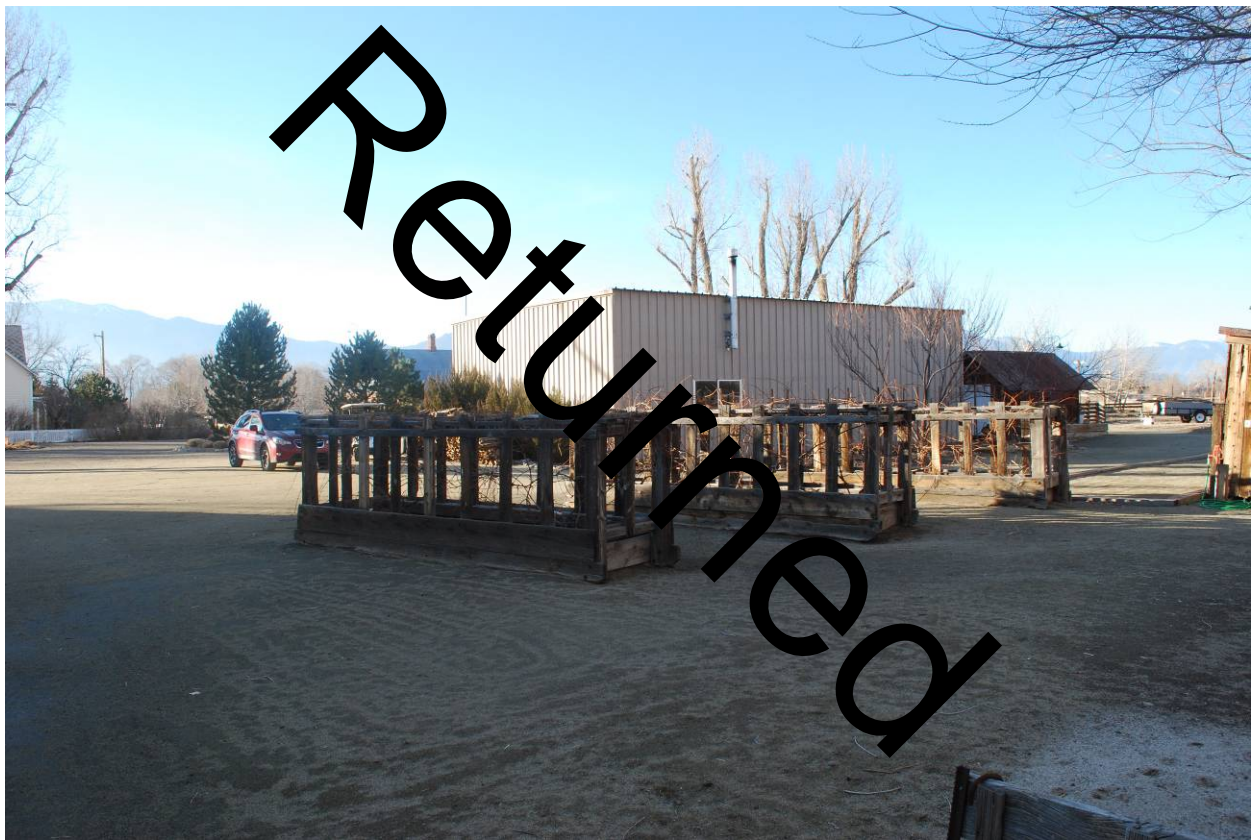
The Warehouse is a two-story building on a concrete slab foundation with standing-seam steel walls and a very slightly pitched, gabled roof, also of standing-seam steel. The exterior walls are relatively unbroken, except for a single-view double window on the east elevation near the southeast corner, a simple panel door on the south elevation near the southwest corner, and a large track garage door on the west elevation near the southwest corner. A ventilation stack vents above the east entry, and a security light breaks the roofline above the garage door. Historic photos indicate that a smaller, one-and-one-half story livestock and equipment barn, as well as an adjacent equipment shed or pig barn, had been on this location, but either burned down or was demolished sometime after the 1950s, and was replaced in 1965 with the current building. A farm and asset inventory series sent from Lampe to the University of Nevada, Reno notes three barns, two sizeable and one small in 1930 but only two barns, one small and one large in 1931.

**Photograph 81 – Warehouse, and grape arbors, looking northwest from northeast corner of the Barn.**

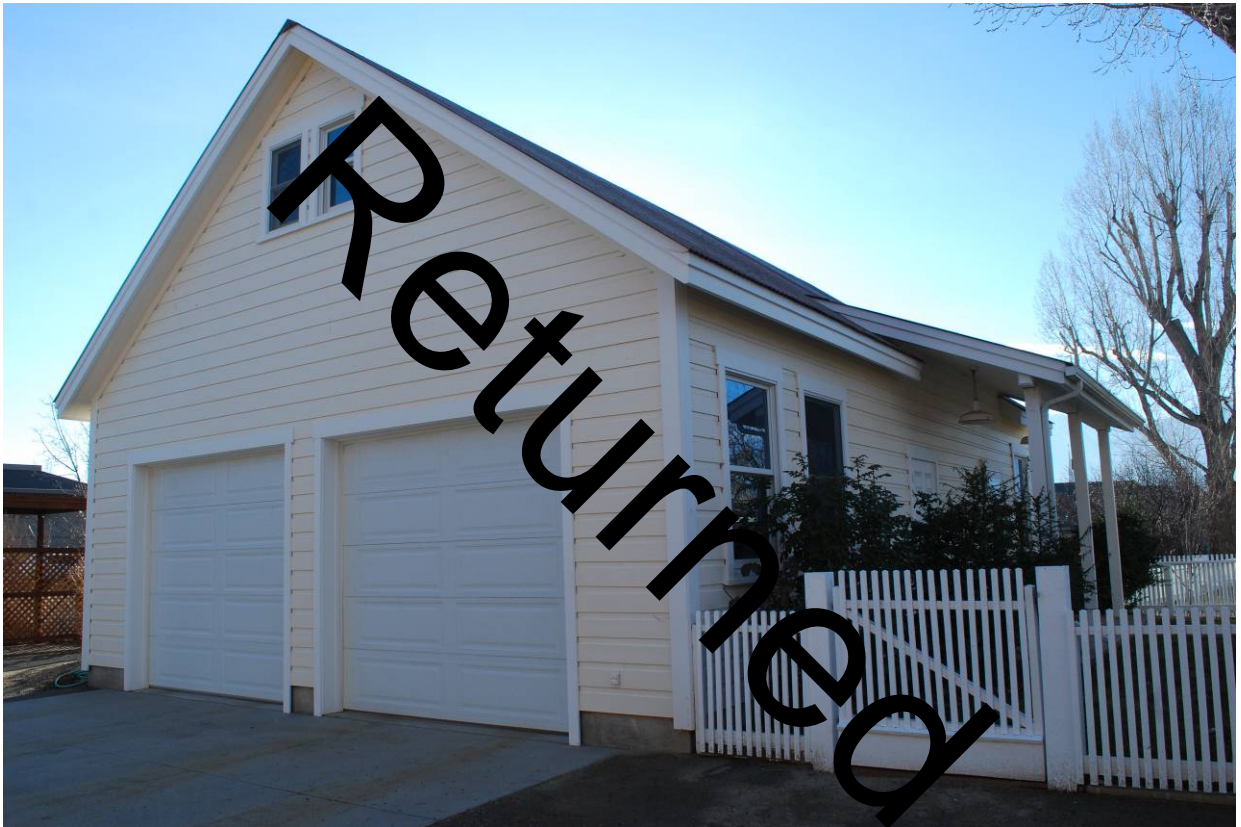
The Guest House is a small, one-and-one-half story residence and garage near the southern end of the property. It has a moderately pitched, side-gabled roof of corrugated steel and wood drop-board siding, allowing it to be stylistically compatible with the historic Ranch House to its northwest. It sits on a concrete slab foundation, and has a pair of large garage doors with a driveway breaking its east elevation. There is a shed porch with squared posts on the north façade, with a simple panel door. Windows on the façade and in the gable ends are vinyl one-over-one windows, both single and paired, of varying sizes. A modern wood picket fence encloses a small yard space around the building's north façade, and is designed in the same style as the fence surrounding the Ranch House.

**Photograph 12 – Guest House, east and north elevations, looking southwest.**

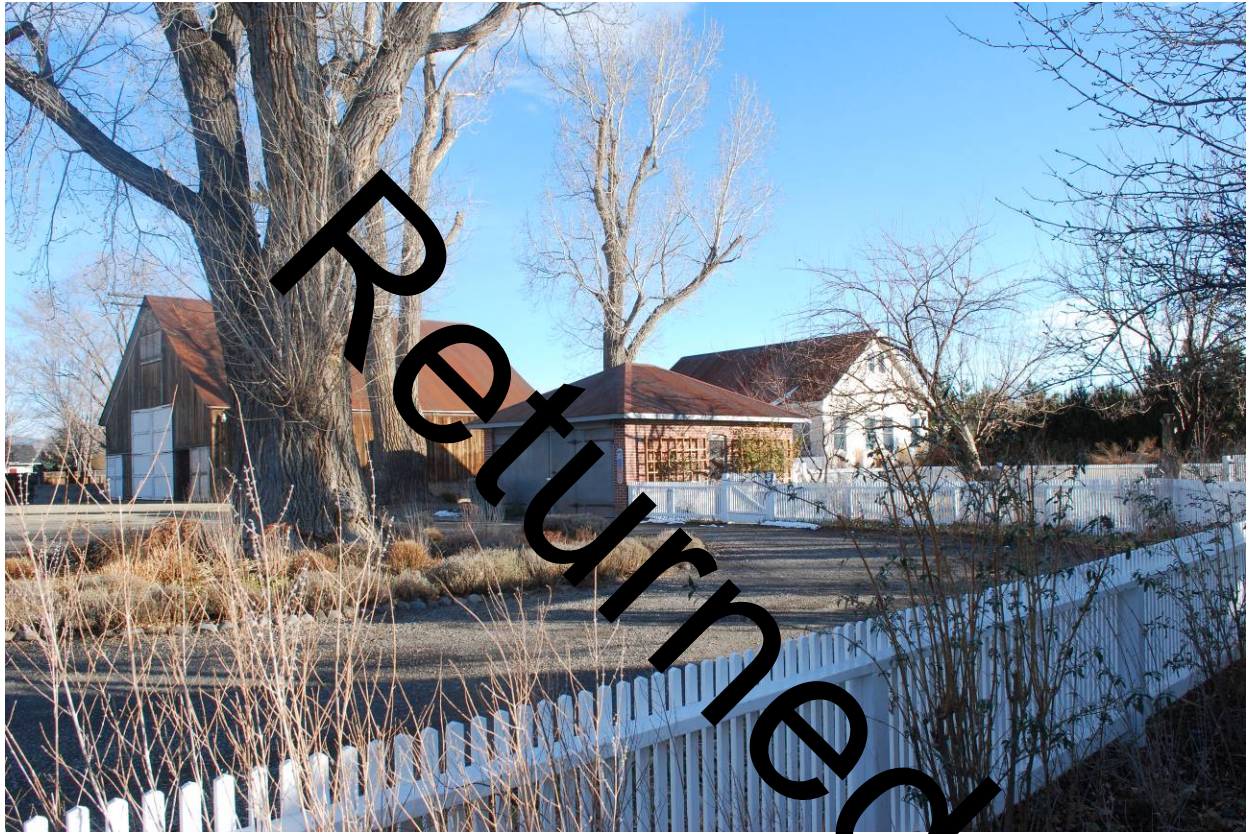
The Garage is a single-story, frame structure with a red brick veneer and sits on a concrete slab foundation, and has a hipped roof with boxed eaves and corrugated steel sheathing. Its north façade is dominated by paired, double-hinge, riveted steel doors, with a small man-door in the middle. The side and south elevations have wood, one-over-one sash windows with arched lintels, red brick sills, and wood screen covers. The interior includes a concrete cutaway drop on the interior for working underneath vehicle chassis. A c.1930s fuel pump and gas tank was situated at the northwest corner of the garage, but has since been removed.

**Photograph 93 – Garage (center), with Barn and Guest House in background, looking southeast.**

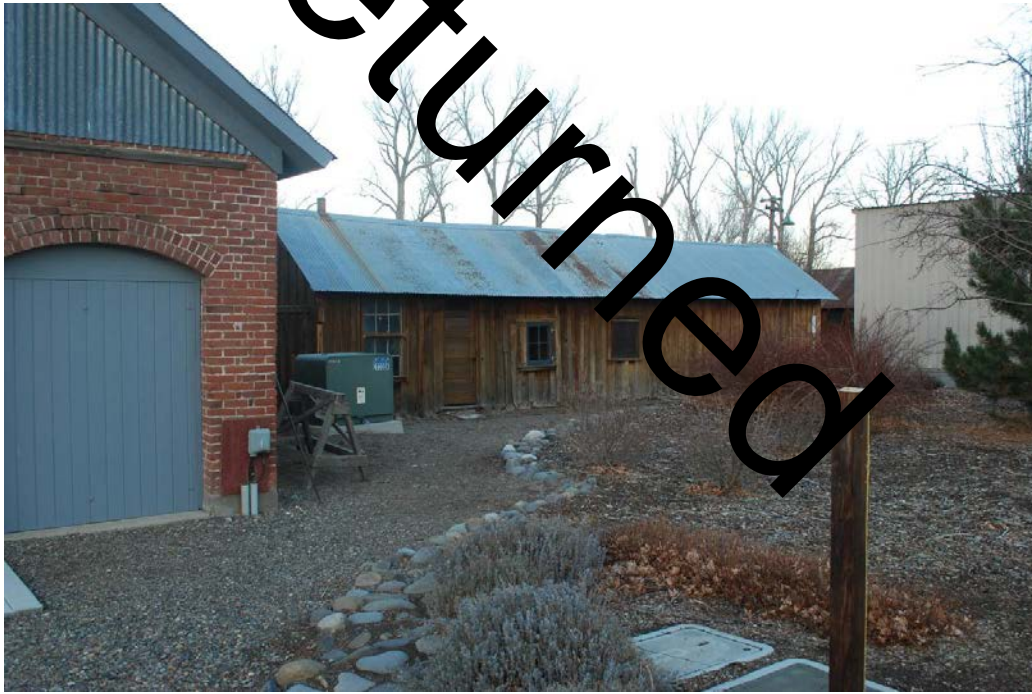
The Poultry House is a modest, narrow, single story building used historically for either storage or a shelter for poultry on the farm, depending on the need. It has a moderately-pitched, side-gabled roof of corrugated steel, and vertical board-and-batten siding resting on a wood sill. The south façade has two entrances, one near the southwest corner with an un-lit wood panel door, and the other near the southeast corner with a vertical board, un-lit door. The rear (north) elevation appears to have been modified during its life as a poultry house. A boarded-up entrance breaks the elevation near the northeast corner, with an un-lit panel door. Near the building's center is an adapted doorway cut into the building's side with simple vertical board panels. A small window port appears to have been cut in the wall, but has since been filled in with vertical boards. Three windows break the south façade, including a six-over-six wood sash window near the southwest corner, a two-by-two wood casement to the east of the southwest door, and a fixed single-light window to the left. The interior is divided into rooms with shelving for storage or poultry roosts.

The Poultry House appears to be a combination of buildings, including the first automobile garage built sometime in the 1910s, then moved across the property around 1920 and connected with another shed building to create the Poultry House as it stands today. This appears to have been in response to a fire at the house, which likely occurred in 1915.<sup>7</sup>

**Photograph 104 – Poultry House, north elevation, looking northeast, with Creamery (left) and Warehouse (right).**

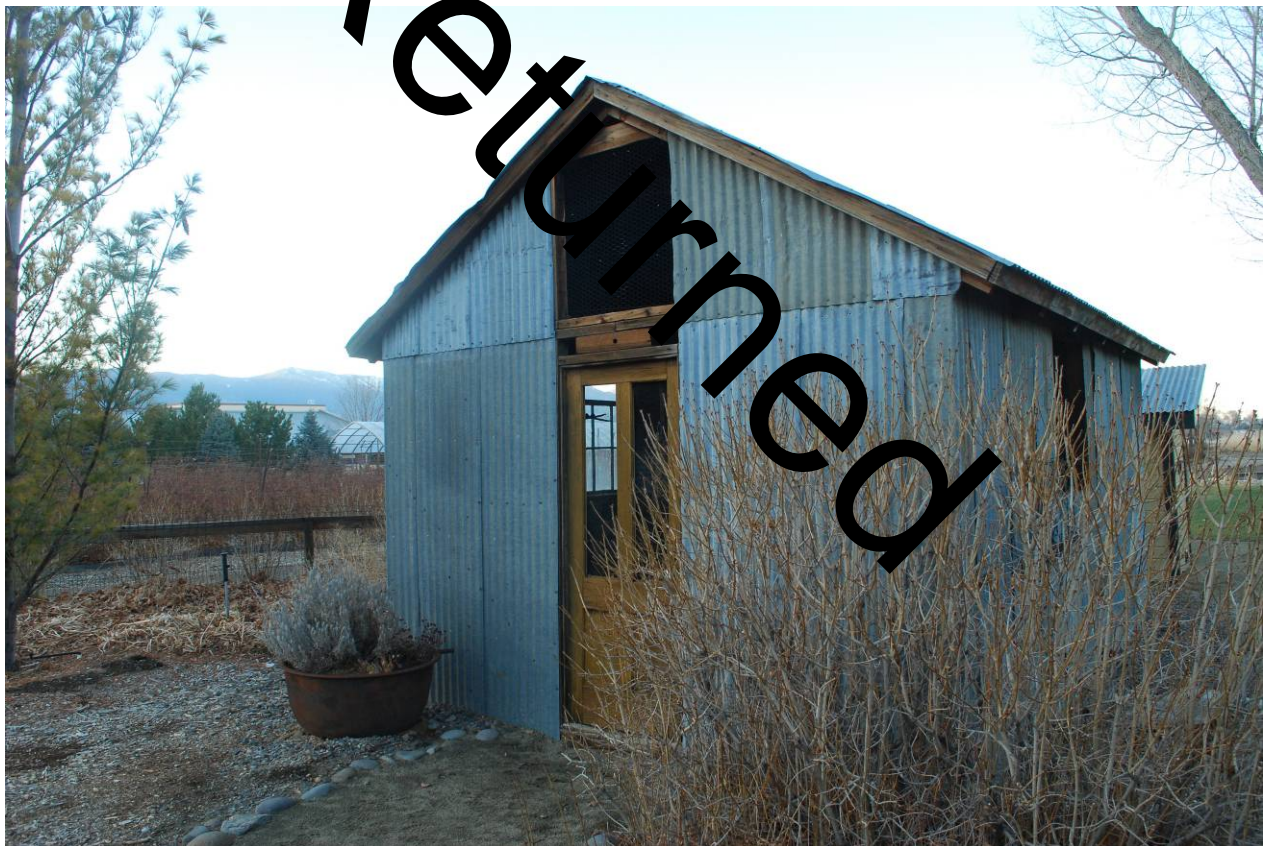
The Workshop is a small, one-story, front-gabled structure with corrugated steel walls and roof. It does not have a foundation, but sits on a wooden sill rested on grade. The building has a simple wooden frame, a salvaged entry door on its south façade, and what appear to be salvaged wood windows on all three remaining elevations, one fixed square (east), one fixed with an arched top (north), and one 2x3 (west). The gable ends above the south entry and north window are open but screened, likely as ad-hoc vents. The interior space contains late-nineteenth and early-twentieth century blacksmith equipment, indicating the structure's historic use. A panel on the rear has painted lettering on it reading:

**Photograph 115 – Workshop, south façade, looking northwest.**

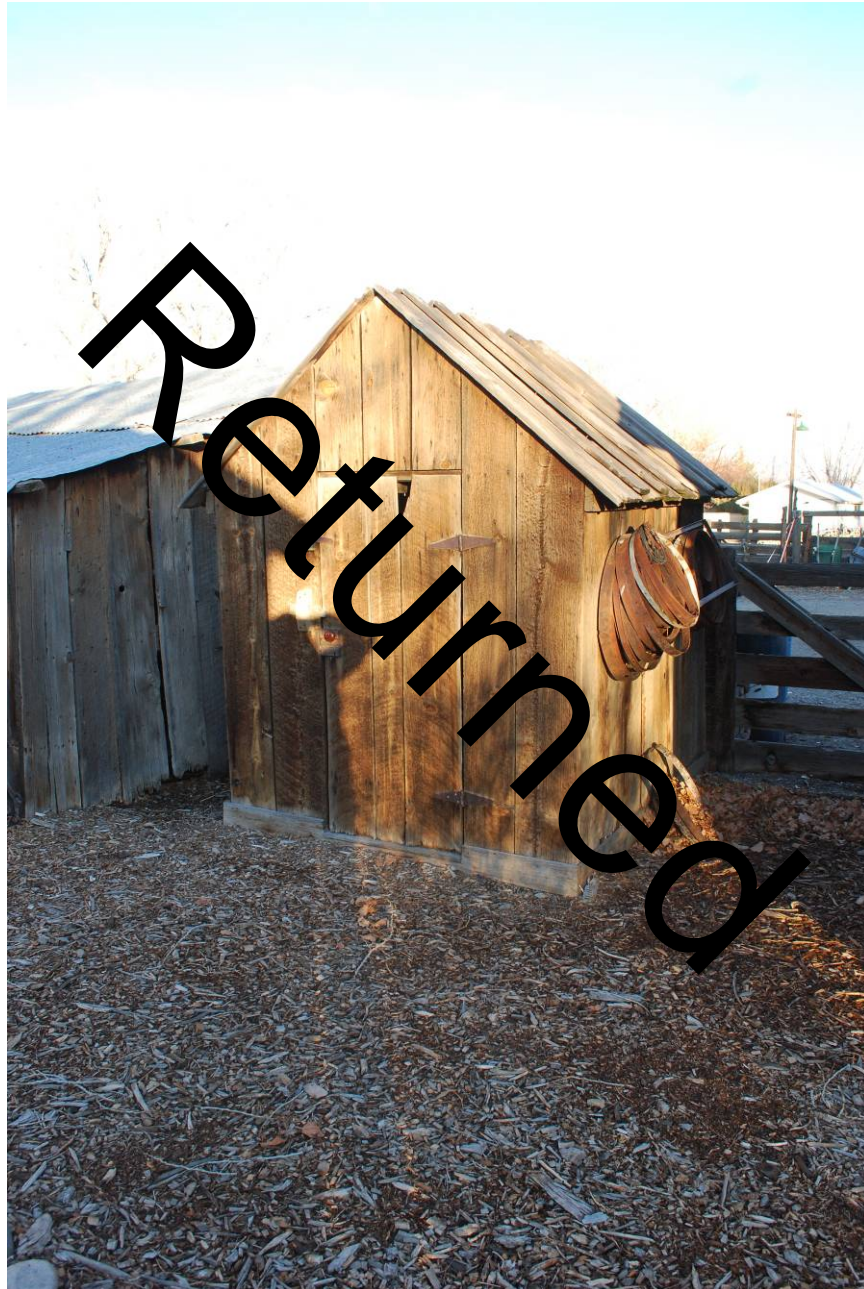
The Smokehouse is a simple, one-story front-gabled structure sitting on grade with no foundation and facing west. It has flush vertical board walls and roofing, with the roof secured with additional battens. A doorway of flush boards is on the west façade, and there do not appear to be any windows in the building. Hooks for equipment are on the north wall's exterior. It is possible the structure was built earlier than the 1920s, but it is first confirmed in records by the 1920s.

**Photograph 126 – Smokehouse, west façade, looking northeast.**

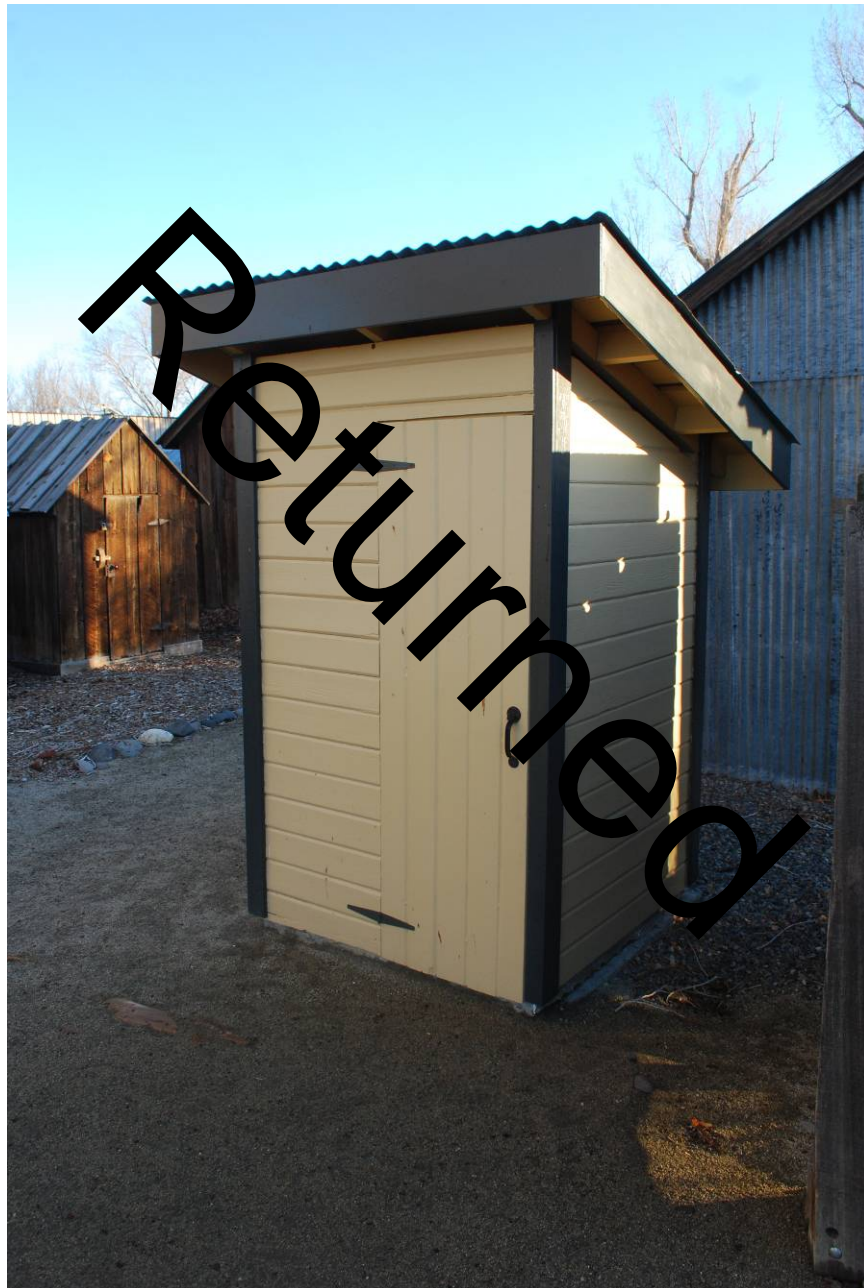
The Privy appears to be a Works Progress Administration (WPA) privy constructed as part of rural sanitation efforts during the New Deal in the 1930s. It is a simple, single-story frame structure on a concrete slab foundation and a shed, corrugated steel roof slanted upward toward the structure's north façade. It has wood, dropboard siding, and a vertical board door that appears to be re-oriented salvage dropboard. The structure has modern vents along its east, west, and south walls.

**Photograph 137 – WPA Privy north façade, looking southeast.**

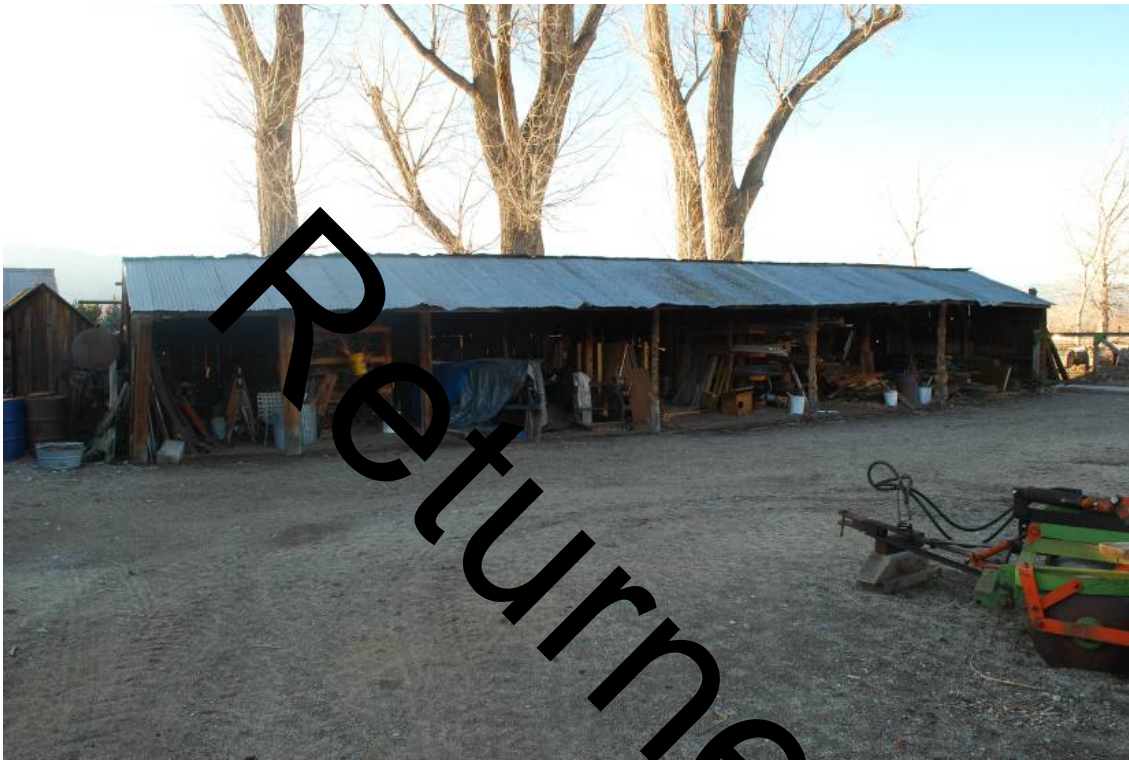
The Large Loafing Shed, which opens eastward into the Corral, is a modest, single-story, side gabled structure with a corrugated steel roof and flush vertical board paneling for its south, north, and west walls. It has no foundation, and posts along its open east façade, ranging from sawn 6"x6" timbers to salvaged rough-hewn timber poles, indicating it was likely cobbled together from scrap materials. Although it was likely used historically as a livestock shelter and milking space as it is encompassed by the Corral, it is now used for equipment and material storage.

Photograph 148 – Large Loafing Shed, east façade, looking west.

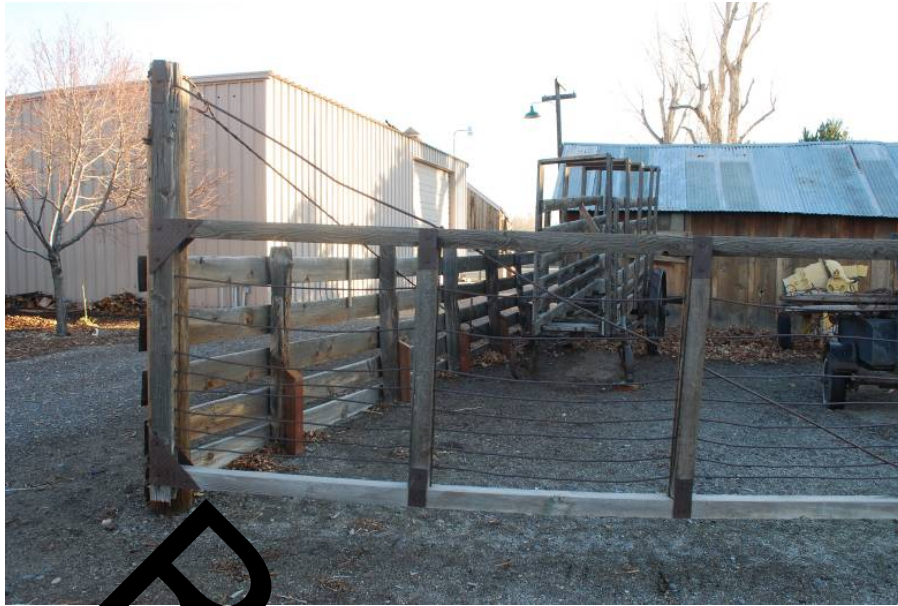
Historic Associated Feature – Corral – The corral is a small space attached to both the Large Loafing Shed and the north elevation of the Poultry House. It has a simple post-and-board fence approximately 5' high. A square-frame, wire gate provides primary access on the east side of the Corral, with a built-in livestock sorting chute along the outer fence just to the north of the gate.

Photograph 159 – Corral and gate, looking south.

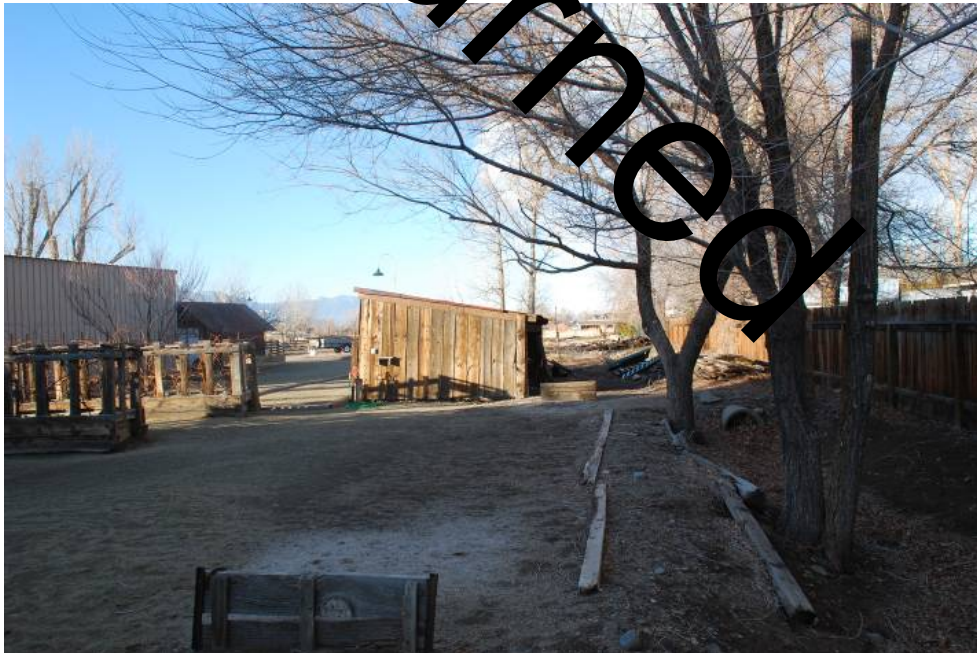
The Small Loafing Shed is a small, shed-roof structure that sits on grade with no foundation, and has flush vertical board siding. It has a corrugated steel roof that slopes downward to the eastern façade. The east façade is open to allow access to livestock historically. It is now used as a storage shelter for salvage material and equipment.

Photograph 20 – Small Loafing Shed, also showing the Hussman Company Ditch running along the fence line to the right, looking north. The Warehouse (far left) and Salvage Shed (left) are also visible.

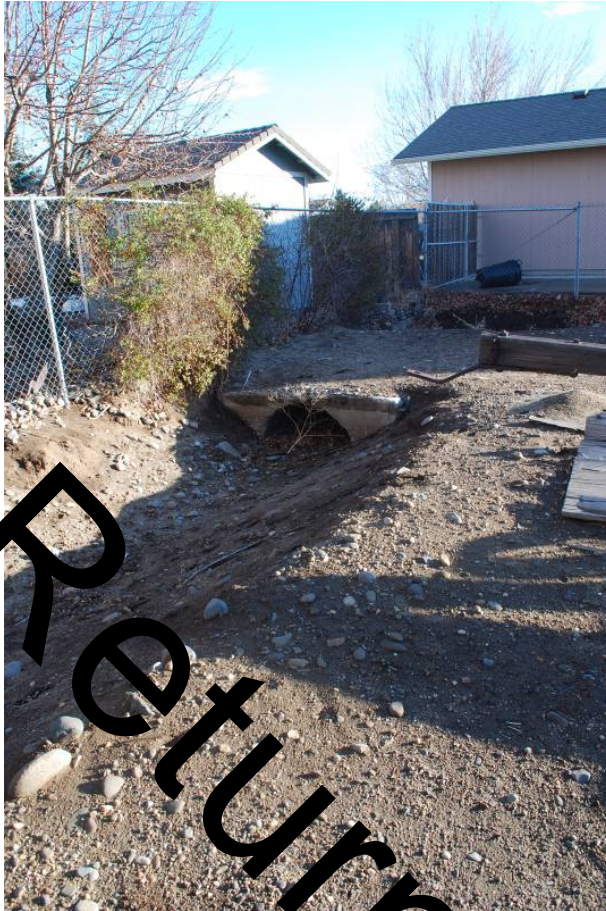
**Photograph 161 (right) – Remnant of the Hussman Company Ditch and a concrete culvert and bridge at southeast edge of property. Formerly, the road leading from the main house and barn led across this bridge and into alfalfa fields to the east.**

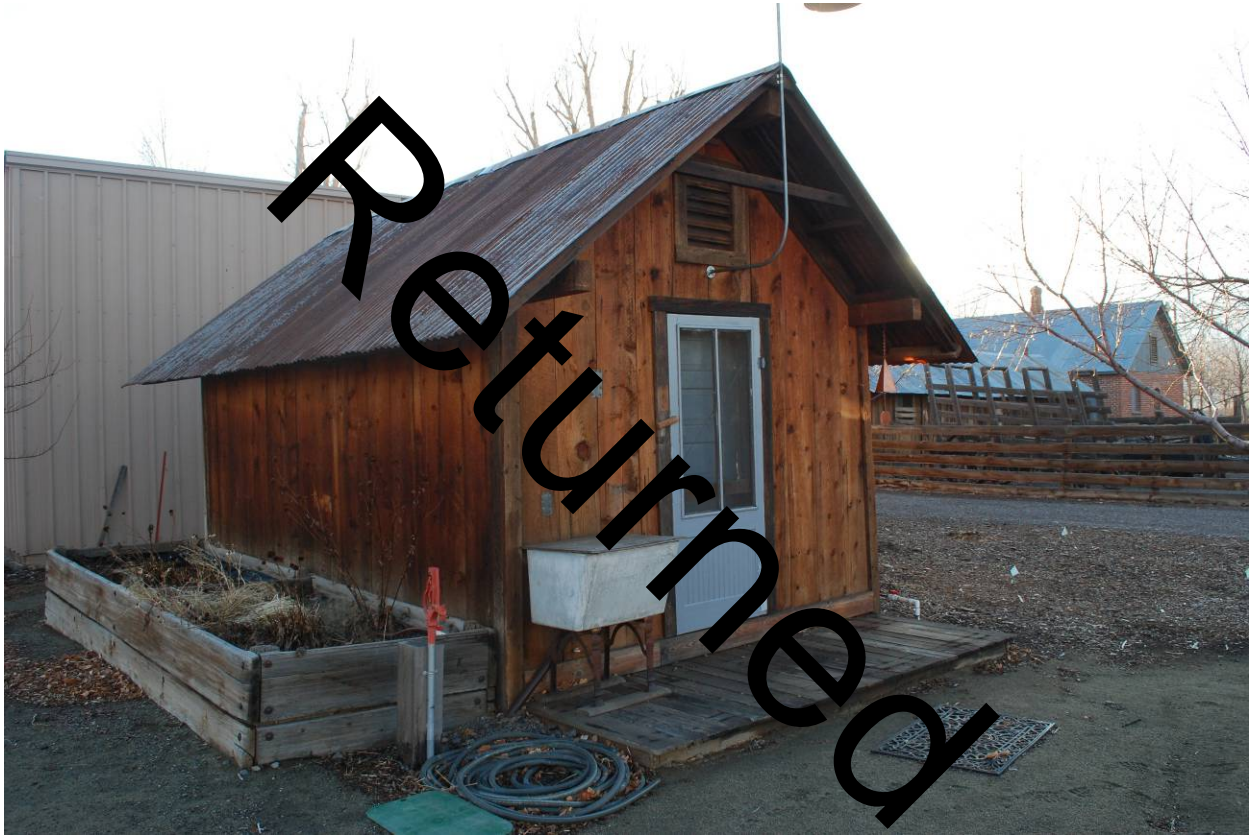
The Salvage Shed was constructed by the Jacobs family in 2007, using salvaged lumber from the ranch site, replacing the remains of a hog shed on the location. It is a single-story, one-room, front-gabled structure on grade with no foundation. It has flush vertical board siding, and a moderately-pitched gable roof of corrugated steel, with exposed beams on the gable ends and a decorative truss brace above the north entry. There are wooden vents in the gable ends. There is a small wooden deck in front of the north entry, which consists of a salvaged historic panel door with a salvaged  $\frac{3}{4}$  view screen door. The south elevation has large swinging doors to provide larger equipment access. The side elevations have salvaged two-by-three fixed wood windows. It is primarily used as a gardening shed by the Jacobs family.

**Photograph 172 – Salvage Shed, north façade and east elevation, looking southwest. Warehouse (left) and Creamery (right) can be seen in the background.**
