# National Register of Historic Places Registration Form

Historic name: Lampe, Wilhelm & William, Ranch

Other names/site number: Jacobs Family Berry Farm

Agriculture on the Carson River in Nevada's Douglas and Ormsby Counties

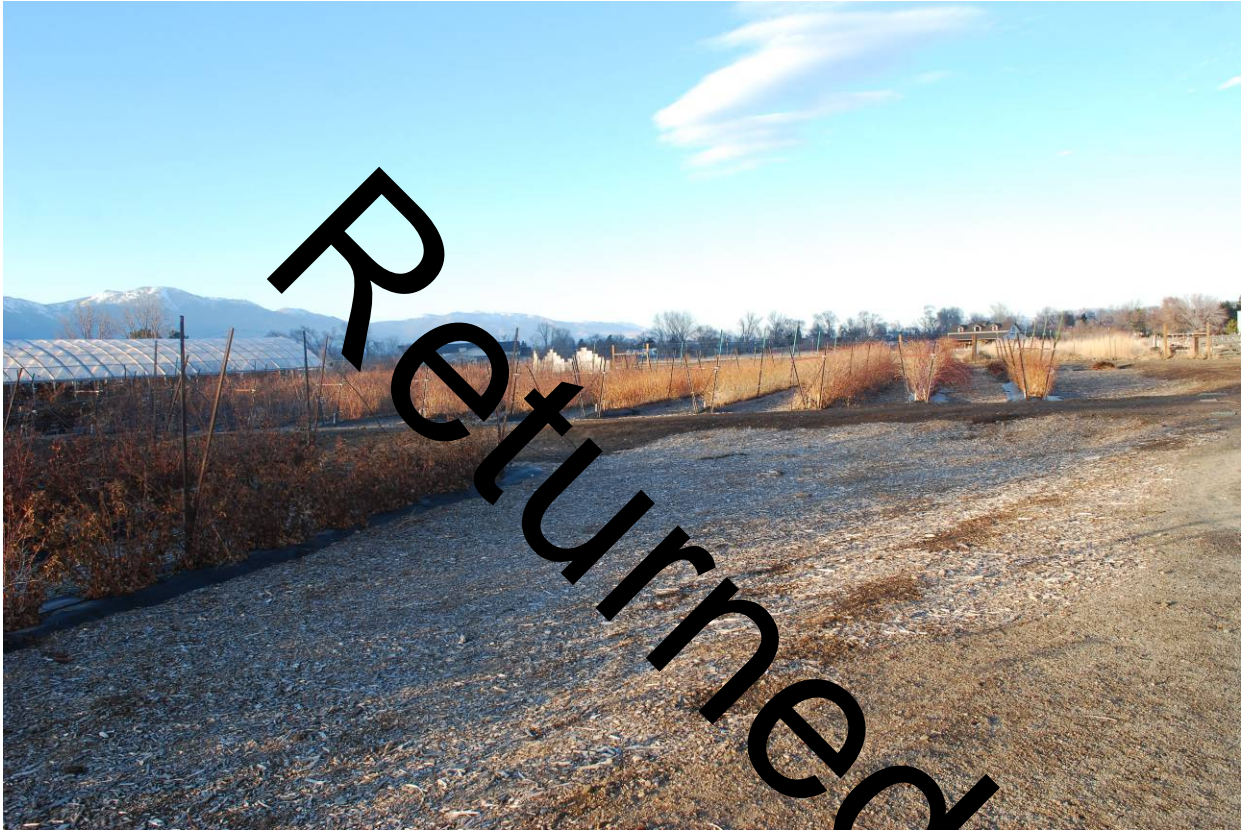
The field that covers the entire northwest extent of the property is the only remaining agricultural land within the property boundary, constituting of a preserved portion of what was once a larger agricultural field that extended to the west. Formerly a roughly 9-acre field used for growing barley and alfalfa, the roughly 1-acre site remaining is now used by the Jacobs family for growing berries, specifically nine varieties of raspberries and five varieties of blackberries. There are also six beehives on the property that provide honey for sale and help pollinate the berry bushes.

Photograph 183 – Northwest field, looking north from the main access road.

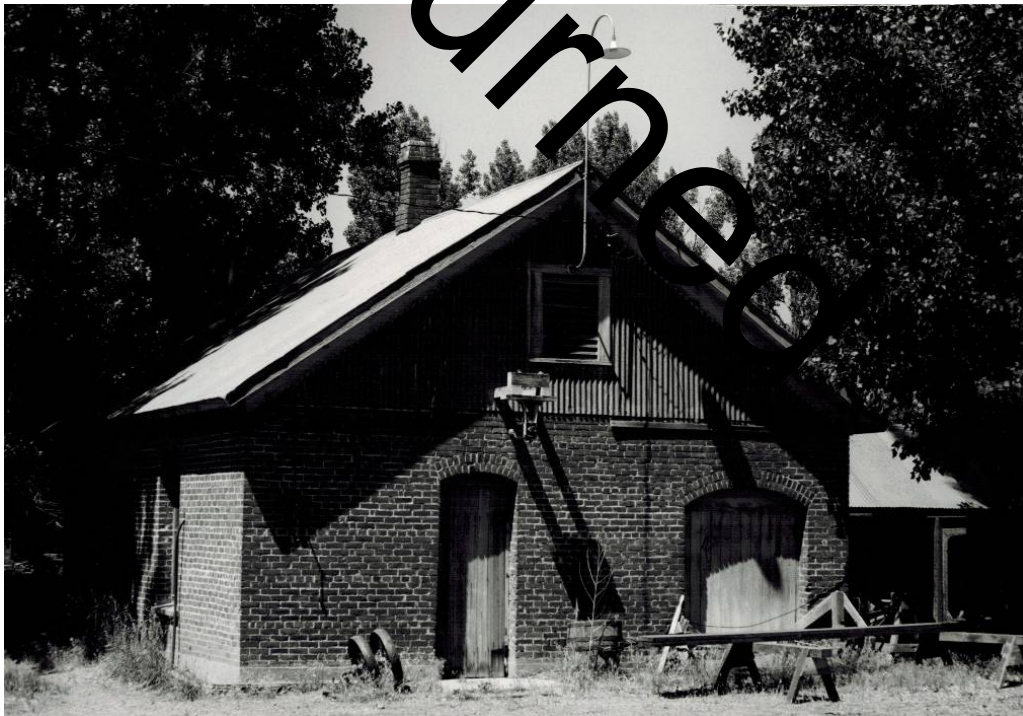
Photograph 205 – Image of the Creamery, c.1940s. Courtesy of Jon Olson.

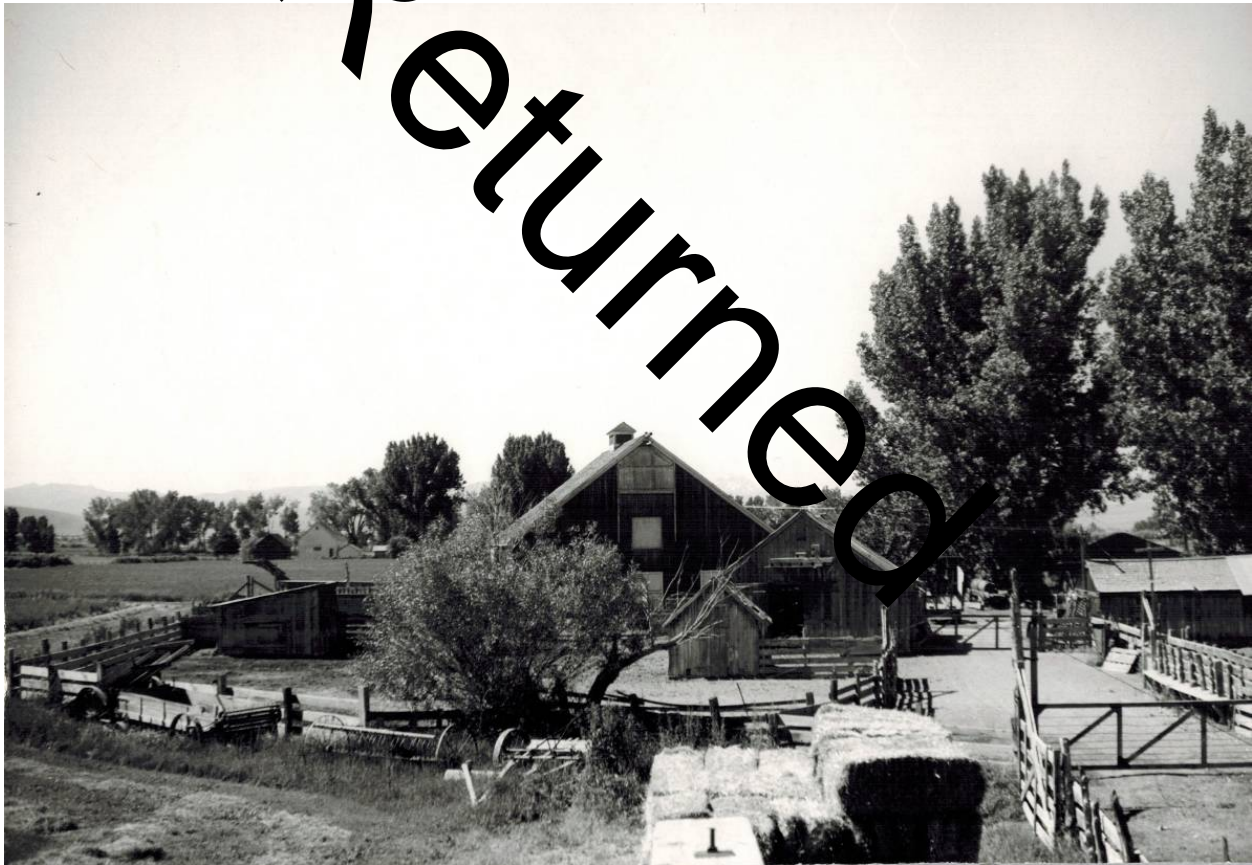
**Photograph 216 – Lampe Barn (center), 1905 barn (smaller building at center), Small Loafing Shed (far left), and Poultry House (far right), looking south. Photograph likely dates to the 1940s when Roger Olsen was helping to work on the ranch. Photograph courtesy of Jon Olsen (Roger's nephew).**

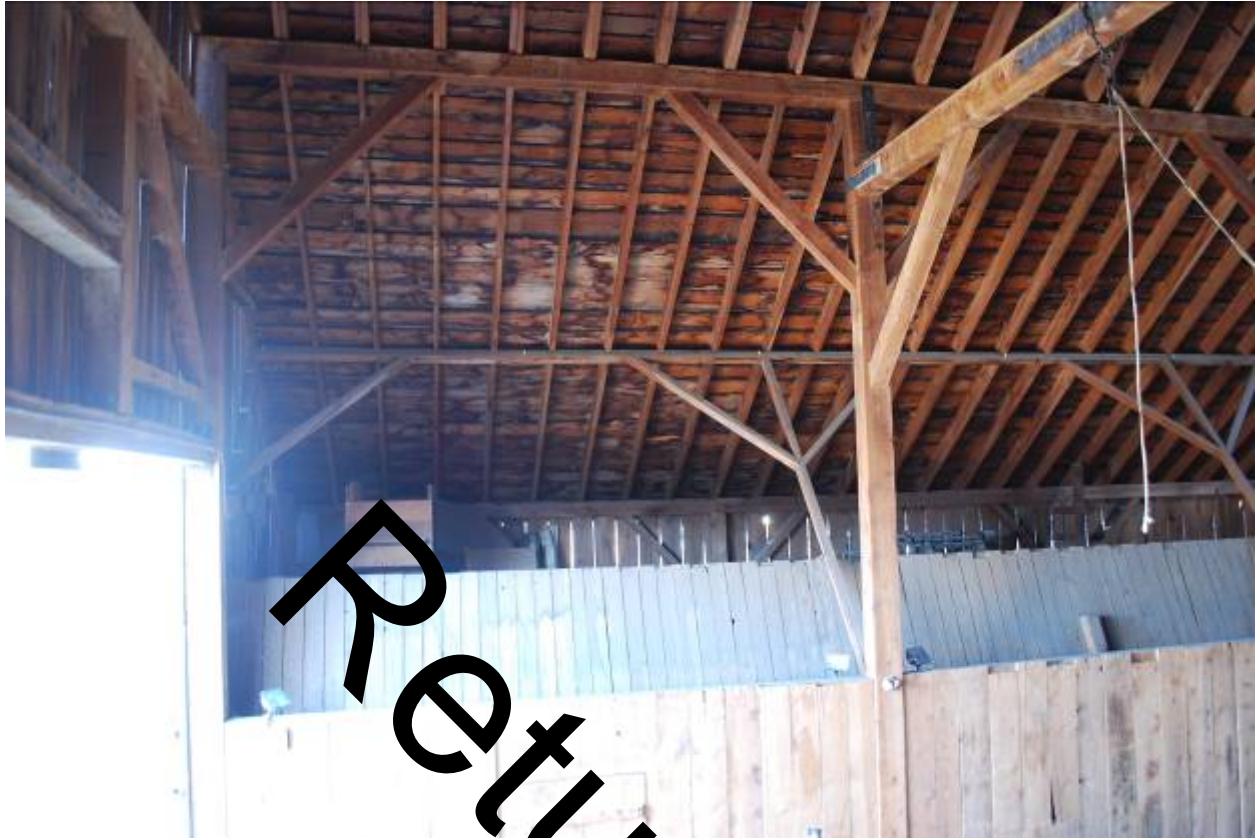
**Photograph 227 – Barn roof framing system, showing dropped tie beam (upper right and left) and unique angled truss bracing system along secondary (lower) beams.**

The barn has heavy timber, mortise-and-tenon framing with selective reinforcement with steel bolts and straps, resting on embedded foundation stones. Oatman provides a detailed description of the barn's structure:
