FARMINGTON CANAL LOCK NO. 13

Hamden, Connecticut

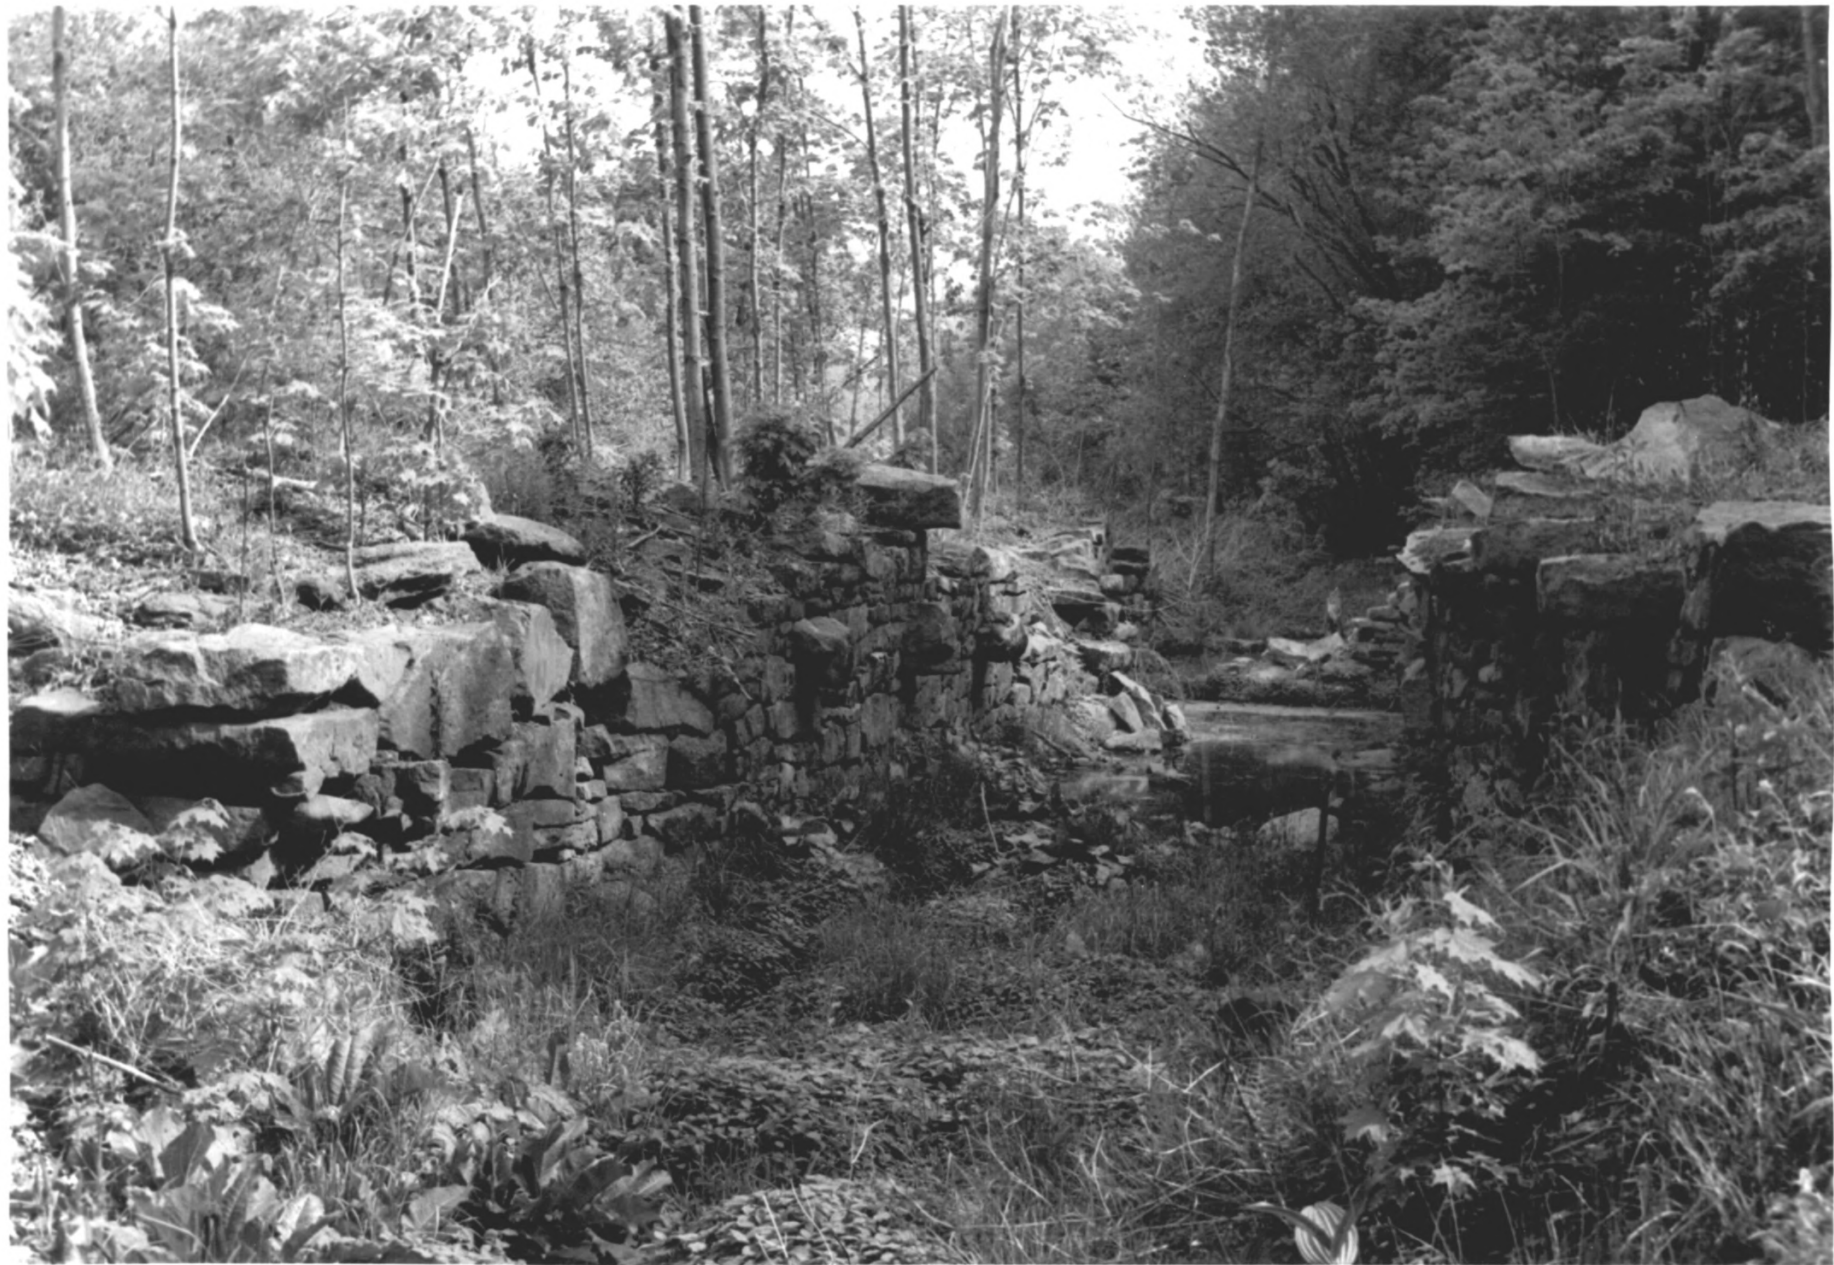
Photograph No. 1

Farmington Canal Lock 13, looking south.
Stone headers which separated masonry from
wooden lock walls in the original structure
are visible along both walls.

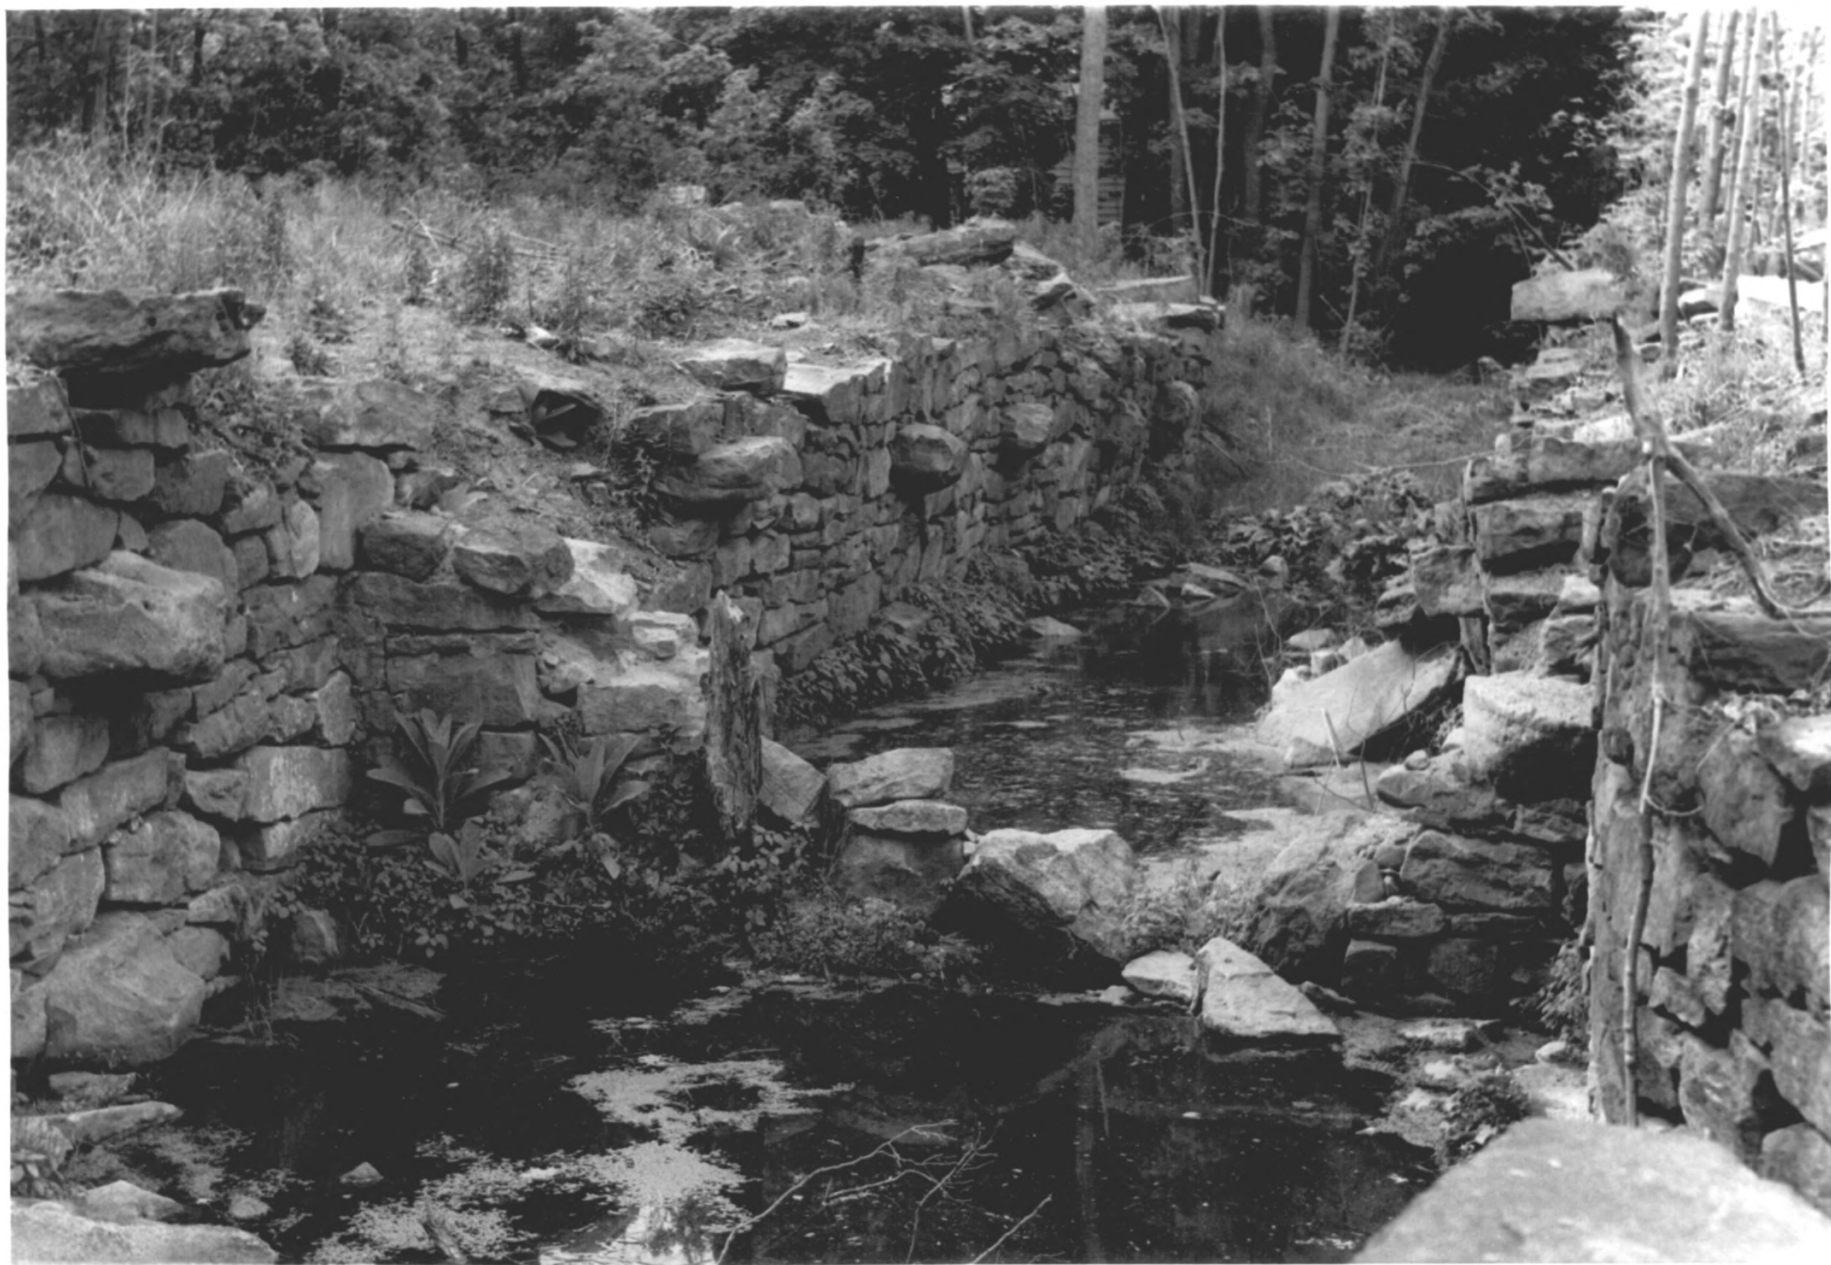
Photograph No. 2

Farmington Canal Lock 13, looking north.

Stone headers which separated masonry from wooden lock walls in the original structure are visible at left and in center. Later wall added across the lock is in foreground.

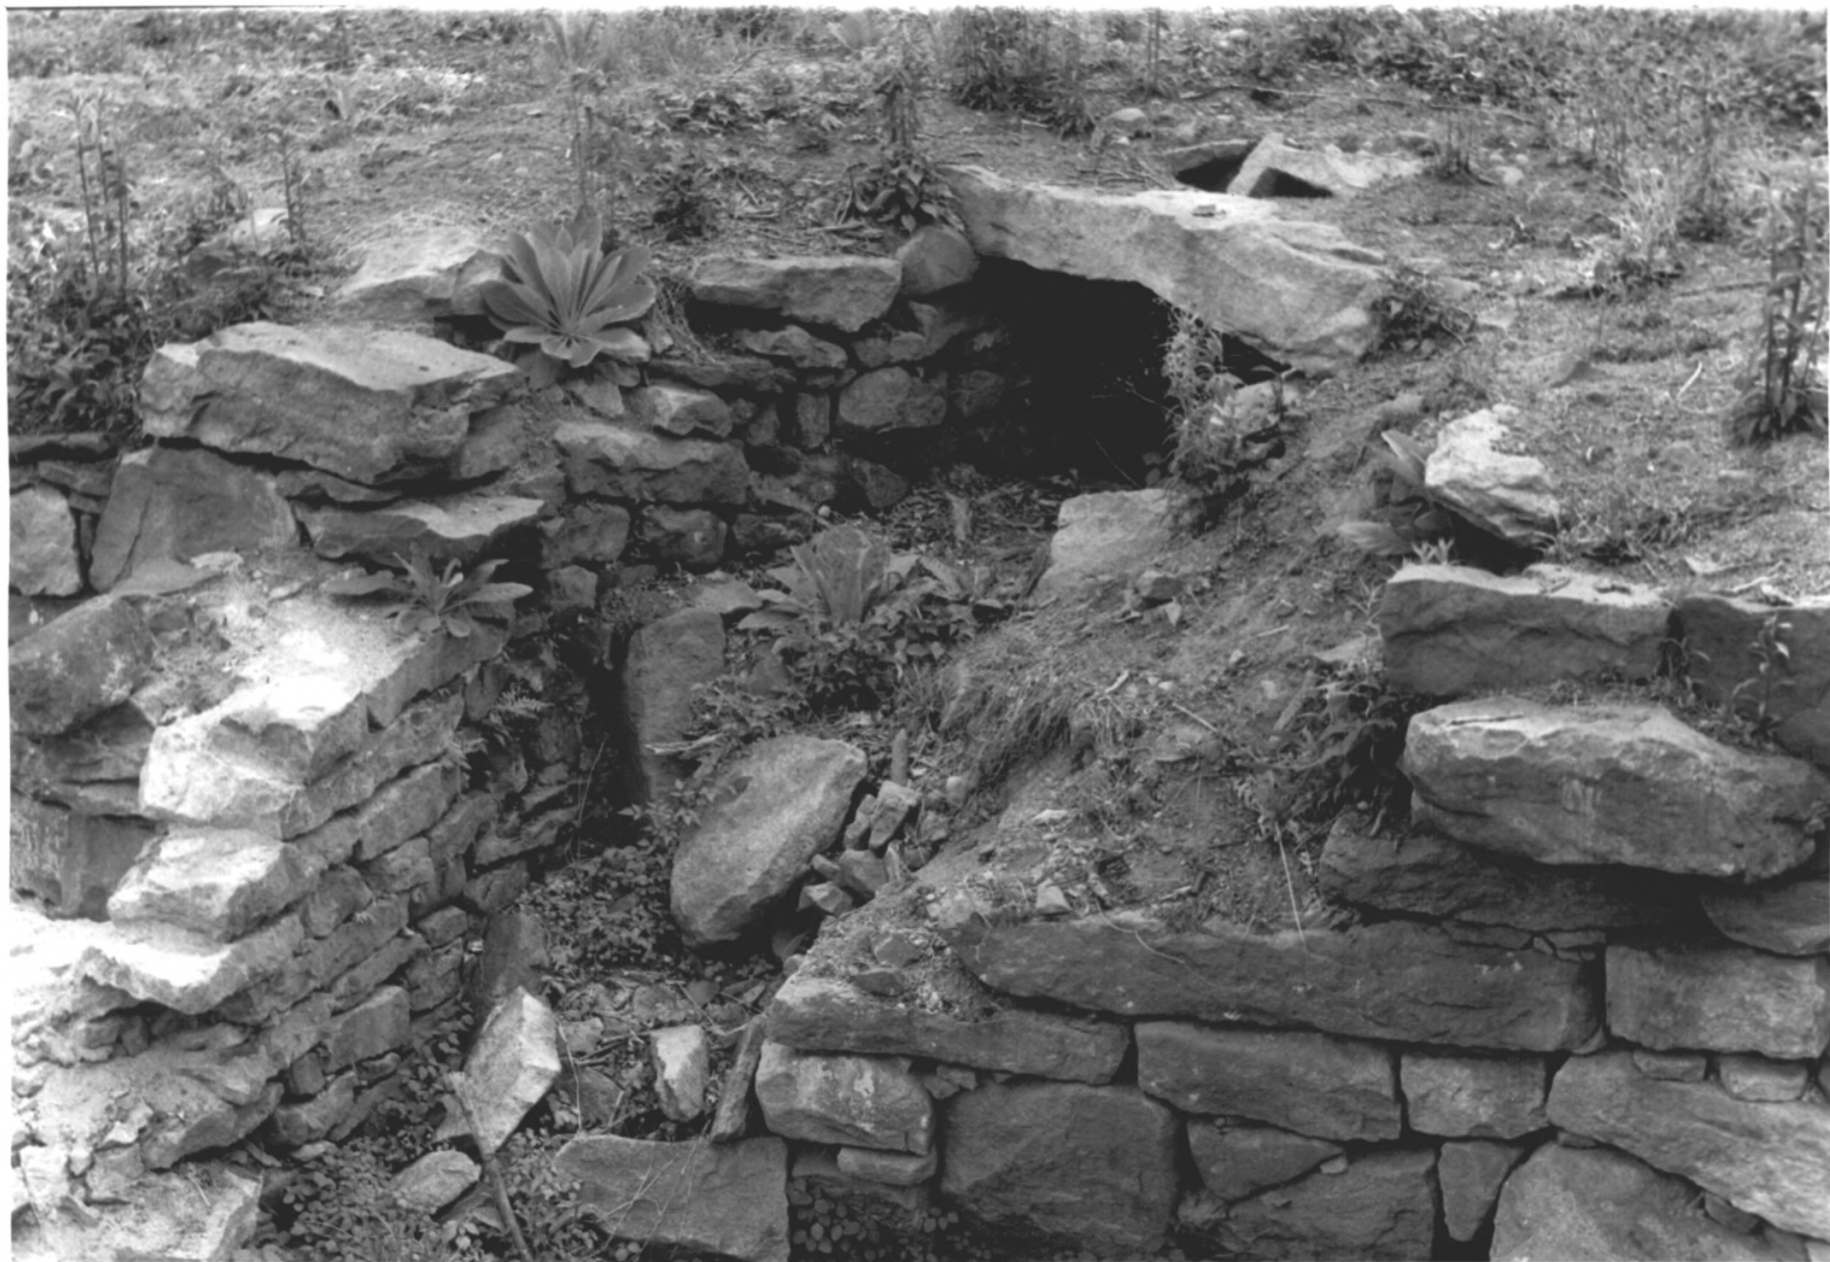
Photograph No. 3
FARMINGTON CANAL LOCK NO. 13
Hamden, Connecticut

Intersection of underground channel and
Farmington Canal Lock 13, looking west. The
masonry wall crossing the lock is at left;
different block sizes between the two layers
of this wall are visible, suggesting two periods
of construction for the cross wall. One of the
stone headers which separated the masonry lock
walls from the original wooden lock chamber is
at right center.
