Property Name: Dirck Gulick House County: Somerset State: NJ

historic name DIRCK GULICK HOUSE

Description

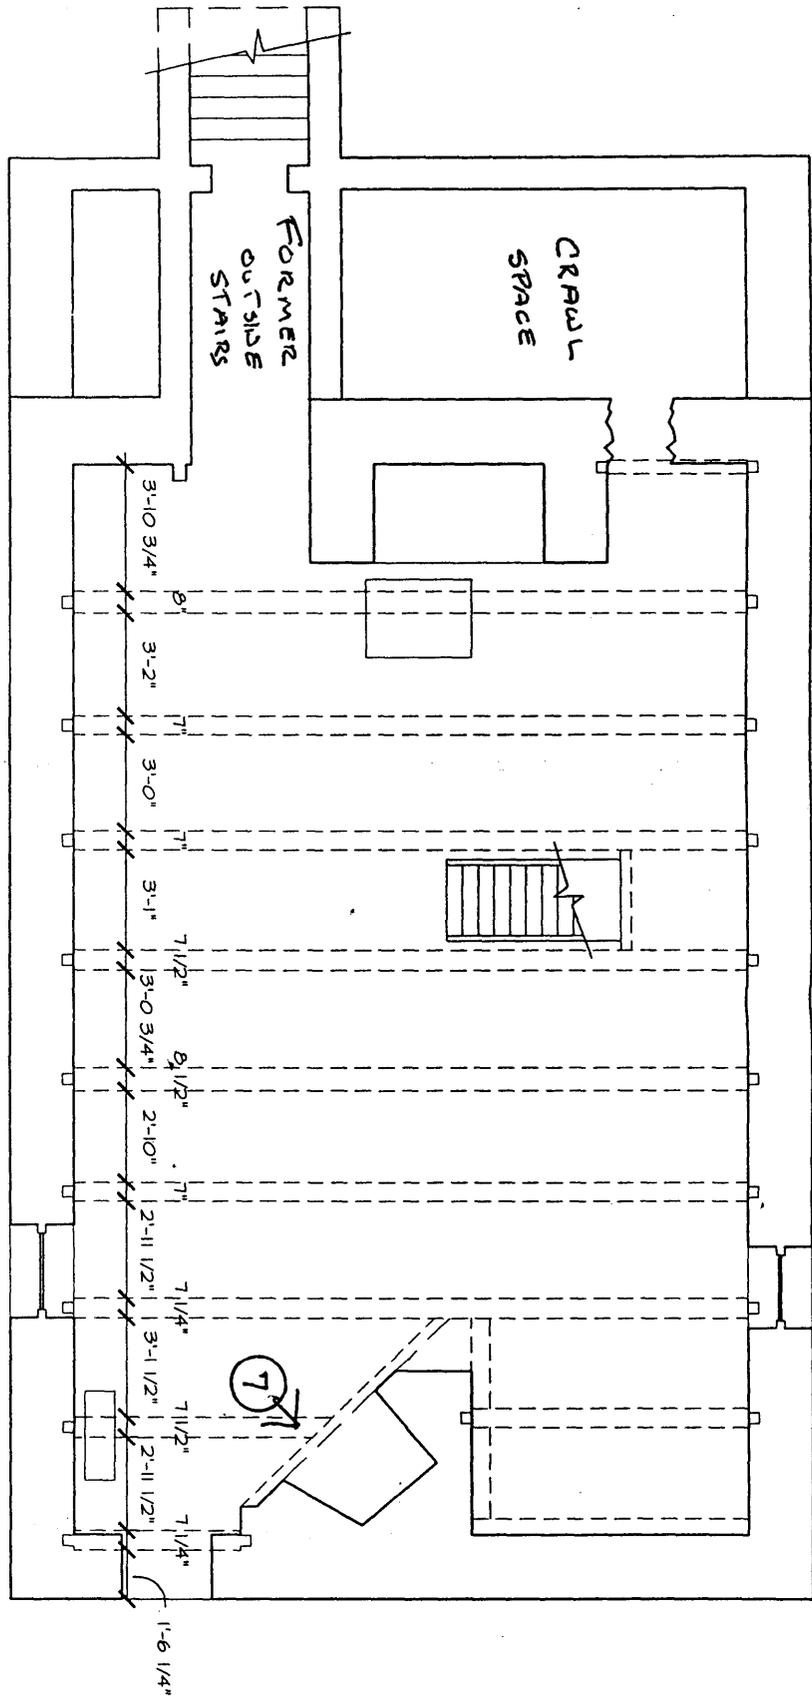
FIRST FLOOR BEAMS

The structural support system is composed of eight massive hewn beams somewhat varying in size, extending from the front wall to the rear wall and serving as joists. The spacing between them is greater for the four under the west half of the house from those under the east. (This is also true in the rooms above.) Nonetheless, there is no evidence that the two halves of the dwelling were built at different times. A plank partition partly separates the rear cellar space from the front under the east side of the house. An open flight of stairs installed by later occupants descends to the cellar at midpoint from the back wall. The cellar, deepened by about a foot, has a cement floor and traces of whitewash on its walls. There is one casement-style opening on each of the long walls.

The ground floor plan offers two rooms on the east side (identified on floor plan as B and C) and one room on the west (A), each half served by one of the two exterior entrances. Large hewn timbers (joists) run the full span of the house from front to rear. They are also of varying dimensions, averaging 6" by 10-1/2" and spaced more widely in the west room (A). A few are beaded. The last, most westerly, internal beam in Room A does not match the others, being less finished. Although of the same proportions and seemingly similar age, it appears to have been a replacement, possibly put in at the time the cooking fireplace was removed and the frame wall erected, unless it replaced a beam that had been scorched by the cooking fire.

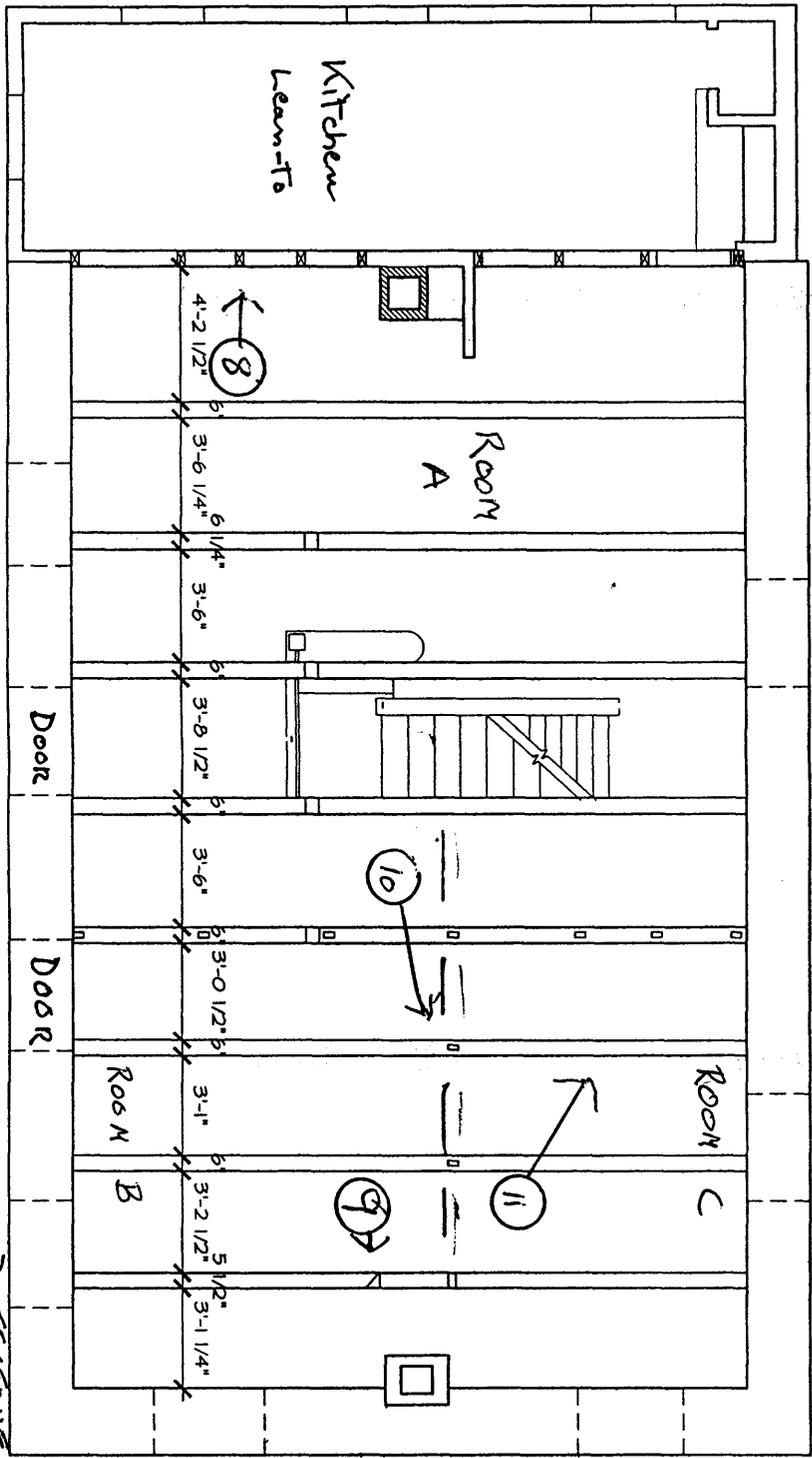
SECOND FLOOR BEAMS

The upper floor or garret was used for several decades for sleeping and for storage. (6) During the occupancy of the Davises double-hung sash were installed in each gable peak, flanking the chimneys. In late 19th century or early 20th century, the space was partitioned into three bedrooms and a bathroom. Door casings with bulls-eye cornerblocks relate to that era. In installing the plumbing the pipes became visible from the ground floor and this led to the mounting of a ceiling on the underside of the beams. Modern flooring was also laid at that time.

The entire garret is ceiled, covering the rafter system, but sawn rafters can be seen in an unfinished storage space. (See floor plan, Fig. 4)
