**National Register of Historic Places
Registration Form**

historic name Ladd Carriage House

street & number 1331 SW Broadway Street

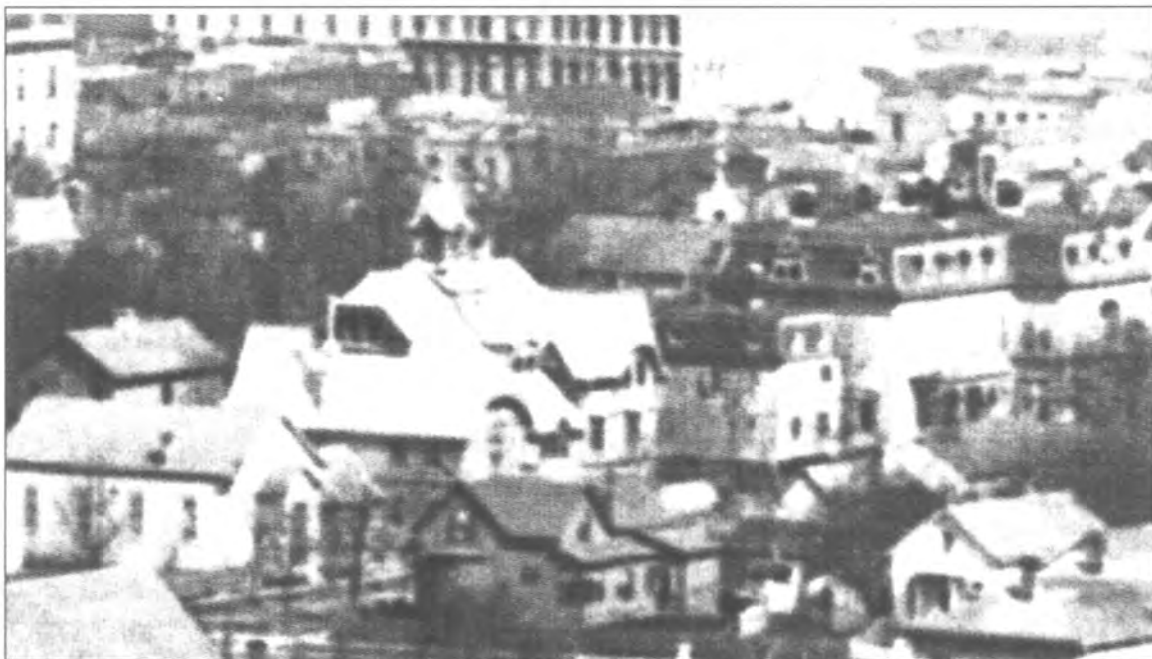
Image 1. c. 1880s photograph showing Ladd Carriage House (center-left) and Ladd House (right) from the southwest. Source: Oregon Historical Society, CN 017530

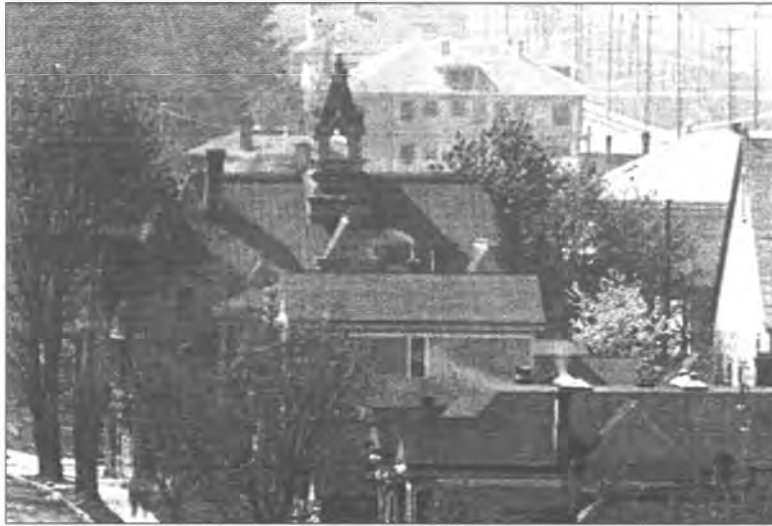
Image 4. 1908 photograph showing Ladd Carriage House from the north.
Source: Oregon Historical Society, OrHi 67367.

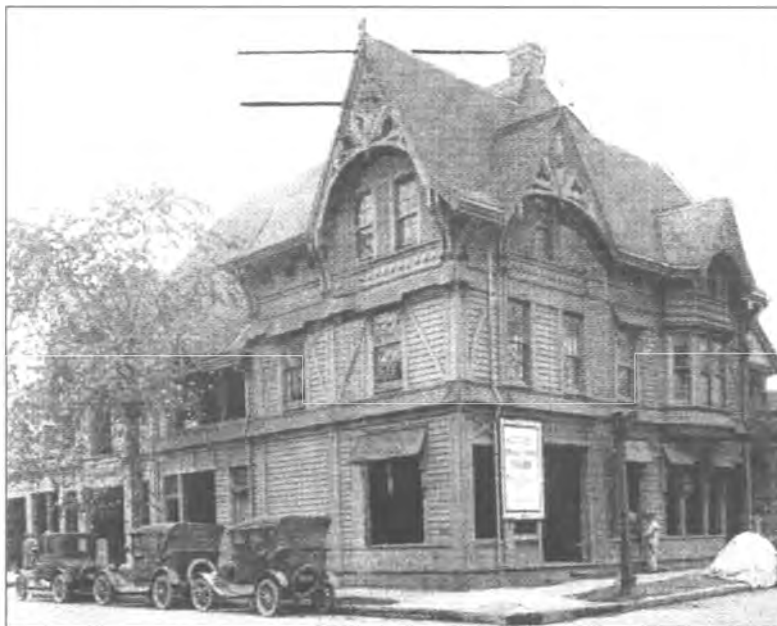
Image 5. 1926 photograph showing Ladd Carriage House remodel work.
Source: *The Oregonian*.

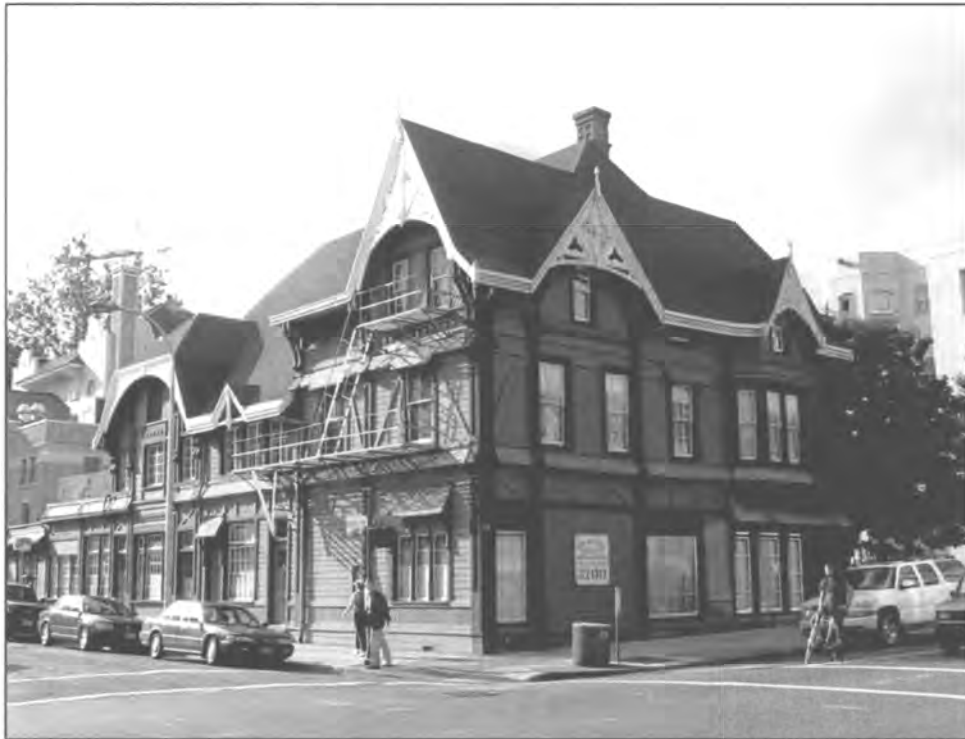
Image 6. 2005 photograph showing the southeast corner of the Ladd Carriage House.
