NATIONAL REGISTER OF HISTORIC PLACES REGISTRATION FORM

historic name: Mantle's Cave
other names/site number: 5MF1

Section number 7 Page 1

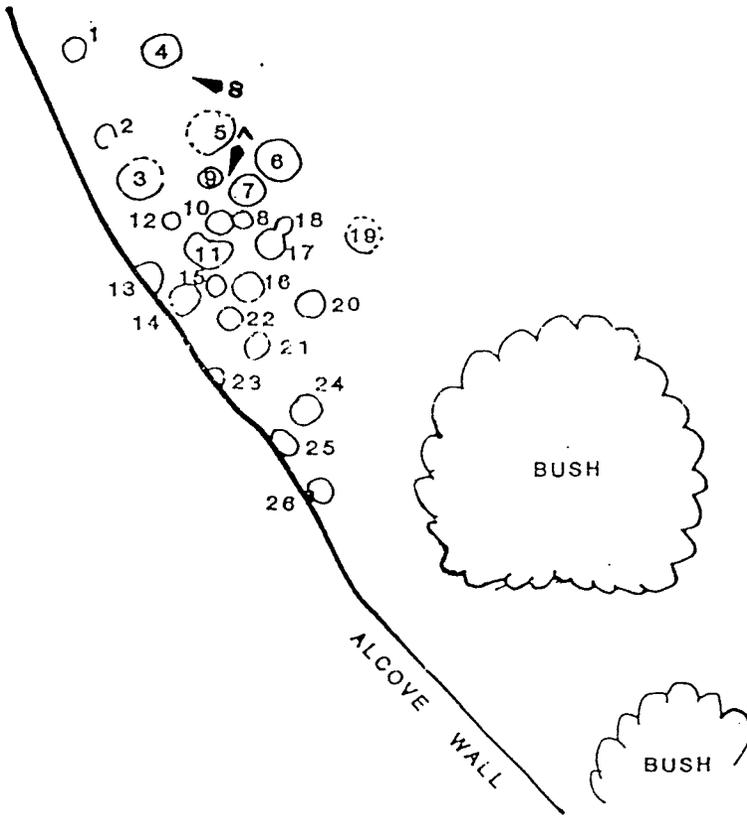
The distribution of earthen cists at the western end of the site.

Features 1 through 26 are presently visible and are located in the silt deposits at the western end of the site. The silt is consolidated, permitting the construction of earthen cists. Features 1, 8, 9, 10, 11, and 15 were stabilized in 1989.

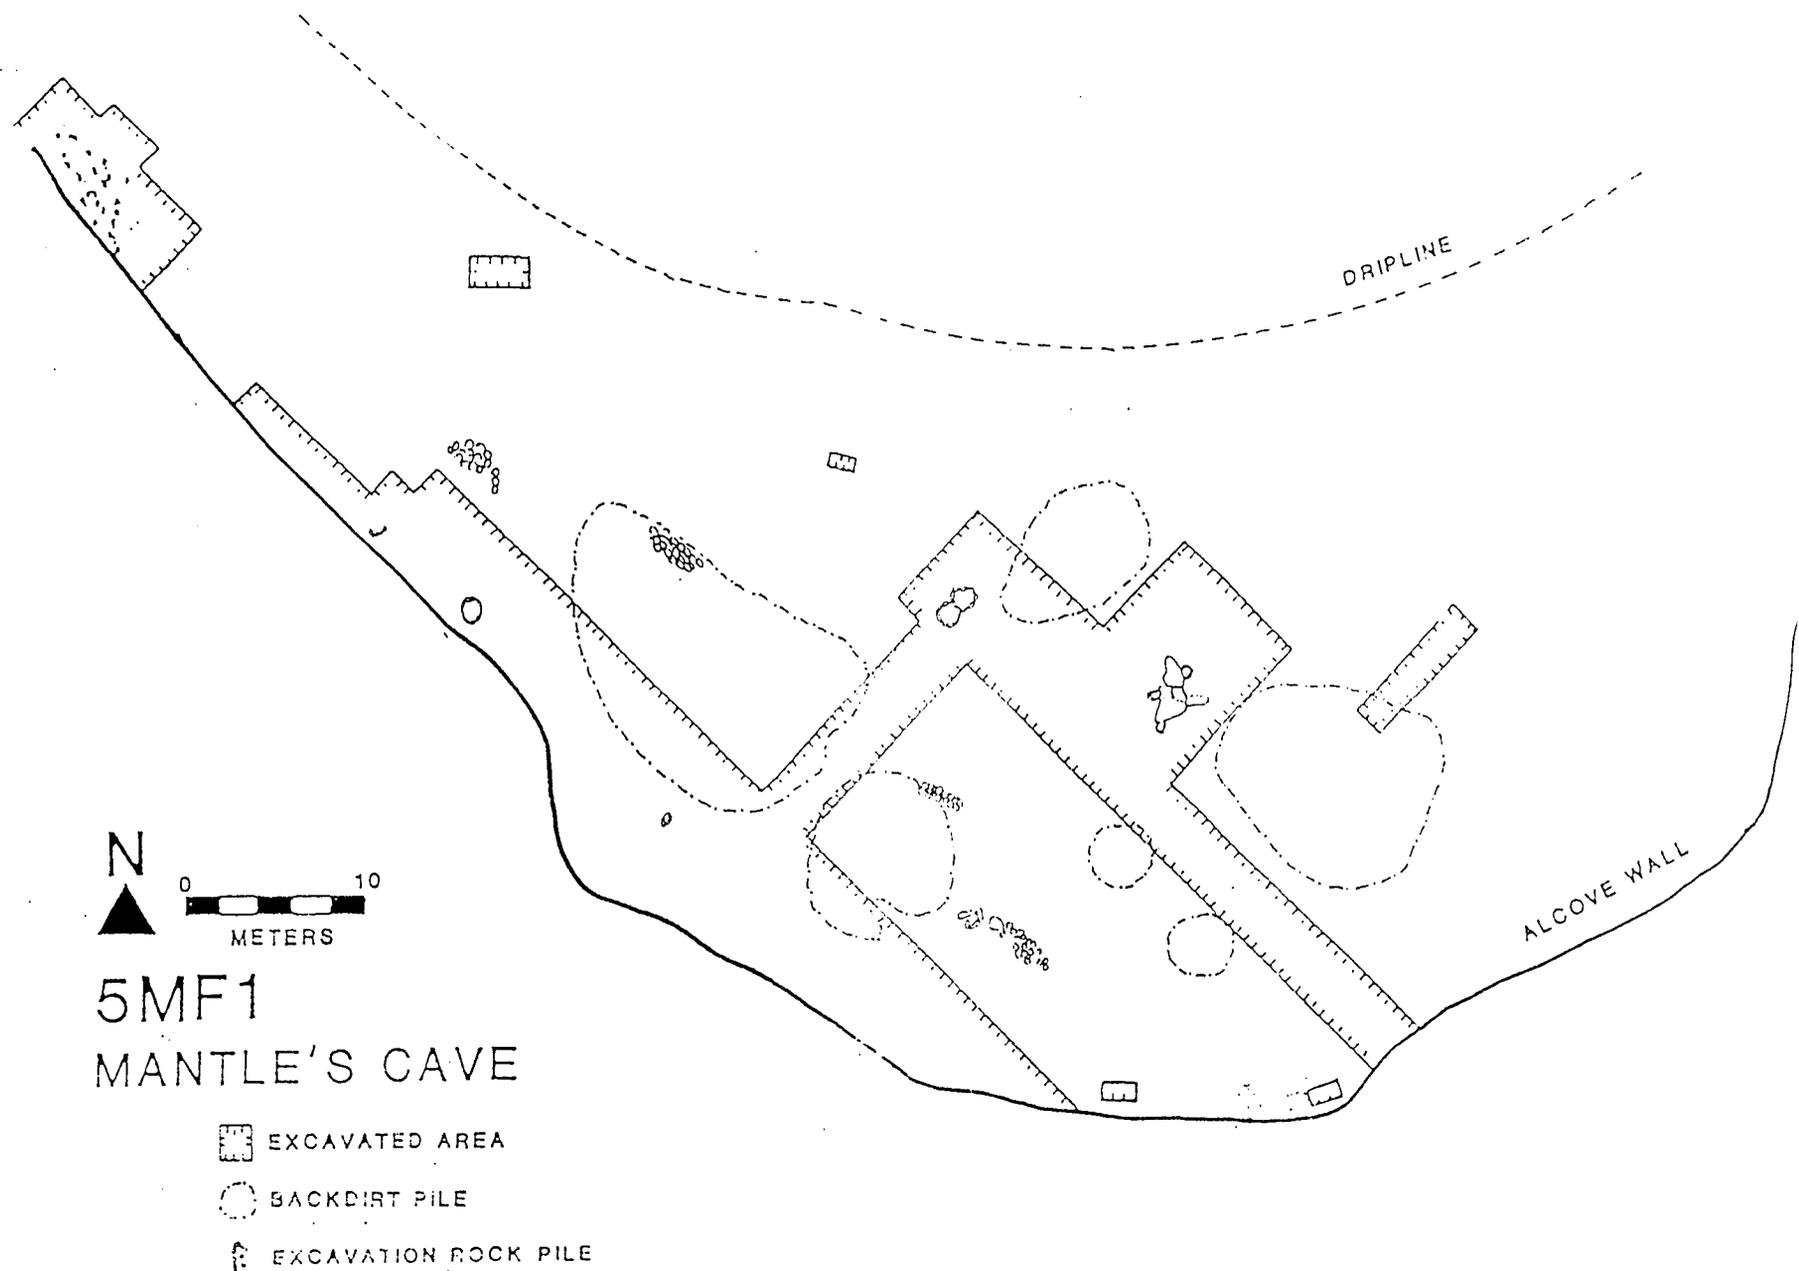
Map showing the distribution of excavation features associated with the University of Colorado Museum's excavation project (after Burgh and Scoggin 1948:23).
