NATIONAL REGISTER OF HISTORIC PLACES  
REGISTRATION FORM

historic name Robinson-Hiller House  
other names/site number Hiller House

street & number 113 Virginia Street not for publication   
city or town Chapin vicinity \_\_\_\_\_  
state South Carolina code SC county Lexington code 063 zip code 29036

**NARRATIVE DESCRIPTION**

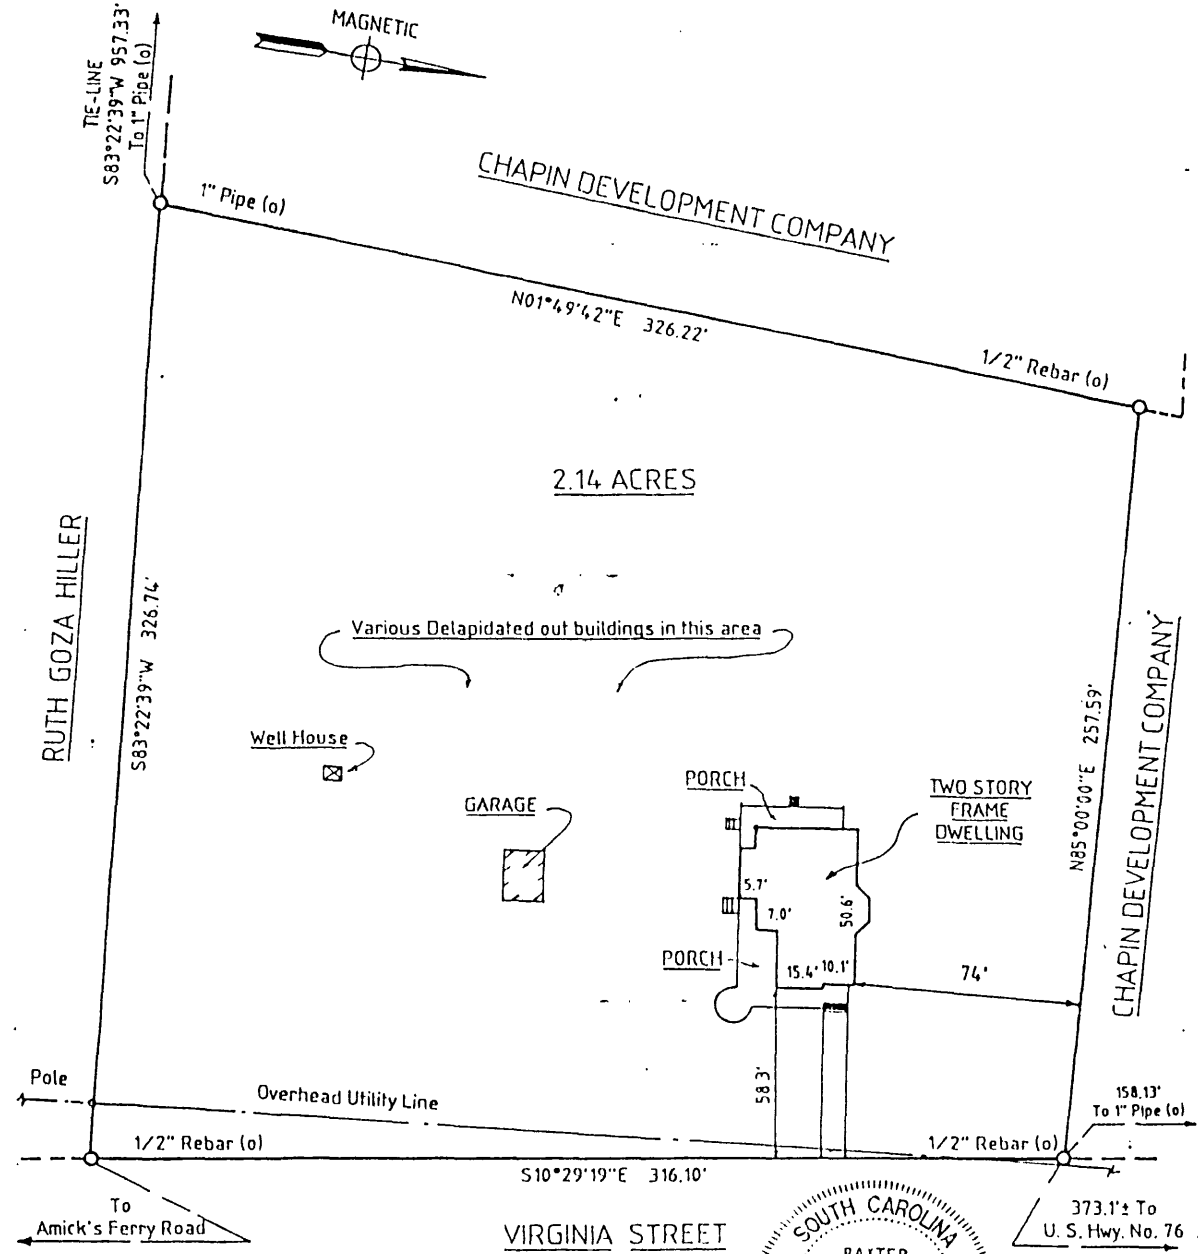
PLAT PREPARED FOR  
**RAY O. CARTER**

I HEREBY STATE THAT ACCORDING TO THE FIRM/FIA FLOOD INSURANCE RATE MAPS, THIS PROPERTY LIES WITHIN UNSHADED ZONE "X".
