Vanderbilt Mansion National Historic Site  
Hyde Park, New York

## Vanderbilt Mansion National Historic Site Historic Structure Report

Volume IV: Second Floor  
October 2018

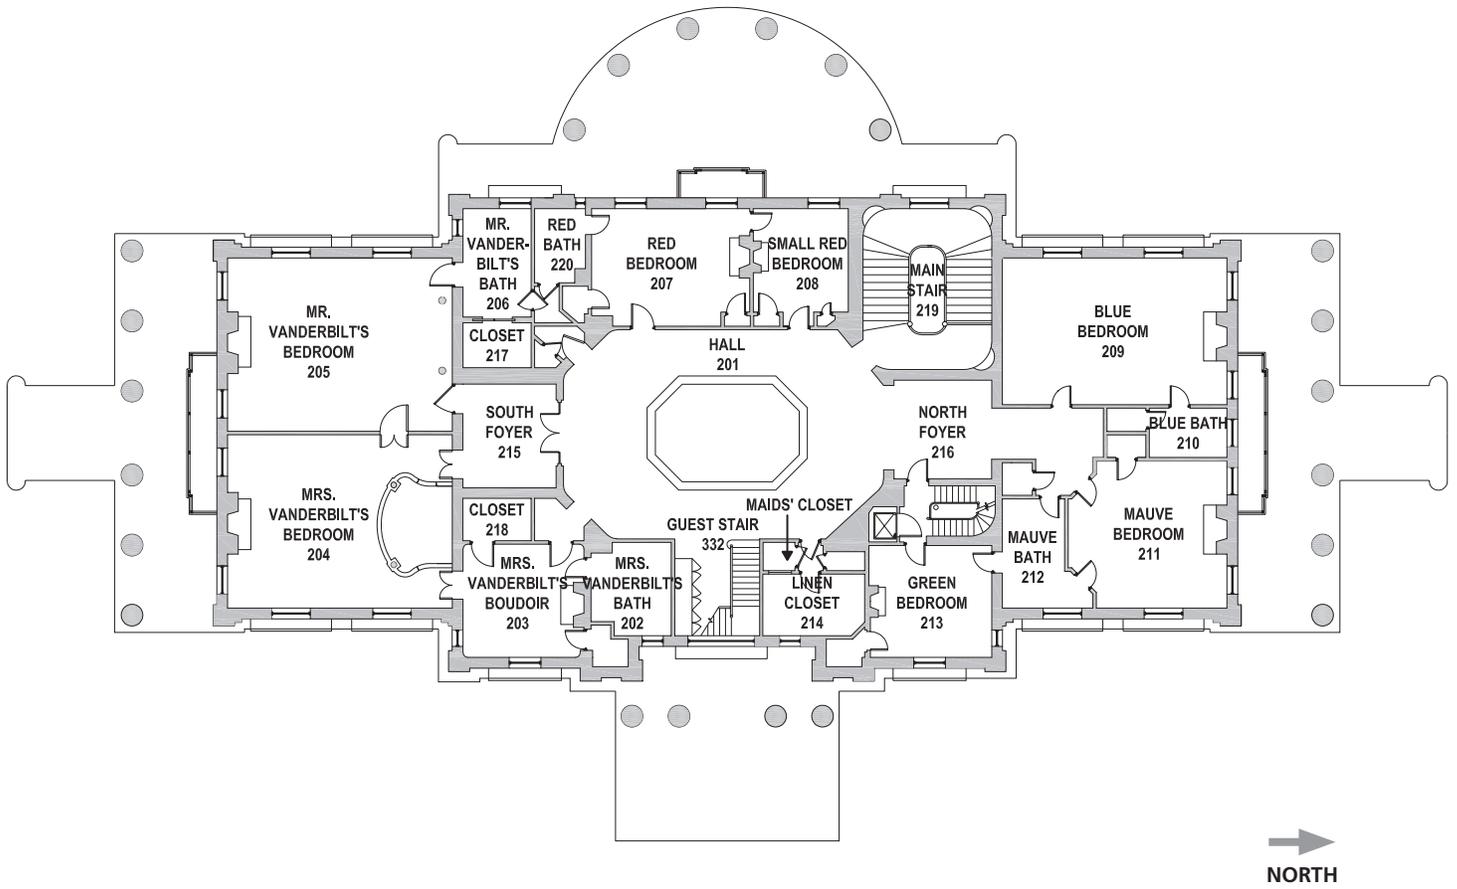
Figure 2. Vanderbilt Mansion second floor key plan. JGWA.

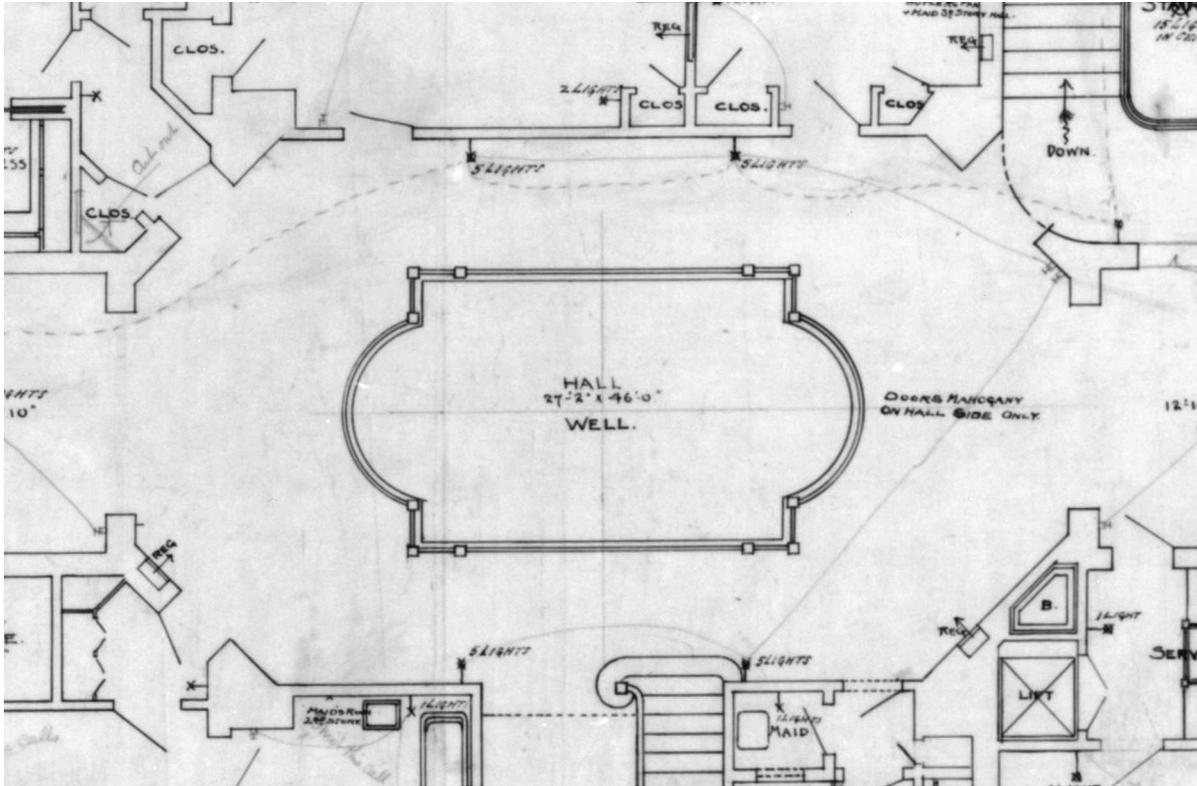
Figure 3. Detail of the second floor Hall from the McKim, Mead & White second floor plan (February 18, 1897). McKim, Mead & White Architectural Record Collection, PR 42, #10, Department of Prints, Photographs, and Architectural Collections, The New-York Historical Society, photographic copy in park archives.

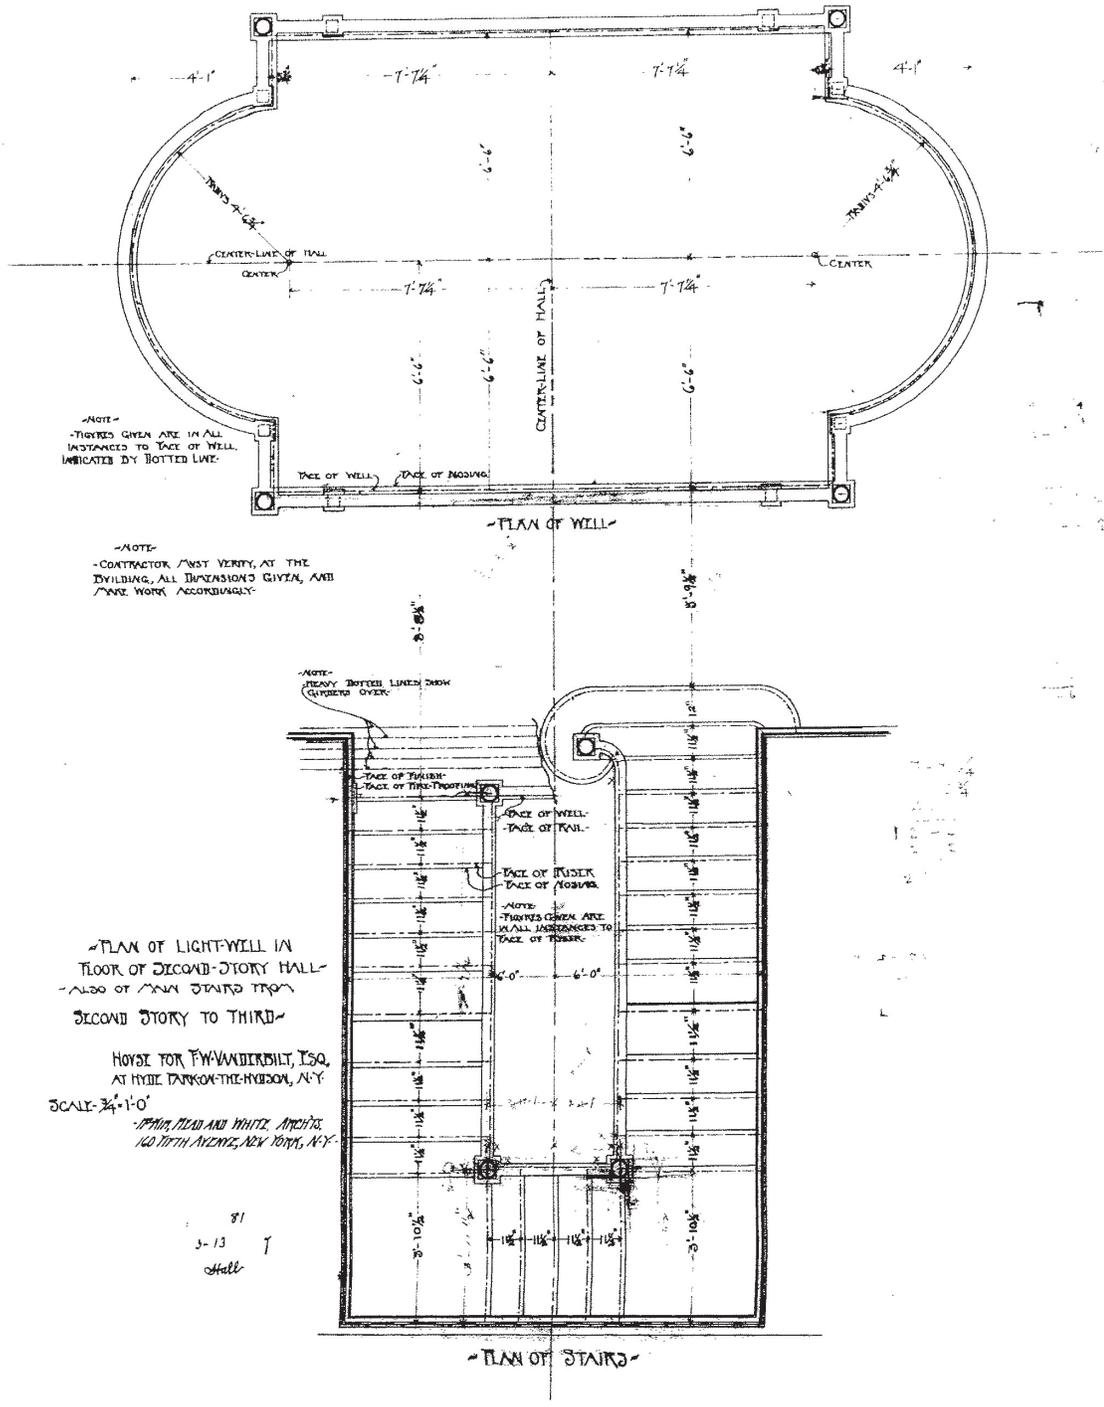
Figure 4. Plans for the well and stairs in the second floor Hall by McKim, Mead & White, March 13, 1897. McKim, Mead & White Architectural Record Collection, PR 42, #81, Department of Prints, Photographs, and Architectural Collections, The Historical Society, photographic copy in park archives.

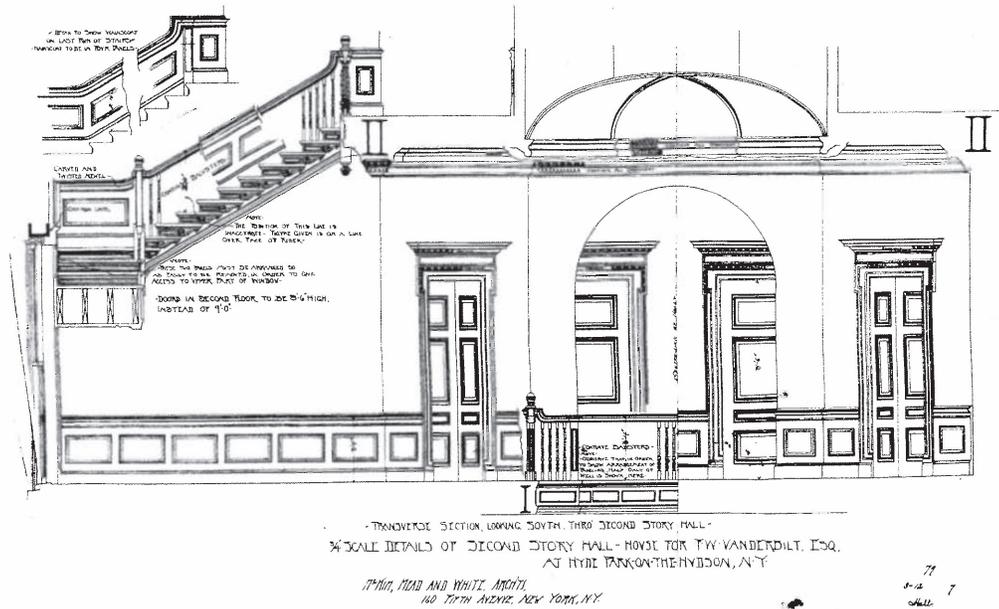
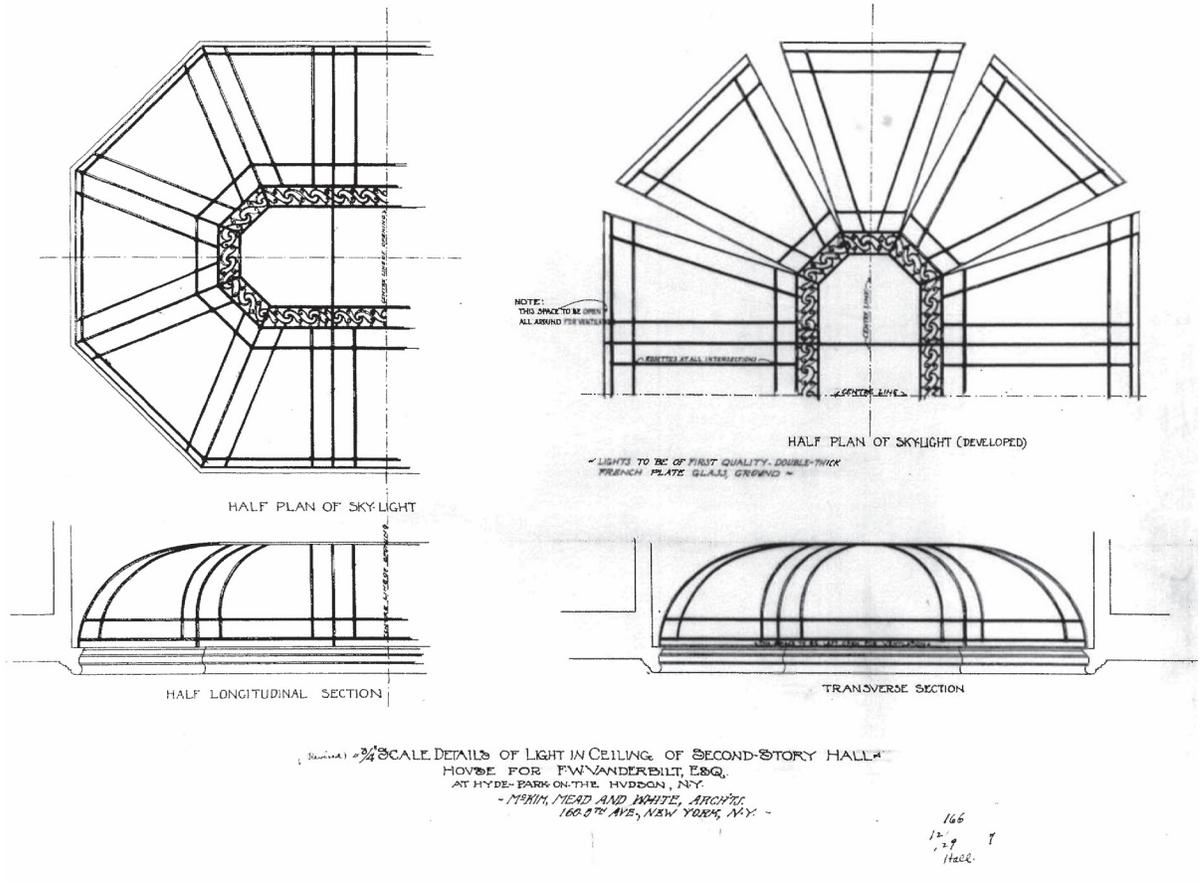
Figure 5. Section through the second floor Hall by McKim, Mead & White, March 12, 1897 (upper image) and details for the light in the ceiling of the second floor Hall (lower image), December 29, 1897. McKim, Mead & White Architectural Record Collection, PR 42, #79 and #166, Department of Prints, Photographs, and Architectural Collections, The New-York Historical Society, photographic copy in park archives.

2. Drawing #28, “¼ Scale Detail – (Revised) of Light in Floor of Second Story Hall” shows the laylight framework as slightly-coved mullions, possibly metal, with a scroll design shown in the narrow sections of framework. A freehand-written note, “Ground plate ground on the under side”, suggests that glass was meant to be used. This same scroll design is depicted in the “Plan of Second Story Hall showing proposed change in Light Well drawing.”

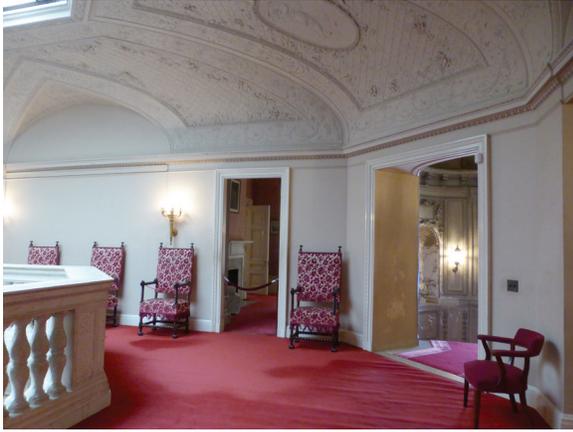
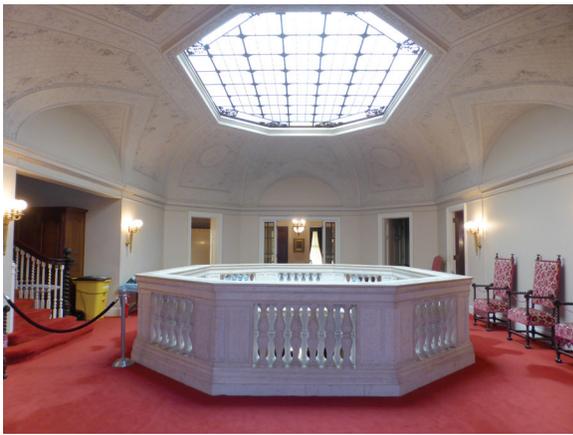
Figure 6. The second floor Hall, looking northwest (upper image) and south (lower image). JGWA, 2017.

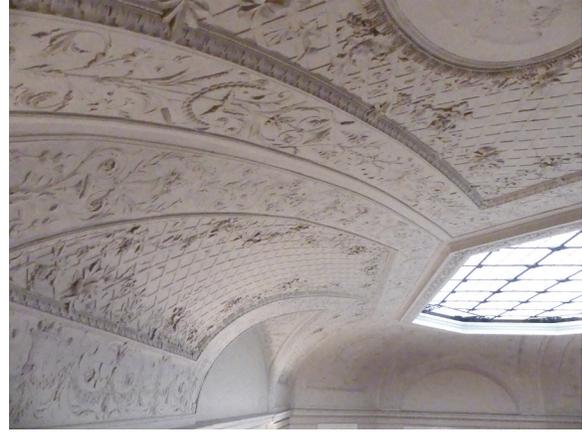
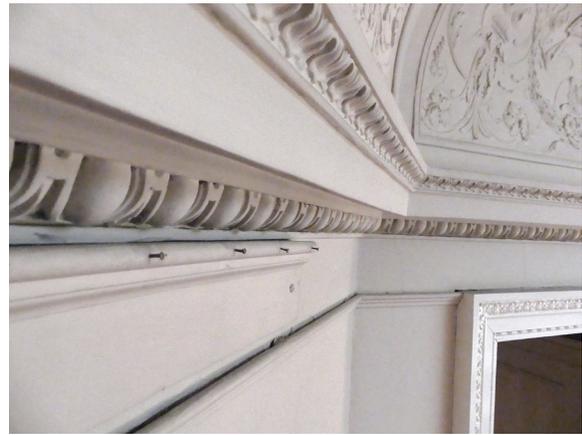
Figure 7. Details of ceiling and cornice in the second floor Hall. JGWA, 2018.

profile carved in a continuing pattern of acanthus with a bead at its terminus, followed by a plain fascia, a bead-and-reel, and a plain fascia.

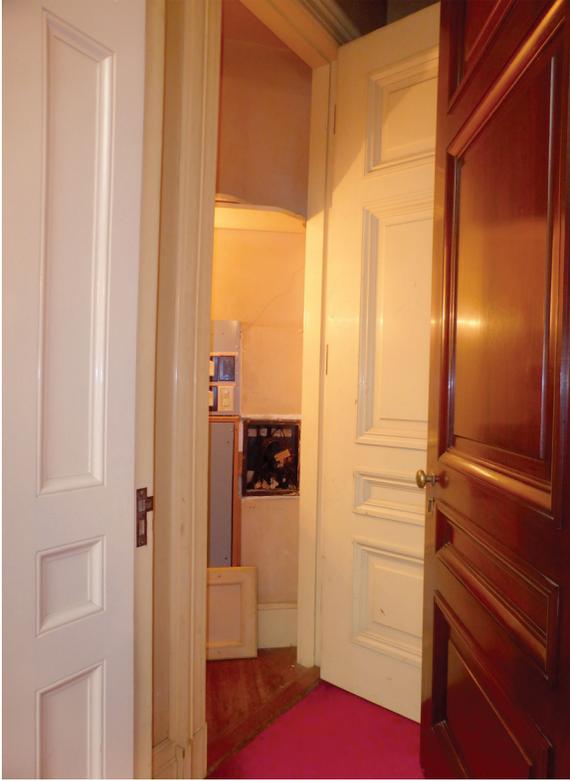
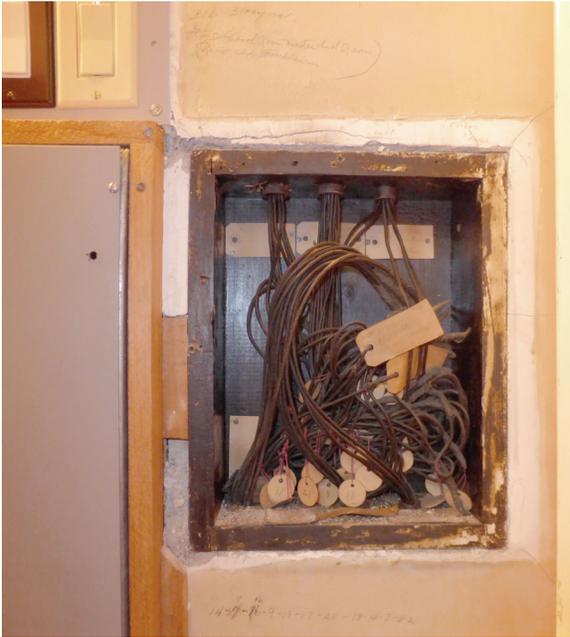
Figure 8. Southwest closet in Hall (upper image) and the old electrical panel in the inner closet (lower image). JGWA, 2017.

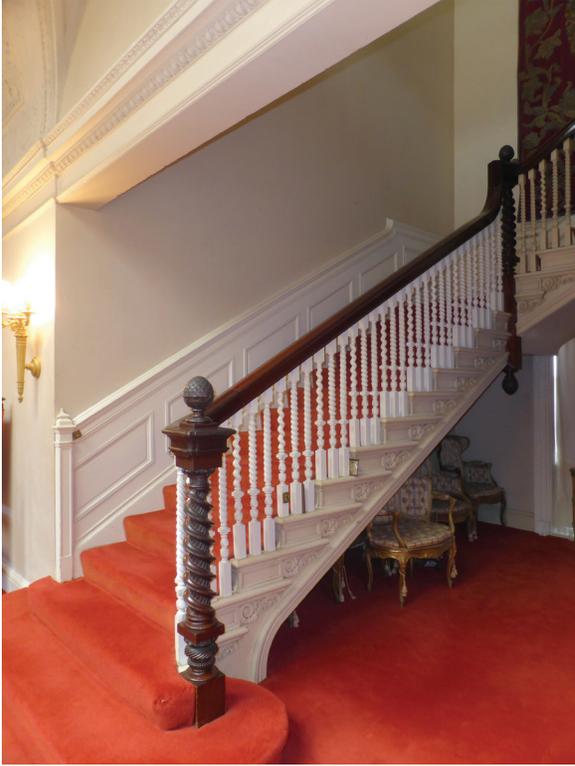
Figure 9. The Guest Stair to the third floor guest quarters. JGWA, 2017.

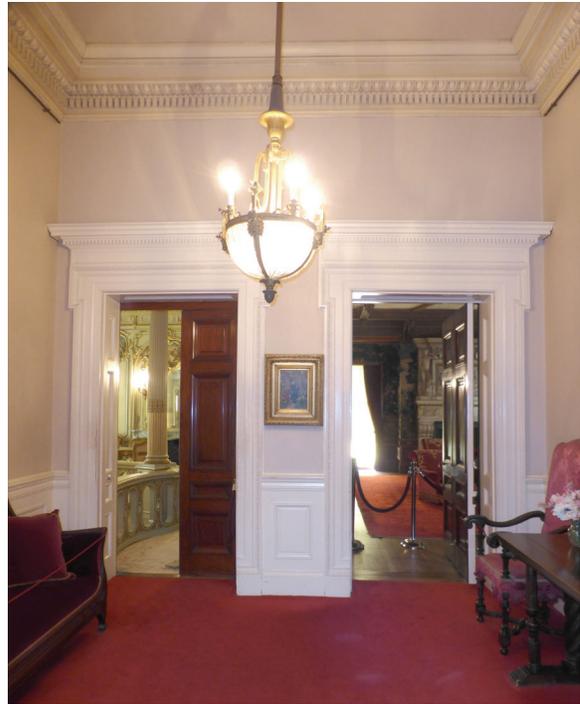
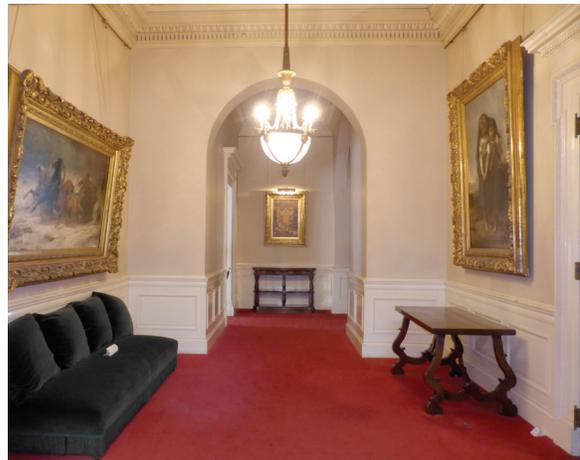
Figure 11. The second floor South Foyer, looking south (upper image); and the North Foyer, looking north (lower image). JGWA, 2017.

The north doorway, originally just a wide arched opening to the Hall, is fitted now with a pair of glazed French doors flanked by four-light sidelights; these may have been added by Whitney Warren in 1906. A 4-1/2" wide architrave fits inside the original opening to frame the doors and their sidelights; the trim is composed of (from the outside) an acanthus cyma recta, a bead, a fascia, a bead-and-reel, and a narrow fascia.

South doors (to 201): The opening is fitted with a pair of glazed doors, each 2'-9 1/2" wide x 8'-4" high x 1-3/4" thick. The inside edge of each door is carved in an S-shaped curve. Eight lights are separated by narrow muntins; small decorative bosses ornament the intersections of the muntins. The stile-and-rail frames are painted off-white. Hardware: A 10" high iron mortise lockset in the curved edge of the east leaf includes decorative cast-bronze lever handles and 7-3/8" high plates (now painted). Each leaf is hung on the jambs with three 4-1/2" high bronze butt hinges with acorn finials. The west leaf includes the same mortise lock, but also has a bronze Cremone bolt with an ornate oval knob on the south face.

**LIGHTING/ELECTRICAL:** A gilt bronze and cut-glass chandelier (VAMA 6945) holds four electric candles. It matches the fixture in the North Foyer. A NPS plate with a toggle switch and two receptacles on the north wall replaced an original switch.

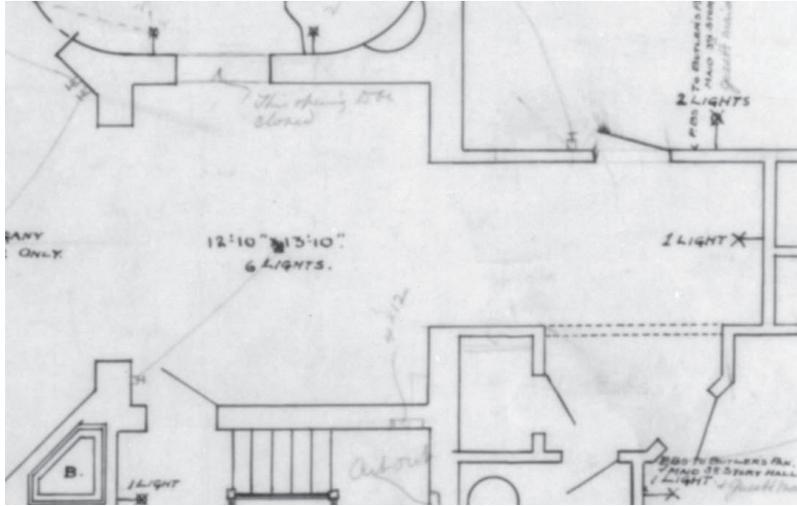
Figure 12. Detail of the North Foyer from the McKim, Mead & White second floor plan (February 18, 1897). Note the doorway in the west wall “to be omitted.” McKim, Mead & White Architectural Record Collection, PR 42, #10, Department of Prints, Photographs, and Architectural Collections, The Historical Society, photographic copy in park archives.

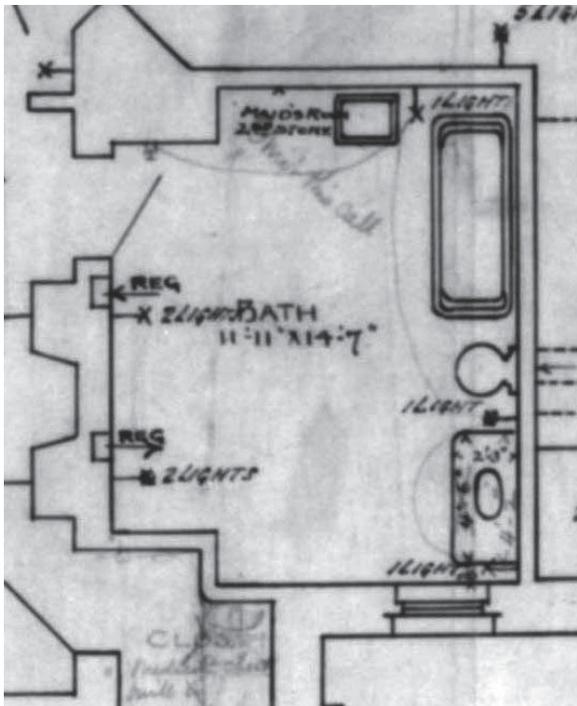
Figure 14. (Upper image) Detail of Mrs. Vanderbilt's Bathroom from the McKim, Mead & White second floor plan (February 18, 1897). The plumbing fixtures are shown in their final positions. McKim, Mead & White Architectural Record Collection, PR 42, #10, Department of Prints, Photographs, and Architectural Collections, The Historical Society, photographic copy in park archives.

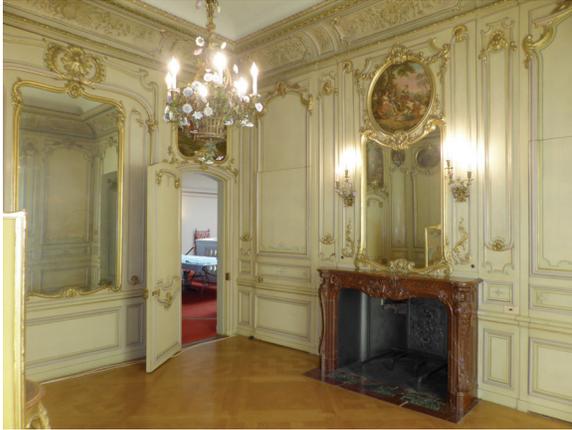
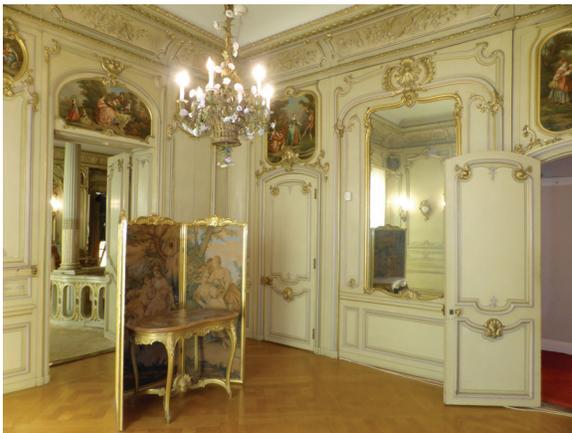
Figure 18. Mrs. Vanderbilt's Boudoir, looking northwest (upper image) and southwest (lower image). JGWA, 2017.

**CORNICE:** The 1'-6 1/2" high cornice begins with a bed molding (D) composed of a flat band, surmounted by small gold-leafed dentils, a filleted cyma reversa, and a gilded egg-and-leaf foliated border trim. A large cove

with trimmed relief panels (E) depicts representations of the arts, primarily of musical instruments. The panels are trimmed with clipped, curved corners and each is bordered by a large painted bead with gilded foliation at the corners, a plain band, and a gilded bead. A gilded holly garland and a small cove, containing panels of foliated ovals with gilded highlights, crown the large cove (F). The cornice appears to be painted in greens that are slightly darker than those used in the room but may just retain more dirt.

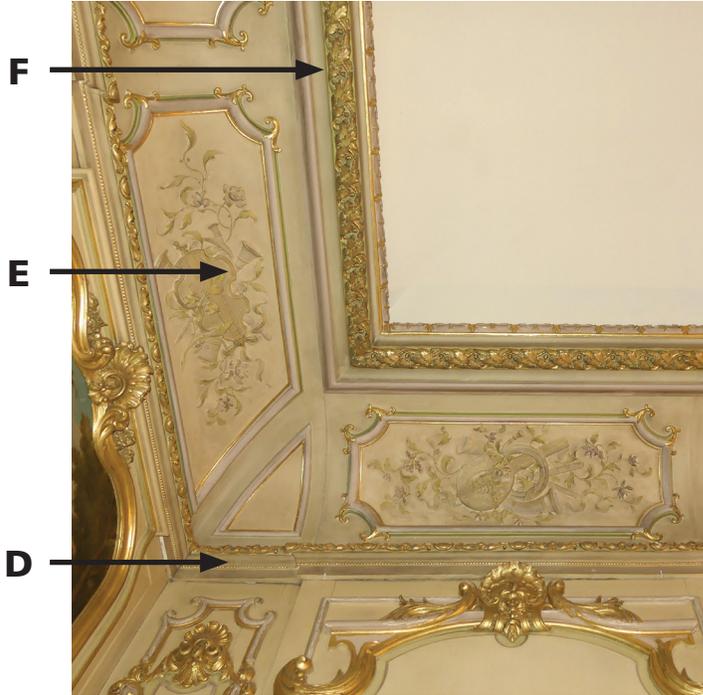
Figure 19. Paneling and cornice details in Mrs. Vanderbilt's Boudoir (203). JGWA, 2018.

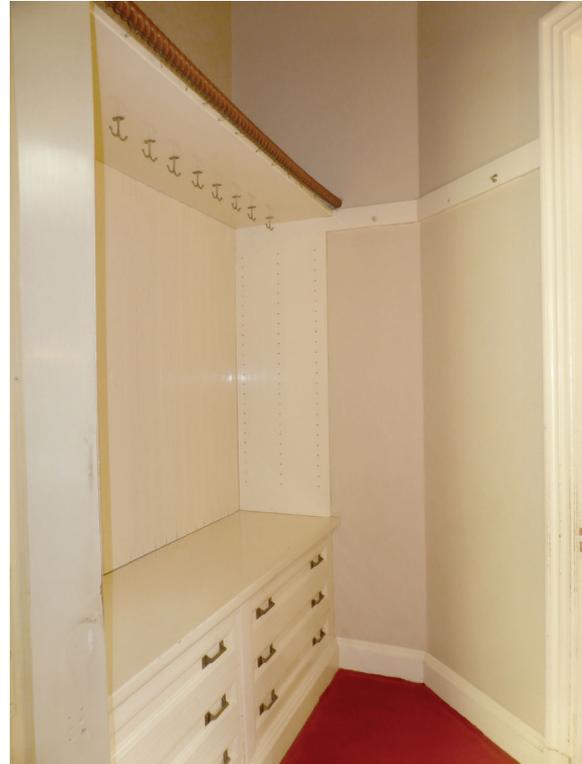
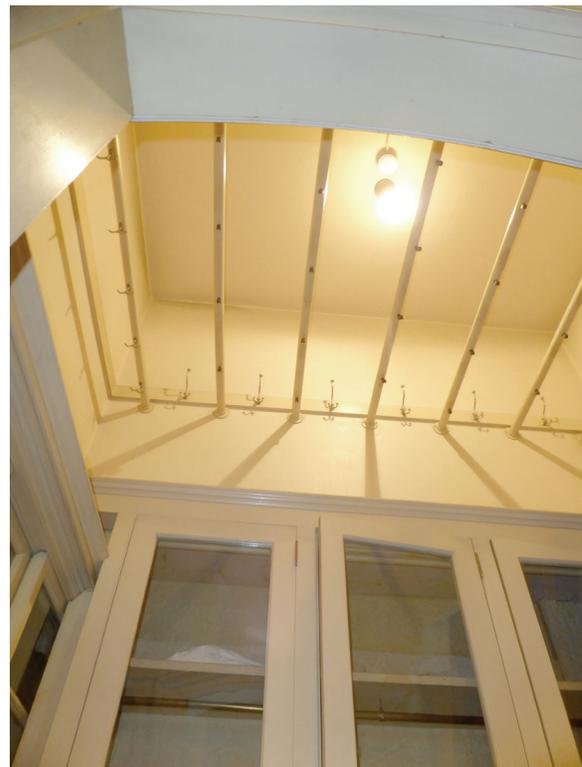
Figure 21. The northwest vestibule into Mrs. Vanderbilt's Boudoir (upper image) and the pulley system in the southwest closet (lower image). JGWA, 2017.

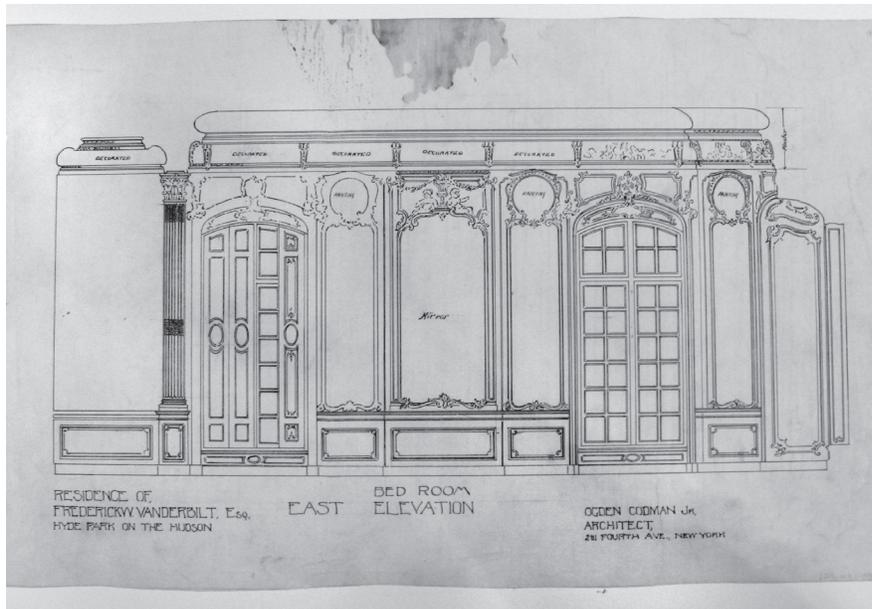
Figure 29. Ogden Codman, Jr. drawing for the east elevation of Mrs. Vanderbilt's Bedroom. Some details differ from the room as actually constructed. Ogden Codman architectural drawings and papers, Department of Drawings & Archives, Avery Architectural and Fine Arts Library, Columbia University.

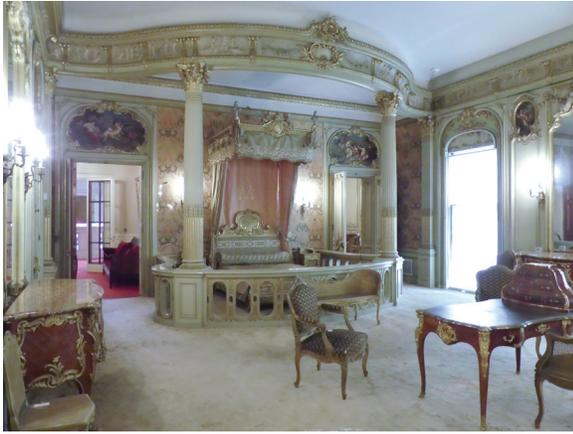
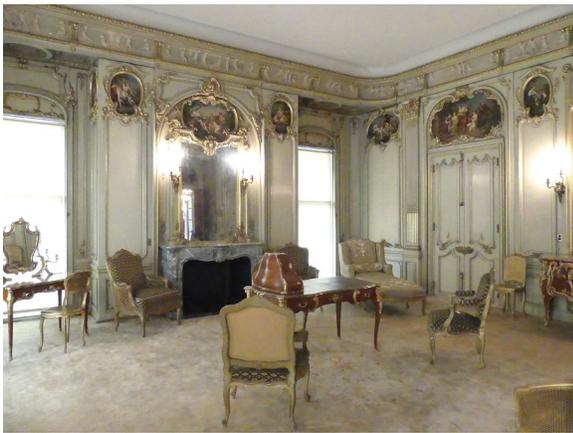
Figure 31. Mrs. Vanderbilt's Bedroom, looking north (upper image) and southeast (lower image). JGWA, 2018.

**WALLS:** The distinguishing feature of the room is the treatment at the north end where the imposing bed is enclosed by an undulating, ogee-curved balustrade. Two fluted columns support a frieze and entablature that follows the curve of the balustrade at the south end and then curves back to the east and west walls. Integral gates in the east and west sides of the balustrade provide access to the bed enclosure. Between the balustrade's base and rail is an open, stylized guilloche design. All of these elements are painted green with gold leaf highlights.

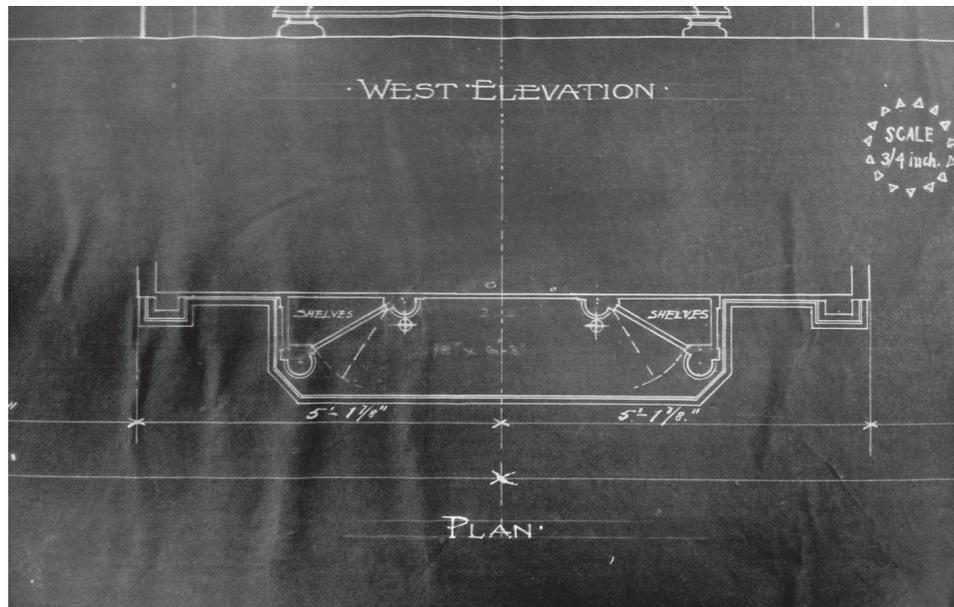
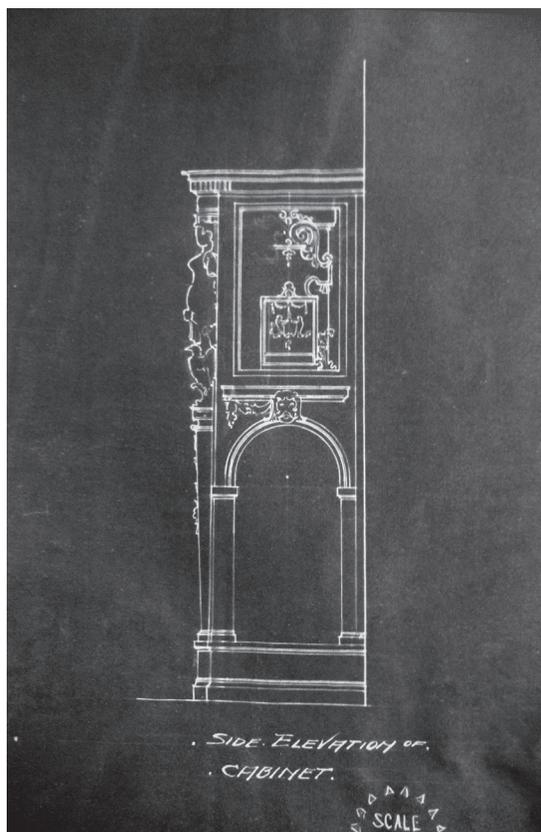
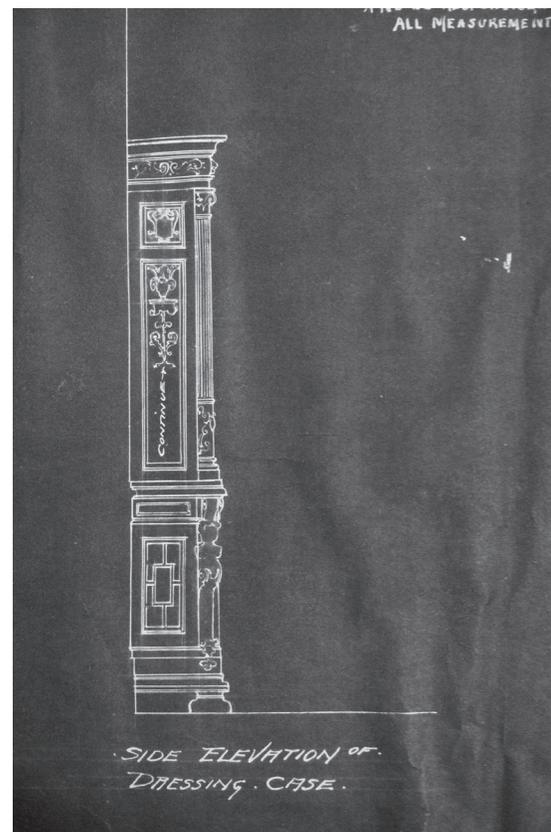
Figure 35. Georges Glaenger drawings of the proposed built-in furniture for Mr. Vanderbilt's bedroom. The lower left drawing is for a cabinet that was to be centered on the east wall. Instead, a buffet (possibly Herter) from the New York City townhouse was placed in that location. Architectural Drawings Collection, ROVA Archives.

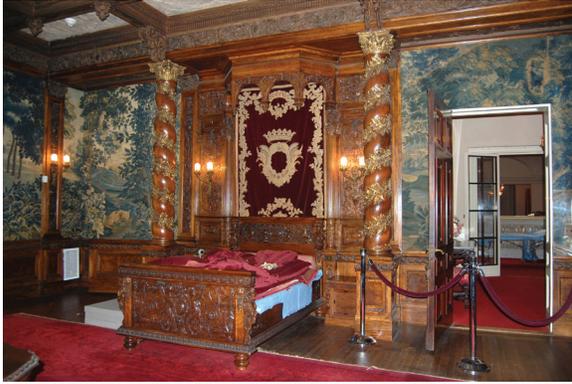
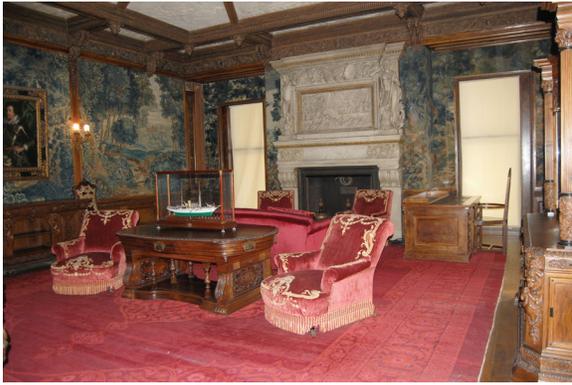
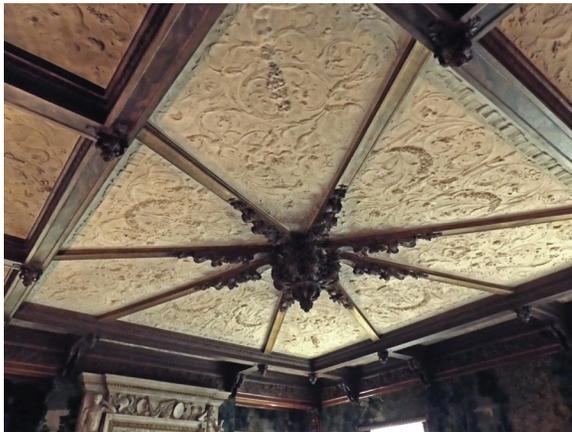
Figure 37. Mr. Vanderbilt's Bedroom, looking northwest (upper image) and southeast (center image); view of the ceiling (bottom image). JGWA, 2017.

The carved headboard (D), ornately carved and supported by caryatids at each end, fills the center bay's lowest tier. Wood rails connect the headboard to the similarly carved footboard. The headboard is flanked by the plinths (E) of the engaged columns, which are deeply carved with an urn scrolled foliation. Squat panels (F) in the outer bays have minimal top and bottom moldings; each is ornamented with a center tablet of an oval medallion set into a rectangular frame.

At the second level, the shafts of the fluted columns (G) are set against fluted pilaster backings and extend up to simplified Corinthian capitals. In the outer bays, tall vertical panels (H) are ornately carved in the Renaissance style, with flowing foliation, swags, and a face.

In the third tier, rams' heads (I) support the springline of the canopy; the outer bays are capped by minimally decorated squat panels (J) flanked by their own squat pilasters that rest on the capitals of the outer pilasters. The only decoration in each squat panel is a rectangular tablet; the pilaster faces are decorated with scrolled foliage.

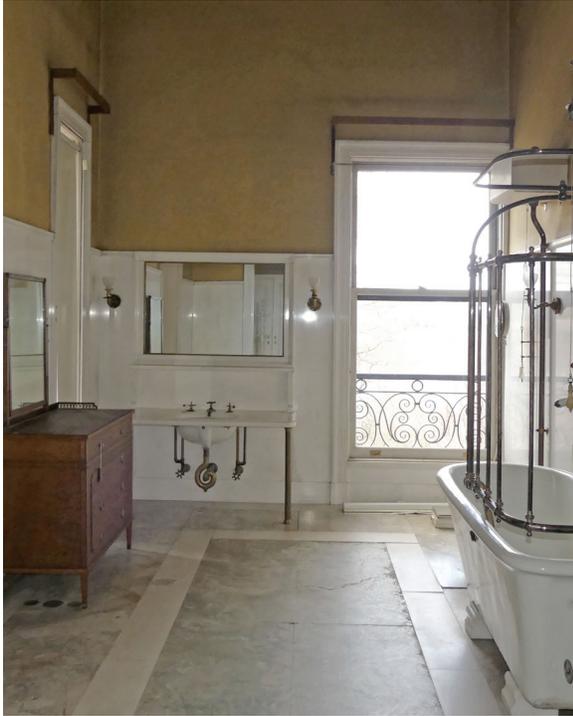
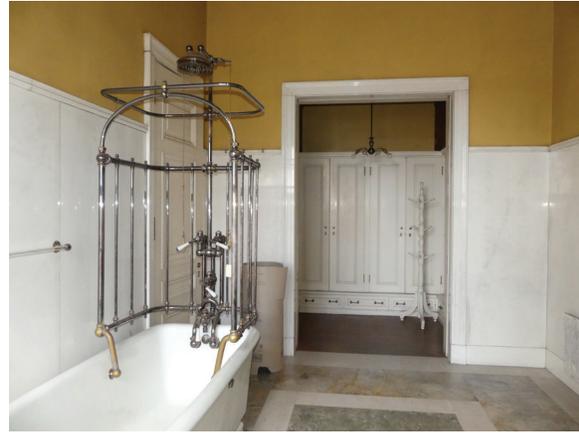
Figure 41. Mr. Vanderbilt's Bathroom, looking west (upper left); into the cedar closet (lower left); and east (above). JGWA, 2017.

(stamped "U" and with a mark for the Mallory, Wheeler Company) on the outer door has spherical glass knobs and bronze teardrop escutcheon covers. It is hung on the west jamb, opening into the Bathroom, with three 5" bronze hinges with ball finials, five knuckles, and five screws per hinge plate.

**Cedar door:** The interior cedar door is made up of narrow vertical beaded boards applied to a 2'-4 3/4" x 8'-4 1/2" high x 1-5/8" stile-and-rail frame. **Hardware:** The cedar closet door is secured with an iron-cased "Yale and Towne Mfg. Co." surface latch. Above the latch is a "Best" modern cylinder lock. The door is hung on the west jamb with three 4" iron butt hinges that have ball finials, five knuckles, and five screws per plate. It opens into the Bath.

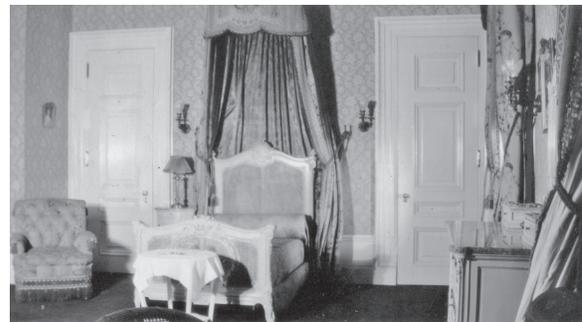
Figure 42. (Upper image) Detail of the Large Red Bedroom from the McKim, Mead & White second floor plan (February 18, 1897). McKim, Mead & White Architectural Record Collection, PR 42, #10, Department of Prints, Photographs, and Architectural Collections, The New-York Historical Society, photographic copy in park archives. (Lower image) The Large Red Bedroom, 1940. Traudt Family Album, ROVA Archives.

The McKim, Mead & White second floor plan (see Figure 42) refers to the space as a "Bedroom."<sup>79</sup> There are no other known drawings for this room.

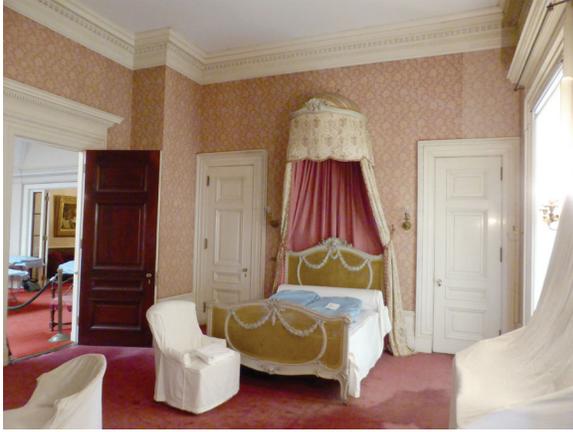
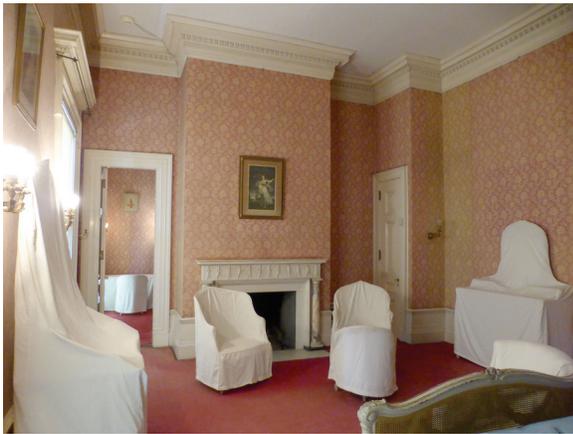
Figure 43. Large Red Bedroom, looking south (upper image) and north (lower image). JGWA, 2017.

Southwest door (to 220): This door mirrors the southeast door. Hardware: The 6-1/2" high bronze mortise lockset includes glass ball knobs and turnkeys. The door is hung on the west jamb to open to the bedroom with three 5" high bronze butt hinges with ball finials, five knuckles, and five screws per hinge plate.

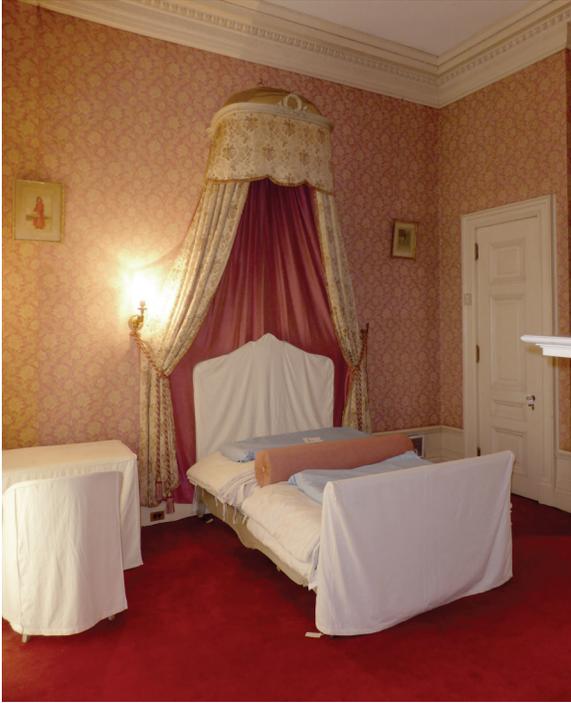
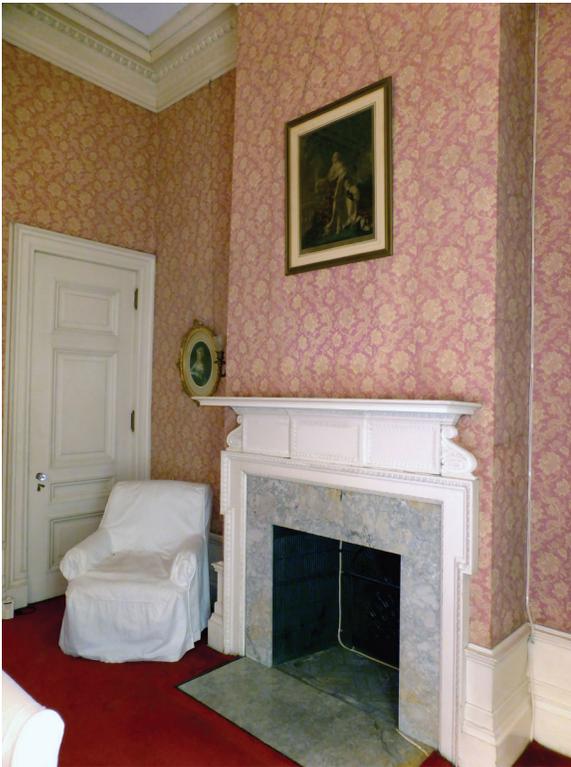
Figure 46. Small Red Bedroom, looking northeast (upper image) and southeast (lower image). JGWA, 2017.

**DOORS:** The doorway to the Hall, centered in the east alcove, is flanked by the northeast and northwest closet doorways. All three doors are framed in 6" wide

architraves that match the trim at the northeast closet in the Large Red Bedroom: a raised fillet, a bead, a cavetto curving into a filleted bead, a fascia, a filleted cyma reversa, and a fascia. Like the typical, more ornate trim, the architraves terminate with mitered returns at splashboard-height plinths.

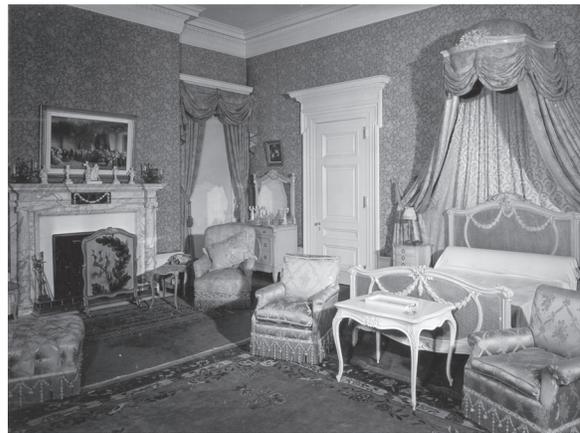
Figure 47. (Upper image) Detail of the Blue Bedroom from the McKim, Mead & White second floor plan (February 18, 1897). McKim, Mead & White Architectural Record Collection, PR 42, #10, Department of Prints, Photographs, and Architectural Collections, The New-York Historical Society, photographic copy in park archives. (Lower image) Blue Bedroom, 1938. Photographs of Hyde Park Property, Residence of Frederick W. Vanderbilt, Hyde Park, NY, by Rodney McKay Morgan for Margaret Louise Van Alen, ROVA Archives.

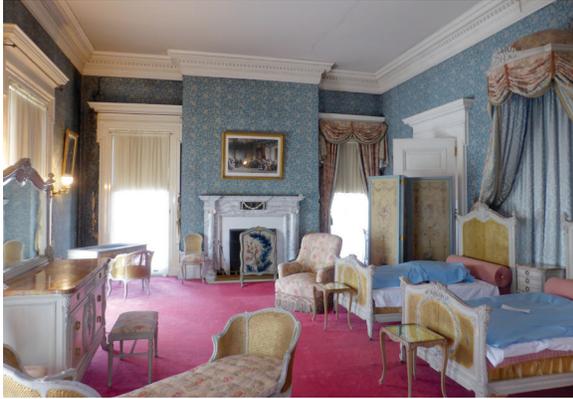
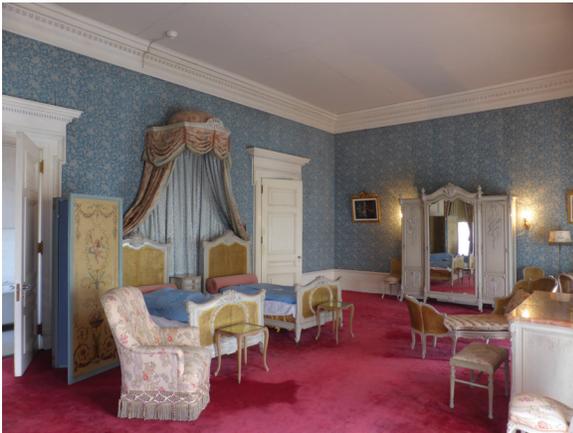
Figure 48. Blue Bedroom, looking north (upper image) and southeast (lower image). JGWA, 2017.

and denticulated hoods, similar to the trim at the doorways. Each opening is fitted with a 1/1 chain-hung sash. The upper sash is shorter than the lower sash. Each lower sash includes a pair of recessed bronze and lifts in the bottom rail, and slides up into an overhead pocket. Each upper sash has a pair of metal pulls on the bottom rail. The sash are secured with bronze sash fasteners on the meeting rails; part of the fastener is missing from the northeast sash and the entire fastener is missing from the southwest sash. The top of each upper sash includes a recessed bronze socket for a sash hook.

**FIREPLACE:** The fireplace on the north wall has a white marble surround and hearth. The white and grey marble mantel includes a simple architrave that frames the surround, flanked by engaged Ionic columns with angled volutes supporting a bed molding, frieze and crown molding/mantel shelf. A black-and-gold marble panel, embellished with an applied swag of carved

**HEATING:** Three original heating grates—a vertical grate in the east face of the chimney breast, and two horizontal grates in the west dado—have the typical geometric pattern found on the second floor. The grates are painted white. Filters currently cover the grates.

**LIGHTING/ELECTRICAL:** The room is lit by five original bronze electric wall brackets: three double-arm brackets on the west wall (and a plate for a fourth fixture south of the southwest window); and two single fixtures on the south wall.<sup>90</sup> Each fixture has a wreath motif around the brass backplate. The heavily foliated squared serpentine arms each support a brass grape-and-foliated bobesh with an acanthus cap, which holds the bulb. Their frosted glass shades have

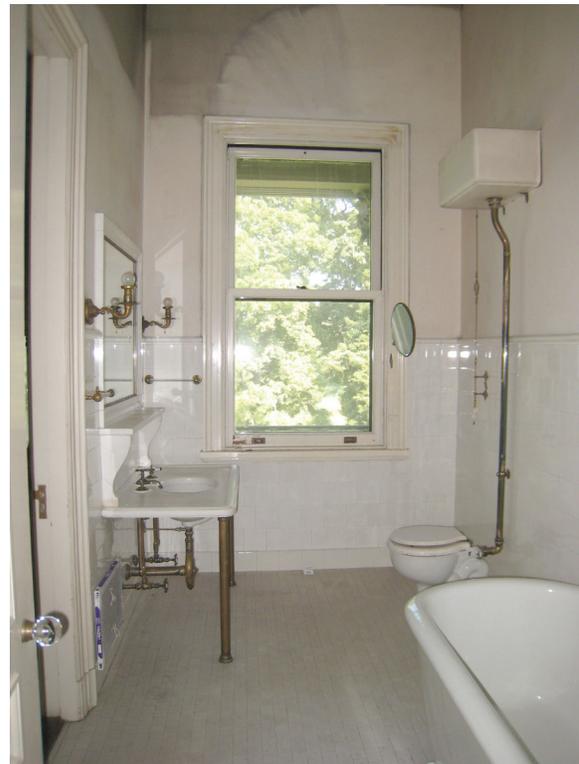
Figure 49. (Upper image) Detail of the bathroom for the Blue Bedroom from the McKim, Mead & White second floor plan (February 18, 1897). McKim, Mead & White Architectural Record Collection, PR 42, #10, Department of Prints, Photographs, and Architectural Collections, The New-York Historical Society, photographic copy in park archives. (Lower image) Blue Bathroom, looking north. JGWA, 2017.

The early McKim, Mead & White plans show a slightly smaller room; by the 1897 plan, it was lengthened to its current size (see Figure 49).<sup>92</sup>

**LIGHTING/ELECTRICAL:** There are two original bronze electric wall brackets on the west wall. Each has a brass backplate ornamented with a wreath motif, a rounded serpentine arm with minimal foliage at the connection of the arm to the backplate, and a plain bobesh that supports the base for the bulb. There are no shades on the fixtures. The room has no electrical outlets.

**PLUMBING:** An original lavatory (VAMA 6994) with a Meyer-Sniffen "Alpha" porcelain basin set in a marble slab is positioned against the west wall. The marble splash includes curved supports for a marble shelf; a marble-framed mirror is positioned immediately above the shelf. An original J.L. Mott "Primo" toilet on the east wall (VAMA 6995) has a wood seat and lid and a high water tank. The chain from the tank is made up of linked brass rods ending in a cut glass pull. The "Royal" bathtub (VAMA 6993) on the west wall, at the south end of the room is marked "49142."

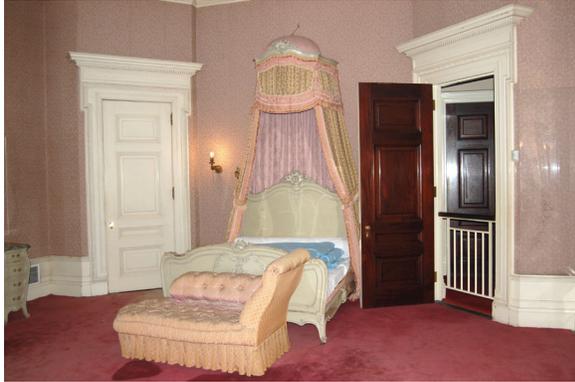
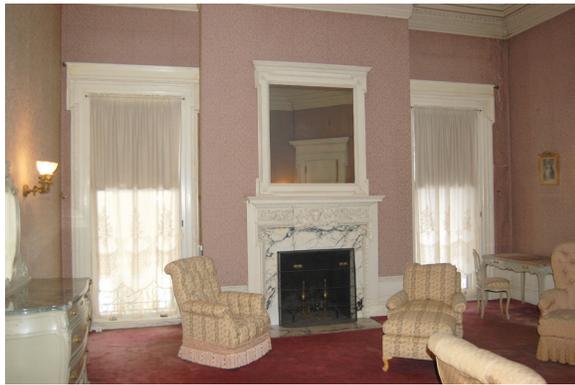
Figure 52. The Mauve Bedroom, looking south (upper image) and north (lower image). JGWA, 2017.

**WALLS:** Above the typical low wood dado (painted off-white), the plaster walls are covered in a French wallpaper, with an overall foliated pattern on a mauve ground. The gray/blue leaf and flower pattern is outlined in flocking that may have originally been white but is now yellowed to a cream color. According to Mrs. Van Alen, she found this exact replacement for
