Vanderbilt Mansion National Historic Site  
Hyde Park, New York

## Vanderbilt Mansion National Historic Site Historic Structure Report

Volume IV: Second Floor  
October 2018

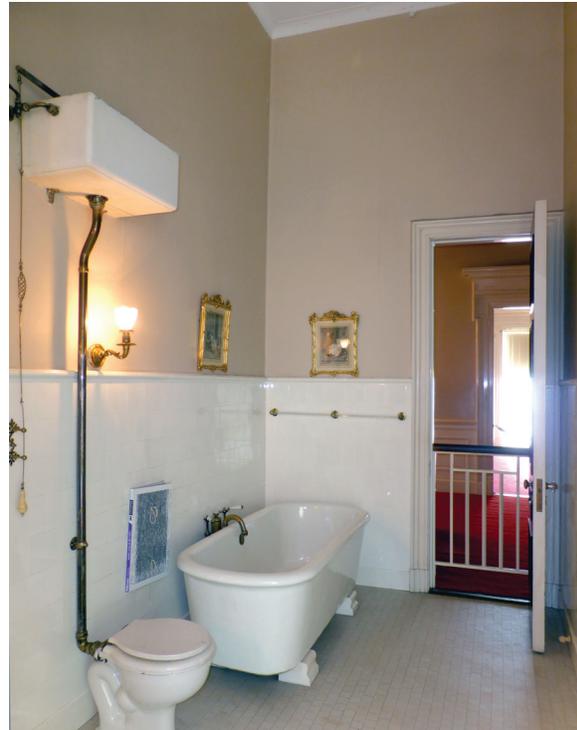
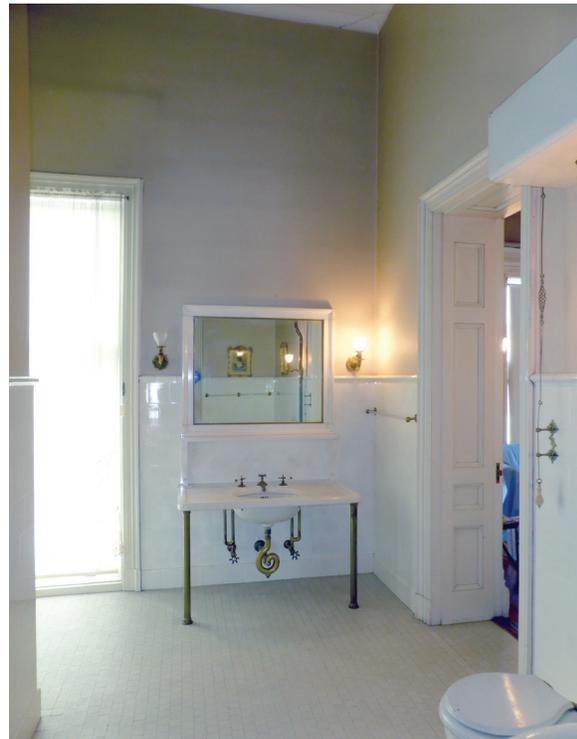
Figure 53. (Above) Detail of the bathroom shared by the Mauve and Green Bedrooms from the McKim, Mead & White second floor plan (February 18, 1897). McKim, Mead & White Architectural Record Collection, PR 42, #10, Department of Prints, Photographs, and Architectural Collections, The New-York Historical Society, photographic copy in park archives. (Right) The Mauve Bathroom, looking west (upper image) and east (lower image). JGWA, 2017.

In the earliest McKim, Mead & White plans for the second floor, this bathroom was larger. By the 1897 plan, the west end of the bathroom was moved east to allow for an alcove off of the north wall that included a closet and doorways to this room and the Mauve Bedroom (see Figure 53).<sup>98</sup> The jog in the northeast corner of the room to accommodate the window opening was part of the plan from the beginning.

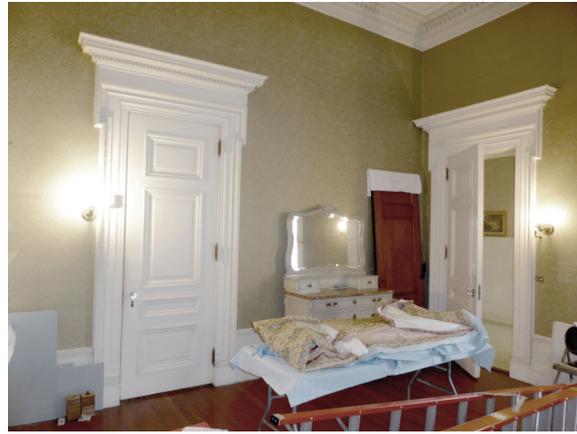
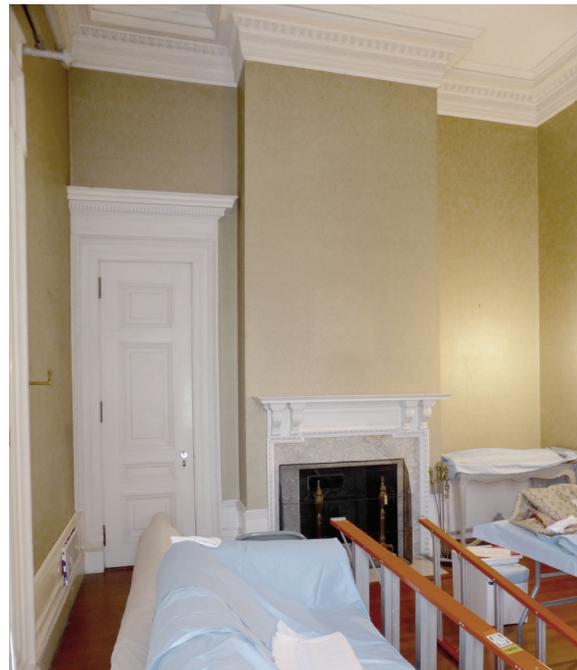
Figure 54. (Above) Detail of the second floor Green Bedroom from the McKim, Mead & White second floor plan (February 18, 1897). McKim, Mead & White Architectural Record Collection, PR 42, #10, Department of Prints, Photographs, and Architectural Collections, The New-York Historical Society, photographic copy in park archives. (Right) Second floor Green Bedroom, looking northwest (upper image) and south (lower image). JGWA, 2017.

The room was originally designed with direct access to the Hall through a hallway that passed a Maid’s Closet and the entrance to the Linen Closet. It did not have direct access from the Room to the Service Stair. However, a lightly drawn door leaf and doorway between the Room and Service Stair were added to the 1896 plan, and the 1897 plan reflects the change, allowing for a larger Linen Closet (see Figure 54).

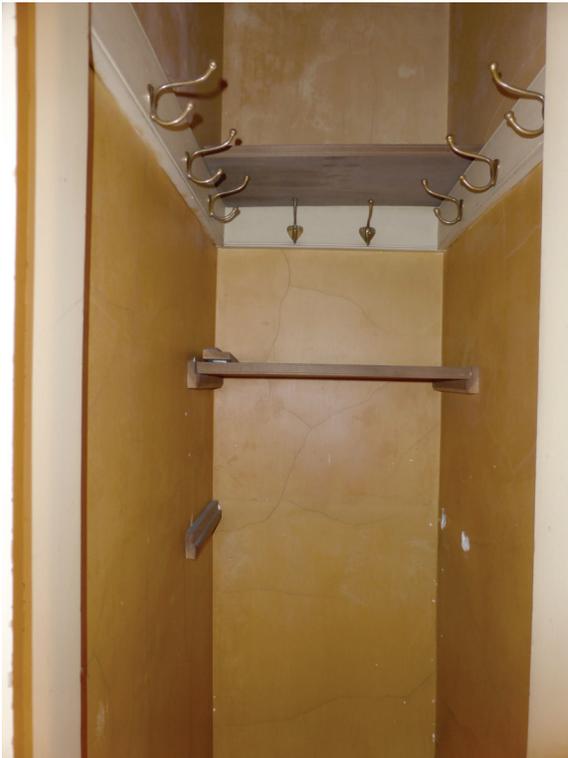
Figure 56. Maids' Closet (upper image) and Broom Closet (lower image). JGWA, 2017.

**PLUMBING:** The original slop sink (VAMA 6999) is positioned against the south wall. It retains its original faucet and handles (as opposed to the third floor Maids' Closet sink, where they are missing), and its high water tank. The pull chain is missing from the tank. The extension pipes above the two faucets have acorn-form caps marked "Meyer-Sniffen."

**FITTINGS:** Vanderbilt-era fittings include a wire soap holder on the west wall, near the sink, that matches the one in the third floor Maids' Closet; a brass bracket, screwed to the east wall, that supported an unknown object; and a wood towel rod on the face of the door. Hooks are found on the window sill and on the east and west walls.

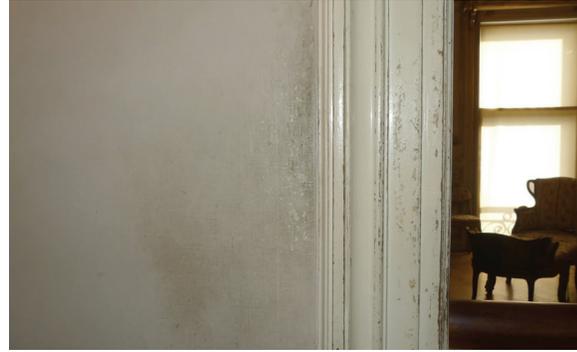
**Figure 58.** Staining and abrasion of original paint finishes is a recurring problem condition on the interior of the house. This is particularly noticeable at the door jambs leading to some second floor bedrooms, which are touched and leaned against by visitors as they admire rooms from the doorways. JGWA, 2018.

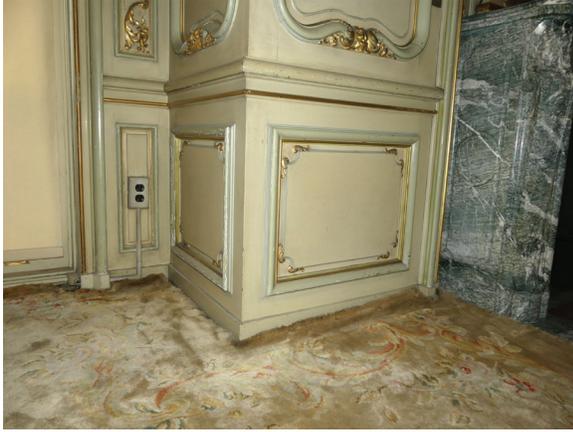
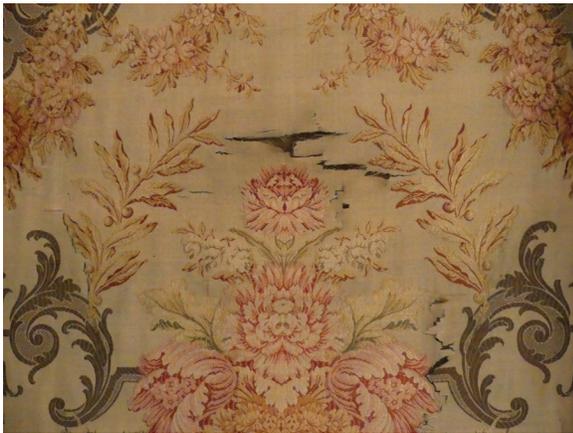
Figure 59. In Mrs. Vanderbilt's bedroom, the historic wall-to-wall carpet is faded and damaged by insect infestation. This condition is most prominent at the edges of the carpet, which are loose in some places. The upper image also shows some minor damage to the original painted finish on the walls. The lower image shows damaged fabric on the east wall of the room. JGWA, 2018.

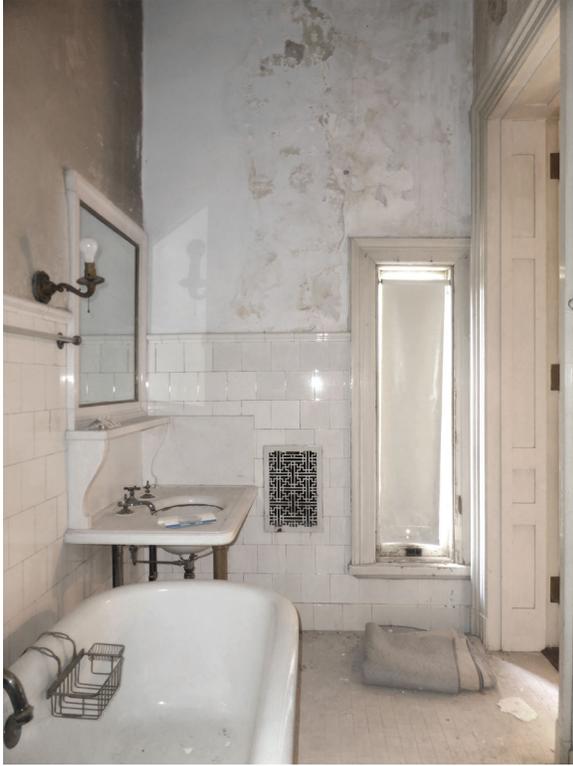
**Figure 60.** Plaster damage on the west wall of the Red Bathroom relates to the adjacent roof of the west portico. This bathroom retains much of its original fabric, but as a result of moisture ingress the plaster and painted surfaces are in deteriorated condition. JGWA, 2018.

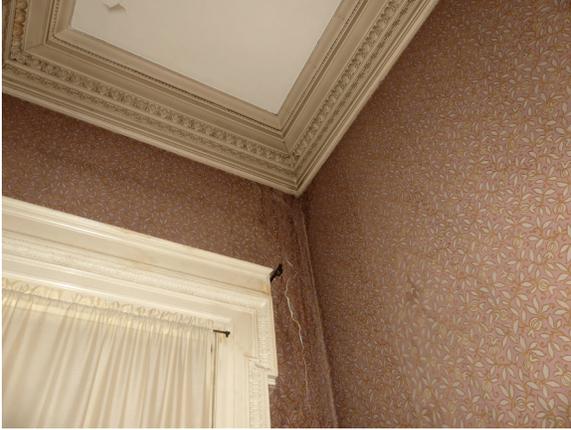
Figure 61. The wallpaper in the northeast corner of the Mauve Bedroom is torn, stained, and partially detached from the wall. This condition is likely the result of past moisture ingress at the roof of the north portico. JGWA, 2018.

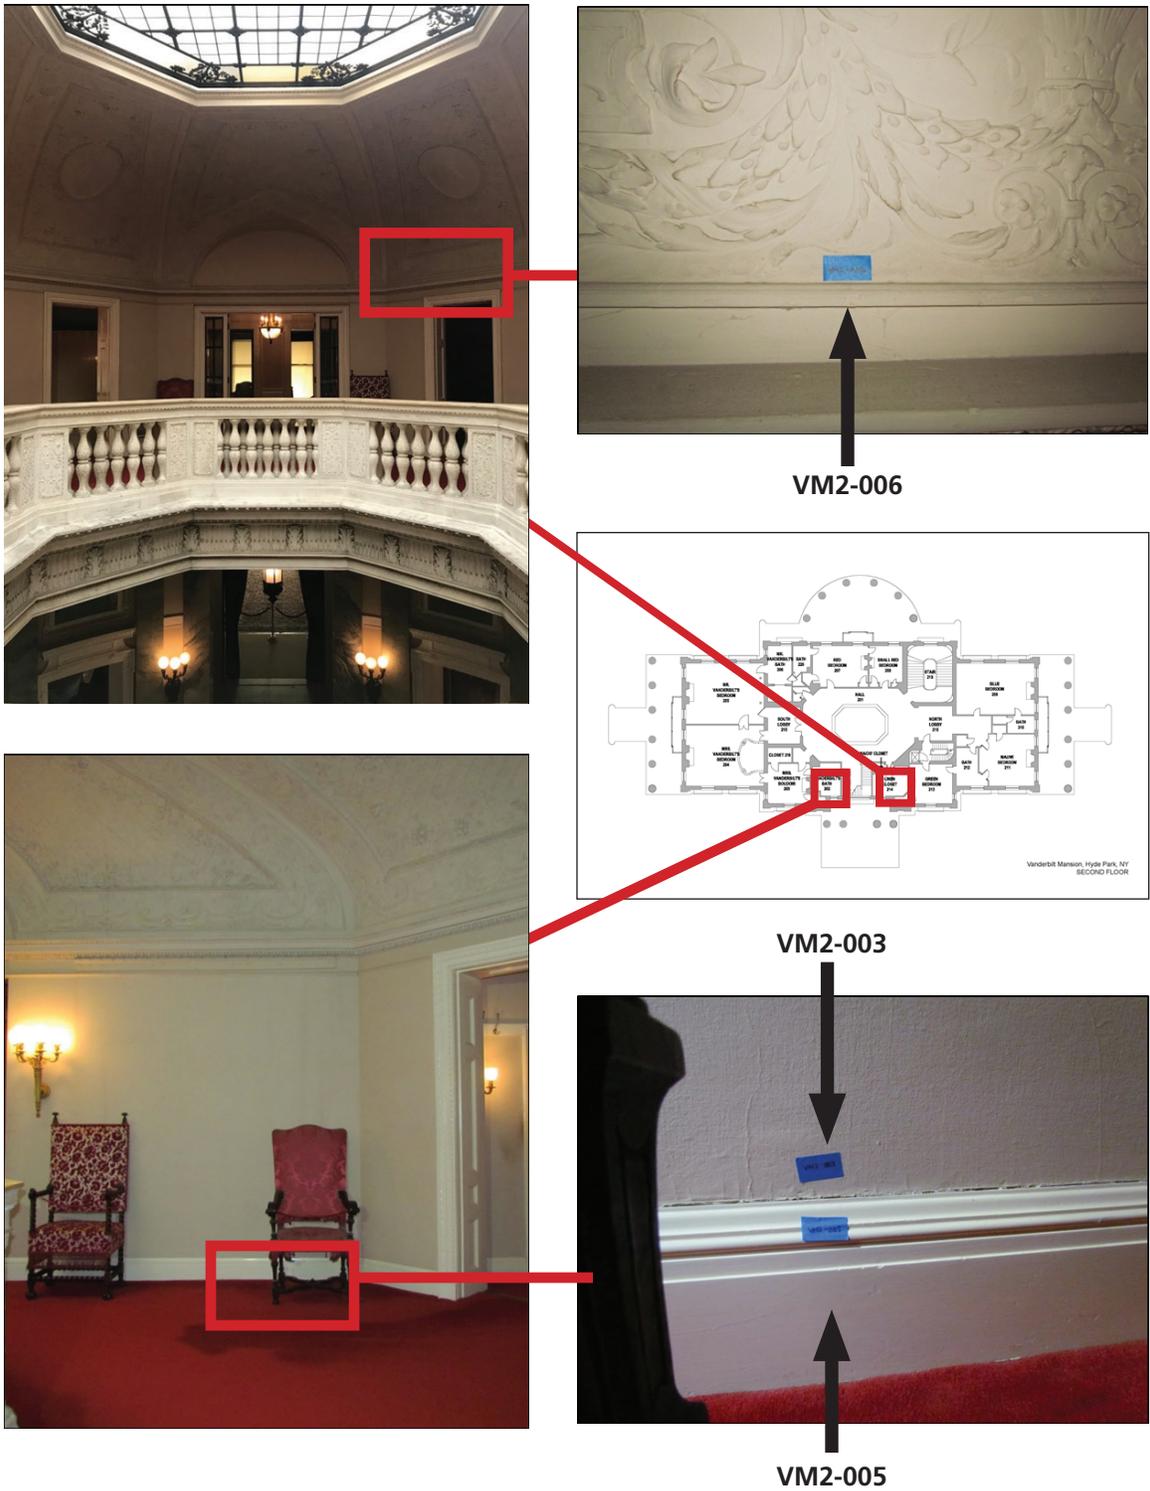
Figure 70. Locations of paint samples from the second floor Hall. JBC, 2018.

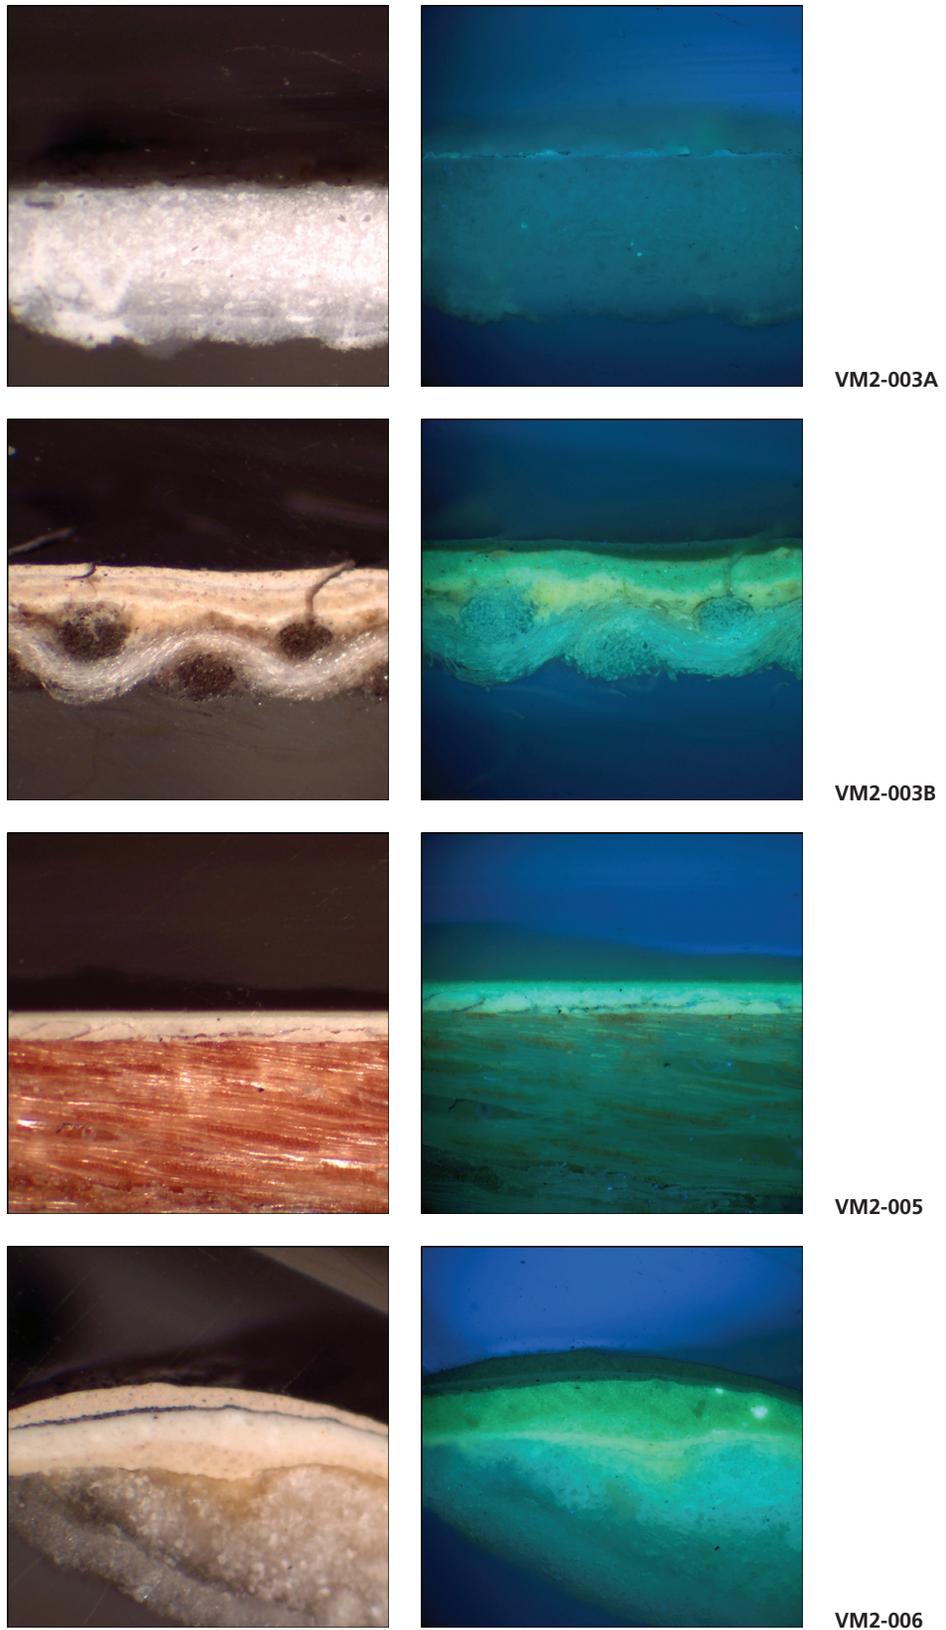
Figure 71. Photomicrographs of paint samples from the second floor Hall, shown in simulated daylight on the left, and in ultraviolet light on the right. The earliest paint layer is at the bottom of each photograph. JBC, 2018.

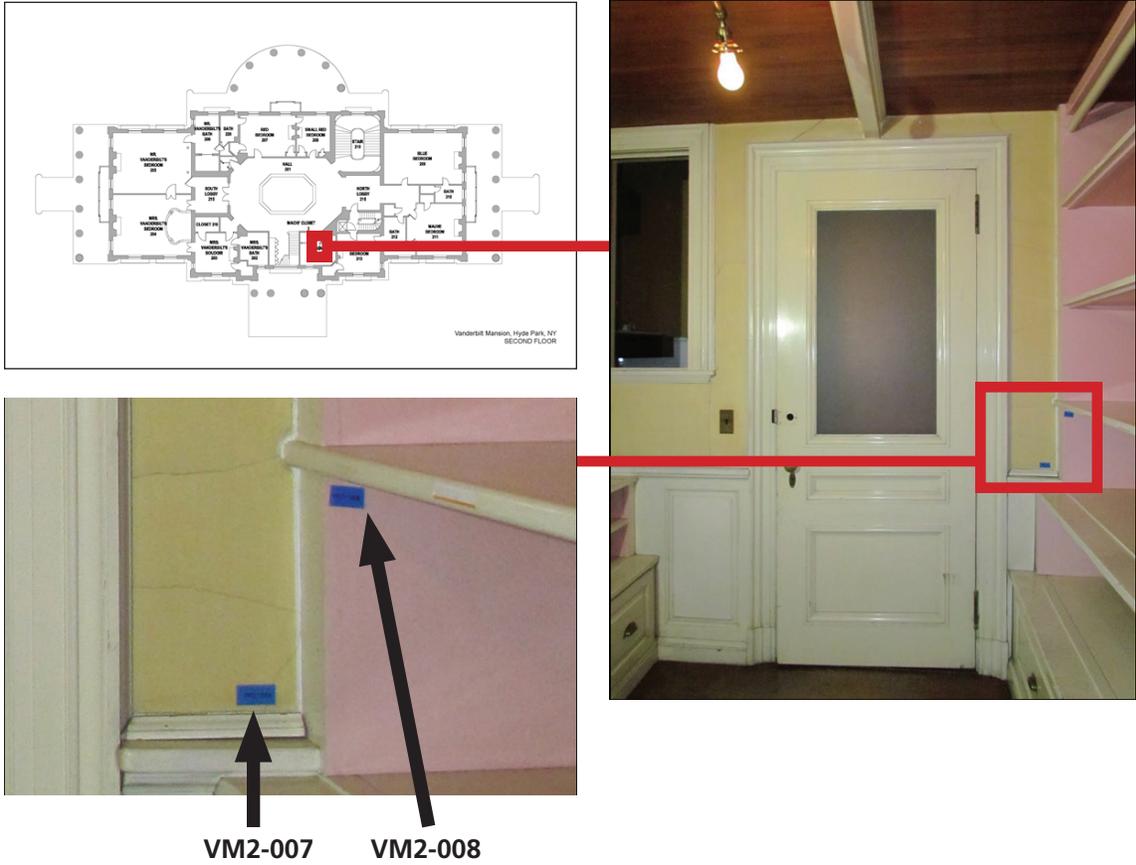
Figure 72. Locations of paint samples from the Linen Closet. JBC, 2018.

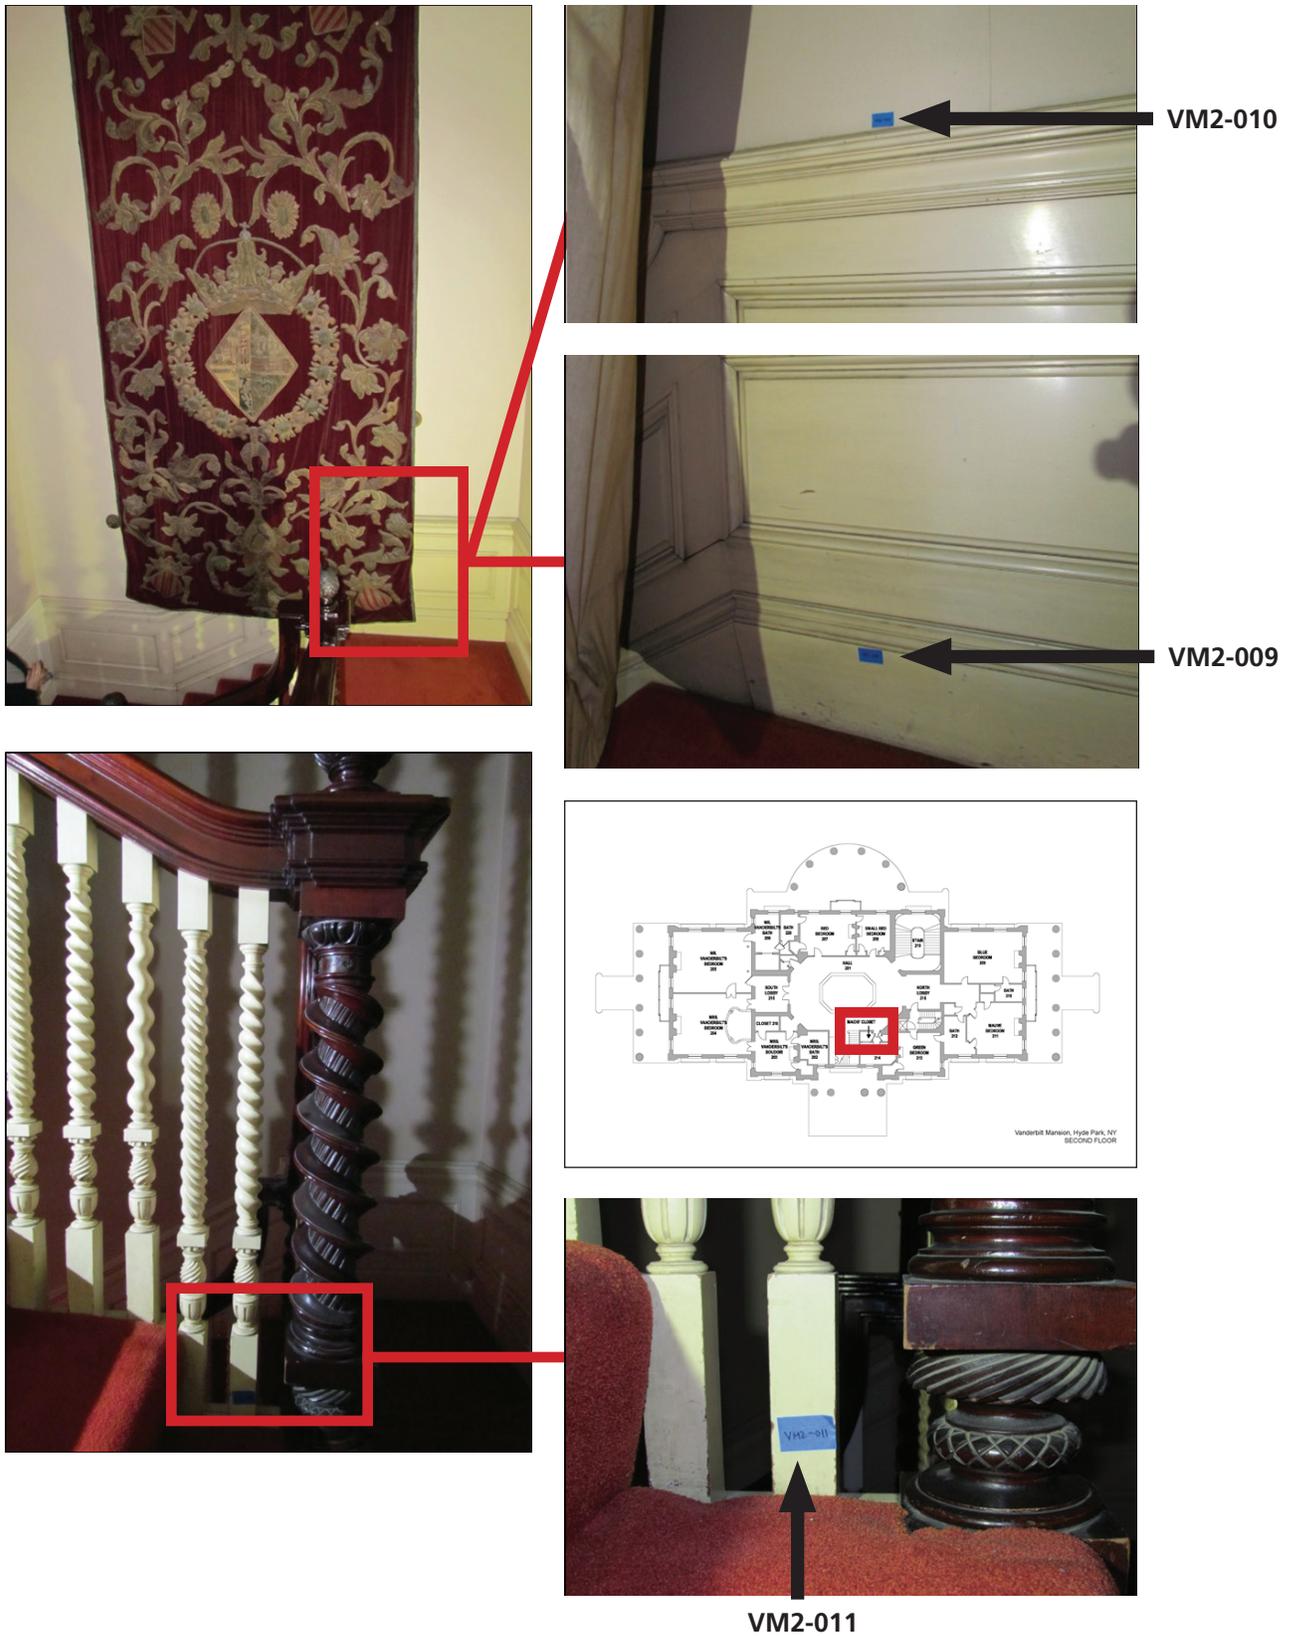
Figure 74. Locations of paint samples from the Guest Stair. JBC, 2018.

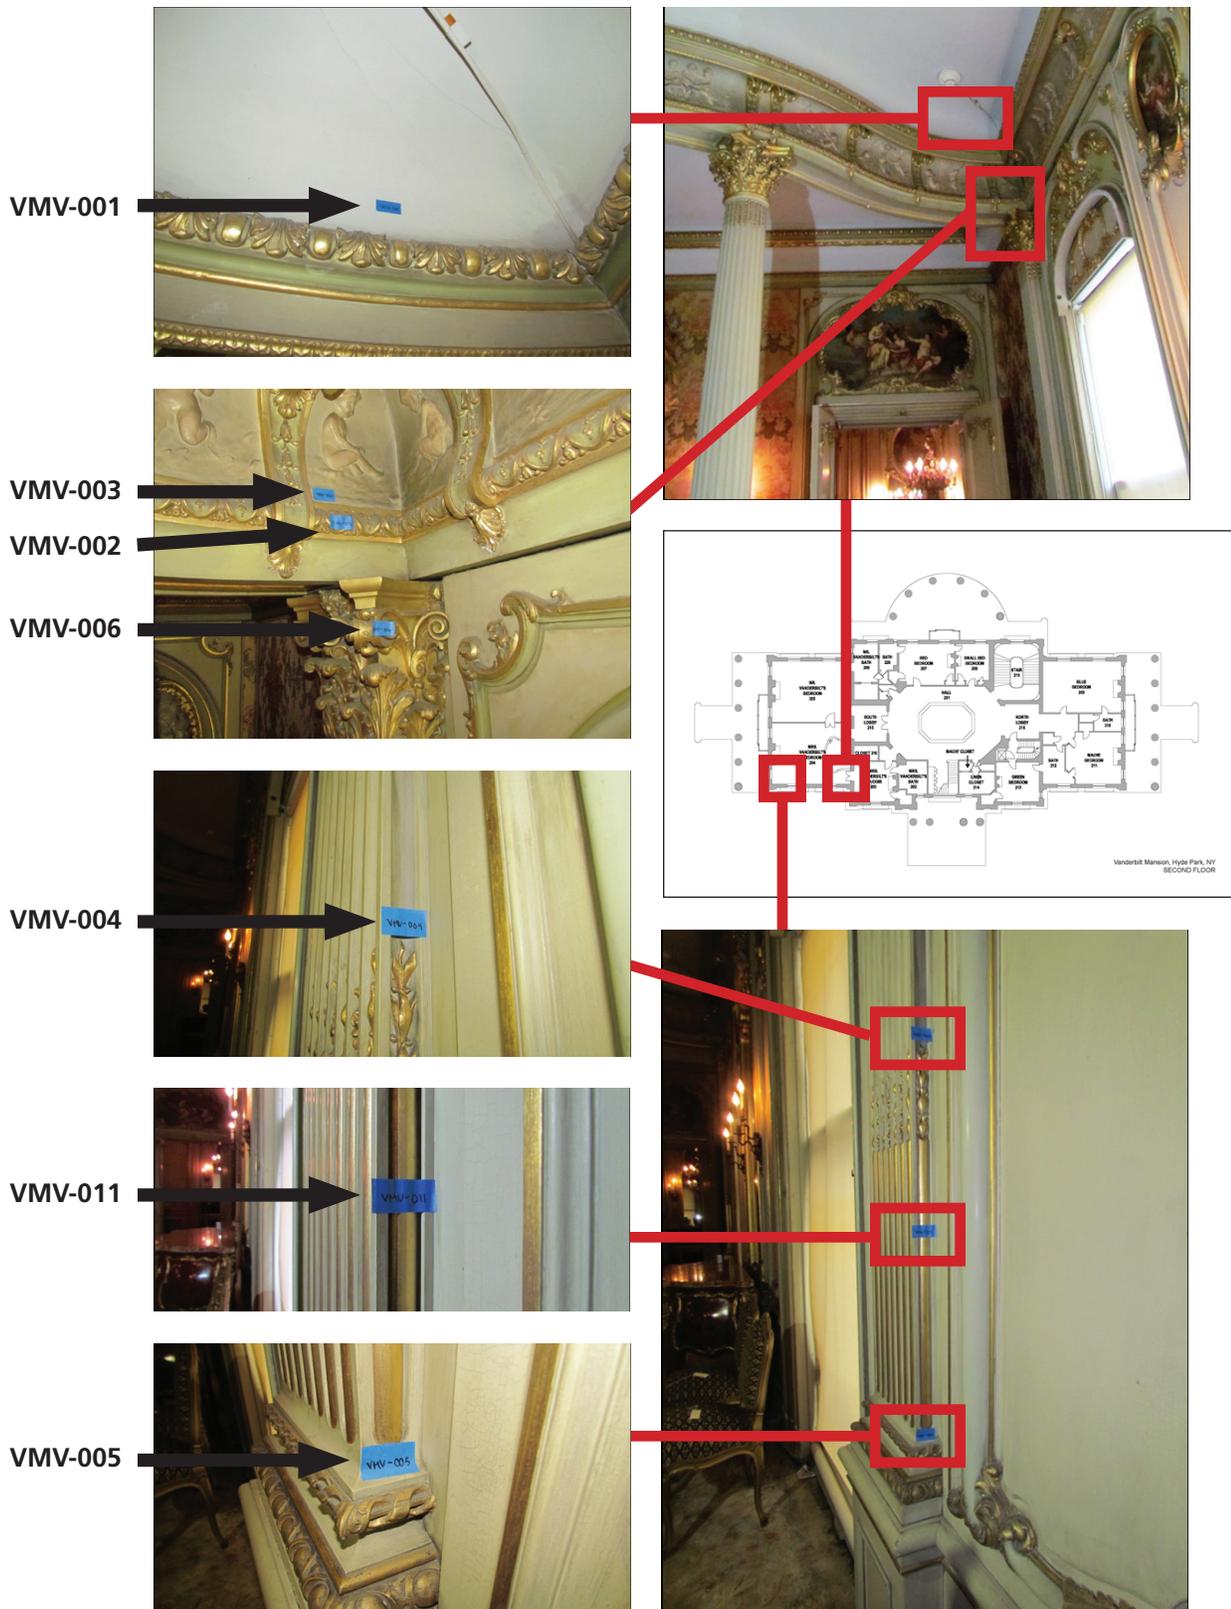
Figure 76. Locations of paint samples from Mrs. Vanderbilt's Bedroom. JBC, 2018.

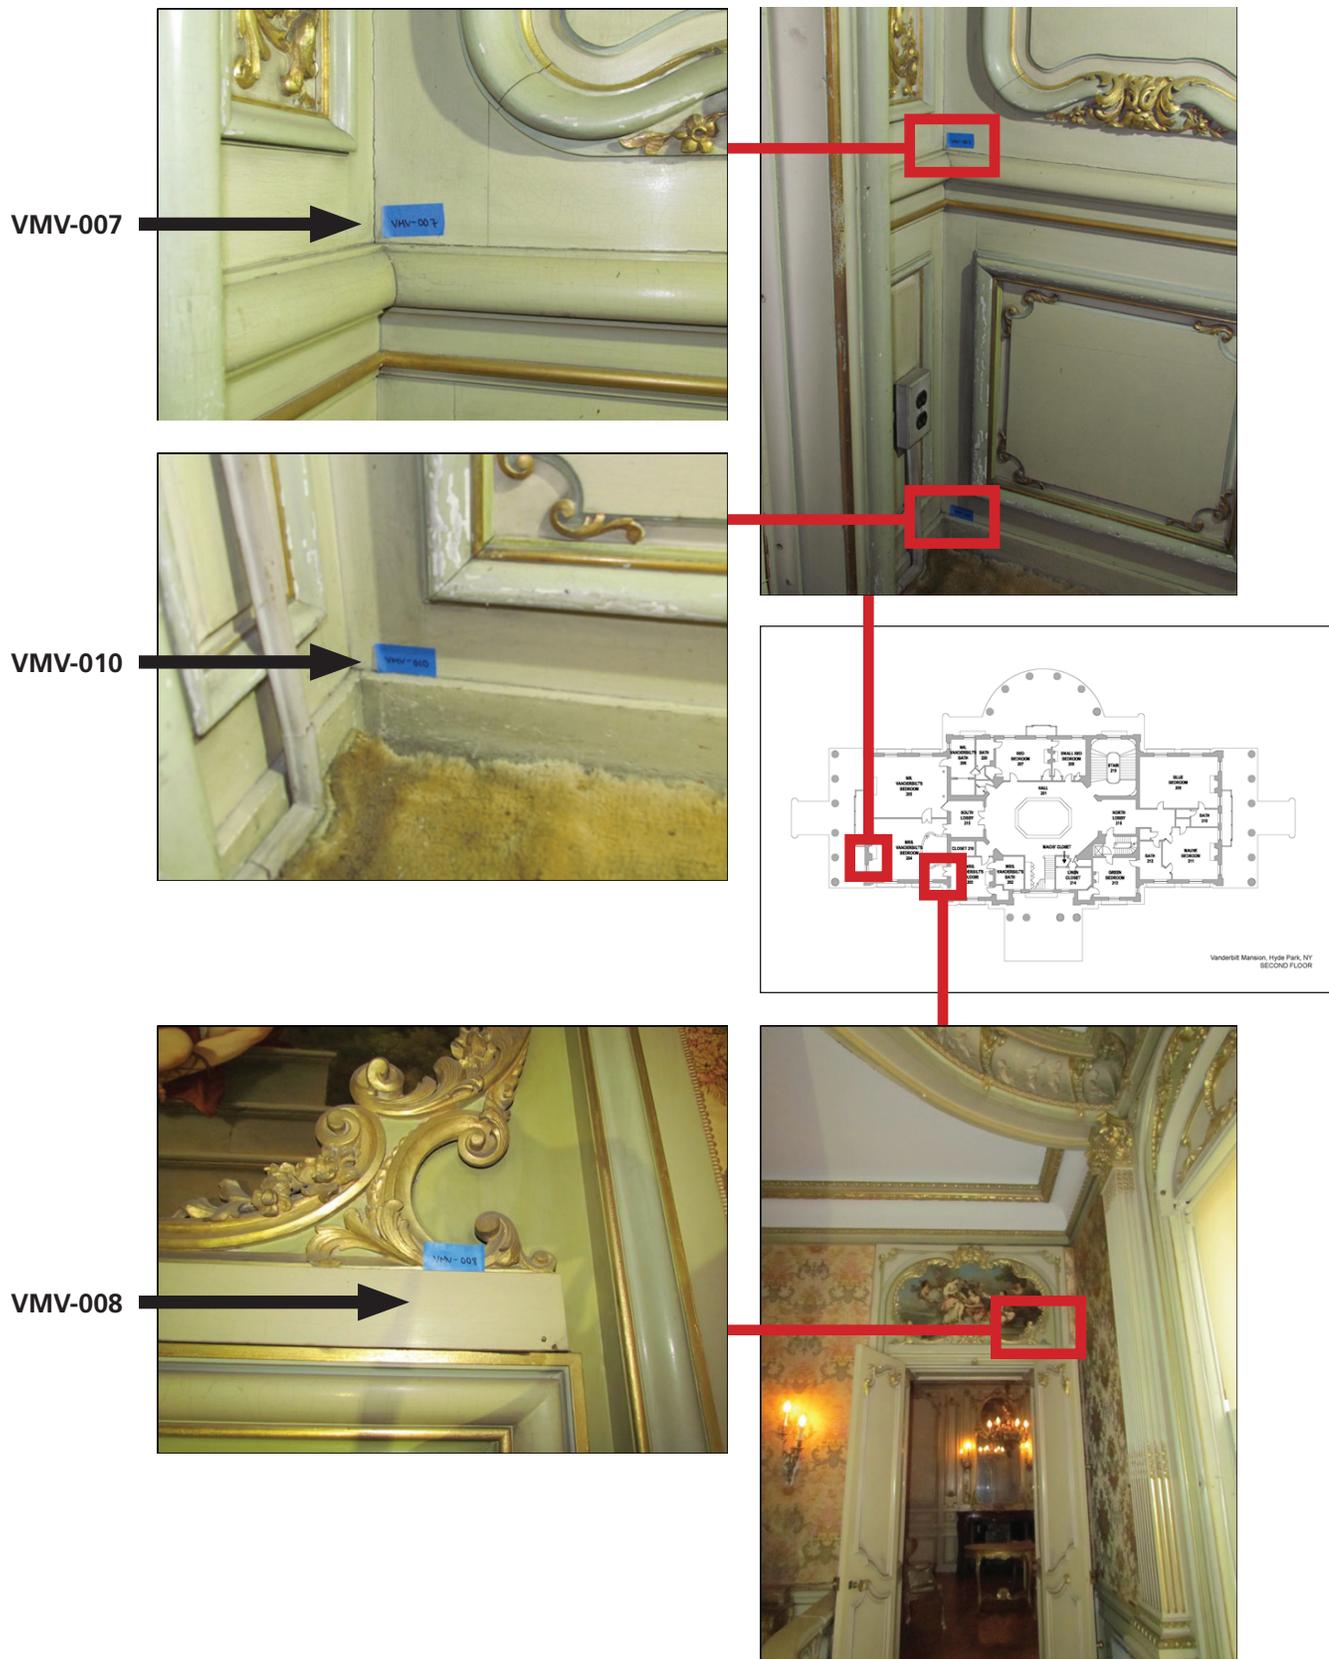
Figure 77. Locations of paint samples from Mrs. Vanderbilt's Bedroom. JBC, 2018.

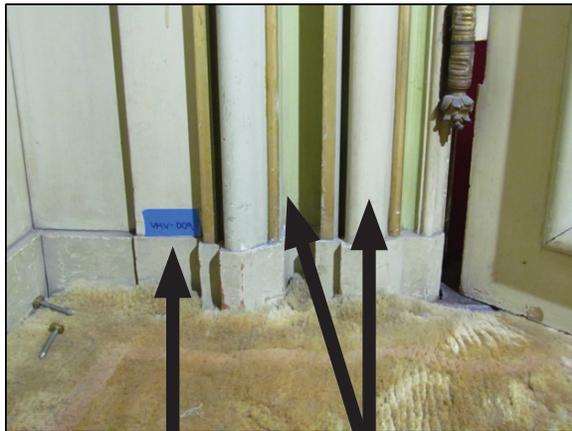
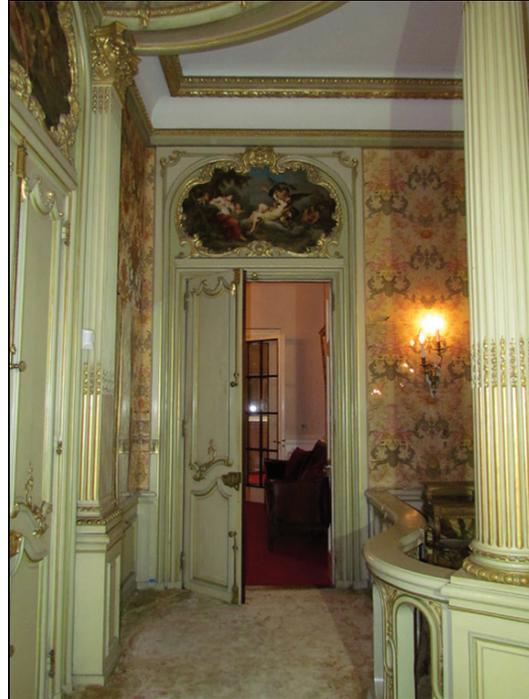
Figure 78. Locations of paint samples from Mrs. Vanderbilt's Bedroom. JBC, 2018.

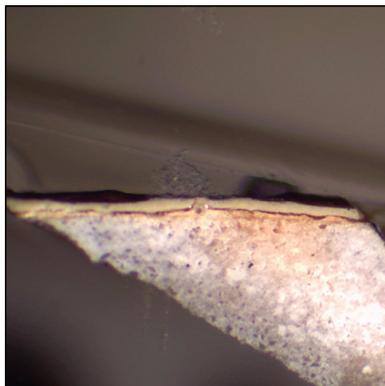
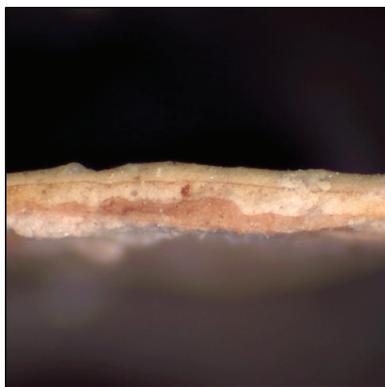
Figure 79. Photomicrographs of paint samples from Mrs. Vanderbilt's Bedroom, shown in simulated daylight on the left, and in ultraviolet light on the right. The earliest paint layer is at the bottom of each photograph. JBC, 2018.

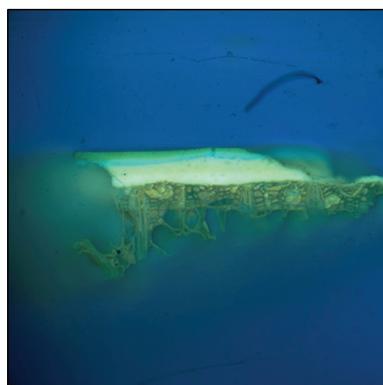
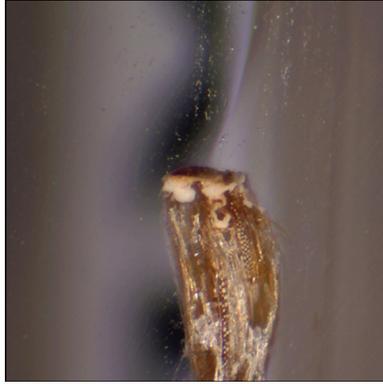
Figure 80. Photomicrographs of paint samples from Mrs. Vanderbilt's Bedroom, shown in simulated daylight on the left, and in ultraviolet light on the right. The earliest paint layer is at the bottom of each photograph. JBC, 2018.

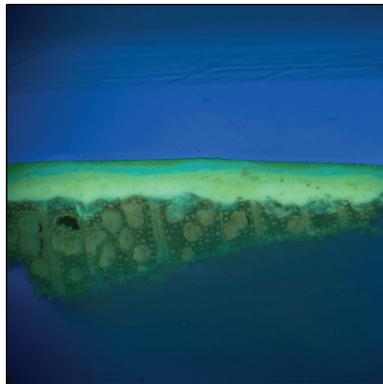
VMV-010

Figure 81. Photomicrographs of paint samples from Mrs. Vanderbilt's Bedroom, shown in simulated daylight on the left, and in ultraviolet light on the right. The earliest paint layer is at the bottom of each photograph. JBC, 2018.
