National Register of Historic Places Registration Form

Historic name Murfreesboro Veterans Administration Hospital Historic District

Other names/site number Veterans Affairs Tennessee Valley Healthcare System - Alvin C. York Campus / NA

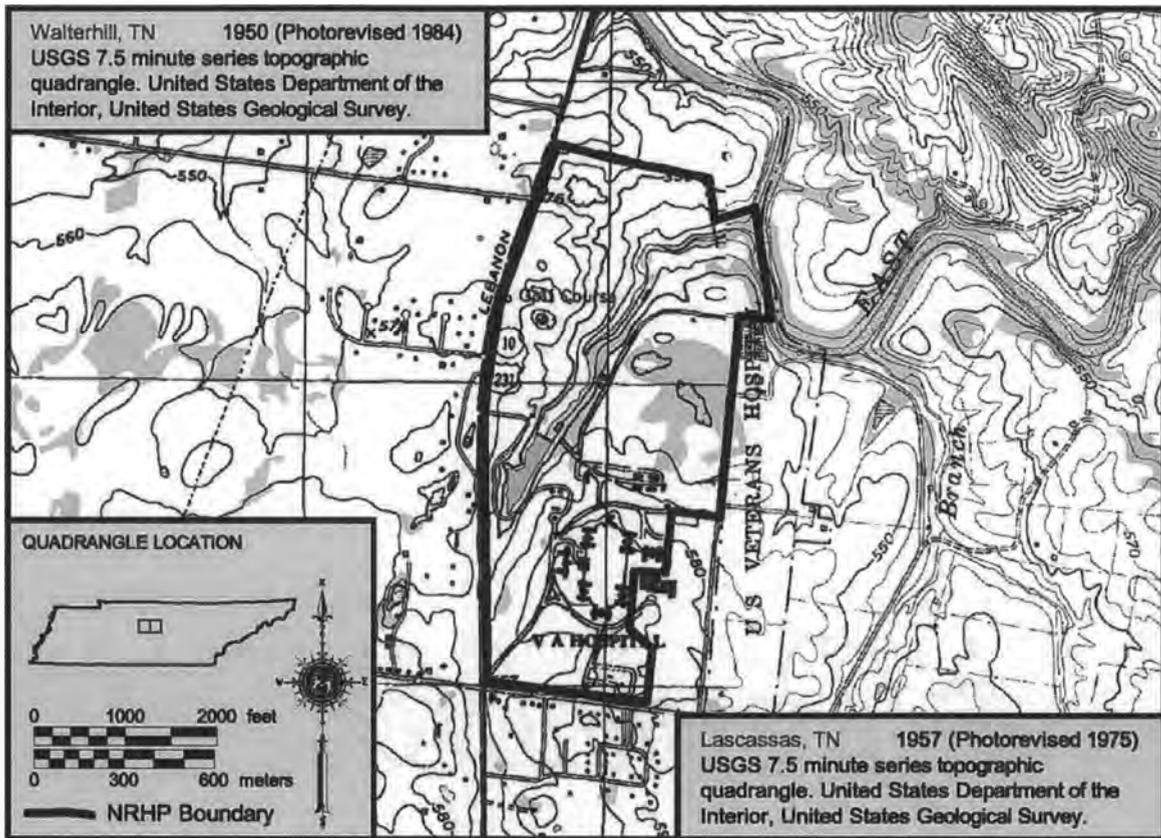
1950 (Photo revised 1984) Walterhill, Tennessee, and 1957 (Photo revised 1975) Lascassas, Tennessee, 7.5-minute topographic quadrangle maps depicting the National Register boundary.

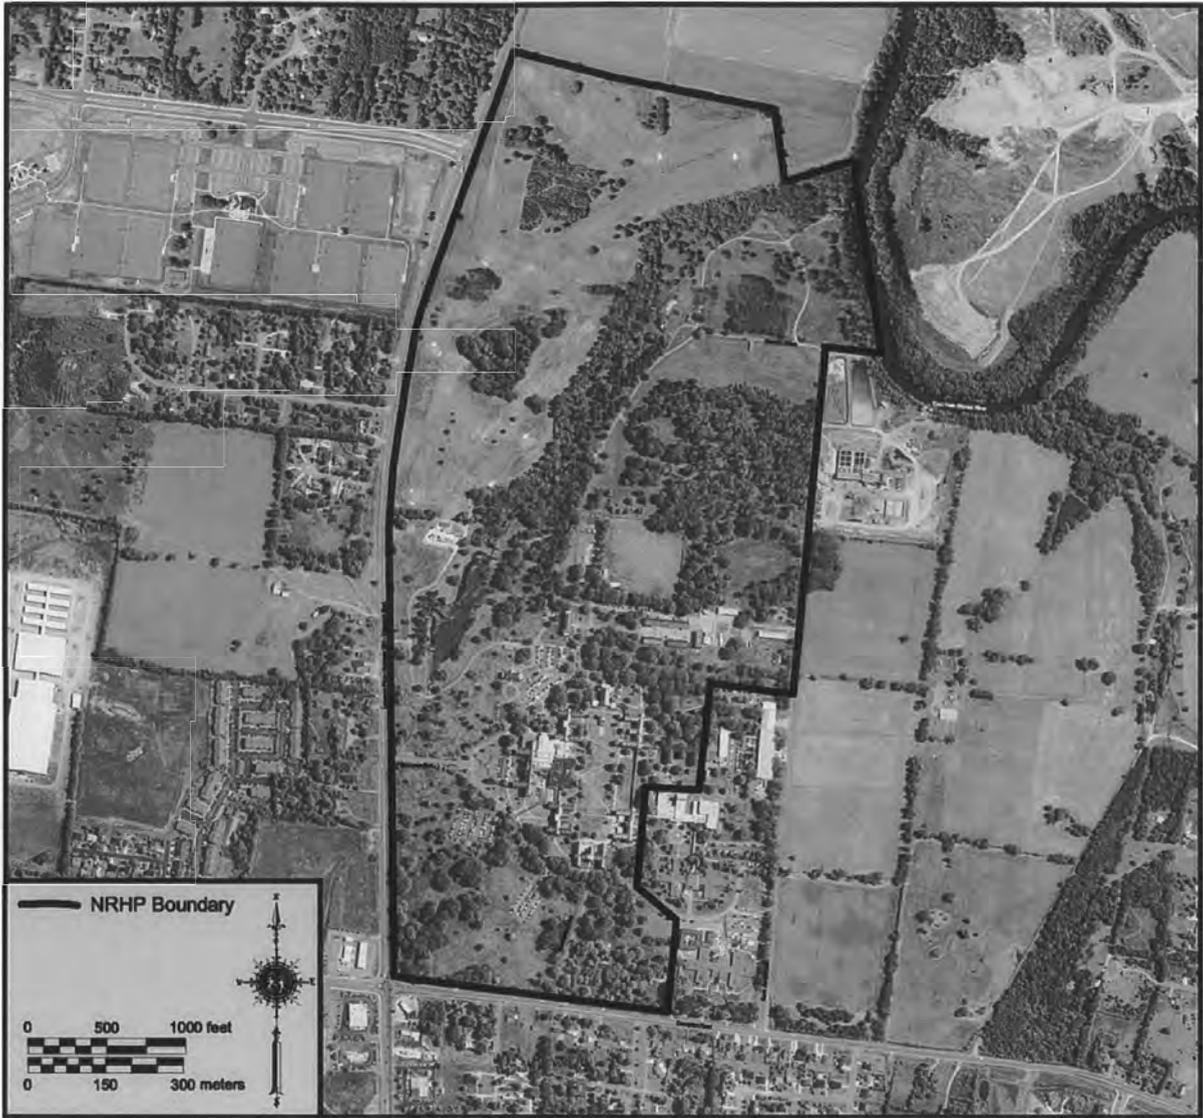
Overall National Register boundary indicated on an aerial map.

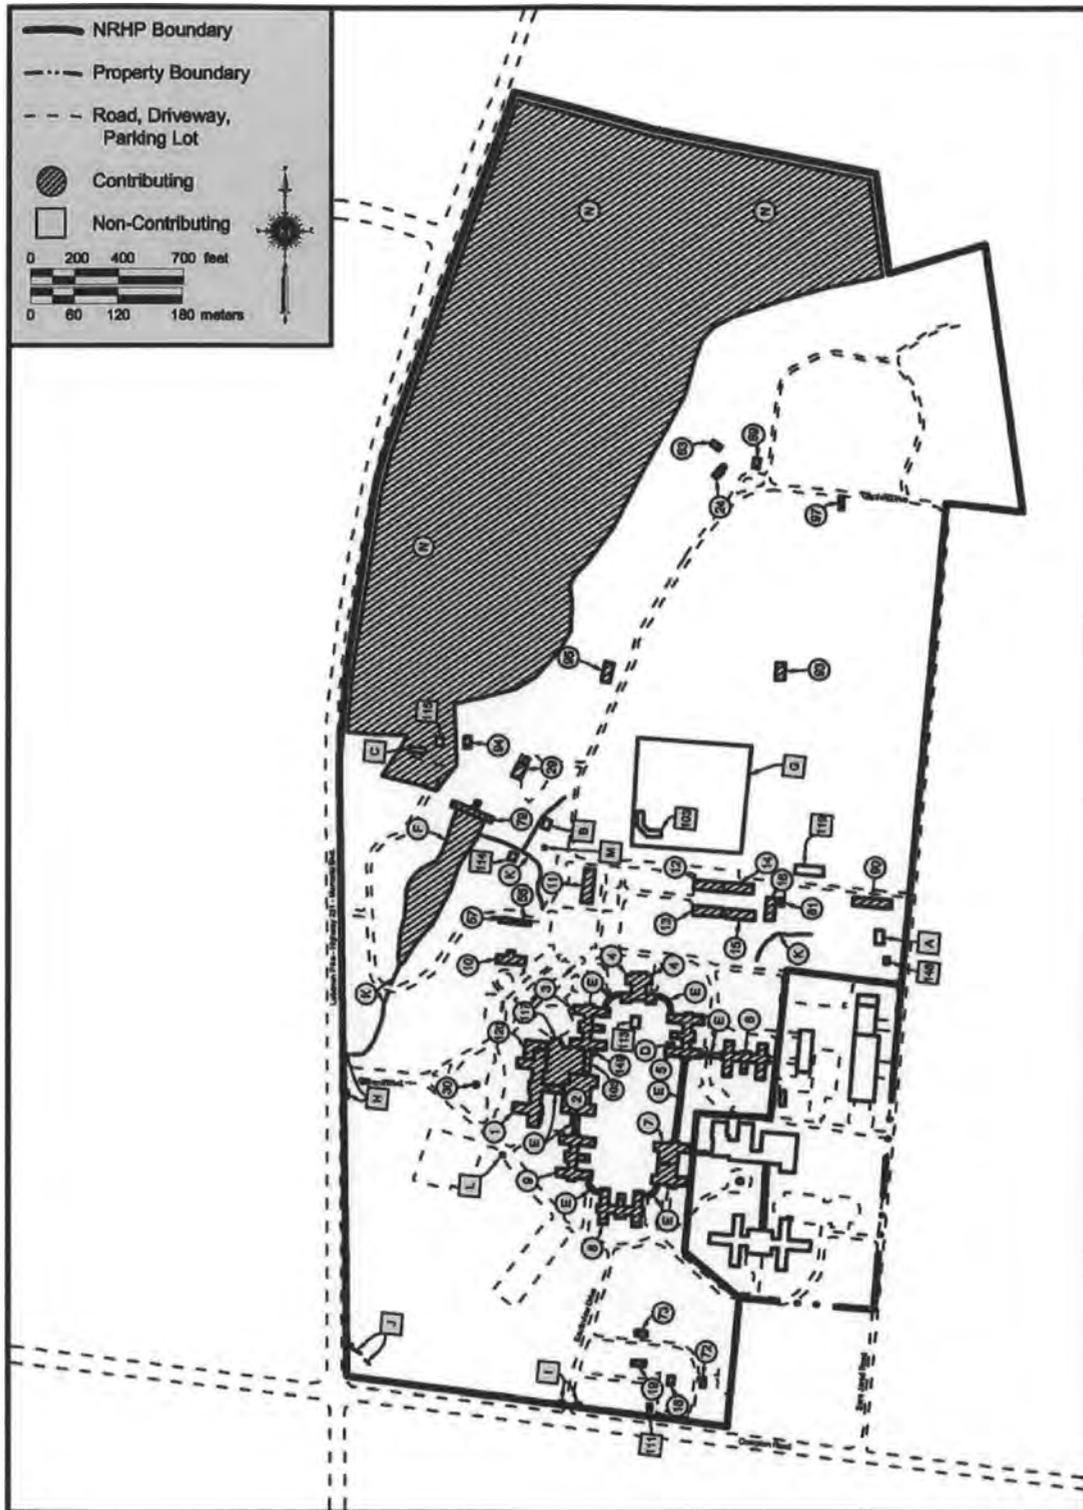
Sketch map indicating contributing and noncontributing resources.

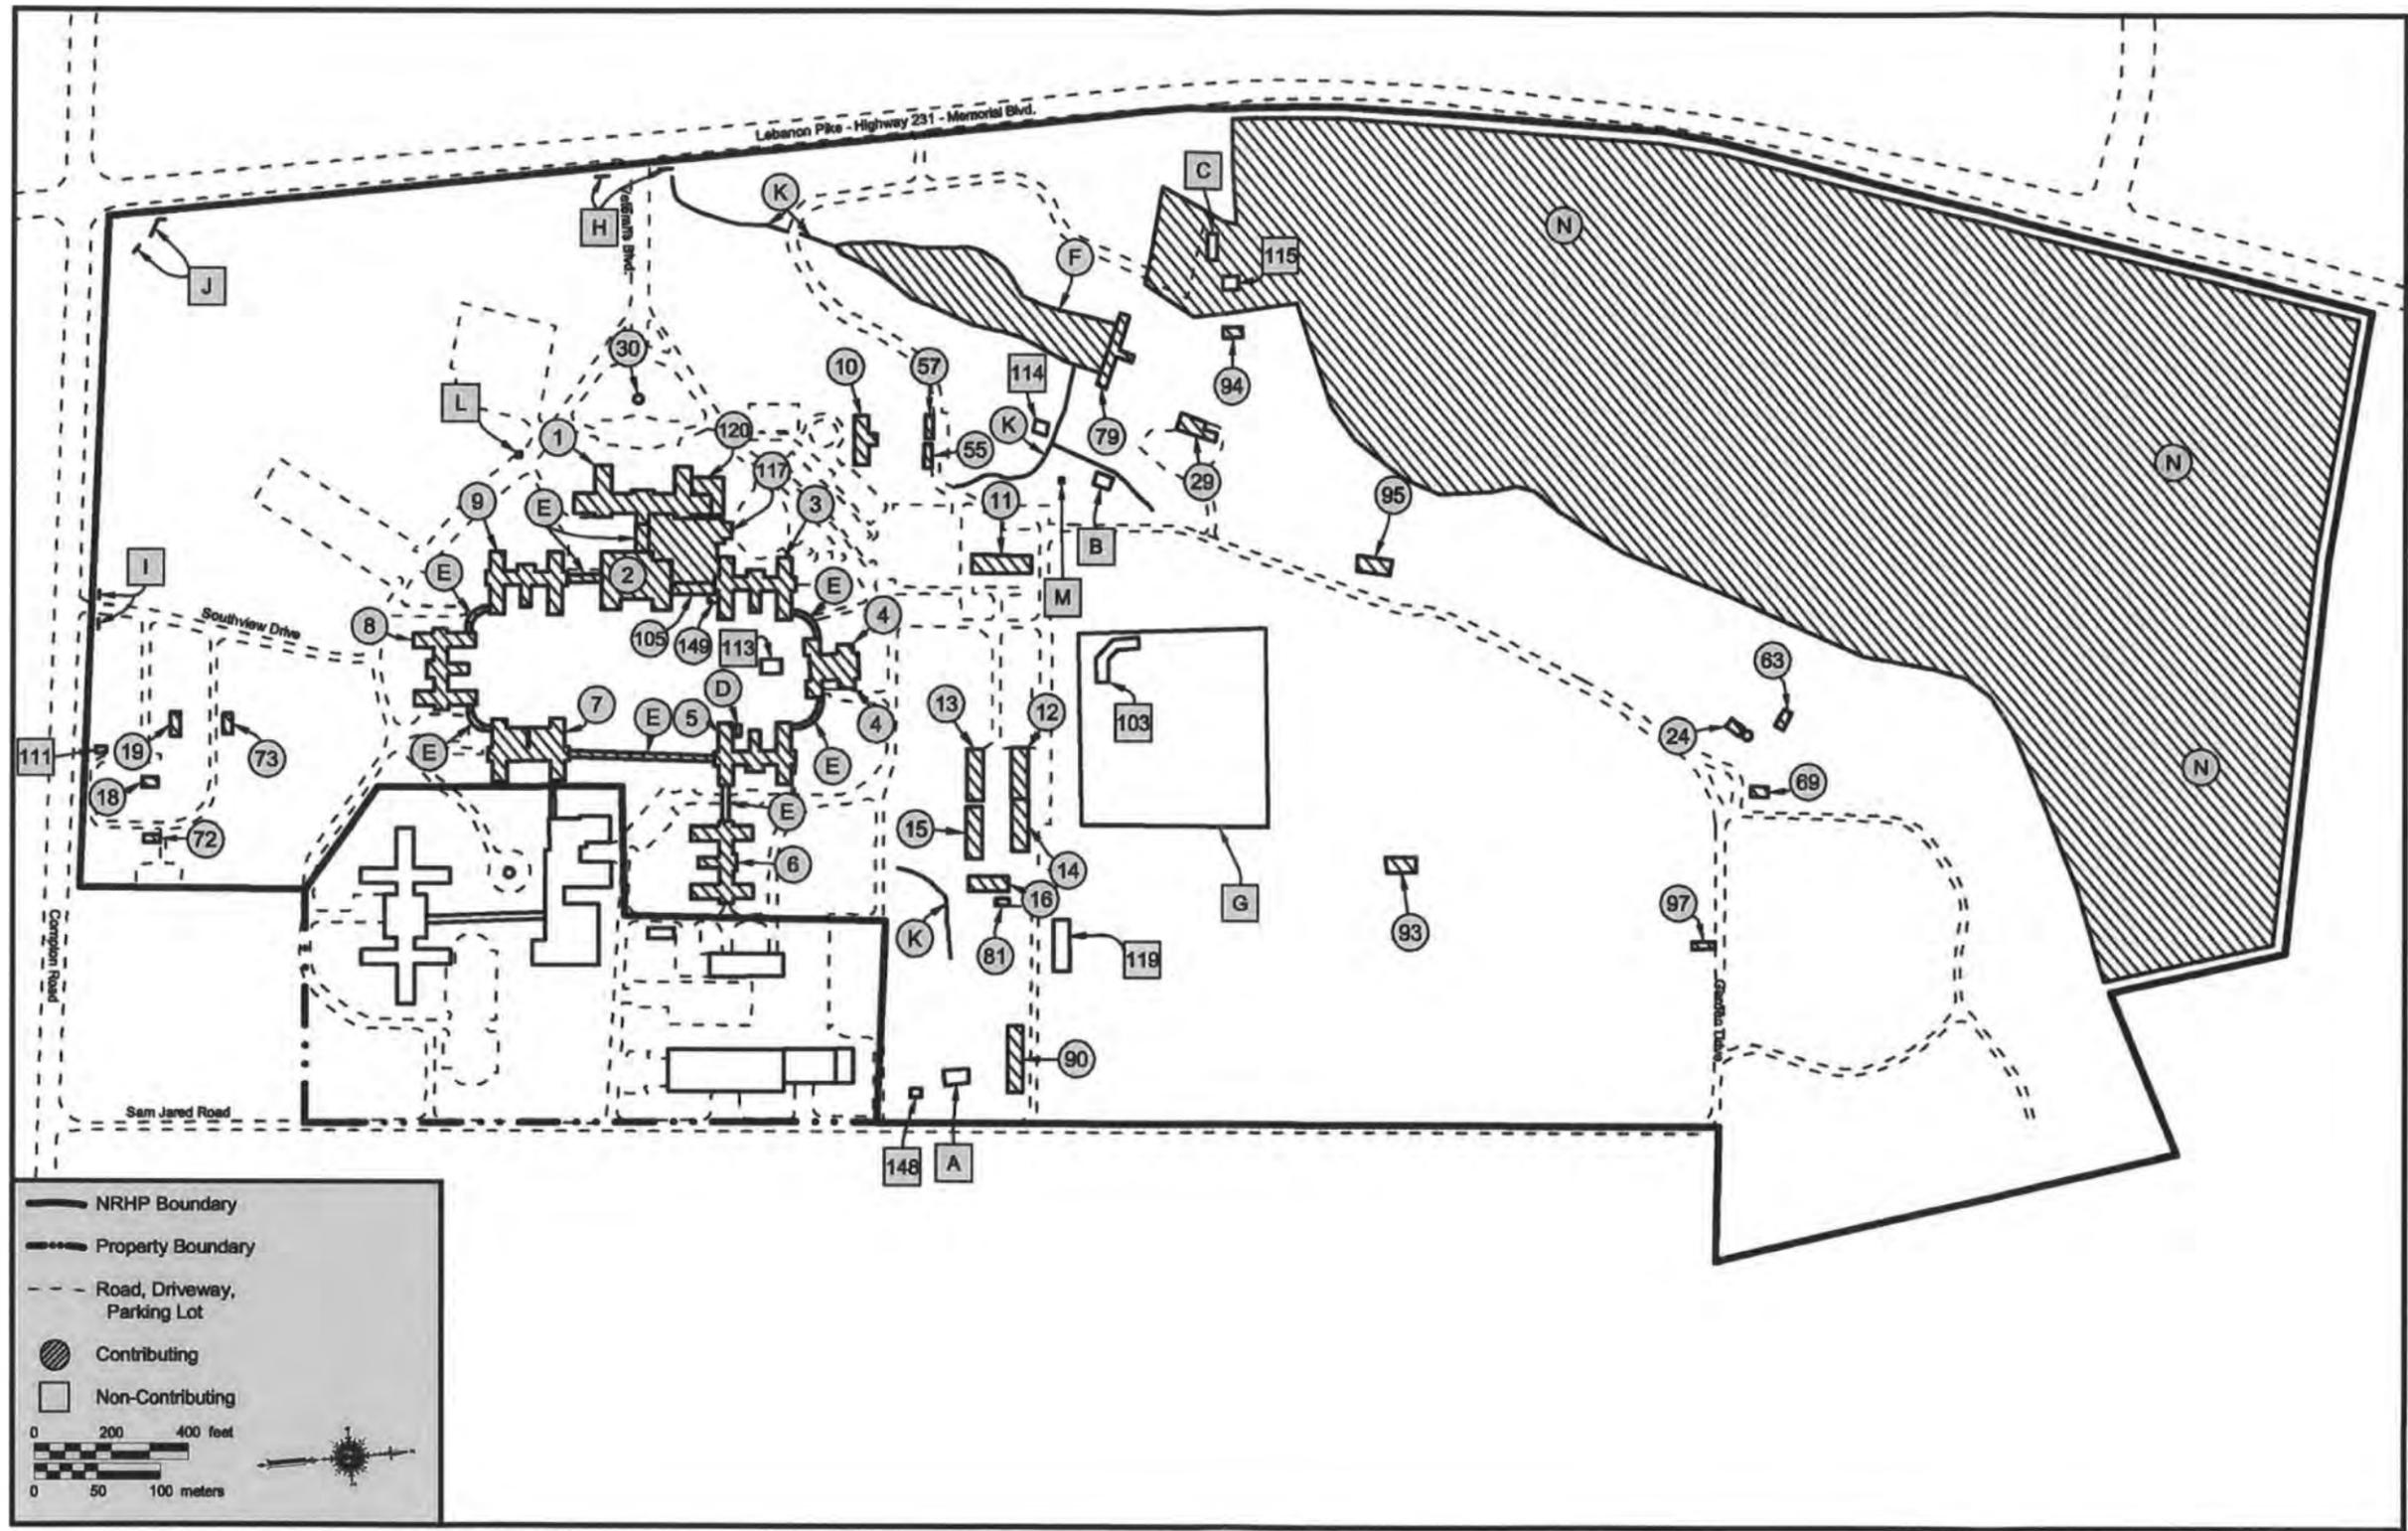
Sketch map indicating contributing and noncontributing resources (oversize).

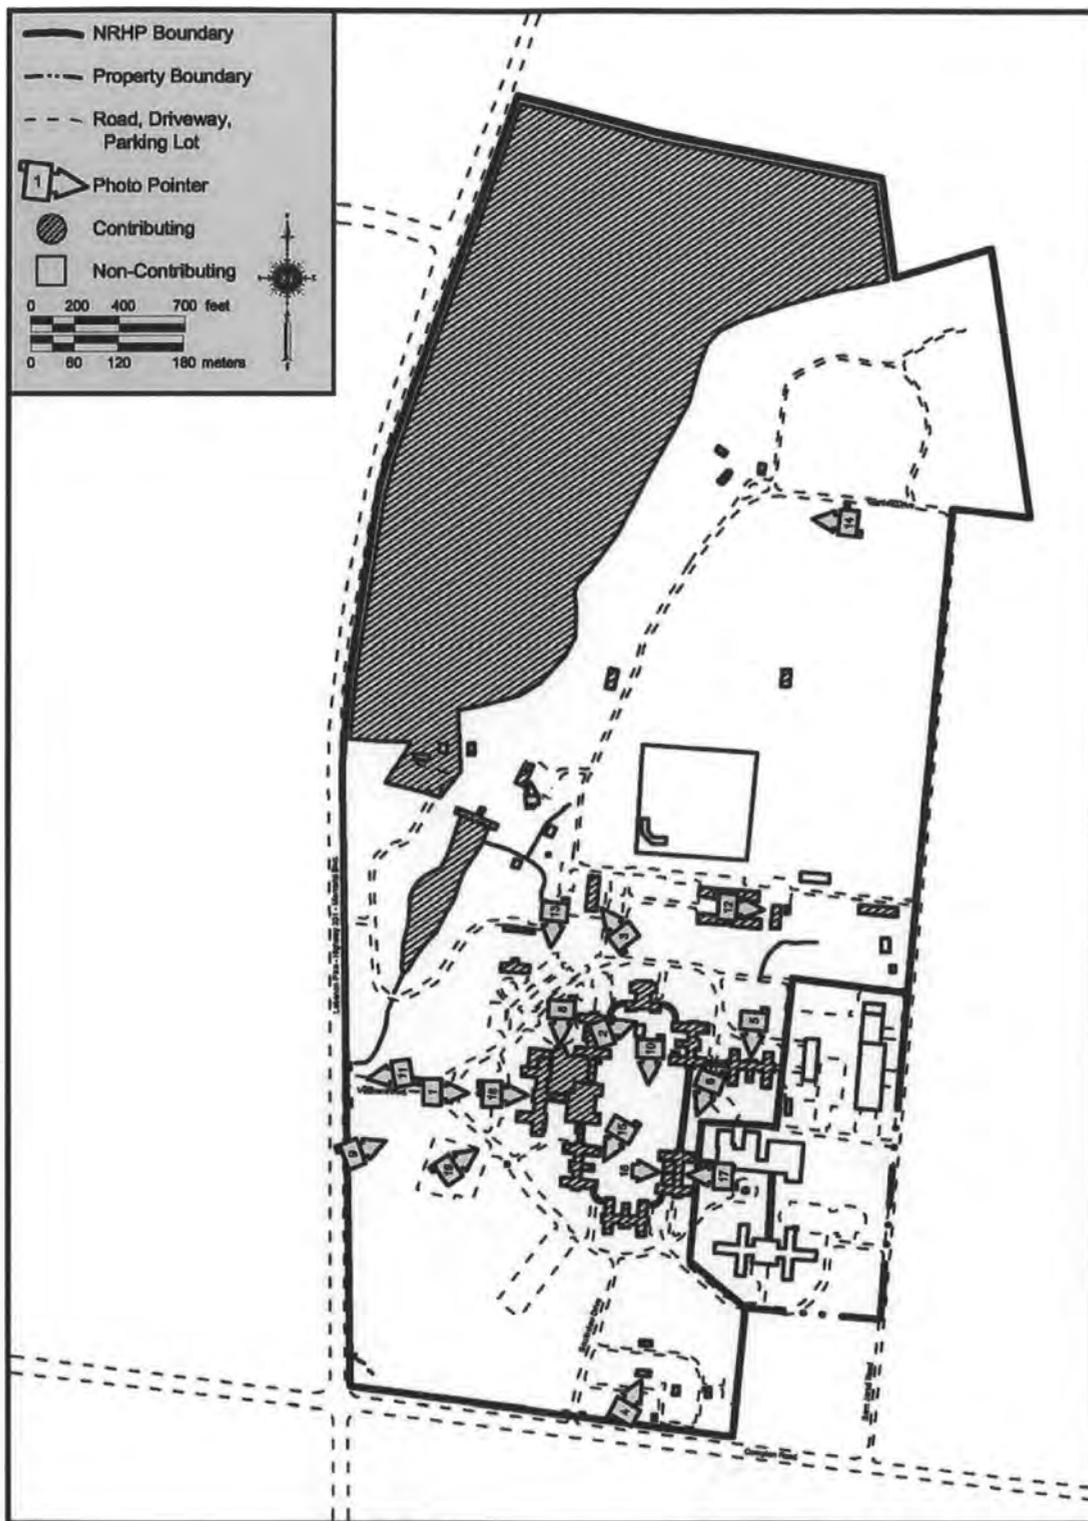
Sketch map indicating locations of photographs corresponding to those of the Photograph Continuation Sheet.

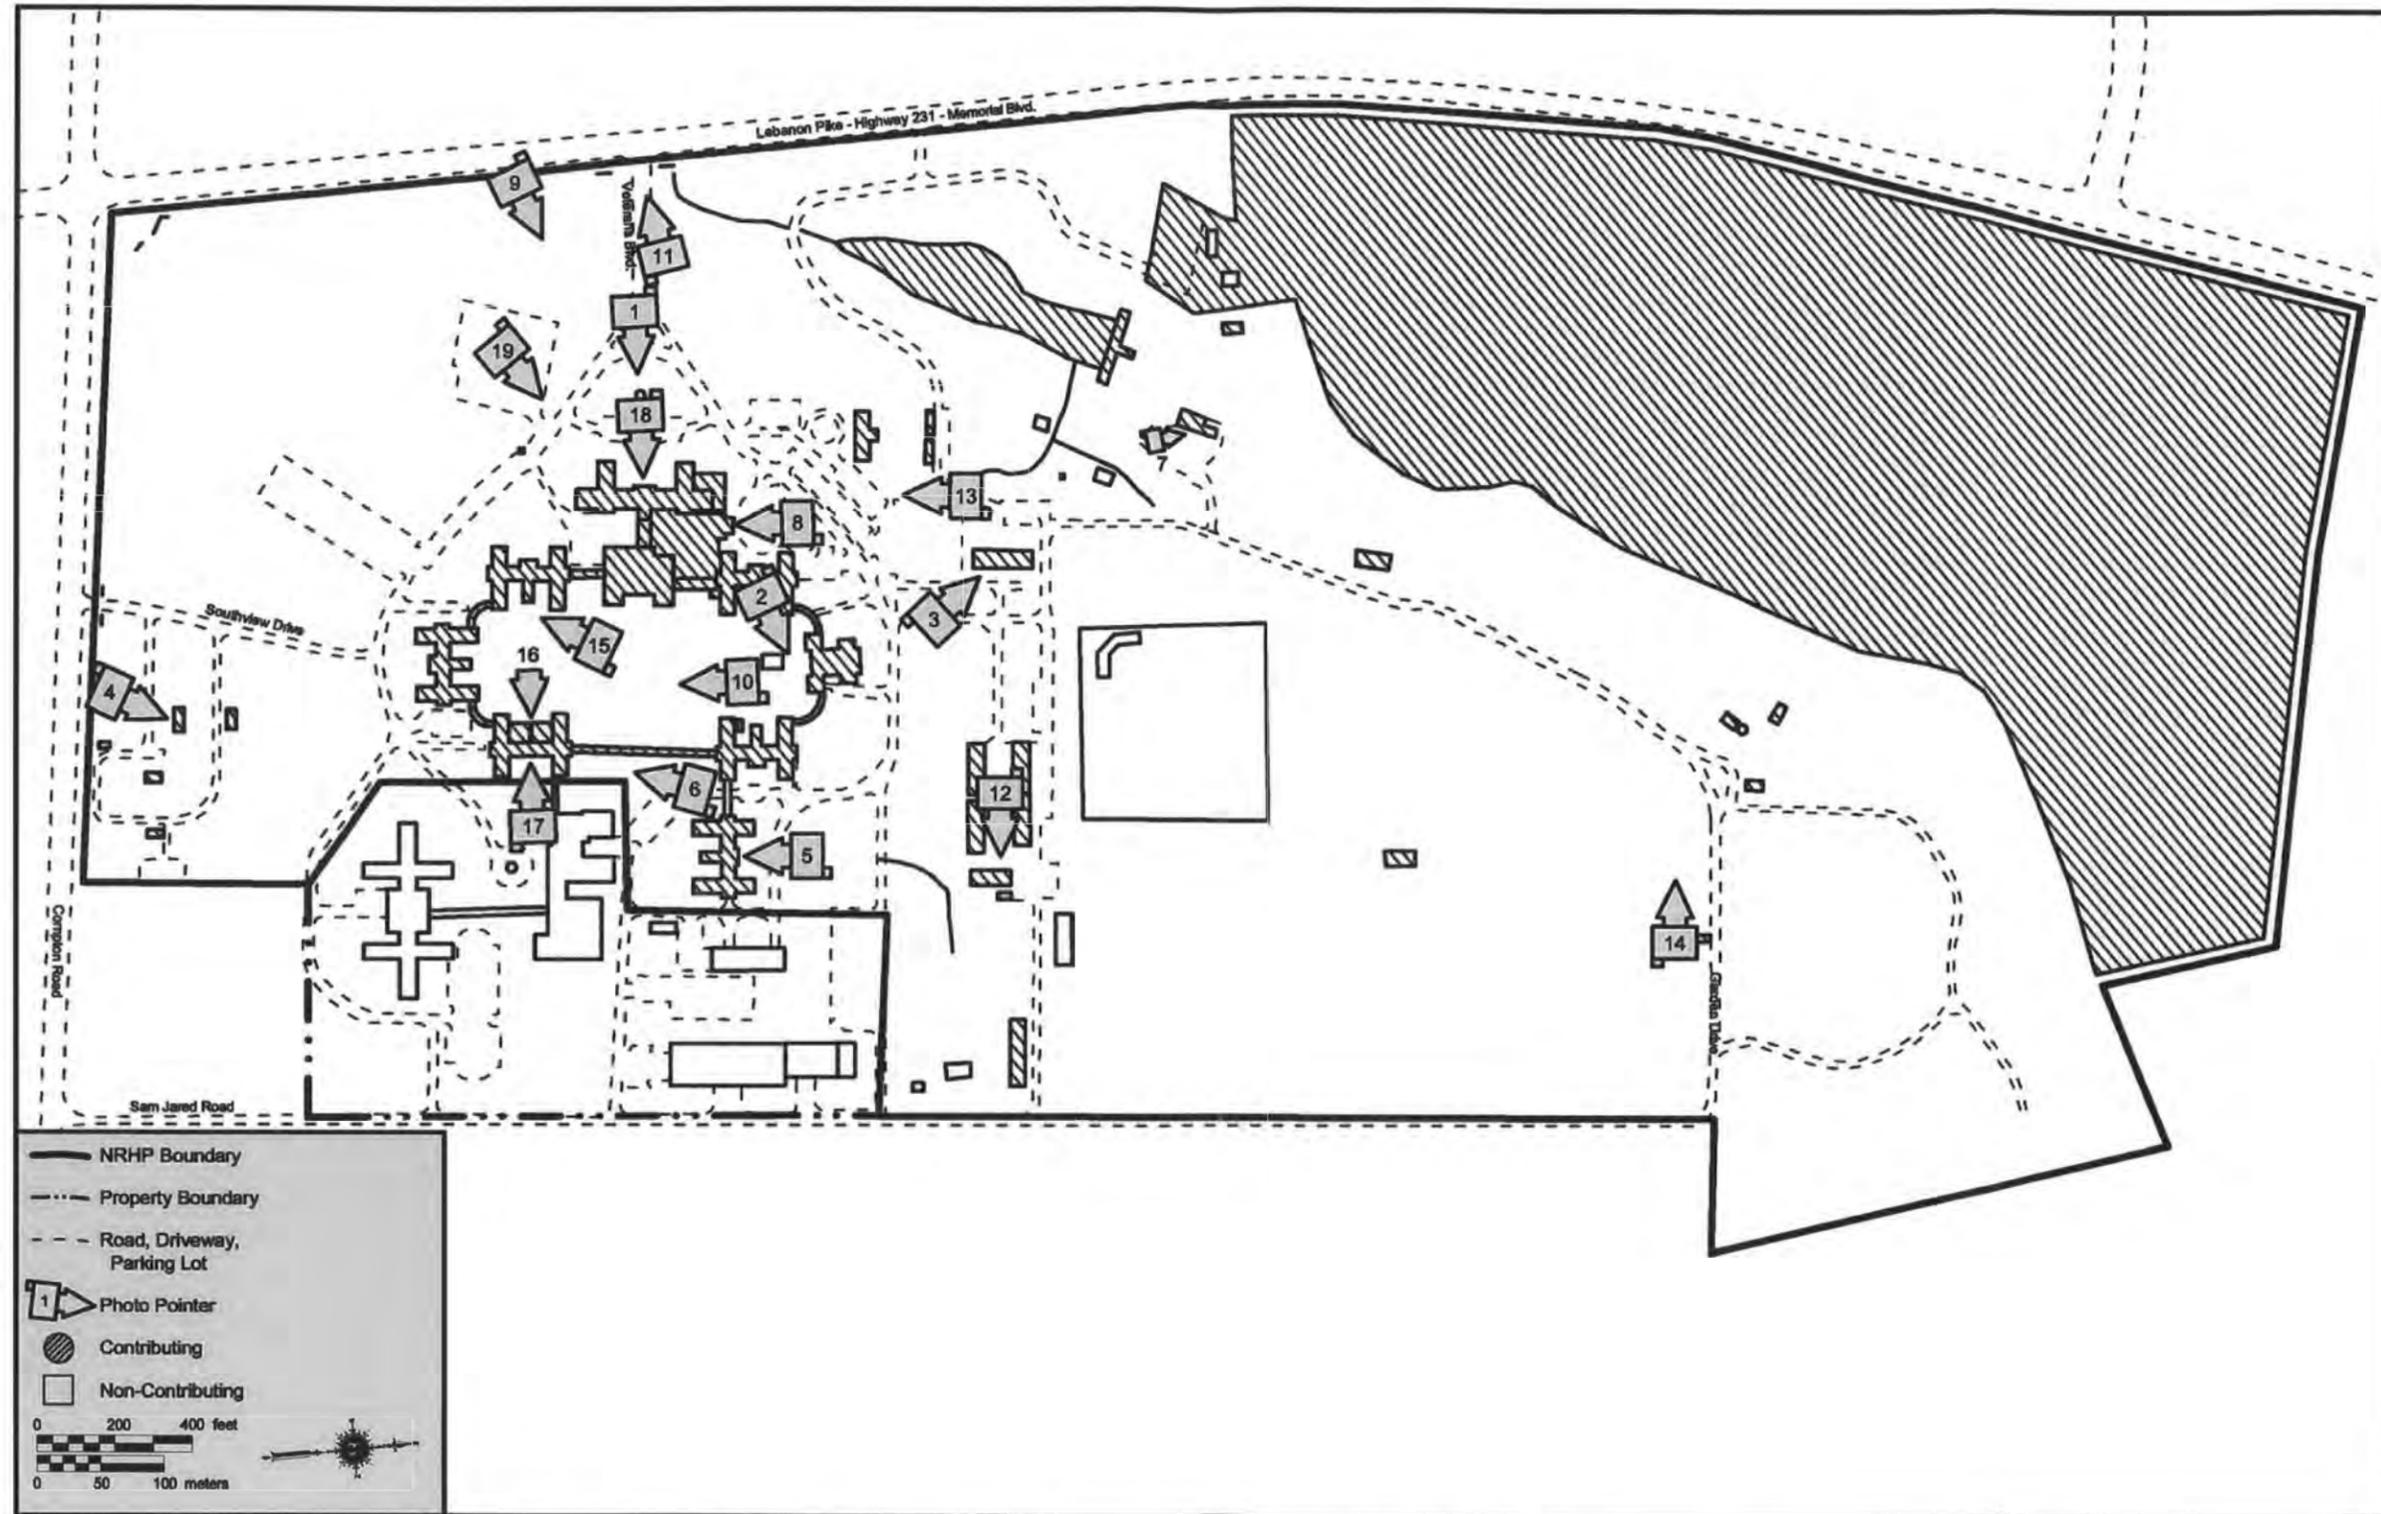
Sketch map indicating locations of photographs corresponding to those of the Photograph Continuation Sheet (oversize).
