United States Department of the Interior National Park Service

National Register of Historic Places Registration Form

1. Name of Property	
historic name Country Woman's Club	
other names/site number N/A	
2. Location	
street & number 2216 Old Russellville Pike NA not for publ	ication
city or town Clarksville NA vicini	ity
state TN code TN county Montgomery code 125 zip code 370-	<u>43</u>
3. State/Federal Agency Certification	
As the designated authority under the National Historic Preservation Act, as amended, I hereby certify that this nomination	
Signature of certifying official/Title Date	
State or Federal agency and bureau	
4. National Park Service Certification	
I hereby certify that the property is: entered in the National Register. See continuation sheet determined eligible for the National Register. See continuation sheet determined not eligible for the National Register. removed from the National Register. other, (explain:)	of Action

Section 7: Narrative Description

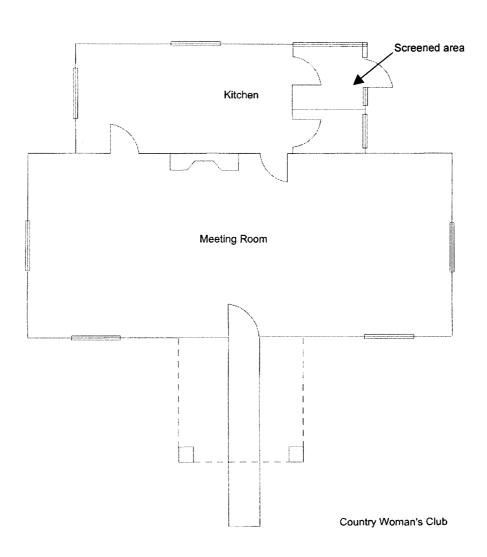
Section number	7 Page	3	Montgomery County, TN	
Sketch nlan	Not to scale

By entering the front door on the east façade, you step into the rectangular meeting room that occupies all of the log portion of the building. This space is dominated by a massive stone fireplace, hearth, and mantel against the west wall. (The stone chimney above the roofline was removed when the roof was replaced several years ago due to water leakage around the chimney.) The original wood floors, log walls with chinking, and exposed rafters are all extant. The window and door surrounds are wood. The original light fixtures remain, although they are non-operational and have been moved just off center to make room for the modern ceiling fans with light kits.

To either side of the fireplace is an opening that leads to the rear portion of the building. The kitchen, bathroom, and screened porch occupy this portion, which can be separated from the meeting room by the original swinging wood paneled doors. These doors and the exterior paneled doors leading to the bathroom and the screened porch still have their original hardware. The bathroom, constructed in 1936 from a portion of the porch and remodeled in the 1980s, is located in the northwest portion of the rear section. It is a half bath with a sink and toilet. The kitchen contains 1950s linoleum floor, faux wood paneling, and wallboard on the ceiling. There is a non-historic ceiling fan in the center of the room with a naked light bulb on either side. Circa 1950 wood cabinets line the east wall in between the doors to the meeting room. Earlier cabinets line the opposite wall as does a water heater, stove, and refrigerator. The screen porch with its wood floor, exposed lathe, framing, and rafter system is entered from the north wall of the kitchen.

The clubhouse is a rectangular log building with a board and batten rectangular portion that runs along the rear or west façade. On the northwest corner of the rear portion is an integrated screened porch. It is constructed of varying width hand-hewn logs with varying thicknesses of solid chinking to accommodate for the varying widths of logs. The hipped roof is covered with modern asphalt shingles and has exposed rafter tails. The building has a stone pier with concrete-block infill foundation. The concrete was added sometime during the mid-twentieth century.

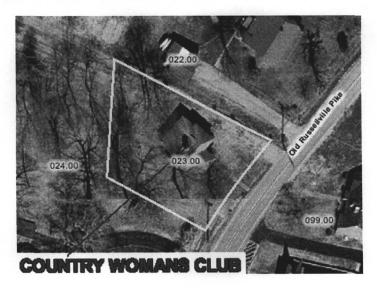
The Country Woman's Club boundaries are indicated on the attached Montgomery County Tax Map as found online at

http://gisweb.apsu.edu/website/general_viewer_v0_html/MapFrame.htm_on_12/20/205. The clubhouse is located on the west side of Old Russellville Pike, just north of Rossview Road. It is parcel 23 on Montgomery County tax map 041K.
