# National Register of Historic Places Registration Form

historic name JOHN & CHARLOTTE WISTAR FARM

other names/site number BARTHOLOMEW WYATT FARM/RICHARD WISTAR FARM

street & number 120 HARRIS ROAD  not for publication

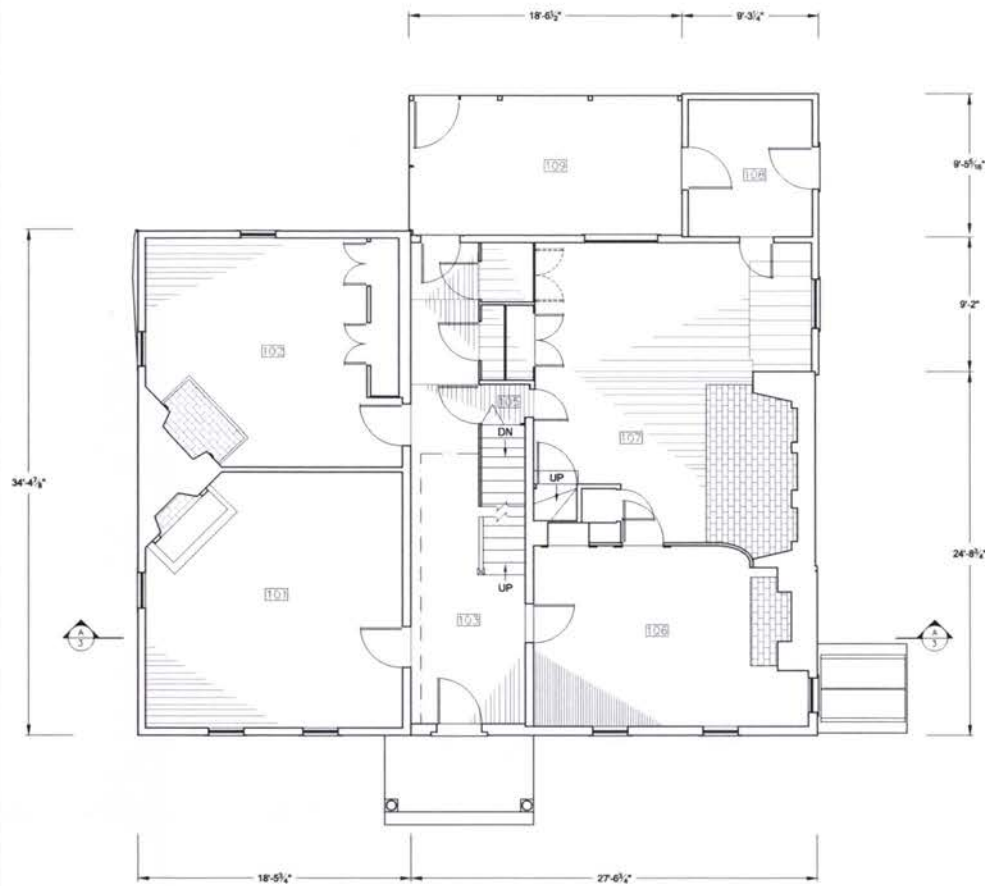
FIRST FLOOR PLAN, DWELLING

1. NORTH-SOUTH JOISTS IN ROOMS 001/002 & 003 ARE HEWN AND APPEAR CLOSE IN PERIOD.
2. STAIR HALL JOISTS ARE SASH-SAWN AND UTILIZE A CENTRAL TENON AND SOFFIT SPUR TIMBER JOINT ALSO FOUND IN THE BARN.
3. JOISTS OVER ROOM 004 ARE SASH-SAWN, JOINED AND PINNED.
4. SHADED MEMBERS ARE LATE 20TH C REPAIRS.

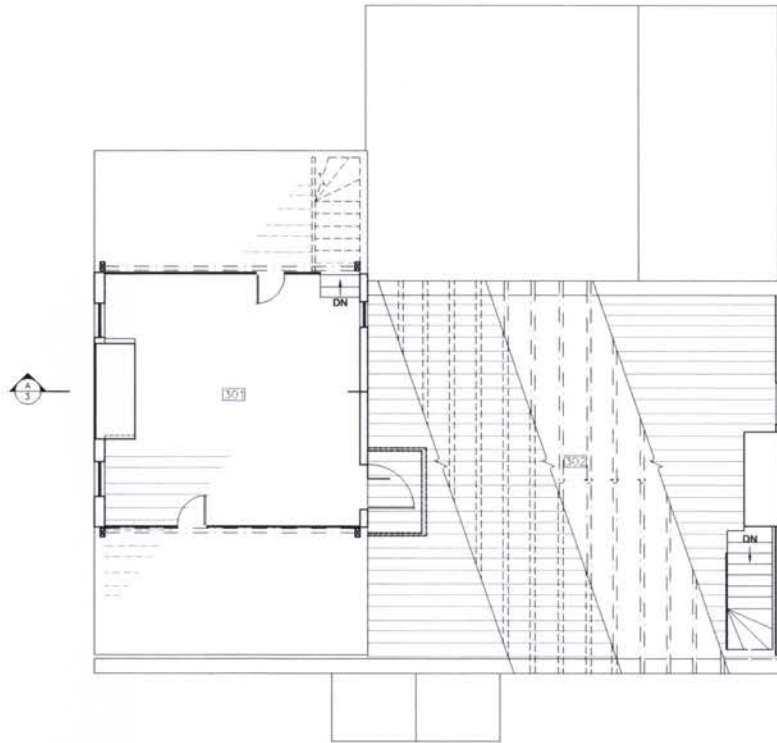
GARRET AND PARTIAL REFLECTED ROOF FRAMING PLAN, DWELLING

NOTES:  
1. DASHED LINES IN ROOMS 201 AND 204  
INDICATE REMOVED ORIGINAL PARTITIONS.

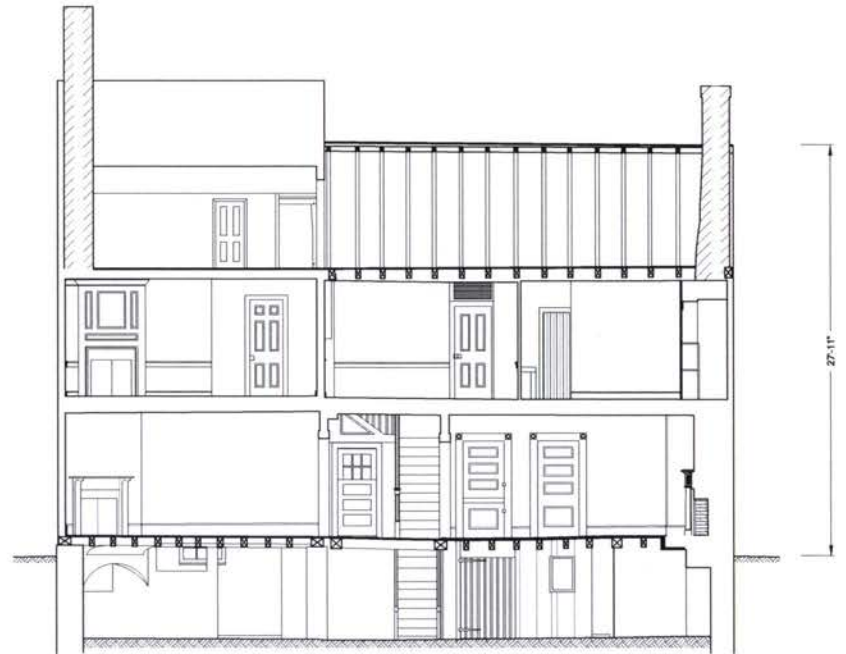
SECTION A-A LOOKING NORTH, DWELLING

1. EAST GARRET VIGNETTES DEPICT FLOORING, FLOORING WITH UNDERLYING JOISTS, AND ROOF RAFTERS.
2. ALL GARRET FLOOR JOISTS ARE HEWN. RAFTERS ARE SAWN.
3. FORMER CLOSET BETWEEN THE TWO GARRETS STORED MEAT, AND WAS LOST IN A FIRE STARTED BY LIGHTNING IN THE 1940s.
4. EAST WALL OF WEST SECTION IS SIDED WITH UNFINISHED BEADED WEATHERBOARD, PARTIALLY REPLACED WITH SALVAGED, PAINTED WEATHERBOARD IN THE AREA OF THE FIRE.
5. WEST ROOF IS SUPPORTED BY HEWN PURLIN PLATES BEARING ON HEWN POSTS BEARING ON THE WALL TIE BEAMS.

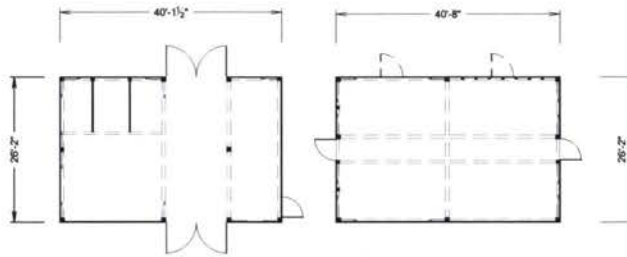
**BUILD I**  
 THRESHING BARN AND ANIMAL BARN FOR GRAIN PRODUCTION, LIVESTOCK AND FODDER STORAGE. OVERHEAD FRAMING IS SHOWN WITH DASHED LINES. MISSING MEMBERS ARE SHOWN BASED UPON PHYSICAL EVIDENCE IN SURVIVING MEMBERS.

**BARNs: EVOLUTION IN PLAN**

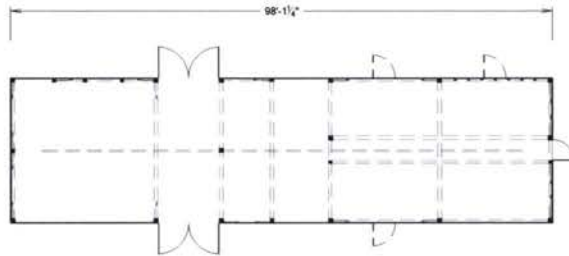
**BUILD II**  
 BARN WERE CONNECTED, AND EXPANDED, POSSIBLY TO INCREASE SPACE FOR ANIMALS AND FODDER AS MEADOW BANKING EXPANDED IN 19TH CENTURY. A WOODEN HAY TRACK AND CARRIER PROBABLY PRE-DATE THE 1880s.

The fact that the hay track runs the entire length of the barn means the barn was connected and extended in the 1870s when wood tracks for hay carrying were first marketed to ease the very laborious task of filling hay mows. By one 19th-century account, in the 1860s the harpoon fork was invented to aid the hoisting of hay into a barn. That was followed by grapple forks and tracks that were attached to the rafters allowing a car or carrier to move a pile of loose hay anywhere in the barn. The first sort of track was an iron rod (1869), followed in 1872 by a wood track of 2x4 scantling. In the early 1880s Ohio inventors first introduced tracks made of steel angles. By 1900 the market was dominated by steel track systems.<sup>63</sup> The tie beams between the roof purlins would have interfered with the movement of hay on the track, thus they would have been removed at that time, sacrificing the integrity of the roof structure to the efficacy of improved hay loading.

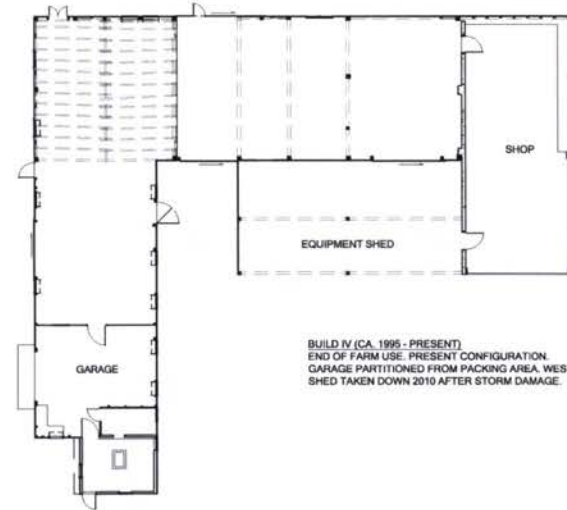
**BUILD IV (1941-1995)**  
 END OF DAIRYING, BEGINNING OF TRUCK FARMING. BARN MODIFIED FOR EQUIPMENT STORAGE AND MAINTENANCE. HORSE STALLS ELIMINATED AS HORSE-POWER WAS REPLACED WITH MOTORIZED EQUIPMENT. SILO REMOVED.

**BUILD IV (CA. 1995 - PRESENT)**  
 END OF FARM USE. PRESENT CONFIGURATION. GARAGE PARTITIONED FROM PACKING AREA. WEST SHED TAKEN DOWN 2010 AFTER STORM DAMAGE.

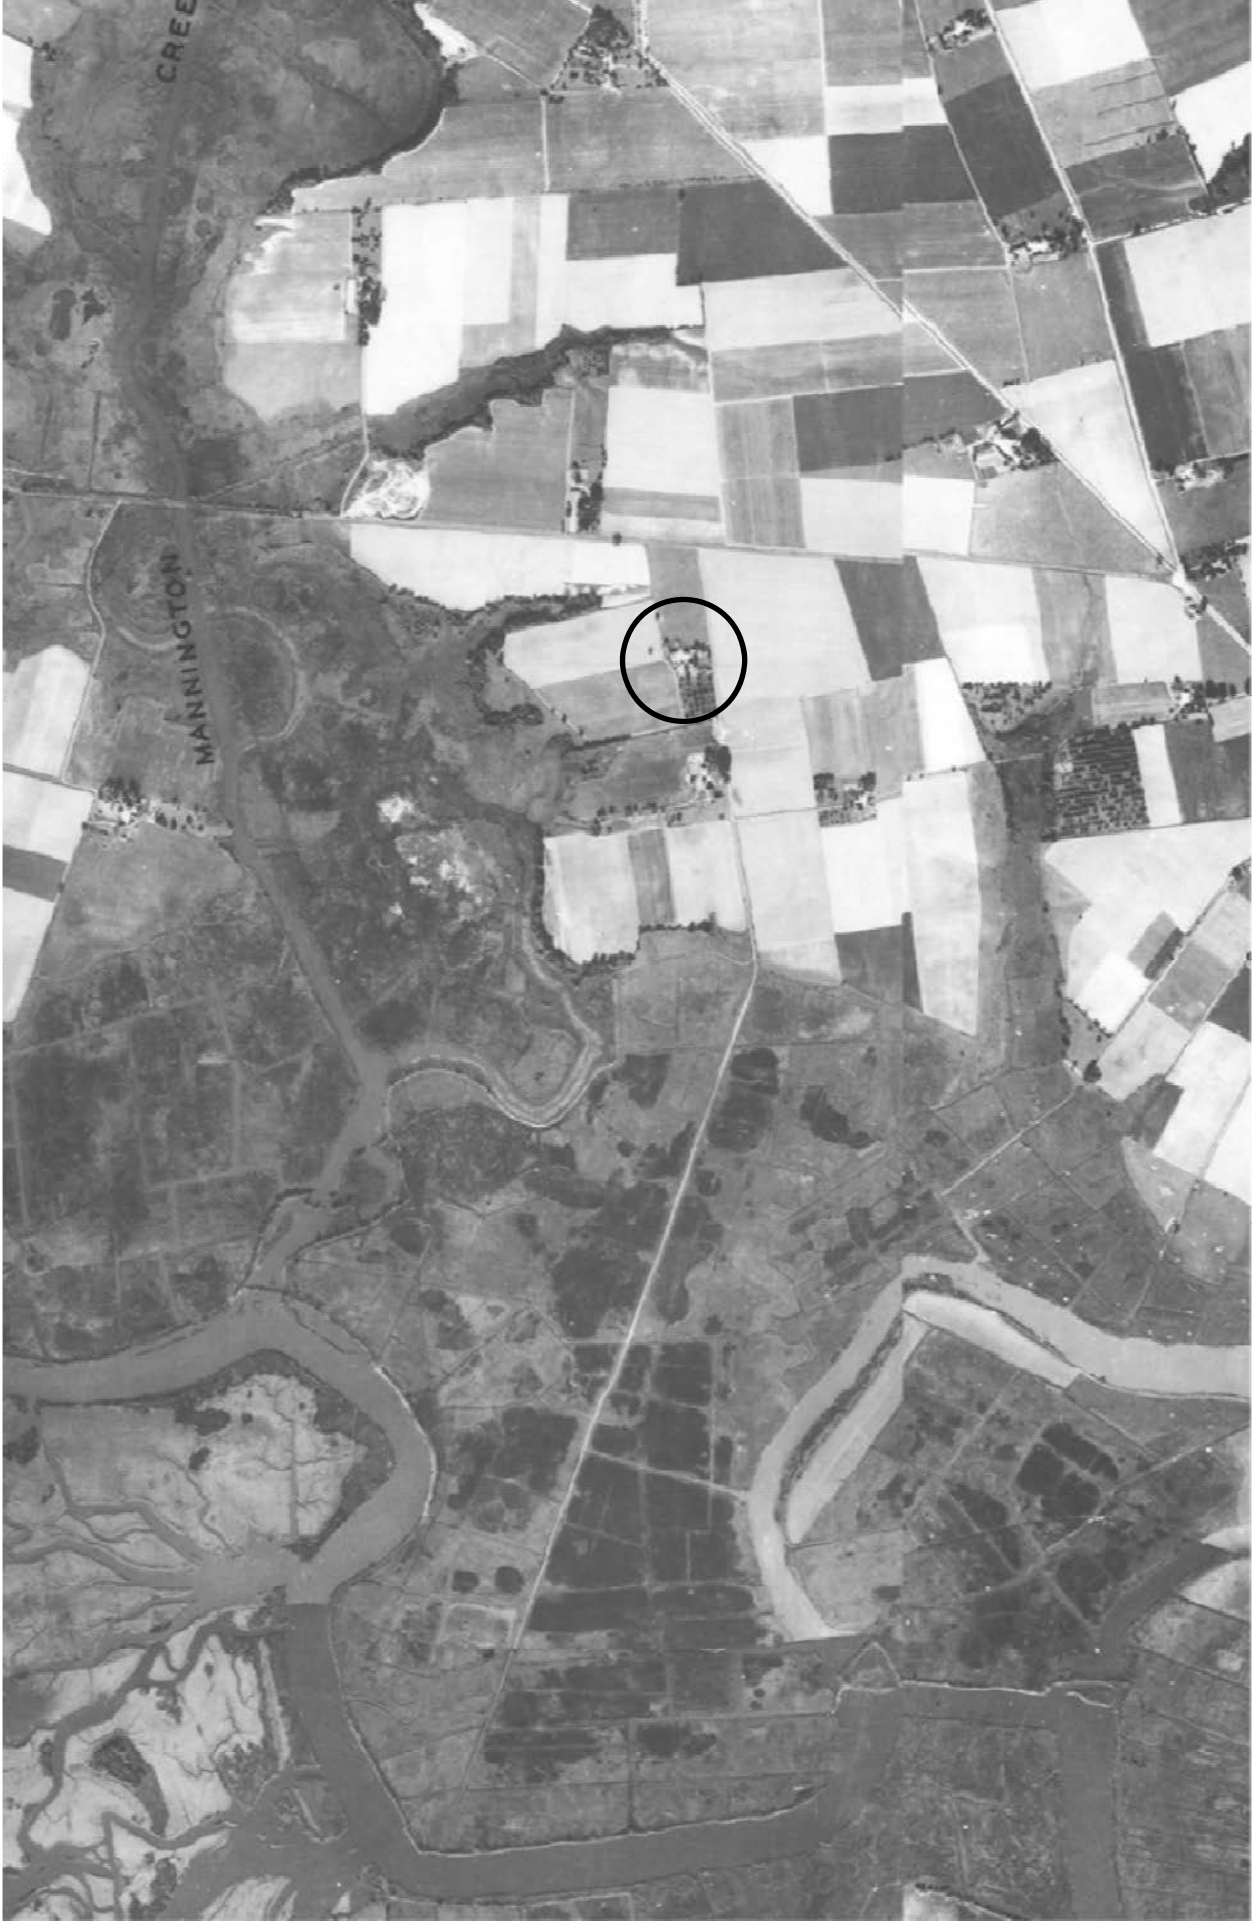
**1930 Aerial Photo. (New Jersey State Atlas <http://njstateatlas.com/1930/>). Wistar Farmstead is circled. Note the extent of banked meadows.**

Banks are apparent along the edges of the creeks.

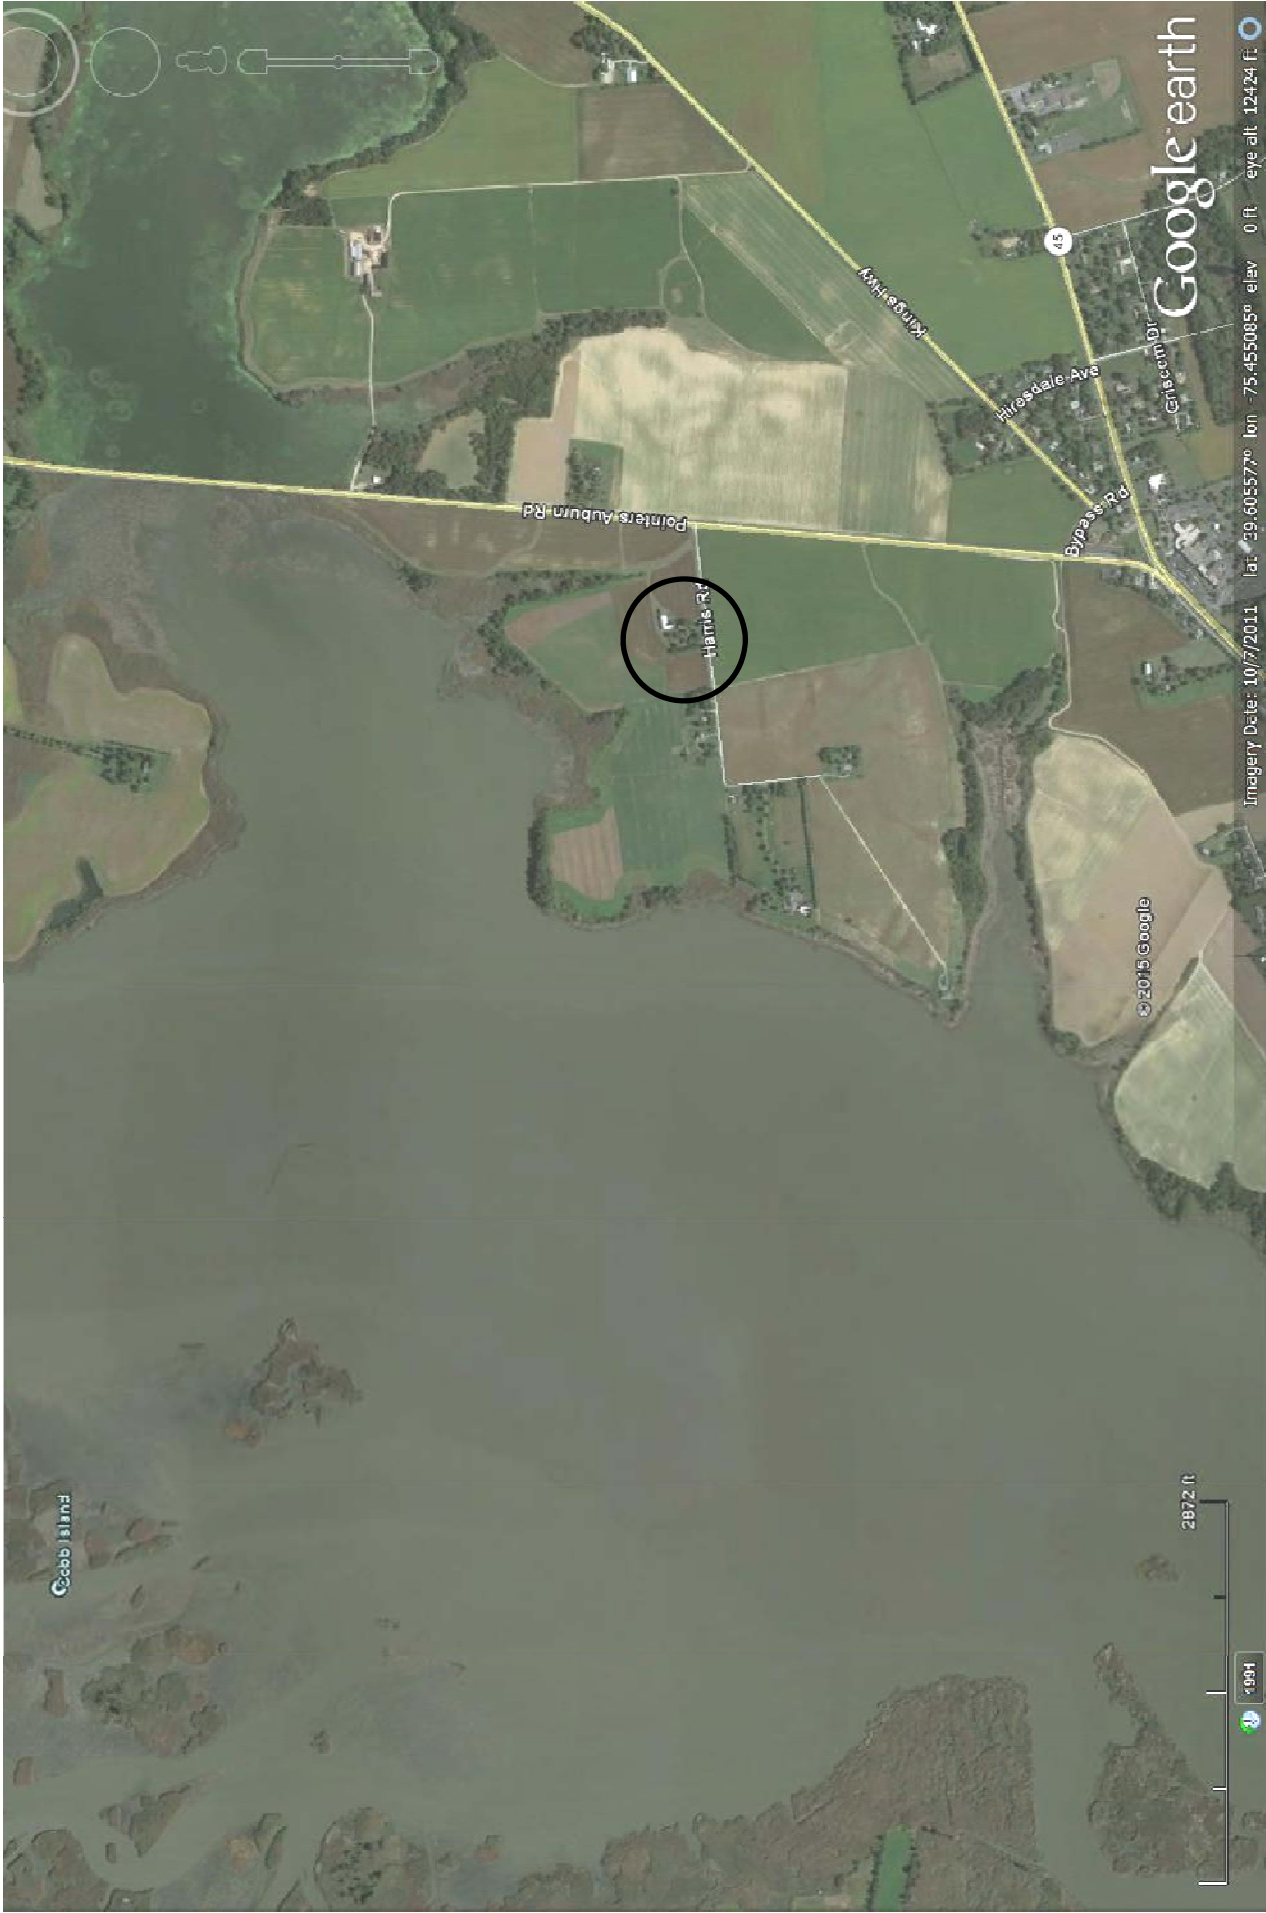
**2011 Imagery. (Google Earth).** Wistar Farmstead is circled. Note the integrity of the farms north of Route 45, the loss of banked meadows, change in field patterns and suburbanization along Route 45 since 1930.

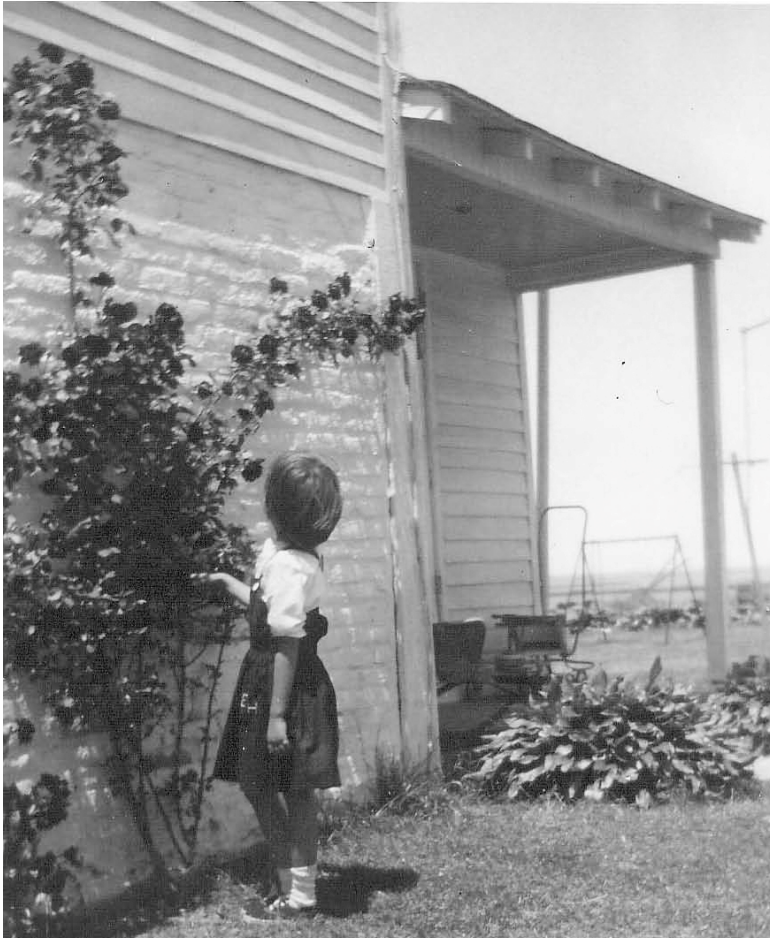
**3. East end of the house and kitchen shed, looking northwest circa 1953. A more extensive work shed over the house well on the east side of the house was removed in 1947. (Courtesy Suzanne H. Culver)**

Initial changes in the house included: replacement of some ceilings with drywall, repair of rotted first floor framing, and removal of a large shed on the east gable end. This shed, which enclosed the house well, was of unknown age, but likely it was a historic domestic work area where washing and other chores took place. Sometime between 1941 and 1947, the house was struck by lightning which set the roof ablaze. Charred rafters survive, but the closet between the two house sections which stored smoked meat was destroyed. In 1963, the basement of the house was freshly parged and the kitchen was slightly expanded to the east to include an area where a small porch stood and a mud shed with a new entry was built to provide exterior access to the kitchen, as well as a laundry, and a place for Mr. Hancock to conveniently come in during the work day to make phone calls without having to enter the house. In 1980 the front porch was replaced with a smaller pedimented porch and a new screened porch was added on the north side of the kitchen.

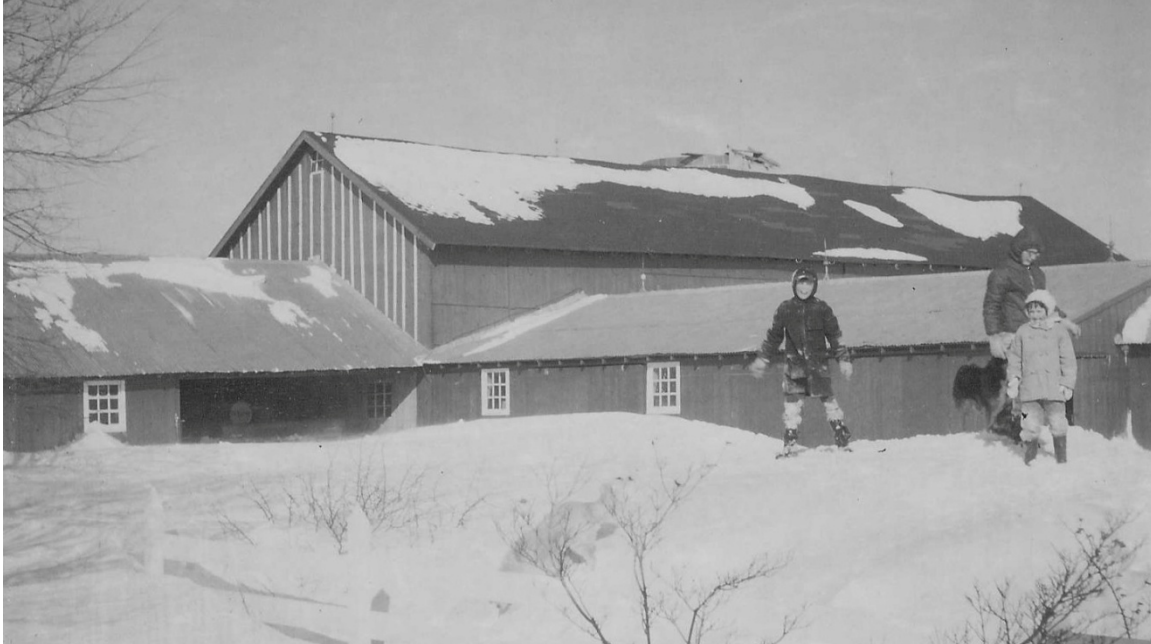
**6. Barn and former diary wing looking northeast, 1966. At the barn ridge the remains of the tile block silo and its wood roof is visible. The equipment shed is as it was rebuilt after Hurricane Hazel in 1954 (see other shed photos).  
(Courtesy Suzanne H. Culver)**

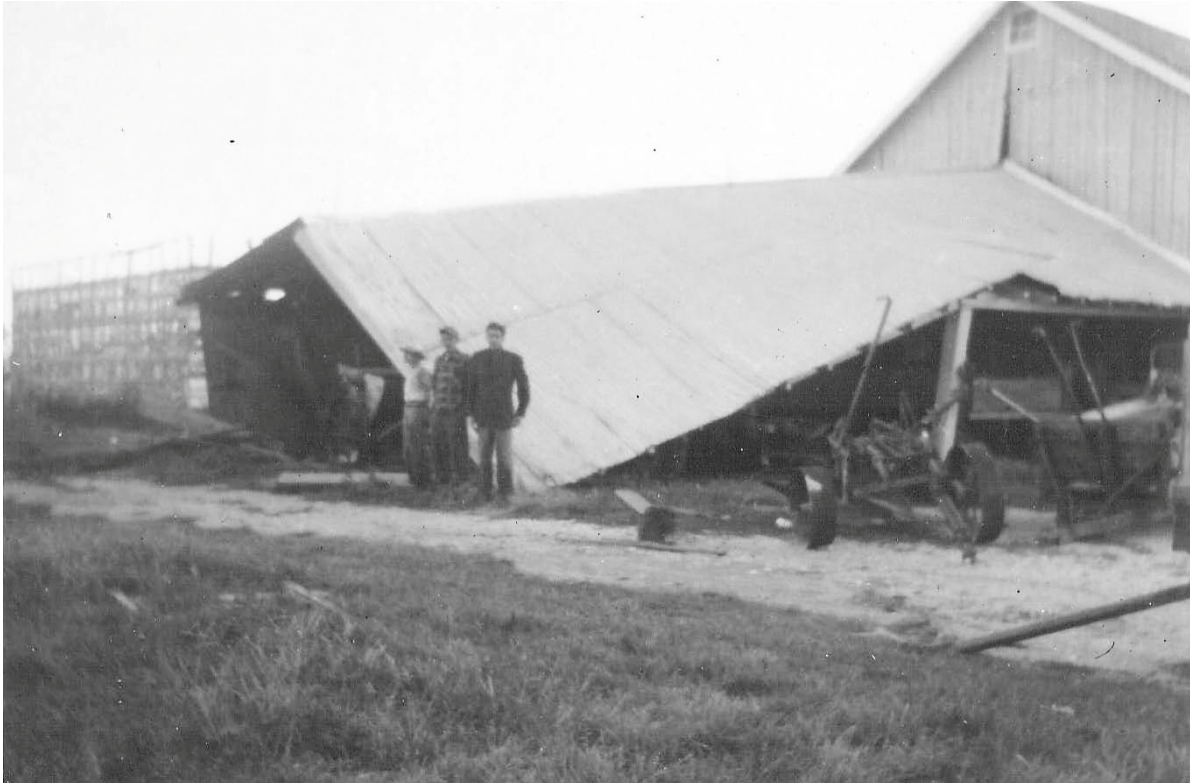
**9. The ruined equipment shed after Hurricane Hazel in 1954. The three men are Puerto Rican migrant workers. (Courtesy Suzanne H. Culver)**

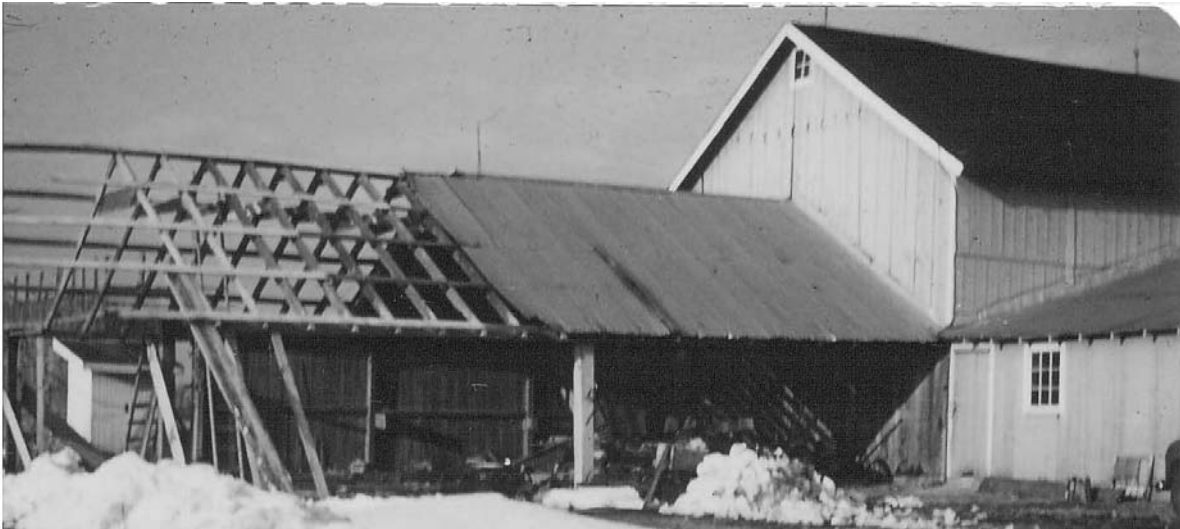
**10. The rebuilding of the equipment shed after Hurricane Hazel in 1954. (Courtesy Suzanne H. Culver)**

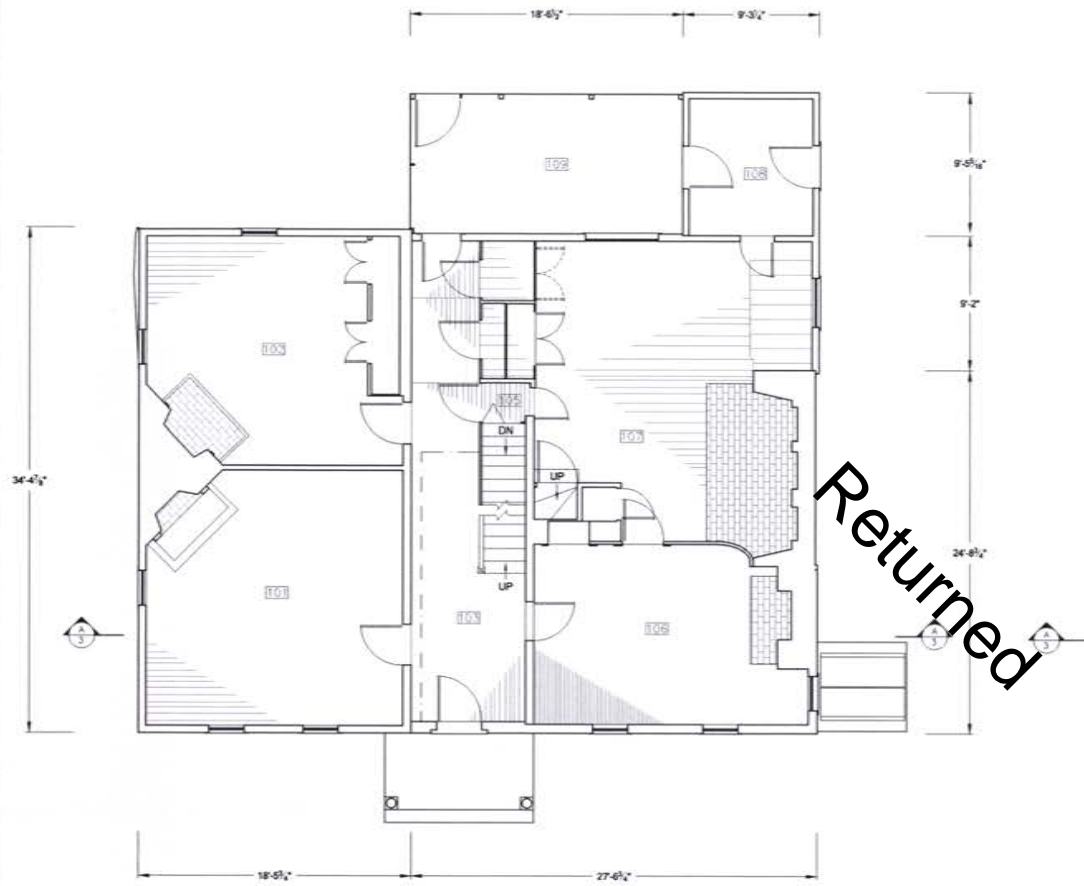
FIRST FLOOR PLAN, DWELLING

1. NORTH-SOUTH JOISTS IN ROOMS 001/002 & 003 ARE HEWN AND APPEAR CLOSE IN PERIOD.
2. STAIR HALL JOISTS ARE SASH-SAWN AND UTILIZE A CENTRAL TENON AND SOFFIT SPUR TIMBER JOINT ALSO FOUND IN THE BARN.
3. JOISTS OVER ROOM 004 ARE SASH-SAWN, JOINED AND PINNED.
4. SHADED MEMBERS ARE LATE 20TH C REPAIRS.

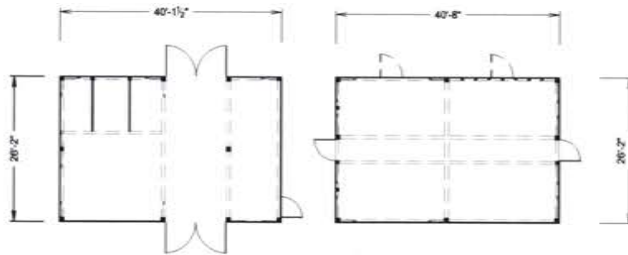
**BUILD I**  
 THRESHING BARN AND ANIMAL BARN FOR GRAIN PRODUCTION, LIVESTOCK AND FODDER STORAGE. OVERHEAD FRAMING IS SHOWN WITH DASHED LINES. MISSING MEMBERS ARE SHOWN BASED UPON PHYSICAL EVIDENCE IN SURVIVING MEMBERS.

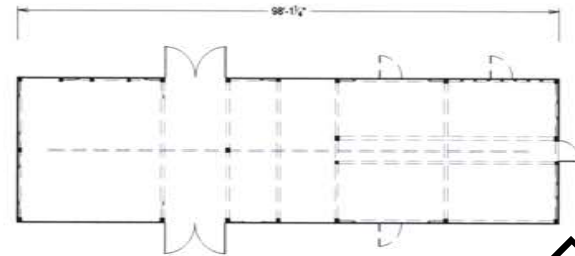
**BUILD II**  
 BARNS WERE CONNECTED, AND EXPANDED, POSSIBLY TO INCREASE SPACE FOR ANIMALS AND FODDER AS MEADOW BANKING EXPANDED IN 19TH CENTURY. A WOODEN HAY TRACK AND CARRIER PROBABLY PRE-DATE THE 1880s.

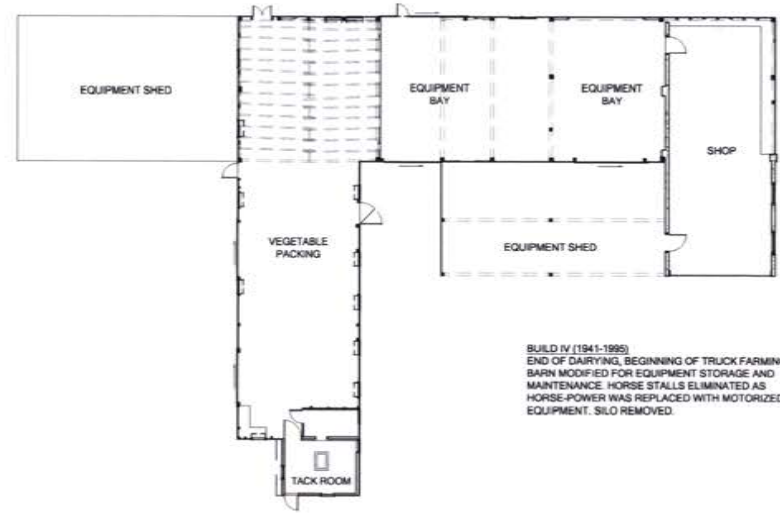
**BUILD III (EARLY 20TH C.)**  
 ONSET OF DAIRY FARMING. MILKING PARLOR, MILK HOUSE, SILO, AND EQUIPMENT SHED ADDED. NEW HAY MOW FLOOR OVER MILKING PARLOR. LARGE SWINGING DOORS REPLACED WITH SLIDING DOORS.

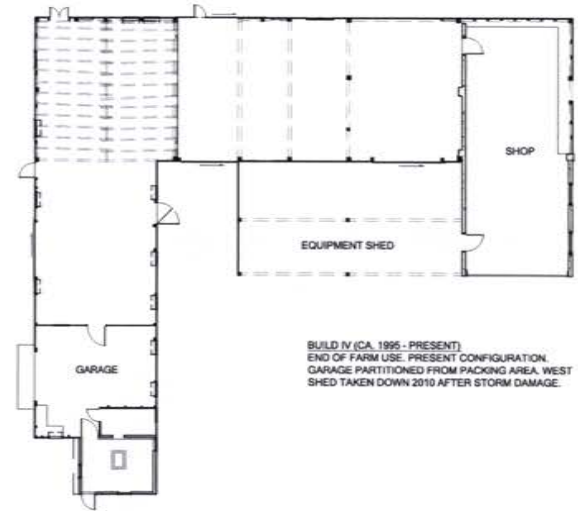
**BUILD IV (1941-1995)**  
 END OF DAIRYFARMING, BEGINNING OF TRUCK FARMING. BARN MODIFIED FOR EQUIPMENT STORAGE AND MAINTENANCE. HORSE STALLS ELIMINATED AS HORSE-POWER WAS REPLACED WITH MOTORIZED EQUIPMENT. SILO REMOVED.

**BUILD IV (CA. 1995 - PRESENT)**  
 END OF FARM USE. PRESENT CONFIGURATION. GARAGE PARTITIONED FROM PACKING AREA. WEST SHED TAKEN DOWN 2010 AFTER STORM DAMAGE.

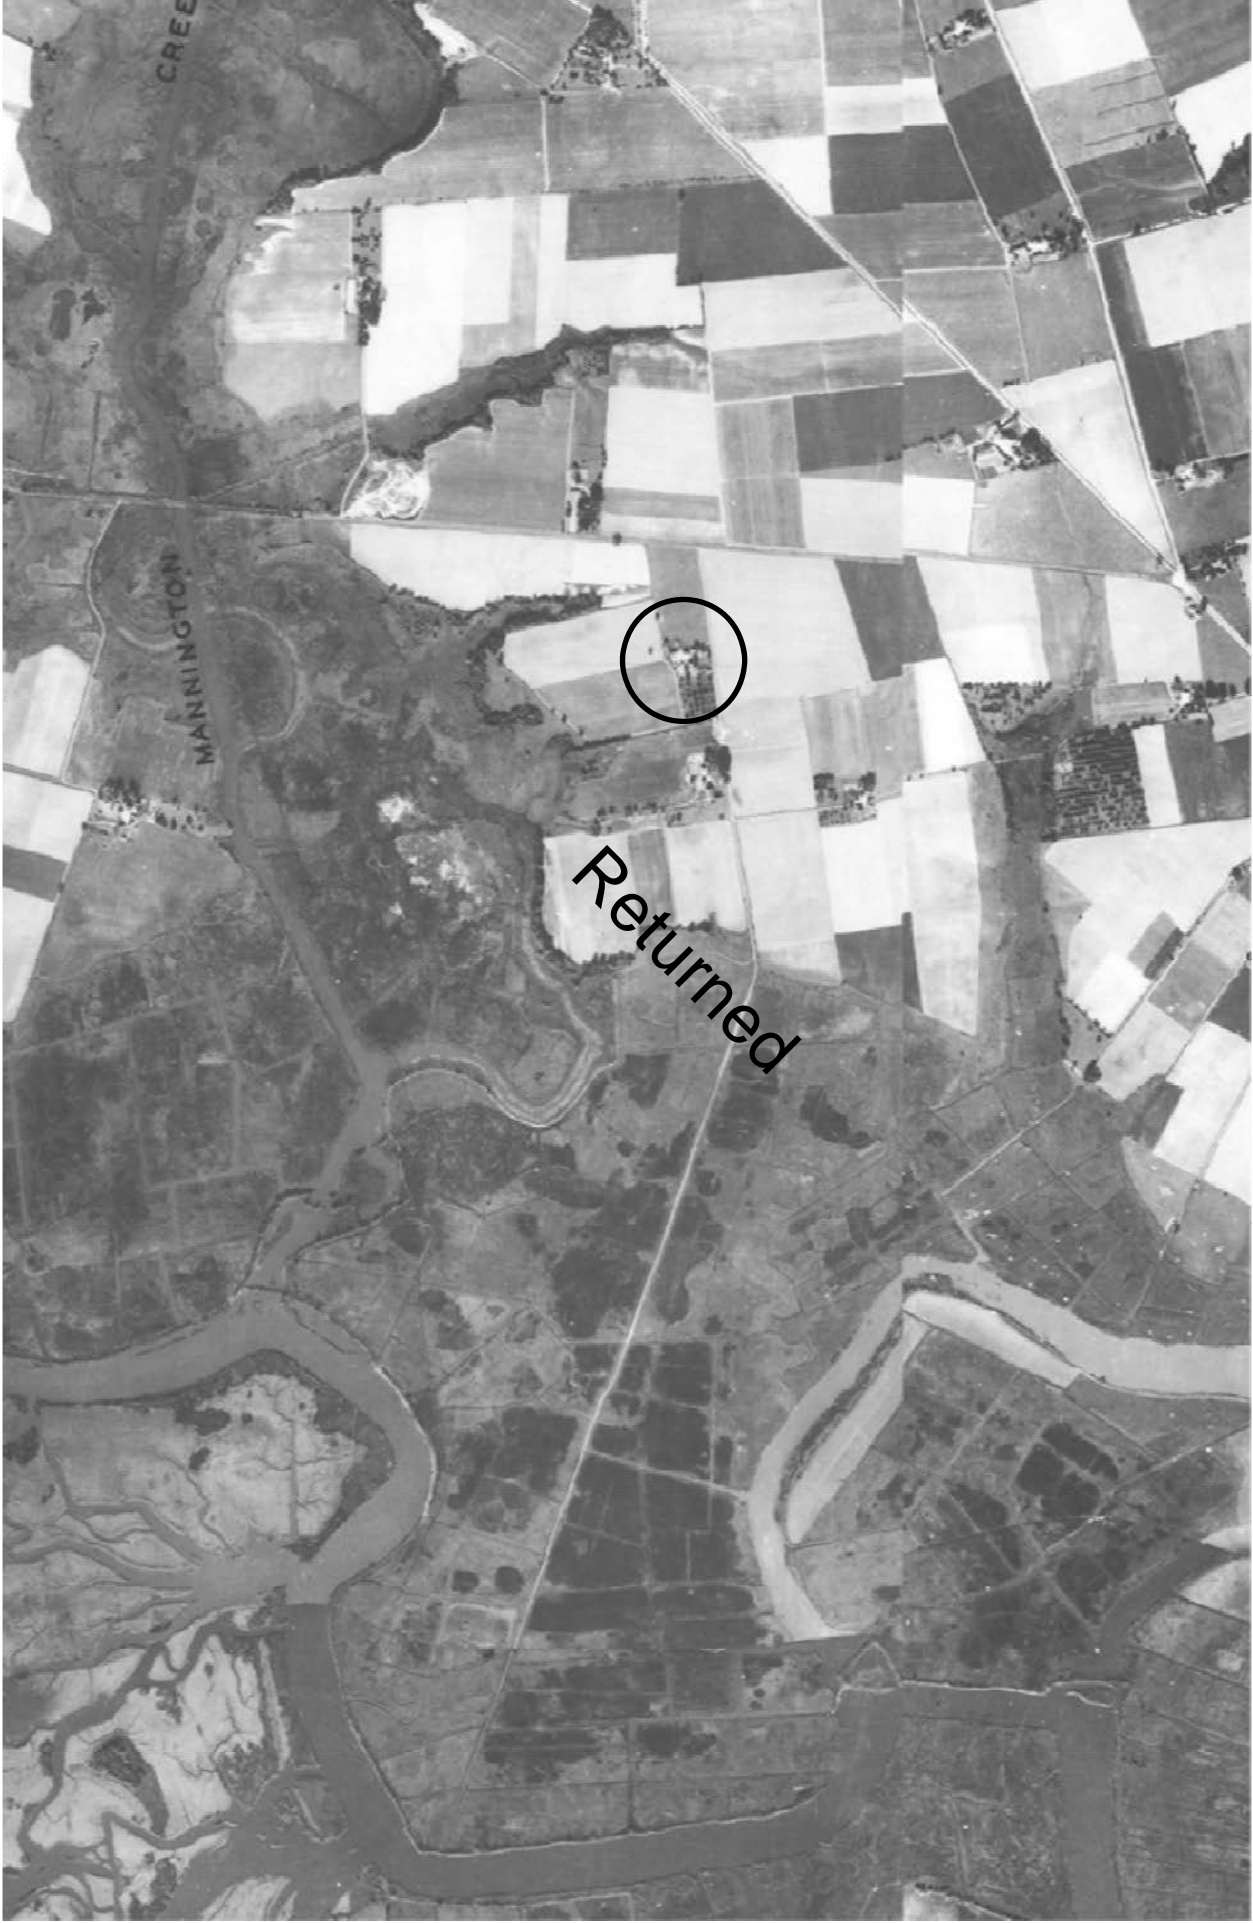
**1930 Aerial Photo. (New Jersey State Atlas <http://njstateatlas.com/1930/>). Wistar Farmstead is circled. Note the extent of banked meadows.**

Banks are apparent along the edges of the creeks.

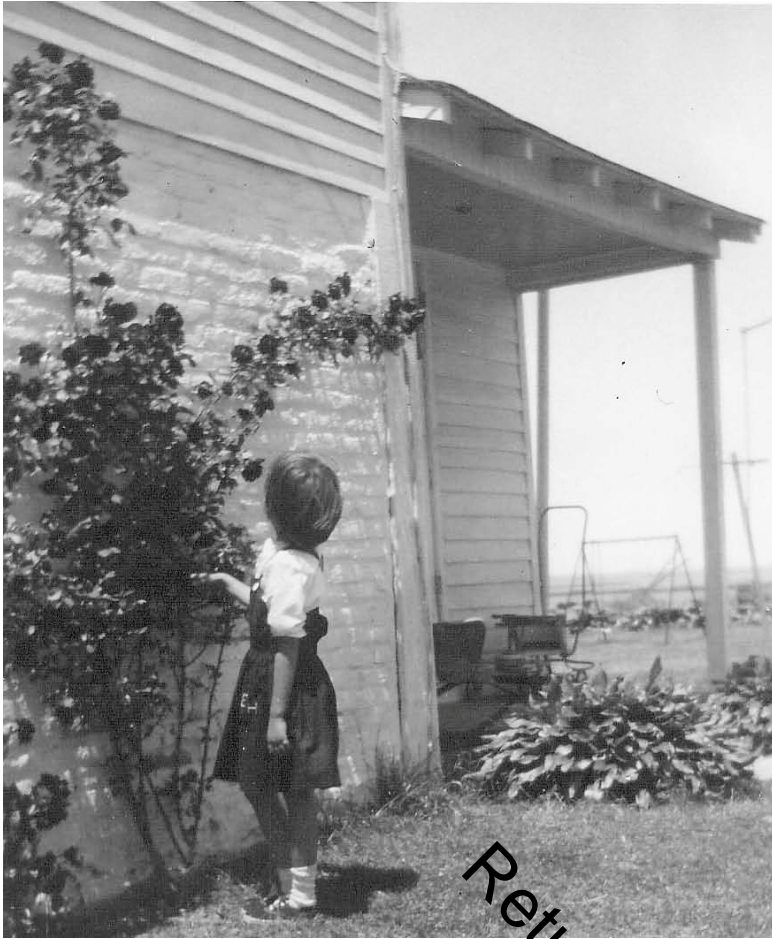
**3. East end of the house and kitchen shed, looking northwest circa 1953. A more extensive work shed over the house well on the east side of the house was removed in 1947. (Courtesy Suzanne H. Culver)**

East Elevation: The east elevation (right side) is the end gable wall of the east section (photos 6, 7). It contains the kitchen chimney stack with exposed brick masonry at first floor level, a front parlor window, a basement bulkhead entrance, a garret window, a kitchen window, and a shed door. The wall is clad with four-and-one-half-inch reveal wood weatherboard. From ten courses above the brick masonry, the weatherboard was recently replaced after framing repairs. The first floor parlor window is nine-over-nine double-hung with reproduction panel shutters that are screwed to the wall. The architrave is flat with a quirk-beaded edge. The kitchen window and wall extension, and entry addition, were built between 1959 and 1967. Before 1959 there was a kitchen entrance where the window is in the kitchen addition, but the wall was set back under a small porch with a brick deck. Before 1947 there was a shed on the side of the house over the chimney wall which covered the well and

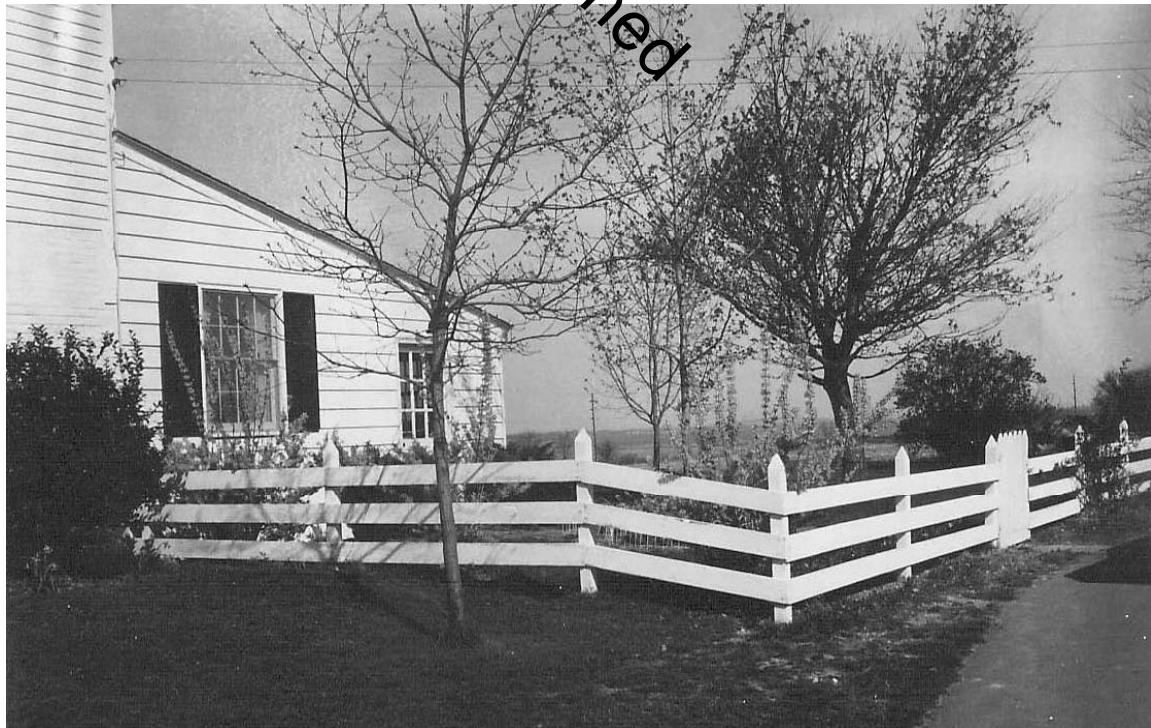
**4. The remodeled kitchen shed on the northeast corner of the house, looking northwest circa 1967. (Courtesy Suzanne H. Culver)**

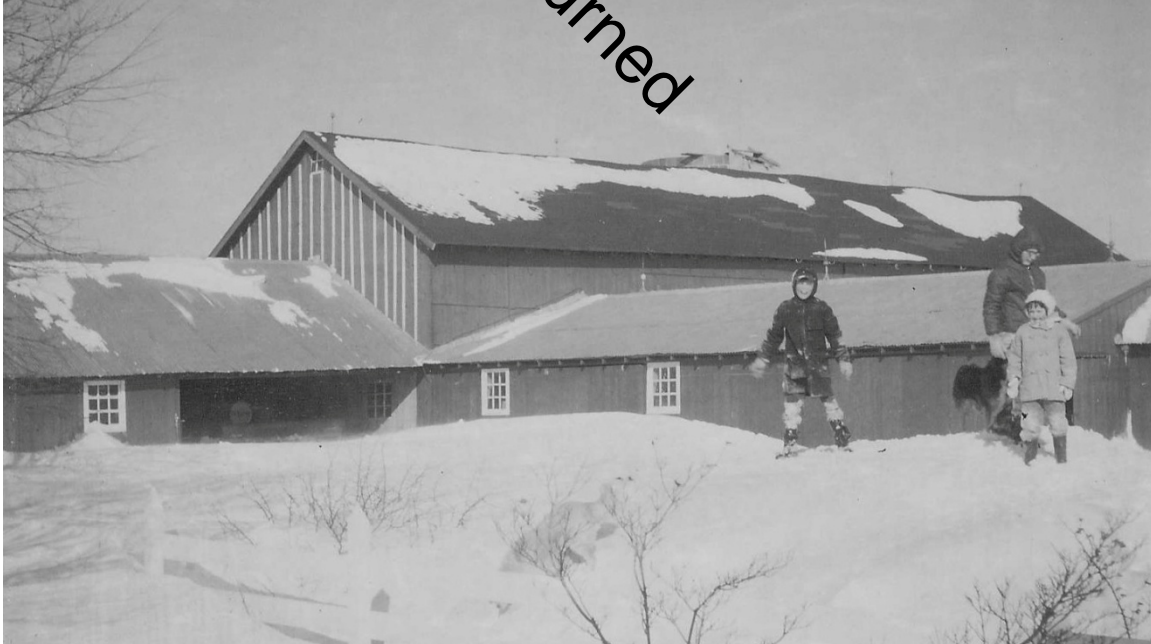
**6. Barn and former dairy wing looking northeast, 1966. At the barn ridge the remains of the tile block silo and its wood roof is visible. The equipment shed is as it was rebuilt after Hurricane Hazel in 1954 (see other shed photos).**  
(Courtesy Suzanne H. Culver)

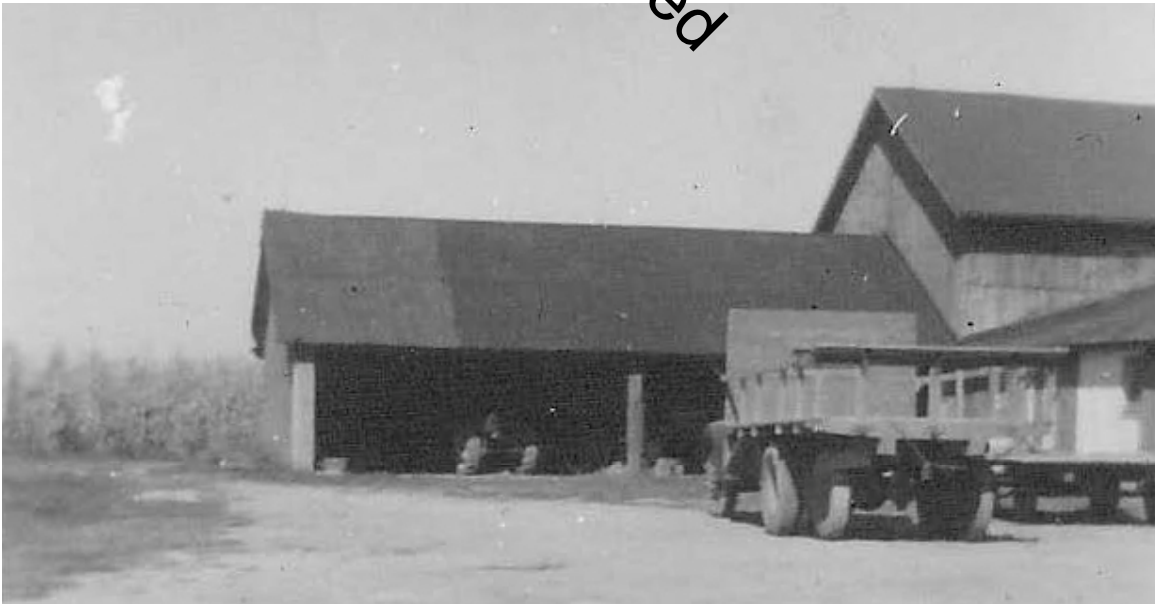
**8. Equipment shed on the west end of the barn, looking north before 1954. (Courtesy Suzanne H. Culver)**

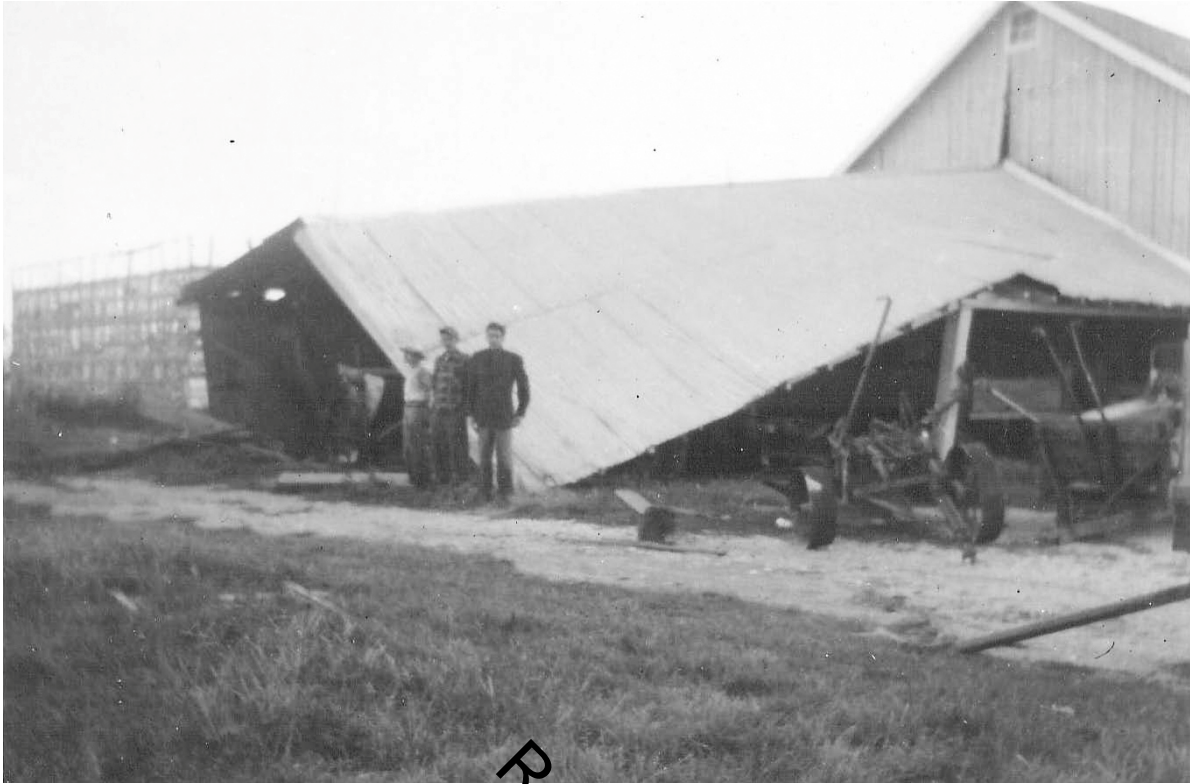
9. The ruined equipment shed after Hurricane Hazel in 1954. The three men are Puerto Rican migrant workers. (Courtesy Suzanne H. Culver)

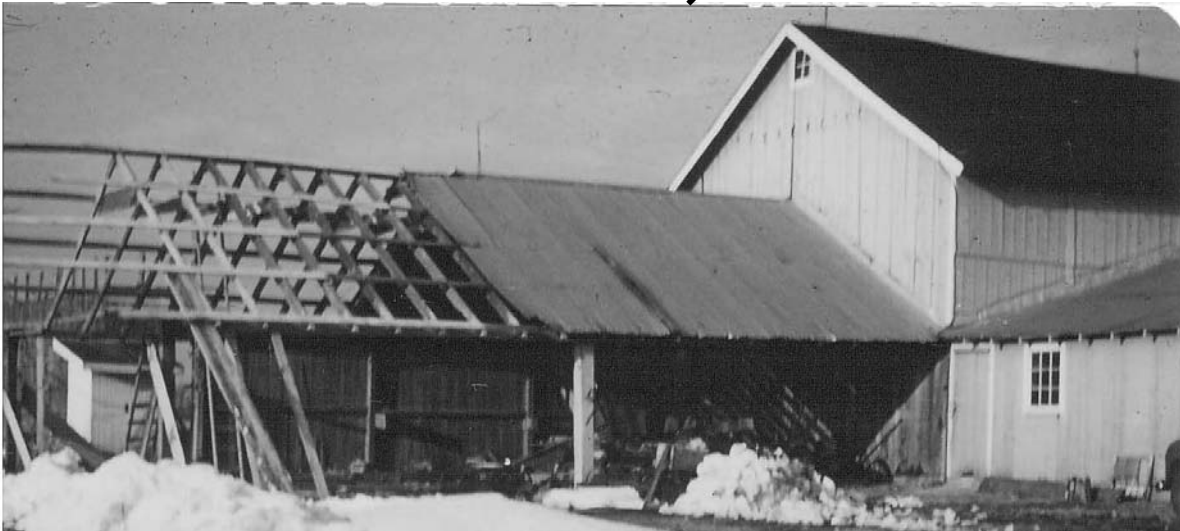
10. The rebuilding of the equipment shed after Hurricane Hazel in 1954. (Courtesy Suzanne H. Culver)

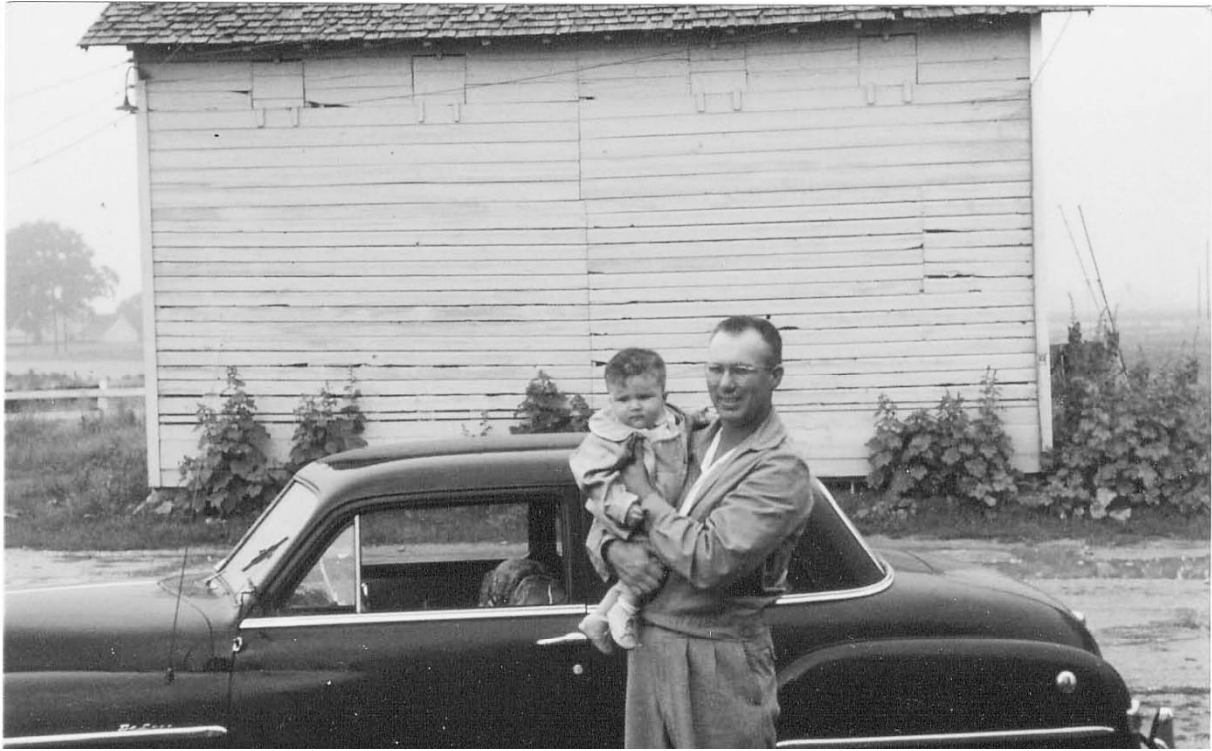
11. West facade of the crib barn/wagon house looking east across the driveway, 1950s. (Courtesy Suzanne H. Culver)
