# National Register of Historic Places Registration Form

historic name JOHN & CHARLOTTE WISTAR FARM

other names/site number BARTHOLOMEW WYATT FARM/RICHARD WISTAR FARM

street & number 120 HARRIS ROAD  not for publication

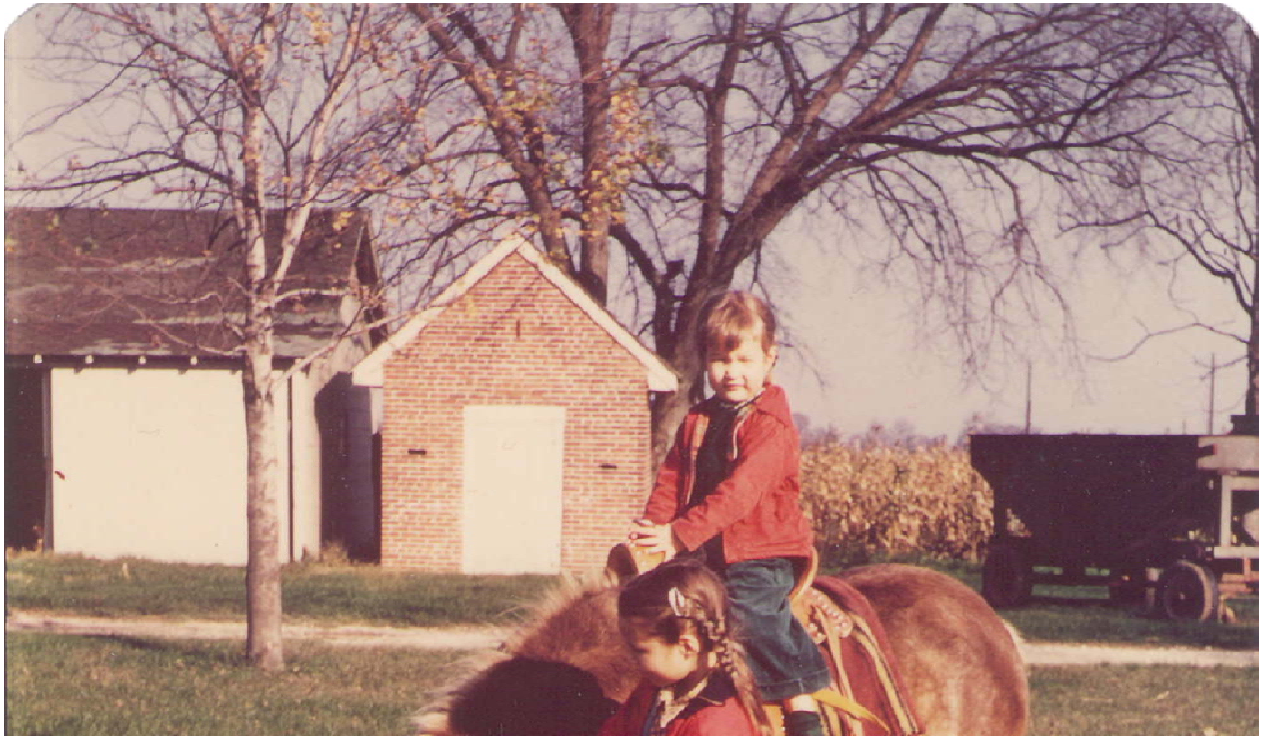
**13. Auto garage and smokehouse looking east across the driveway. These buildings stood south of the wagon house. A corn wagon stands south of the smoke house. The smokehouse was wrecked by the tree falling on it during a storm. (Courtesy Suzanne H. Culver)**

Non-extant buildings and site features included a small brick smoke house of the “English Tidewater Smokehouse” type<sup>1</sup> and a frame early twentieth century garage (removed early 1970s) which stood south of the crib barn, several migrant labor houses northeast of the main barn (removed late 1980s), chicken houses and two labor houses northwest of the house (houses were later moved), a twentieth-century, one-story open-fronted frame equipment shed that was attached to the west end of the main barn (rebuilt after Hurricane Hazel in 1954, and removed in 2010 after snow storm damage), a tile-block silo on the north side of the barn (not used after 1947), a free-standing corn crib on the north side of the main barn, a fenced animal barnyard on the south side of the main barn, a privy near the northeast corner of the house, and an apple orchard west of the house (see historic photo attachments). The equipment shed housed tractors and trucks, and was open on the south side. According to historic photos, it appears to have been constructed as a gable-roofed box frame. Sometime after the 1950s, the west half was enclosed.
