National Register of Historic Places
Inventory—Nomination Form

historic Lewis Tower House

street & number 2199 Mendon Road

city, town Cumberland

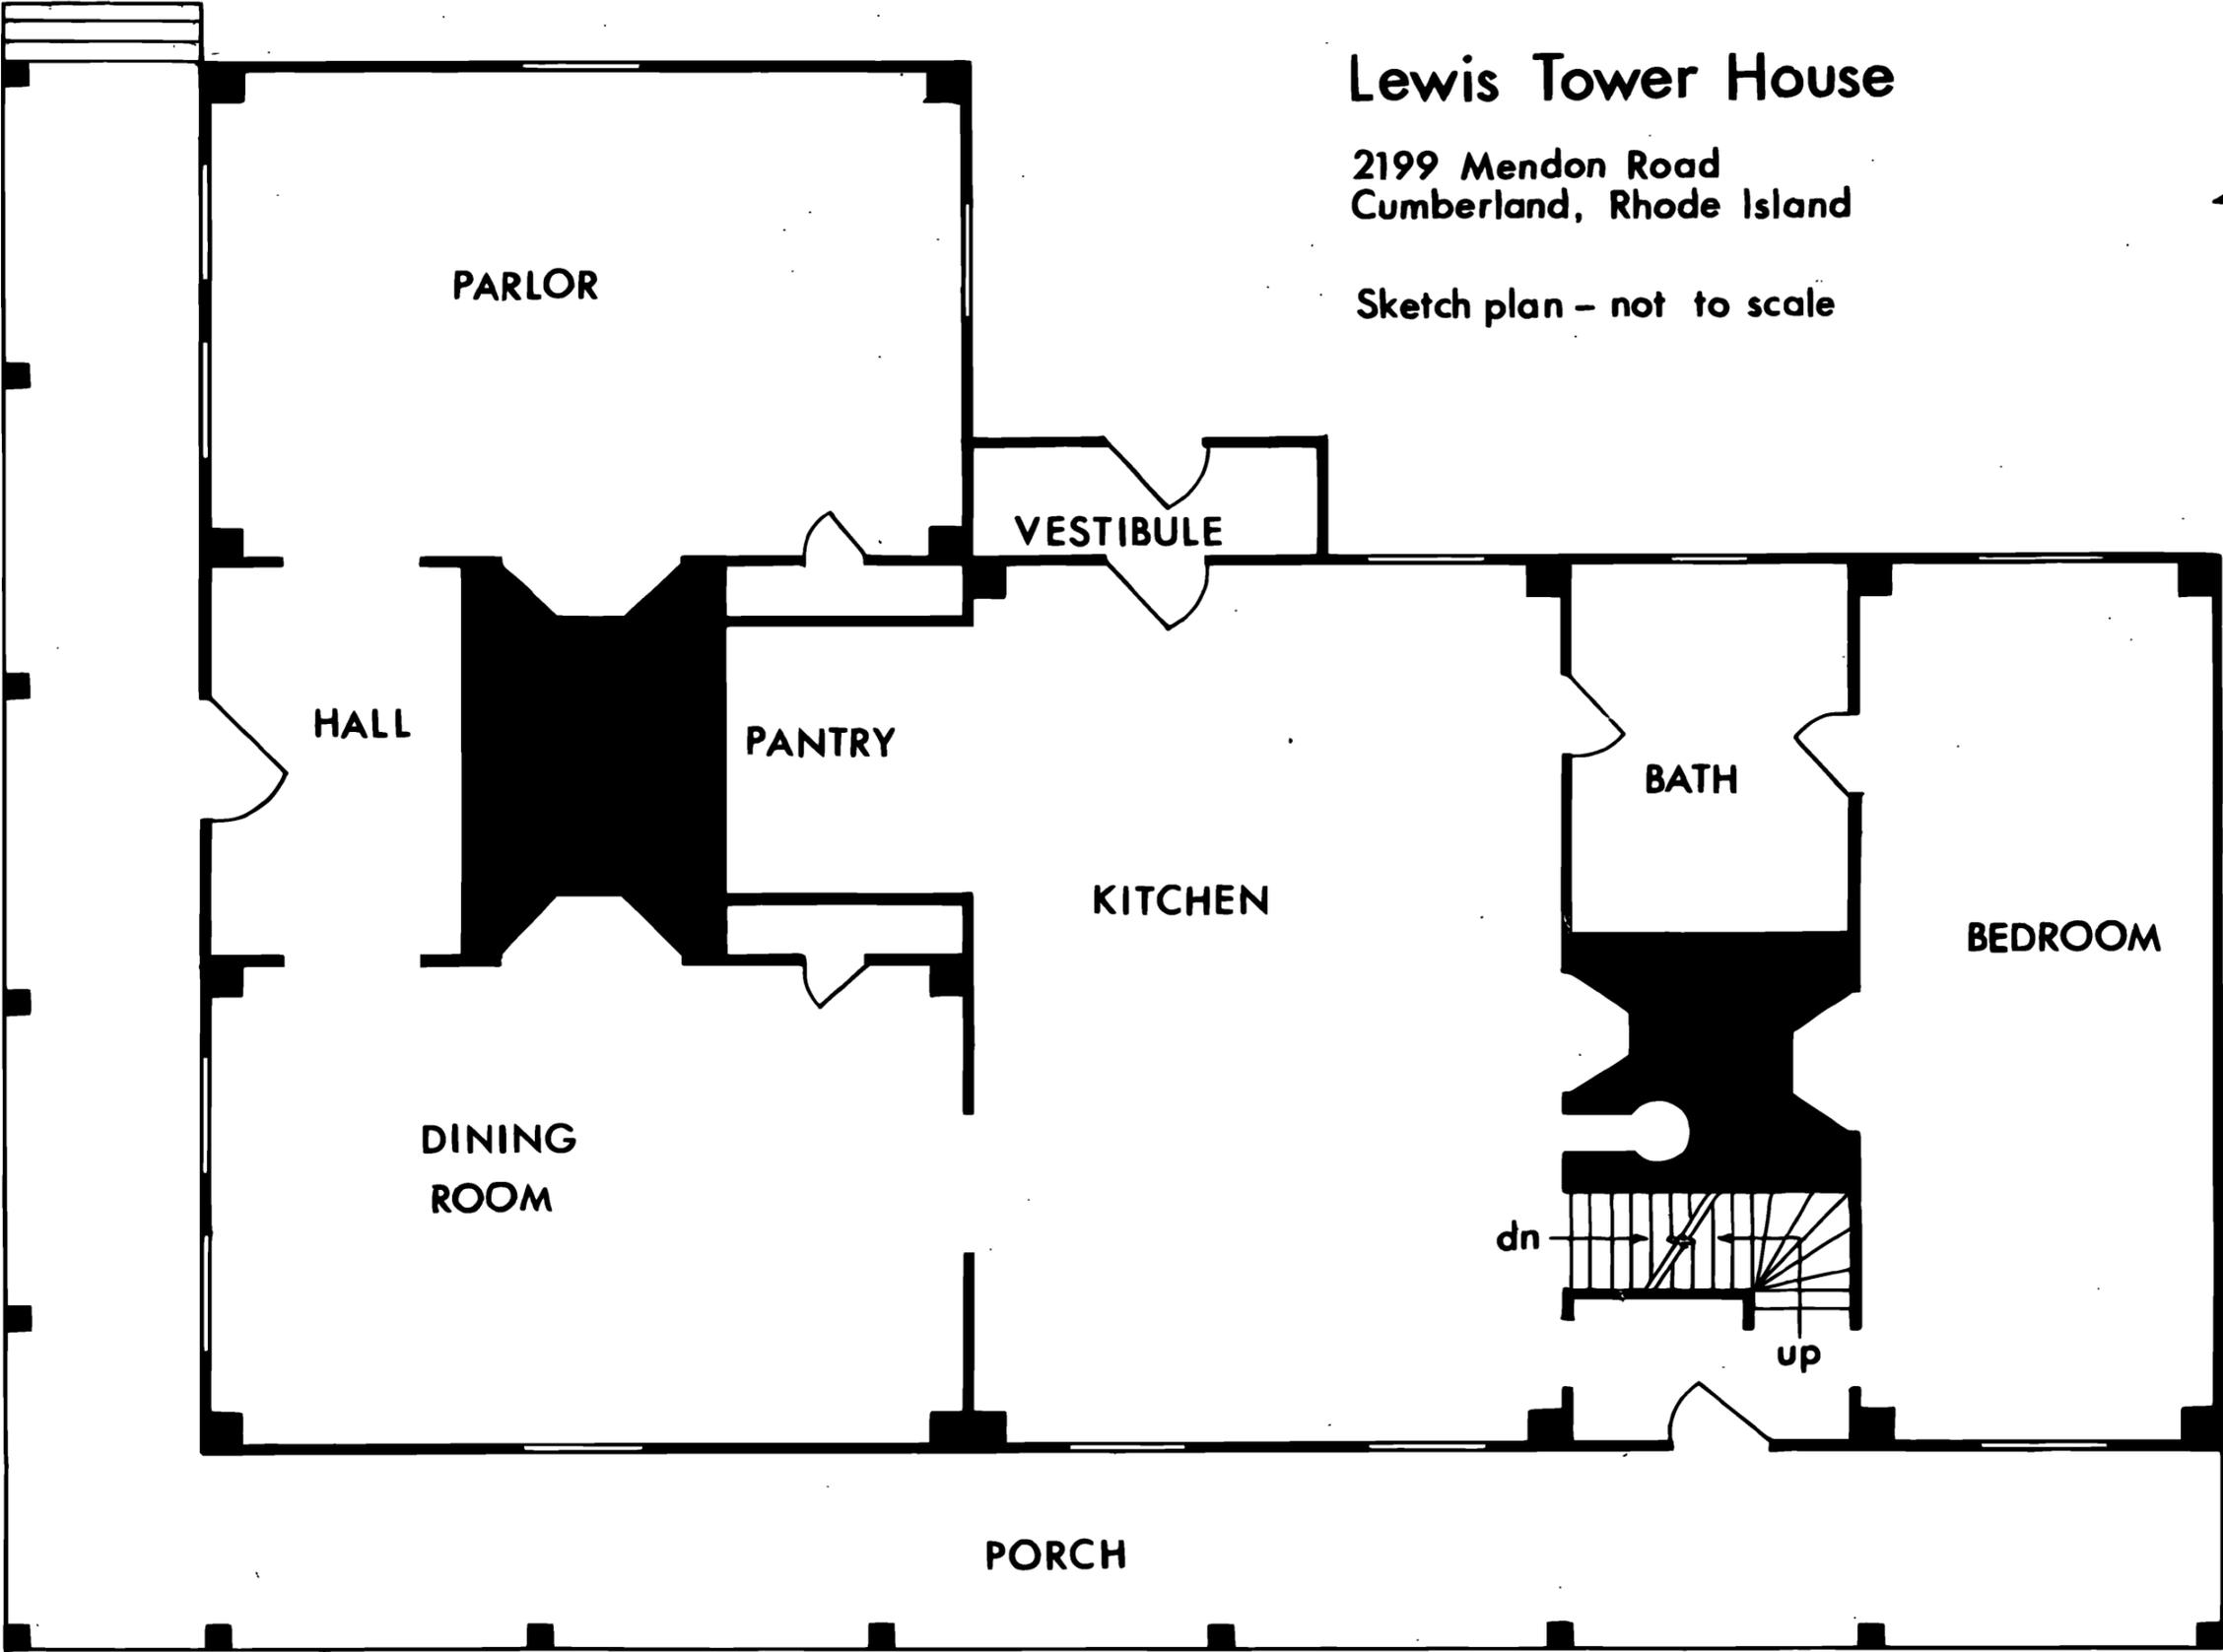
Sketch plan - not to scale

Lewis Tower House

2199 Mendon Road
Cumberland, Rhode Island

In plan, the house resembles two center-chimney, two-room-plan houses joined at right angles, end to back, with a little extra width to accommodate tiny rooms behind the chimneys. In the front section, the main entrance--with sidelights and narrow pilasters surmounted by a broad, flat entablature band with a molded cornice and impost-like blocks over the pilasters--opens into a vestibule. The adjoining rooms to the left (north) and right (south), now used as a bedroom and living room, respectively, were probably used originally as the parlor and dining room. Both rooms have plastered walls, cased corner posts, and fireplaces with one-story Federal-style mantels. The mantels are composed of architrave surrounds framing the fireboxes with broad frieze panels above containing impost-like blocks supporting the mantel shelves (photo #3). In each room a shallow closet is located next to the fireplace, on the sides opposite the doorways to the vestibule. The old parlor (present bedroom) has shutters on the windows with louvers in the lower leaves and beveled panels in the upper ones.

In the ell the southern entrance, topped by a transom light, opens into a vestibule and stair hall containing an enclosed, steep staircase with winders leading up to the attic. The attics of the ell and front section are connected and have plastered ceilings and partitions dividing the space into bedrooms arranged en suite, now used only for storage by the present occupants of the house. On the first floor, the room to the left (west) of the vestibule is the kitchen. It has plastered walls and cased corner posts and the plastered ceiling has been removed to expose the joists above. Behind a modern wood stove the original cooking fireplace remains intact, with a bake oven and wood box to one side behind a paneled door and a cupboard over the mantel (photo #4). A small pantry opens off the northwest corner of the kitchen, occupying space in the front section behind the chimney. The room to the right (east) off the ell vestibule is a small bedroom and a bathroom is located in the small space behind the chimney between the kitchen and bedroom. The bedroom has a fireplace with a cupboard above it. Both the kitchen and bedroom fireplaces have simple flat-board mantels.

The front part of the basement, which opens out to the lower grade of the terraced yard through a central doorway, is unfinished, leaving its original use in question. It has an uneven floor partly covered with cement and partly dirt, fieldstone walls partly covered with cement, a brick partition separating it from the basement section under the ell, and two slab-like brick piers topped by hewn timbers supporting the center chimney above.
