NATIONAL REGISTER OF HISTORIC PLACES REGISTRATION FORM

historic name: Smith Mine Historic District

city/town: Bearcreek

state: Montana

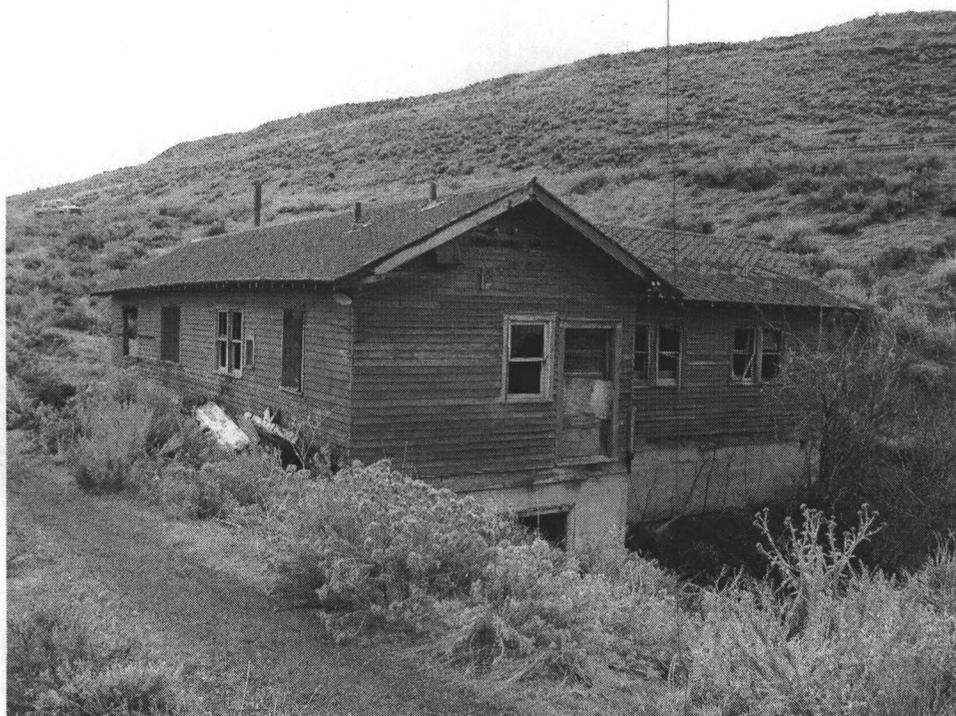
0003. Manager's Residence (1), view to southeast

This one-story wood frame L-shaped gabled roof building is located in the southeast corner of the site. This residence straddles the coulee and sits south of the two-track road that accesses the site. The building rests on a high concrete foundation and measures 52' x 16' with an intersecting gable measuring 24' x 6.' It is believed this building was the manager's residence and office.

All gable roofs are covered with both deteriorating scalloped asphalt shingles and rolled roofing. The main east/west gable has a metal ridgcap with end finials. Roof details include extended exposed rafters and several protruding stove pipes. The roof extends over all gable ends and exhibits curved brace supports accented with pyramidal ends.

All exterior walls are clad with narrow lap siding that extends into the gable ends. Metal clips finish all corners. An exterior baseboard with a protruding lip (water table) separates the concrete foundation from the wall.

The west gable end holds an entry with a five panel solid door (missing several panels) and a one-over-one double-hung window immediately adjacent to the door. A platform, porch or stairway that would have fronted the door and allowed egress/ingress to the building is missing. The east end wall holds the primary entrance although the door itself is missing. To the south (left) of the door is a one-over-one double-hung window presently boarded over with plywood. There is a framed square opening in the apex of the gable end (presumably for a vent).

The north wall contains four window openings across its length, including paired one-over-one double-hung windows, two one-over-one double-hungs that are boarded shut, and one opening missing its window unit. The south wall has paired one-over-one double-hung windows missing all glass panes, and one boarded shut window.

The building's interior consists of finished rooms: two rooms in the main gable and one in the intersecting gable. All interior windows exhibit molding and are painted black. Interior details include wood flooring, fiberboard wall panels and 6" x 6" ceiling tiles laid in a diagonal pattern. A stairway with a half landing leads to the partial basement. Two framed openings pierce the foundation walls to provide light for the stairway: a sliding window on the south wall and a hinged opening on the west wall. The basement contains an iron door that opens into a vault where an old safe still sits. A toilet sits underneath the stairway.

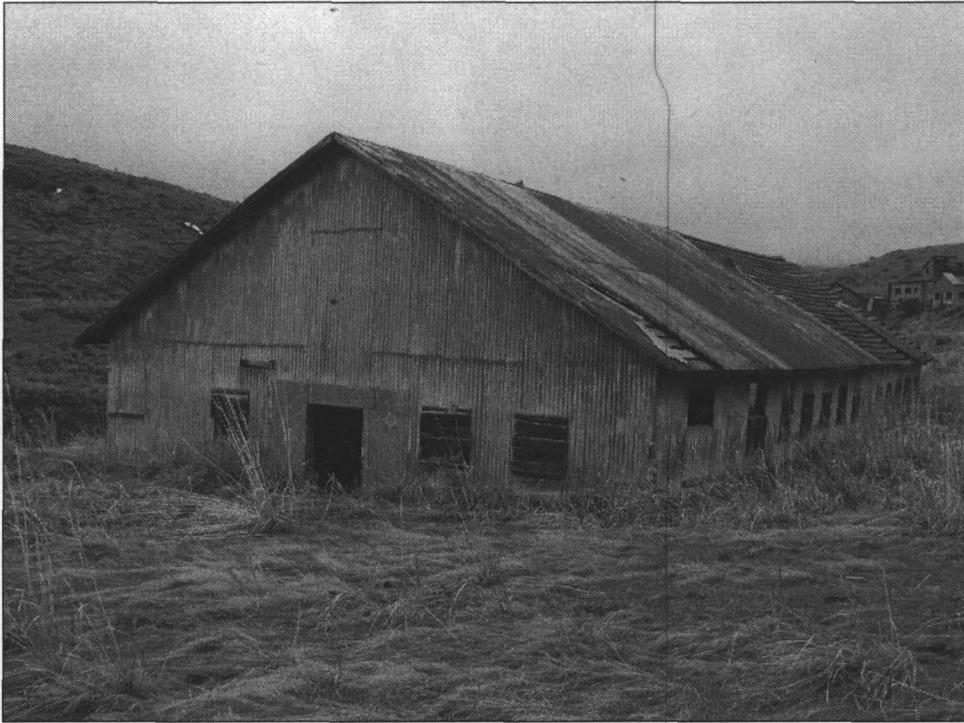
0004. Car Repair Shop (2), view to west

Car Repair Shop (2); constructed 1913, one contributing building

The car repair shop, built in 1913, originally functioned as a carpenter shop until 1924 when the company designated it for use as a warehouse. In 1930, it became the car repair shop. Mine cars damaged during the transport of coal were repaired in this building.

The farthest building to the east at the Smith Mine, the car repair shop measures 38' x 115' and has no discernable foundation. The wood frame rectangular plan building is covered by a gable roof. The roof is deteriorated with sections of the original corrugated metal missing revealing the wood decking underneath. The rafter ends are boxed in.

A bay entry is central to the west façade of the building. It had a door (now missing) mounted on exterior wood tracks. A small man-entry is located on the south façade. It has a vertical tongue-in-groove door that is partially detached from the hinges. A bay entry is central to the east façade. A window opening is located to the south of the bay and two window openings are located to the north of the bay; all are boarded over.

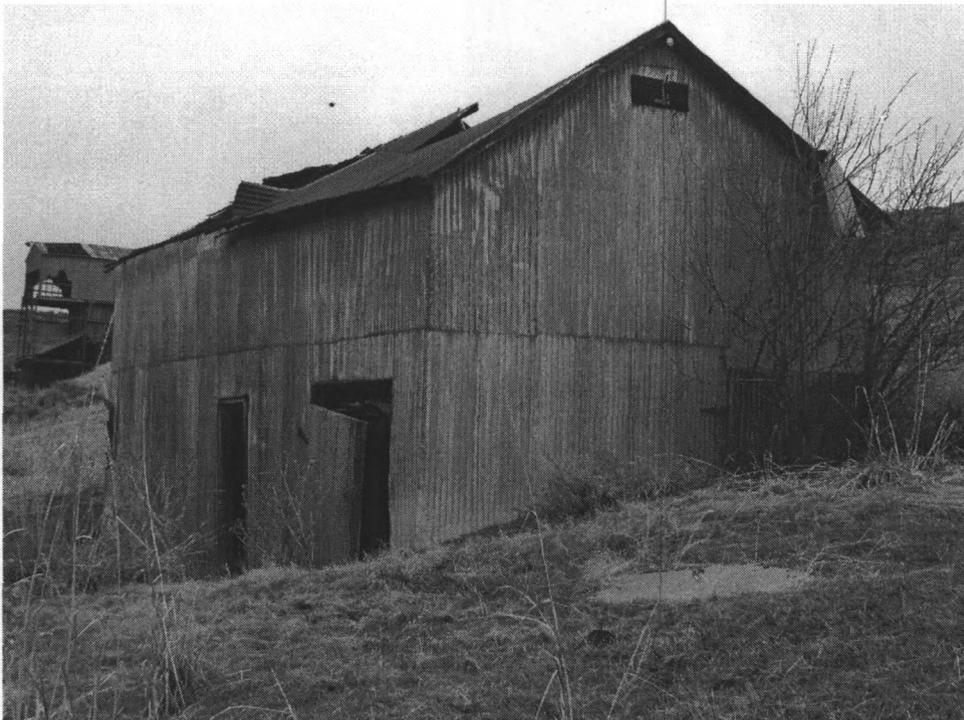
0005. Shed (3), view to northwest

Located west of the car repair shop (Building 2), this two-story gable roofed building is built into a south facing slope and has no visible foundation. It is presently leaning heavily to the north and a portion of its gable roof is collapsing inward. The gable roof runs east/west, has slightly extended enclosed eaves and is covered with corrugated metal. The building measures 30' x 80' and is constructed of 2" x 6" boards. All walls are clad with corrugated metal. The south wall holds two entries: a wide door opening covered with corrugated metal and a five panel wood door missing its lower panels.

The interior of the building displays a wood floor in poor condition. The west one-third of the building has an upper level supported by a centered vertical post. The upper level was not accessible but displays shelving on three walls and a suspended single bulb light centered over the space. The interior metal walls also exhibit some stencil signage, reading "MONT COAL & IRON CO/BEAR CREEK MONT" and "Smoke & Sootless Coal Co/Bear Creek, Mont."

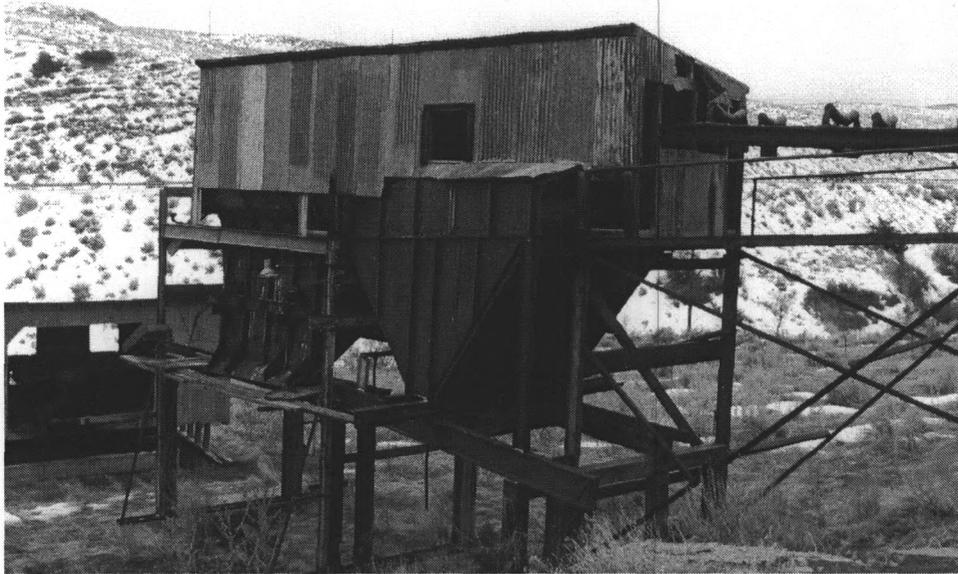
0006. Boxcar loaders (4), view to southwest

A double conveyor belt extends from an opening in the south wall of the coal processing plant. The dual conveyor belts allowed for simultaneous loading of railcars. The paired conveyors exhibit only their flared iron supporting idlers and are missing their belts. The conveyor is supported on vertical steel I-beams resting on concrete pyramidal piers.

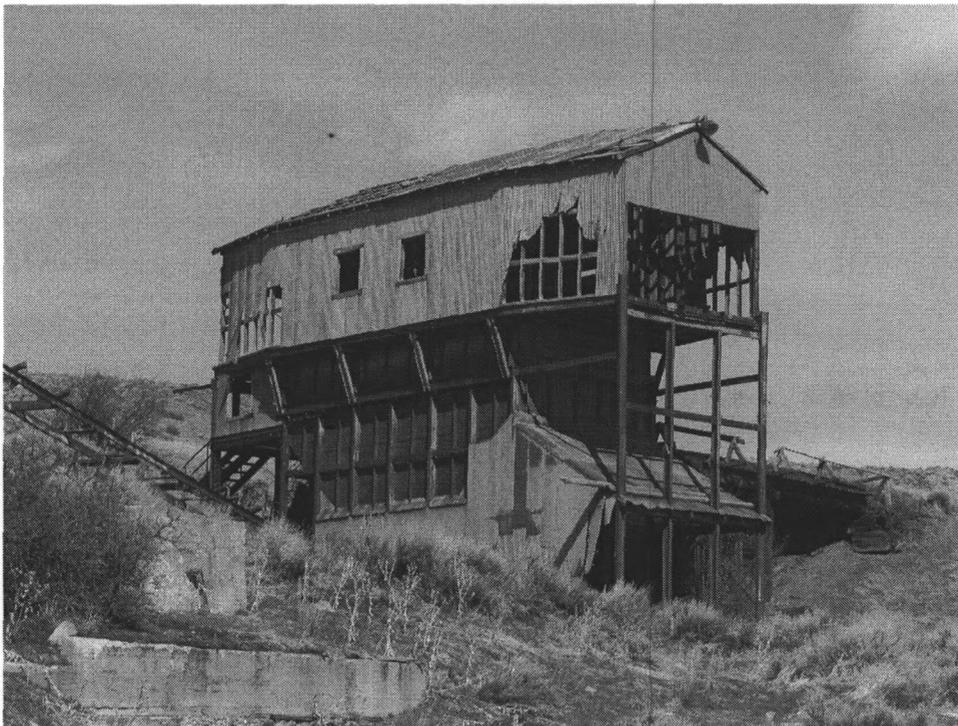
0007. Tipple (5), view to north/northeast

The tipple's overall shape is rectangular and is topped with a wood frame gable roofed head house. This head house overhangs the hopper structure on three sides. Corrugated metal covers the walls and the roof (sections missing). It has two framed window openings on the east and west side walls. The north end is open to allow passage of rail cars into the rotary dump. The south end is also open where it previously connected to the more extensive tipple complex.

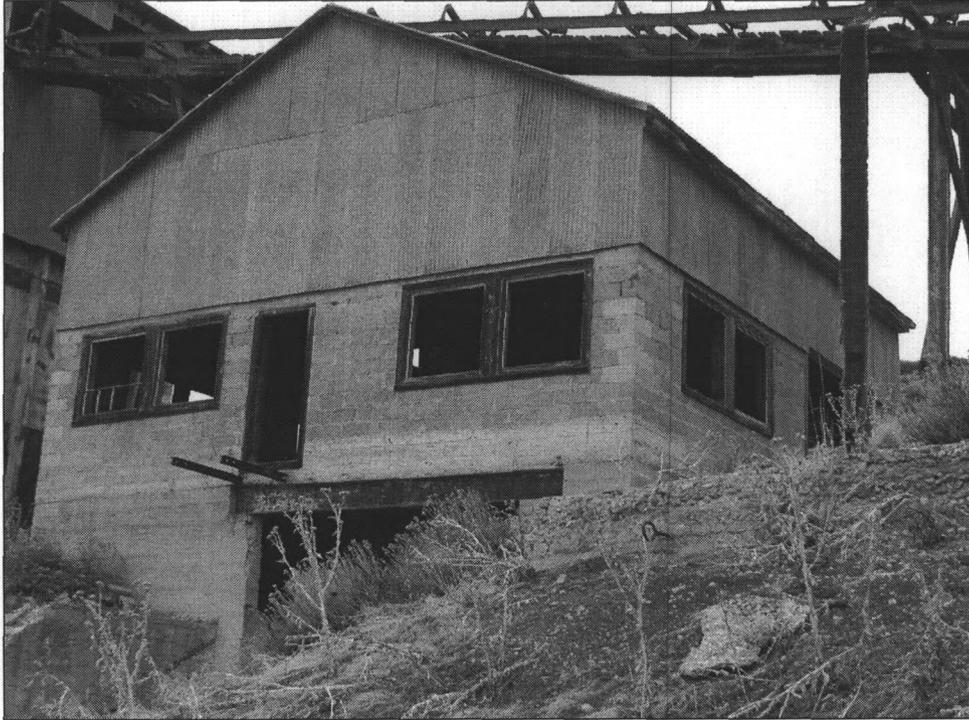
0010. Concrete Block Building (8), view to northwest

This concrete block building is presumably the "washery" built in 1946 that replaced the older original washery destroyed in a October 1945 fire. The plant measures 33' x 43' and the conveyor passes over the top of the building. The building is covered by a gable roof sheathed in corrugated metal. The roof has a gable roofed dormer that projects off its west roof slope. The building has a concrete foundation and is built into the south facing hillside. The lower zone walls are comprised of concrete blocks with a large section of the north wall removed (presumably to salvage the equipment inside). The upper zone is wood frame and sheathed in corrugated metal.

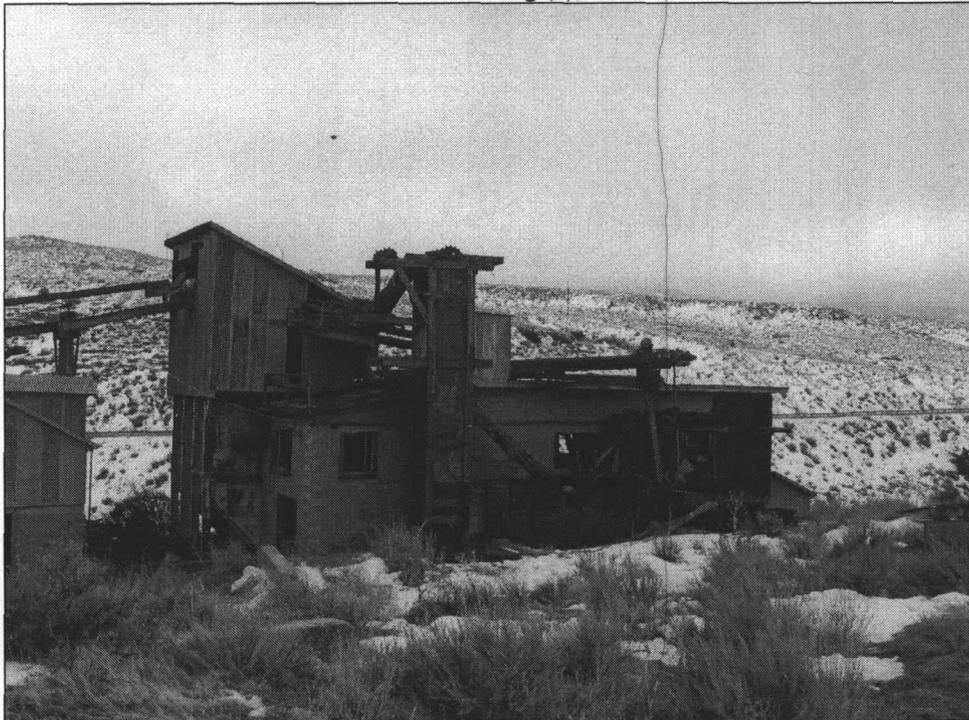
0011. Coal Processing Plant (9), view to south

The coal processing plant was likely built in 1928 and remodeled in 1933. The building was badly damaged in a fire in 1945 and rebuilt to its present configuration that year. The shaker screens and other equipment involved in the coal separation process are still located in this building. Coal slack was also removed from the coal at the plant and deposited in piles that were once located to the east/northeast of the plant (they were reclaimed in 1990). The building is oriented east and west and is the center of the mine's above-ground operations.

The coal processing plant has a poured concrete foundation and the walls of the primary structure are comprised of concrete blocks. The building has a combination shed and flat roof sealed in asphalt. There are window openings on the north and south walls. A small vertical opening is located between the window openings on the north wall and an entry is situated on the west. A small wood frame structure is located on the northeast corner of the roof. It has corrugated metal siding and metal sheathing over the shed roof. There is a metal conveyor belt frame projecting from this small structure to the northwest. The structure opens to the east toward the tipple. The roof between the structure and the tipple at the northeast corner has a duckboard floor and wood railings. A badly deteriorated duckboard cat walk is located adjacent to the conveyor on the south. The structure is associated with a tipple on the east end of the structure. The east end of the building has window openings on the east and north walls. The window frames indicate they once had single fixed lights flanked by three fixed lights on either side. An entry pierces the foundation on the east of the north wall. It has a wood paneled door.

A flat roof addition attached to the west end of the building also functioned as a tipple. Vehicles backed into the structure and coal was unloaded from the tipple into the vehicle. The addition has steel walls supported by steel I-beams resting on a concrete foundation. The bay entry opens to the west. The tipple is comprised of sheet metal with a steel I-beam frame. Some of the I-beams are in poor condition. The addition rests on a concrete pad, while the I-beams are supported by concrete piers. There is an opening on the upper west corner of the north wall. A duckboard platform projects from the opening. There is no window or other openings on the south wall of the addition. A small corrugated metal addition is attached to the west wall. It has a bay entry with two vertical wood doors with vertical braces.

A loader is attached to the east end of the building. It is vertically oriented with a shed roofed man-house located at the top. The main frame is comprised of vertical steel I-beams manufactured by Bethlehem Steel at an undetermined time. The bases of the I-beams rest on concrete piers and there is a concrete foundation underneath the load-out chute of the frame. The frame sheathing is comprised of sheet steel supported by steel railcar tracks. The tracks are not industrial size indicating they may have been salvaged mine tracks. The tracks were manufactured by Illinois Steel Company South Works, a company based in Chicago, and stamped "7201." The rail tracks are welded to the vertical supports.

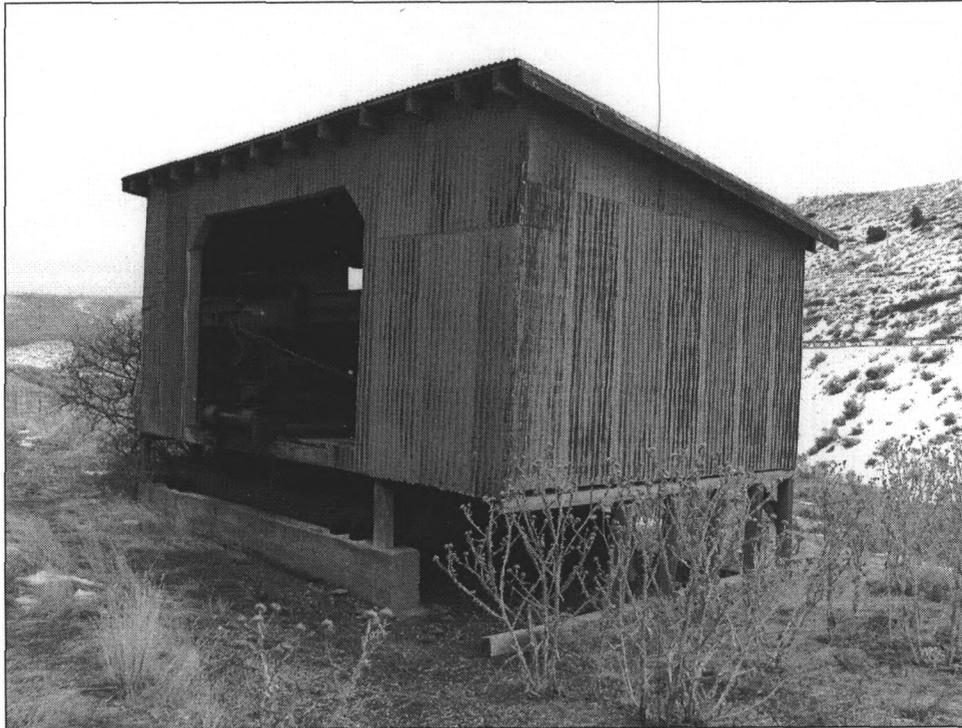
0012. Scale House (10), view to east

The scale house is located south of the west section of the coal processing plant (Building 9) and box car loaders (Building 4). The building was constructed in 1930 to house the scales that had been on-site since sometime between 1906 and 1909. The scales were replaced in 1935 and placed on a new foundation in 1949. The scale house is oriented north and south and faces north toward the boxcar loaders (Building 4). The building rests on steel I-beams with I-beam stringers that are supported by concrete piers. The wood frame building has a shed roof. The roof and walls are clad in corrugated metal and the floor has wood decking. There is a large bay on the façade that reveals the steel weighing machinery inside the building. On the south wall are two window openings and a hole cut into the wall near the floor to accommodate the machinery inside the building. There is also an entry on the south of the east wall of the building.

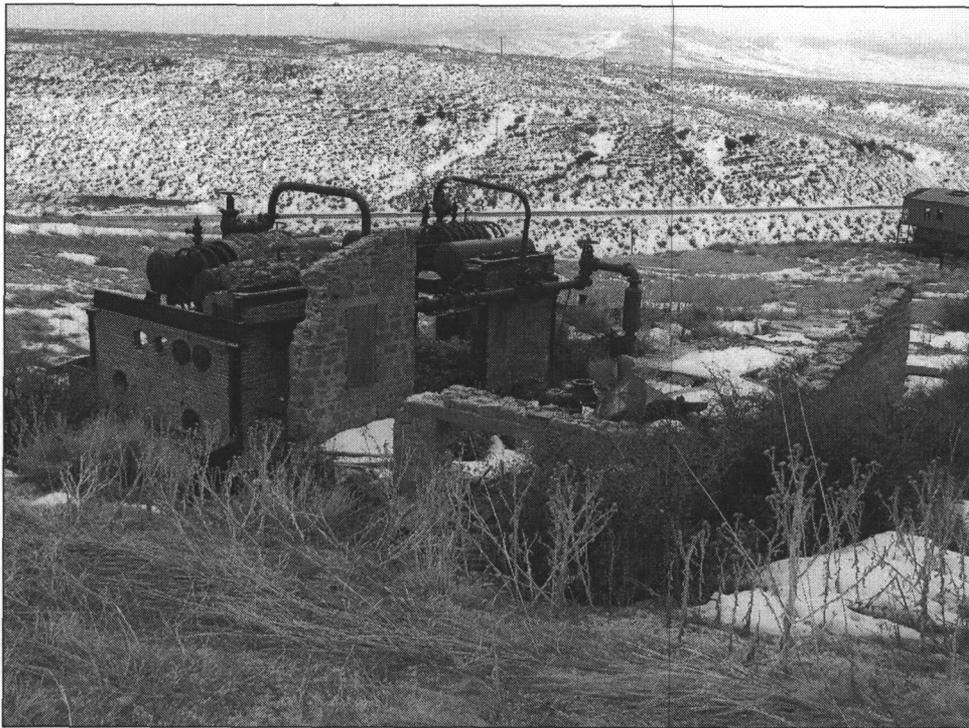
0014. Power Plant (12), view to southeast

Situated northeast of the mine complex are the remains of the Power Plant originally built in 1914. Power plants generally were erected at a distance from the main operation for safety. MCI built this power plant in 1914 after the Montana Power Company failed to honor an agreement to supply power to the Smith Mine. A 1916 historic photograph of the power plant shows a large gable roofed building with two very tall stacks located northeast of the building complex. The power plant burned in 1926 but was rebuilt and expanded. The 1927 Sanborn map shows a nearly square building covered with corrugated metal on its walls and roof. The wall construction incorporates wood framing, locally quarried sandstone and local and regionally made brick. It is unknown when the MCI stopped using this power plant, but by 1942, Montana Power Company provided electric power to the Smith Mine.

It appears that the power plant was originally divided into two sections with the boiler house to the east. Two of three original water-tube boilers are still in place although components from each are missing. They were built on-site with all the components brought in. The steel plate boilers stand in a row along the east section of the power plant. The boilers framework is supported by I-beams. The exterior brickwork displays common bond brick with cement mortar. Interior walls exhibit fire brick on all surfaces that were exposed to heat. The interior boiler wall is doubled walled. Along the base of the interior wall is a row of air spaces with brick headers, possibly to prevent cracking.

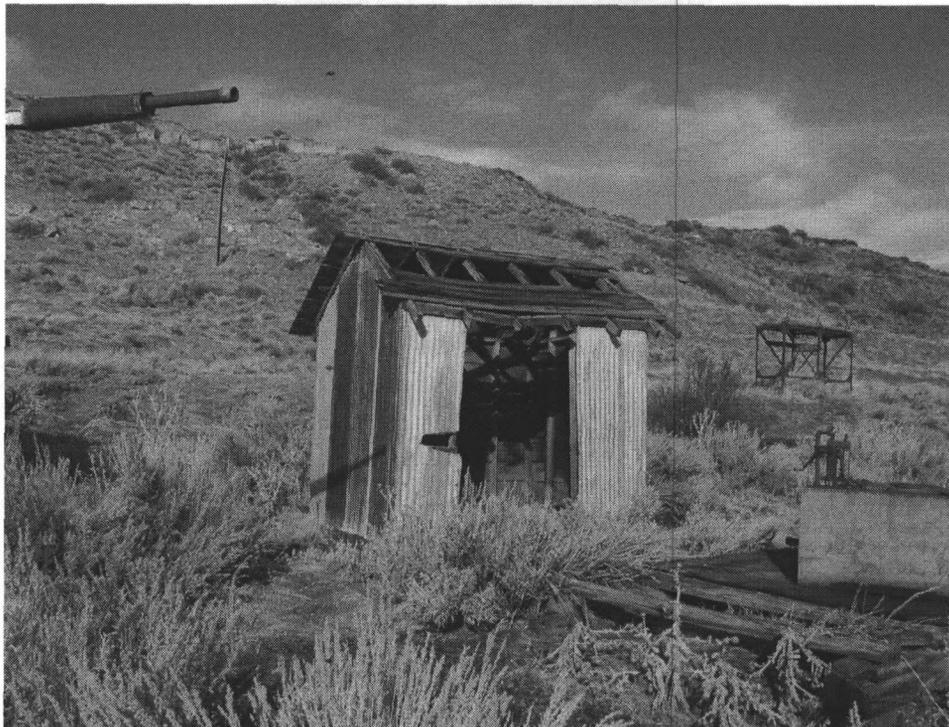
0016. Shed (14), view to north/northeast

This small wood frame shed measures approximately 10' x 8' and sits east of the blacksmith and repair shop (Building 15). The shed reportedly housed the air compressor for the shop. It is not known when it was built. It is oriented east and west and faces south. The entry is central to the south façade. The gable roof has exposed rafters and is badly deteriorated with much of the wood decking exposed. The walls are sheathed in corrugated metal.

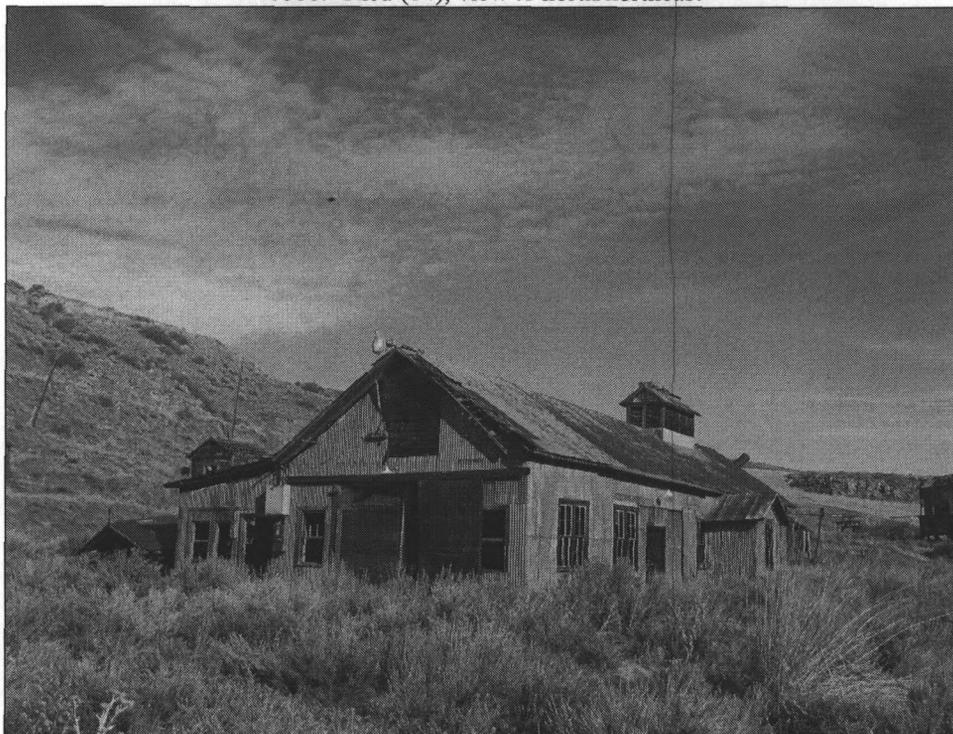
0017. Blacksmith and Repair Shop (15), view to east

Blacksmith and repair shop (15): constructed 1912, one contributing building

The blacksmith and repair shop and geology assay lab was constructed in 1912 and expanded in 1928. The boiler building attached to the east end of the building was built in 1932. The wood frame building rests on a concrete pad foundation and measures 49' x 154'. The blacksmith shop has a rectangular plan covered by a gable roof. Both the roof and the walls are clad in corrugated metal. Loft entries are located on both east and west gable-ends. A gable-roofed cupola is centrally located on the roof of the building straddling the ridge. The cupola has wood louvers on all sides.

Windows throughout the main building are four-light casements except where noted; the glass has been broken out of all the windows. Windows on the south side of the building are in single, paired and tripled openings. A gable-roof vestibule that probably functioned as an office is centrally located on the south elevation of the building. It rests on a concrete pad foundation and has a window opening on the south side. The vestibule gable roof and walls are clad in corrugated metal and the vestibule is only accessible from the interior of the main building.

A gabled roof addition is off-set to the north on the east end of the building. The walls are clad in corrugated metal, while the badly deteriorated roof consists primarily of exposed wood decking and rafters. This addition still houses three boilers and furnaces installed in 1932 and utilized for the blacksmith and repair processes. The largest boiler reads "ERIE CITY IRON WORKS/ERIE PA/40 E" on its north end and displays Morrison boiler tubes. The steel smokestacks associated with the boilers still pierce the roof and are in various stages of collapse. A pressure release pipe is extended to the southeast off the southeast corner of the building.

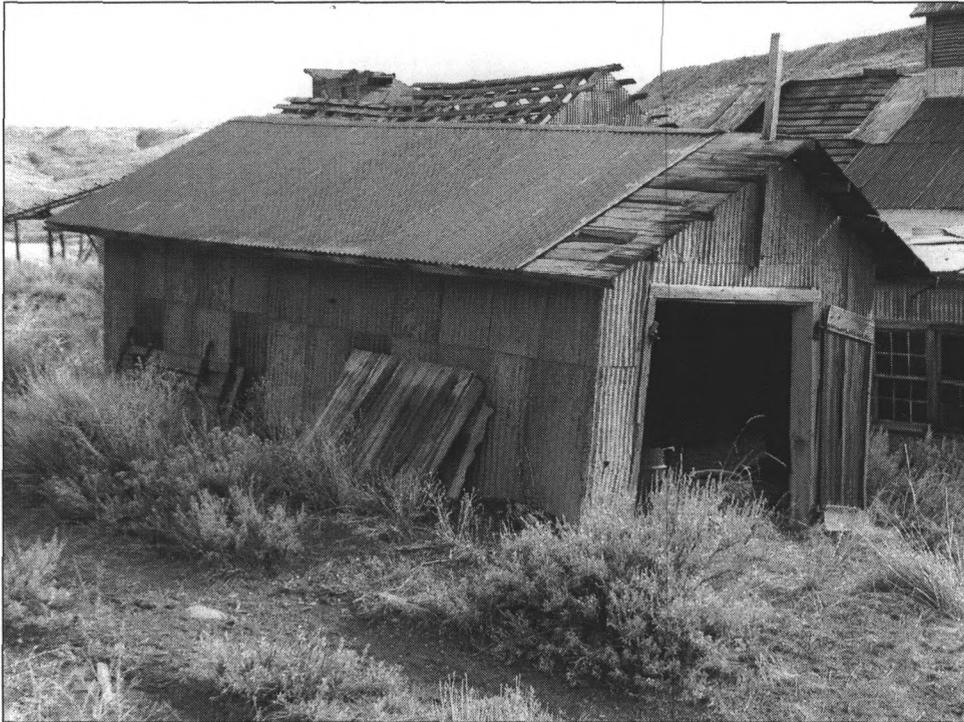
0018. Garage (16), view to southeast

This garage is located adjacent to the blacksmith and repair shop (Building 15). The garage is a wood frame rectangular building that measures 24' x 14'. It is oriented east and west and faces west. The bay entry is central to the façade with one of the two wood doors still hanging from its hinges. A gable roof with exposed rafters and walls sheathed in corrugated metal covers the building. Much of the corrugated metal on the roof is missing revealing the wood decking underneath. There is no discernable foundation.

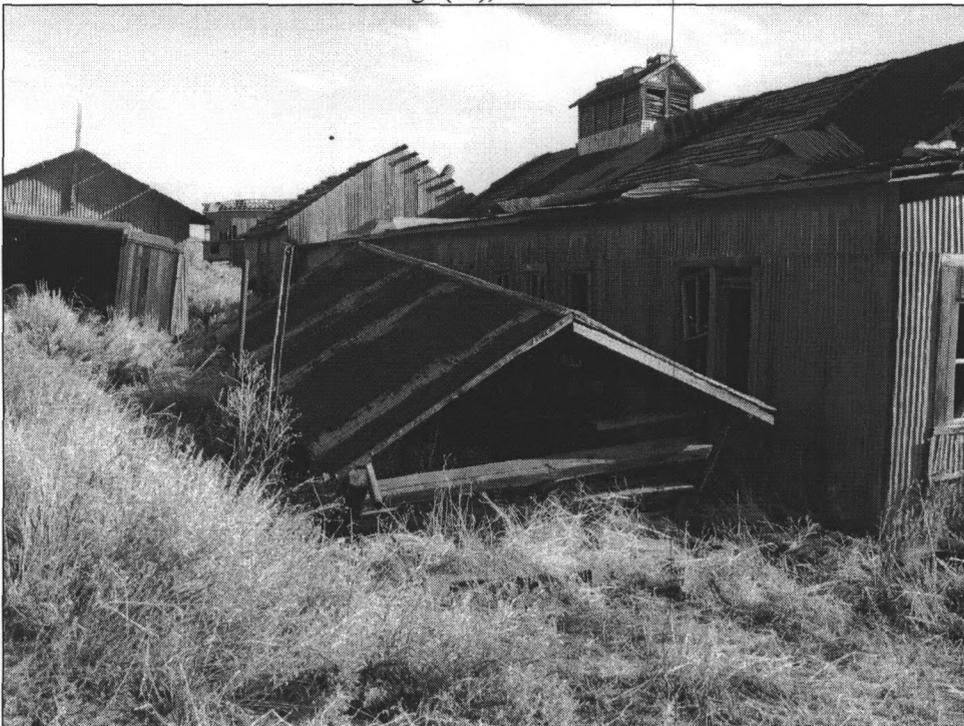
0019. Shed (17), view to east

This outbuilding is located just north of the west end of the blacksmith and repair shop (Building 15). It is oriented east and west and faces west. The wood frame building is partially collapsed, but it is still possible to determine that it had a gable roof that was covered by corrugated metal. The original function and construction date of this building are not known.

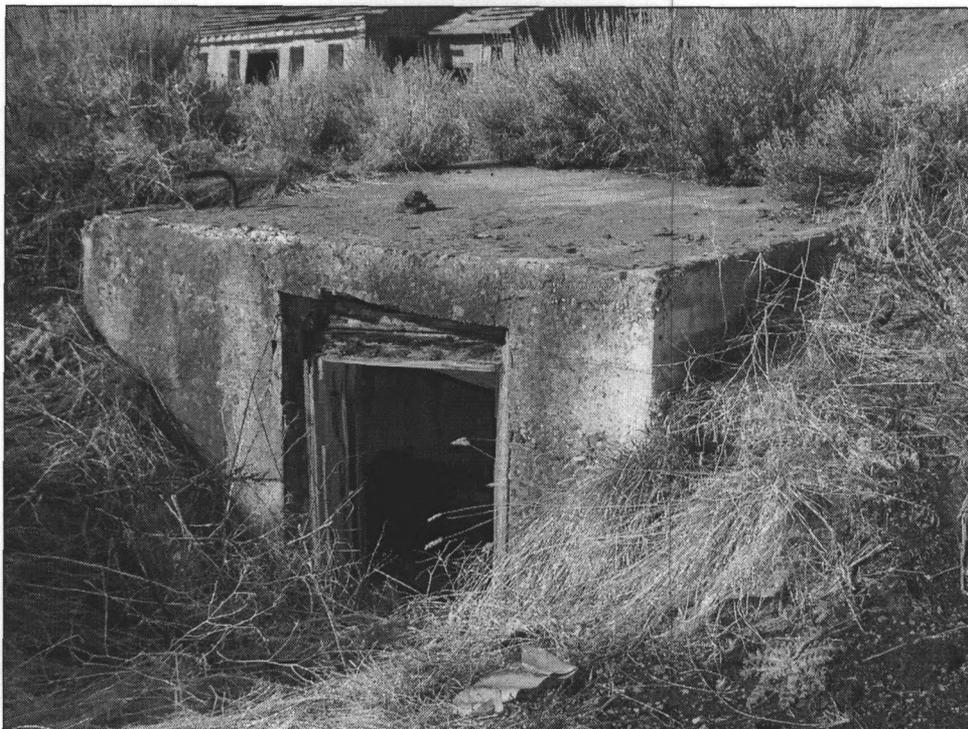
0020. Pumphouse (18), view to north/northwest

A 1943 historic photograph shows a concrete building in the approximate location of this pump house. This nearly square, 9' x 8', pump house is partially buried and situated approximately 41' from the southwest corner of the blacksmith and repair shop (Building 15). Only the flat roof and 4' of the south wall is visible. It is an aggregate concrete structure with 10" thick walls. The south wall is partially exposed and has a wood framed opening. The interior reveals pipes extending from a pump that sits on a concrete slab.

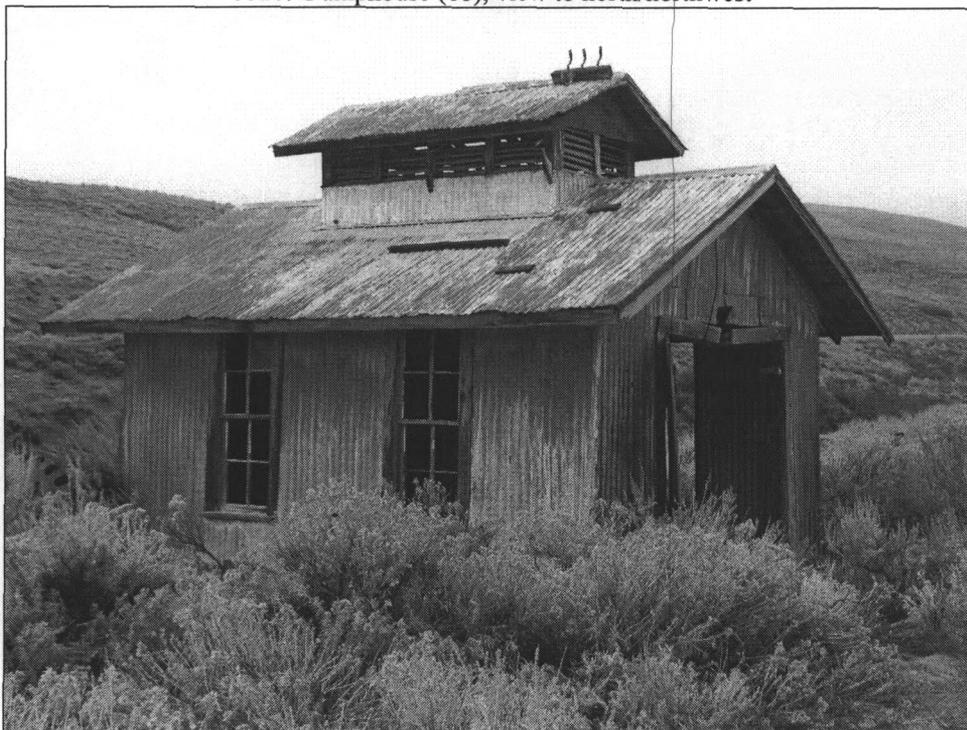
0021. Substation (19), view to southwest

This one-story, rectangular, 16' x 12', wood frame building sits along the coulee edge south of the blacksmith and repair shop (Building 15). This building is clearly visible in a 1943 historic photograph. The gable roof is covered with corrugated metal and has extended exposed rafters. A long ventilation cupola straddles the center of the roof ridge. The cupola has louvered wood vents on all four sides with corrugated metal below the vents. The cupola has extended exposed rafters and vertical boards in the gable ends. High-voltage line conduits are secured at the roof ridge.

Two tall four-over-four double-hung windows (with missing panes) are symmetrical on both the east and west walls. The facade (north end wall) holds a wide opening that originally held vertical lap wood double doors (the west door is presently laying on the ground outside the opening). The interior has a concrete floor with a separate concrete pad centered in the floor. The ceiling is open into the cupola. Corrugated metal also covers the interior walls.
