National Register of Historic Places Continuation Sheet

NATIONAL REGISTER OF HISTORIC PLACES REGISTRATION FORM

1. Name of Property	
historic name Tipover Lookout Tree	
other names/site number AR-03-07-03-702	
2. Location	
street & number N/A	/ /not for publication
city, town Fredonia	/ x/vicinity
state Arizona code AZ county Coconi	no code 005 zip code 86022

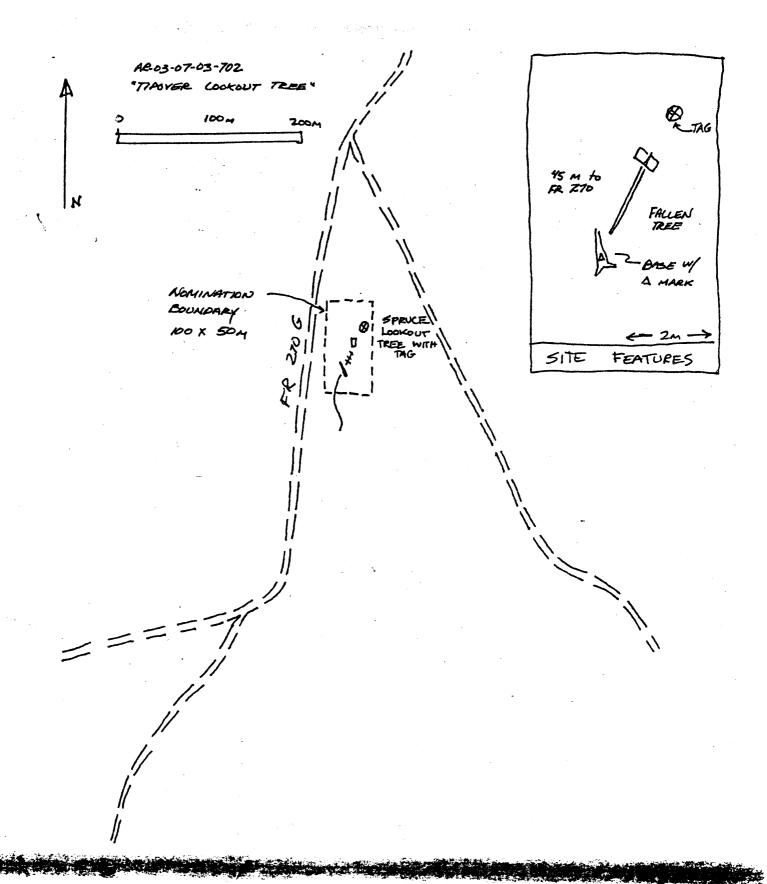
The standing lookout tree is a white fir 75 feet high and 3 feet in diameter with a ladder constructed up its eastern side approximately 40 feet. Two contiguous segments of ladder works remain. The first 10-15 feet are gone. The remaining ladder is in good condition. The construction is typical of other ladders on lookout trees: 2" X 4" lumber sidepieces with 1" x 12-14" crosspieces. It is attached to the tree with lag bolts. This tree is associated with a downed lookout tree with a ladder up its side and 6 foot by 6 foot platform in its top. This is the only documented platform tree on the North Kaibab Ranger District.

- 6). Facing east, tree in its setting.
- 7). #1
- 8). Facing north, fallen tree with platform.
- 9). #2
