Address 75 Arbor Street

Historic Name John Perkins House

Community: WENHAM	Form No: 13
Property Name: John Perkins House

Name First Period Buildings of Eastern Massachusetts TR
State _____

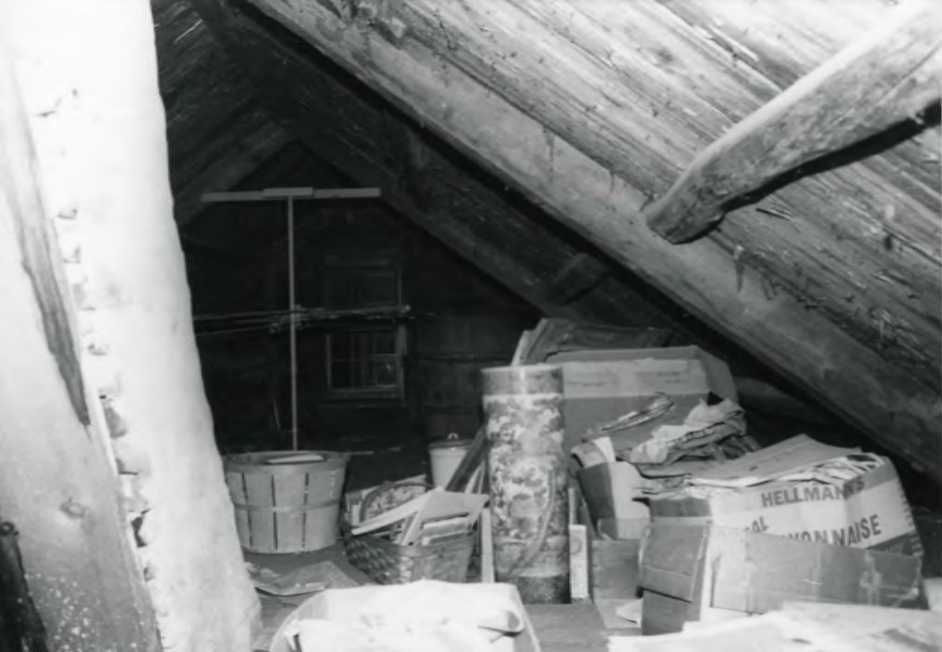
15-20

In the attic, roof framing is composed of principal rafters, 3 common purlins per slope and a ridge purlin. The original right-hand portion of the roof is divided into three bays, and like the summer tie beam in the chamber below the framing members are quite slim. Although the framing system is the same, it is clear that the added left-hand two bays were built in a separate building campaign.

Wenham, MA
John Perkins House
75 Arbor Street
attic
1985

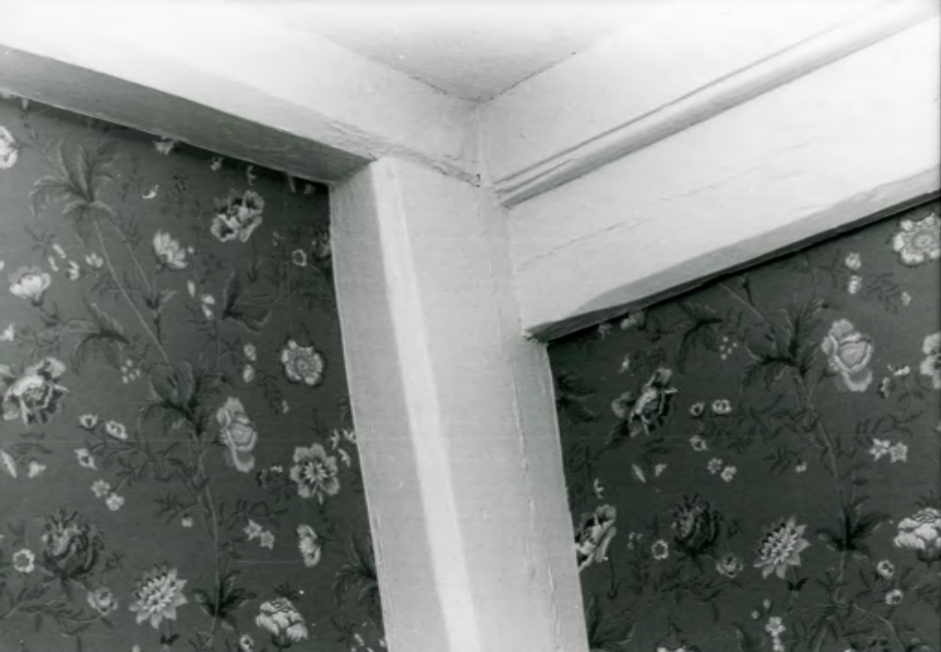
15-24

detached post - s.e. corner

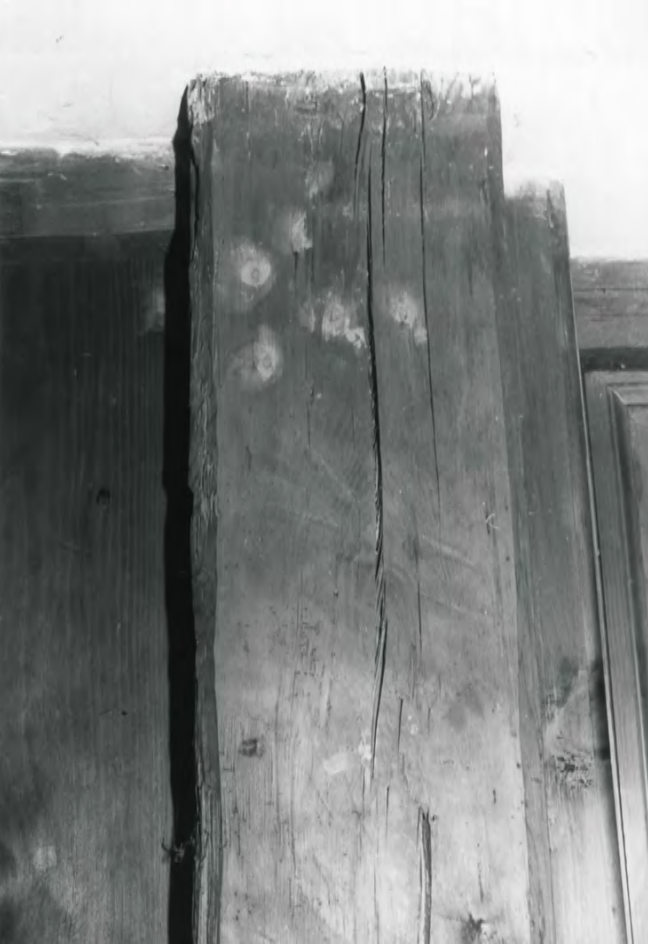
15-25

In the lobby, the exposed chimney girts, one of which is original and the other a replica, display flat chamfers on the rear edge and on the front edge normally concealed in the front wall. A late 19th century photograph shows the house with a two story enclosed porch with overhanging second story. That porch has been removed and replaced by a shallower one story extension with open porch in front of it. The presence of the chamfer on the front edge of the summer

beam, however, suggests that that edge of the beam was intended to be exposed from the beginning as inside the house. Possibly the porch shown in the 19th century photograph is an original feature of the house.

John Perkins Ho
75 Arbor Street
Chimney 91st

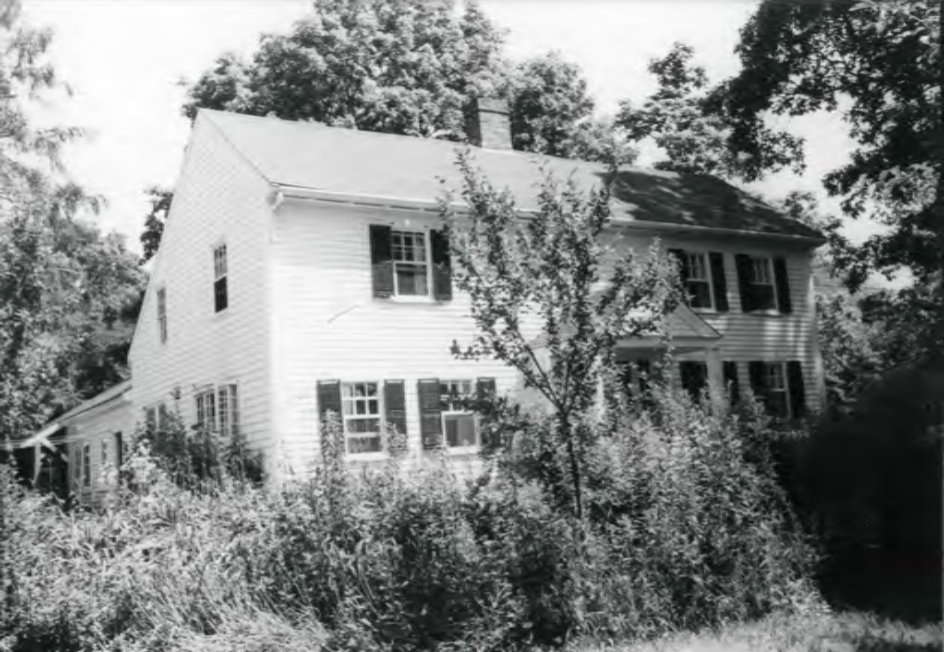
15-28

The John Perkins House is a five bay wide clapboarded structure with rear additions consisting of a lean-to spanning the left-hand three bays, a gable roofed ell to the right and rear of the building and another ell to the left rear. The front, right-hand portion is the original single cell house, but the left-hand rooms and lean-to were added within a generation. The exterior is characterized by simple Colonial Revival trim including an open pedimented porch with square posts and simply-framed sash windows. The single chimney which pierces the ridge of the roof is an 1880's replacement of the original one.

Exterior view
1985
