United States Department of the Interior
National Park Service
National Register of Historic Places Registration Form

Historic Name: Hamilton Apartments
Other name/site number: NA
Name of related multiple property listing: NA

Street & number: 2837 Hemphill Street
City or town: Fort Worth State: Texas County: Tarrant
Not for publication: Vicinity:

Hamilton Apartments, Fort Worth, Tarrant County, Texas

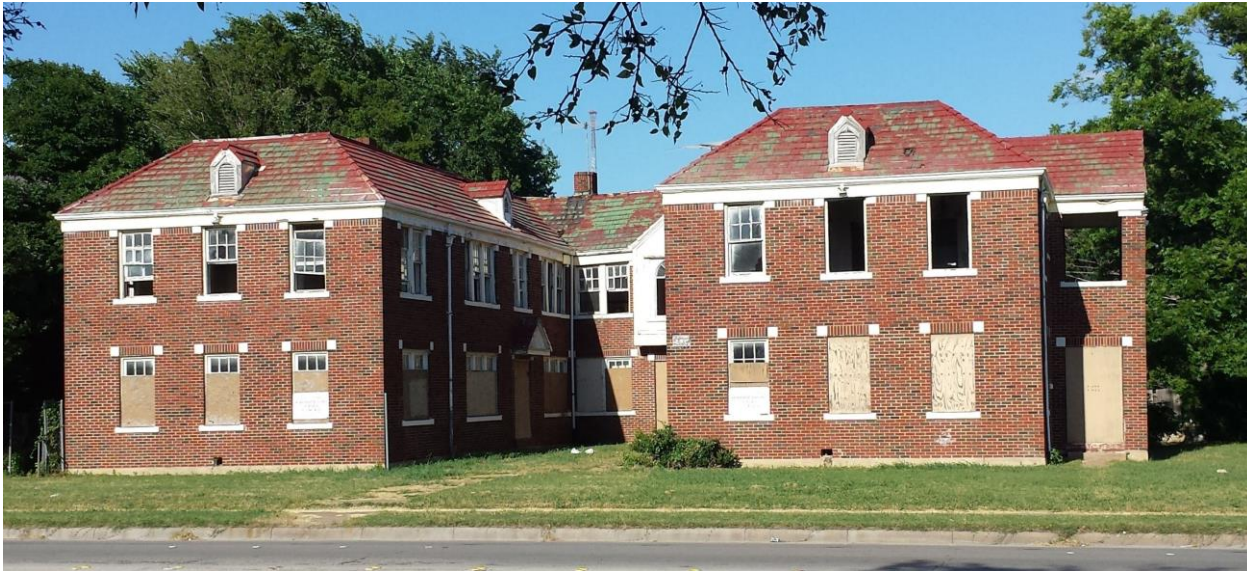
Photo 2

West elevation and interior of the courtyard, camera facing east.
Photographed by James H. Johnson, July 6, 2015

The Hamilton Apartments building is configured in a U shape around a courtyard opening onto Hemphill Street (Figure 1). The courtyard originally contained a concrete walkway leading to each of three front entrances, one on

each side of the U and one in the center (Photograph 2), and then around the sides to the back of the building. The apartment building (labeled “1” in Figure 1) occupies most of the northern two thirds of the property. The southern third of the property contains a grassy area with large trees outlined by a low, L-shaped rock wall (labeled “4” in Figure 1). Directly behind the wall is a driveway leading to the historical parking location. A small non-contributing two-story wood frame garage apartment and attached shed (labeled “3” in Figure 1) at the rear of the property were demolished in 2016, as was another non-contributing shed (labeled “2” in Figure 1). A new compatible garage apartment is planned for the site of the old one.

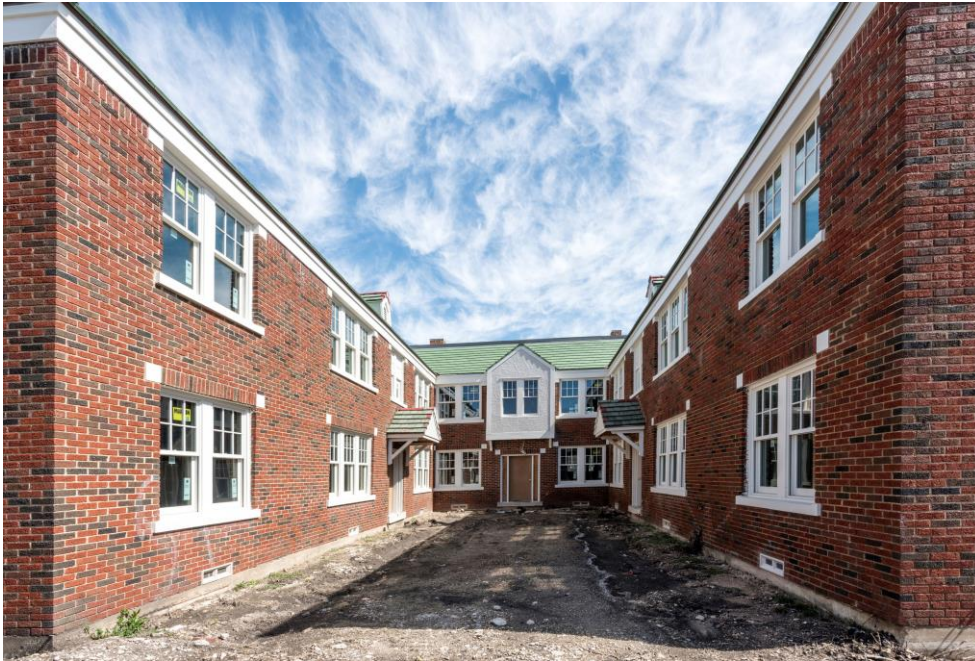
Photo 3

Courtyard south elevation (left), west elevation (center) and north elevation (right), camera facing east.
Photographed by Stacy Lueckner, March 3, 2018

Tiled pediments appear above the two opposing courtyard entrances, and a second story pediment overhangs the central courtyard entrance (Photograph 3). None of the pediments have columns. The overhang contains the street address just above the doorway, and above the address is a rectangular window frame that previously contained an inappropriate arched divided light window. This was replaced by a rectangular double divided light window. There are no pediments above the two side portico entries or the rear entry.

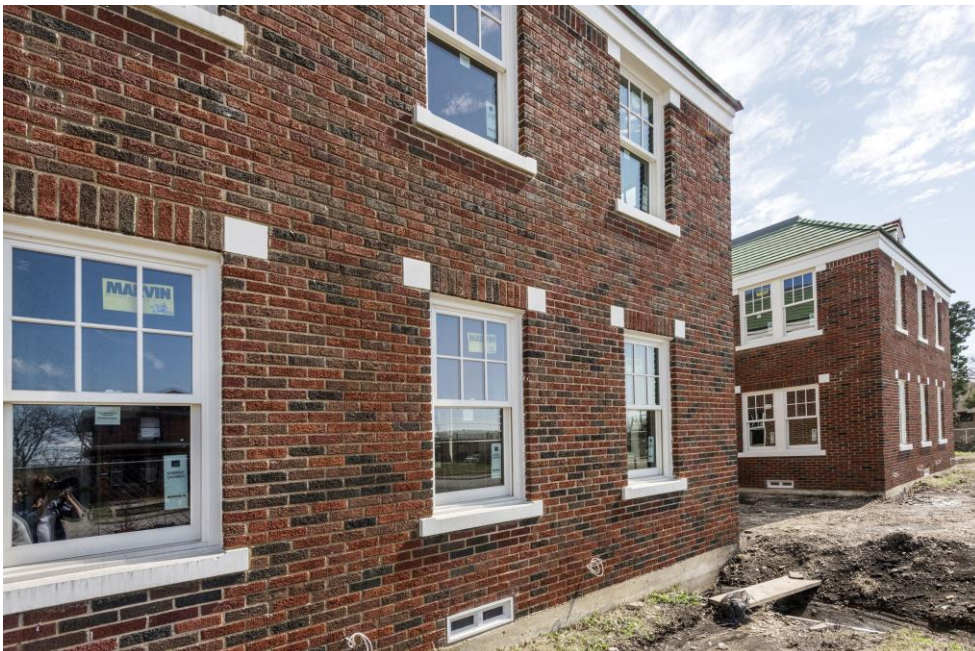
Photo 4

West façade (left and right) and courtyard north elevation (middle), camera facing southeast.
Photographed by Stacy Lueckner, March 3, 2018

window is a large double window. The front façade (west side of the building, exclusive of the courtyard) contains six large single windows on each end of the U shape (Photograph 4). The front-facing courtyard façade has five large double windows including the replaced window (Photograph 5). Each courtyard side façade has four large triple windows and three large double windows (Photographs 5 and 6). Each north and south building side façade, including portico, has three large triple windows, eight large double windows, and seven small single windows (Photograph 7). The rear façade has one large triple window, four large double windows, four small double windows, and eight large single windows (Photograph 8). Repairs have been made where possible; otherwise new windows of the same profile and materials were installed.

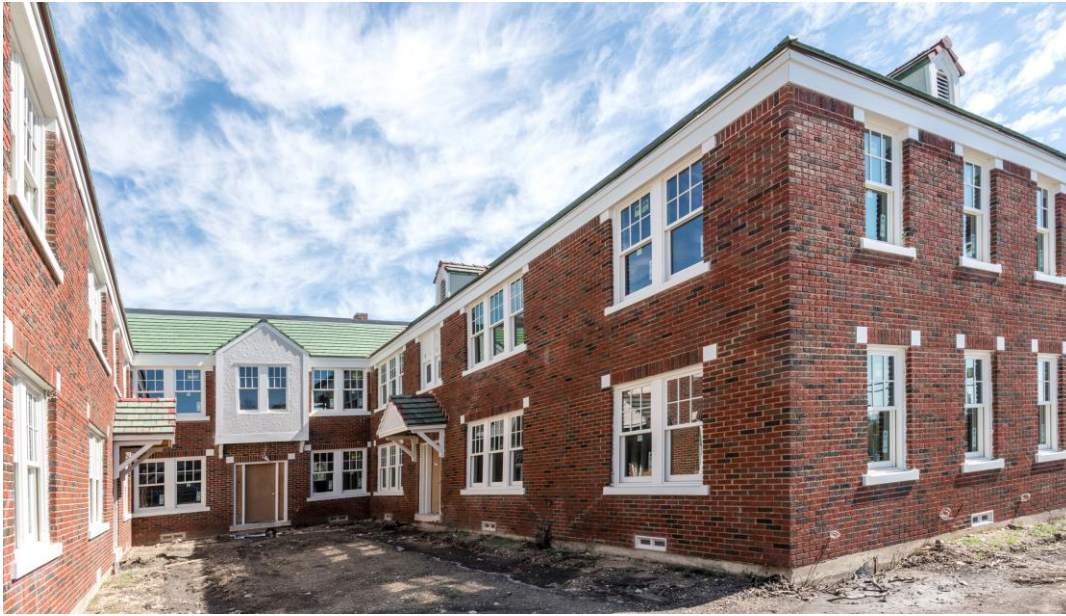
Photo 5
Courtyard north elevation, camera facing southeast.
Photographed by Stacy Lueckner, March 3, 2018

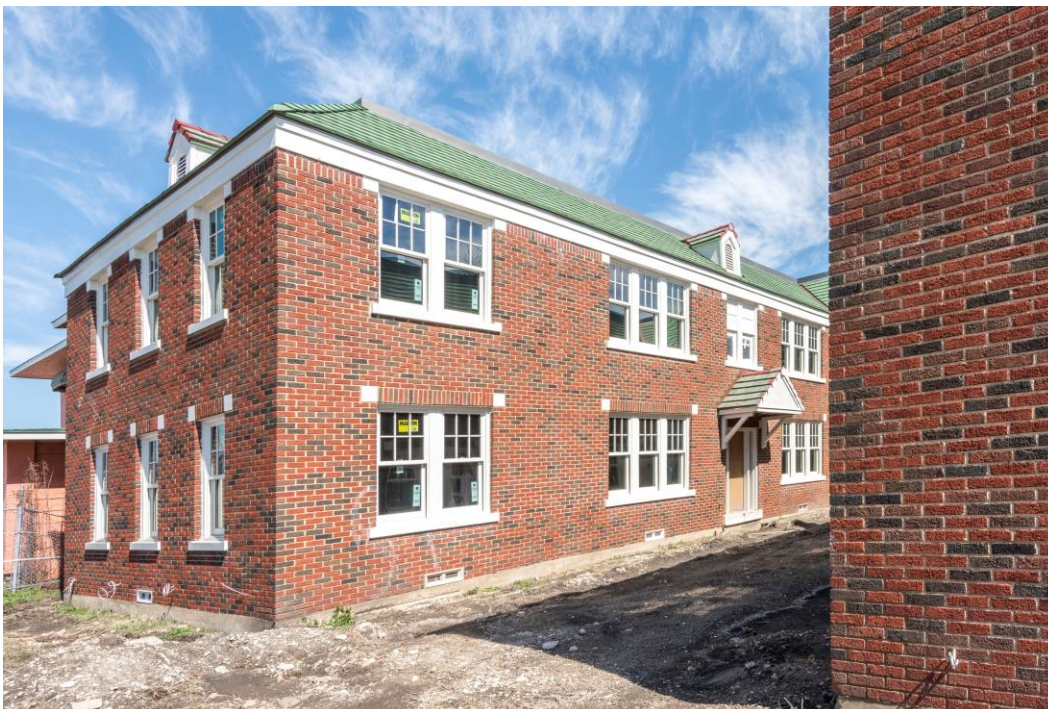
Photo 6
Courtyard south elevation, camera facing northeast.
Photographed by Stacy Lueckner, March 3, 2018

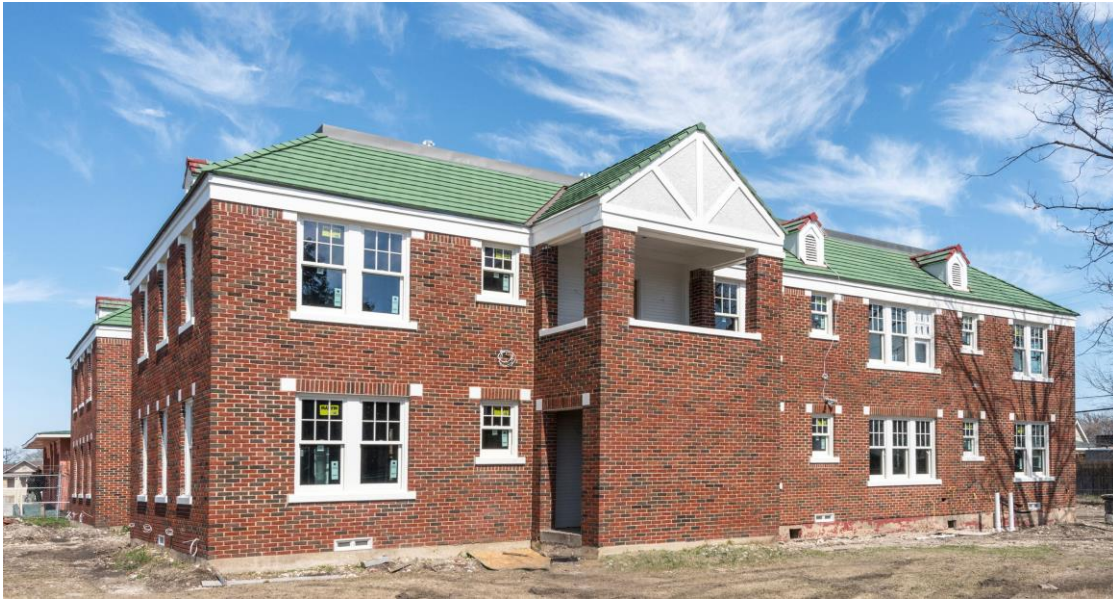
Photo 7

West façade (left) and south elevation (right), camera facing north northeast.
Photographed by Stacy Lueckner, March 3, 2018

Exterior decoration is minimal. Windows and doors are marked by contrasting white cast stone sills and are capped by cast stone squares in the upper corners with bricks set vertically in between (Photograph 9). The three front entries in the courtyard are remarkable for the pediments on each side and the pedimented overhang in the center (Photograph 3). The two side porticos provide variation in the long side building facades, visually breaking up the long spans (Photograph 7).

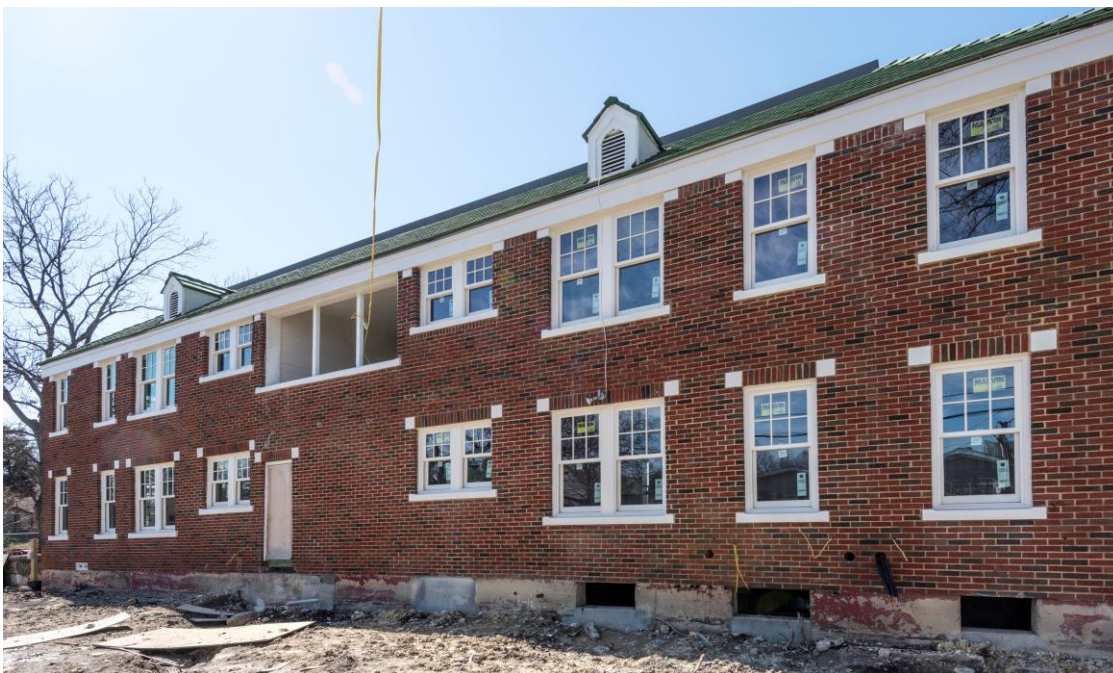
Photo 8

East elevation, camera facing southwest.
Photographed by Stacy Lueckner, March 3, 2018

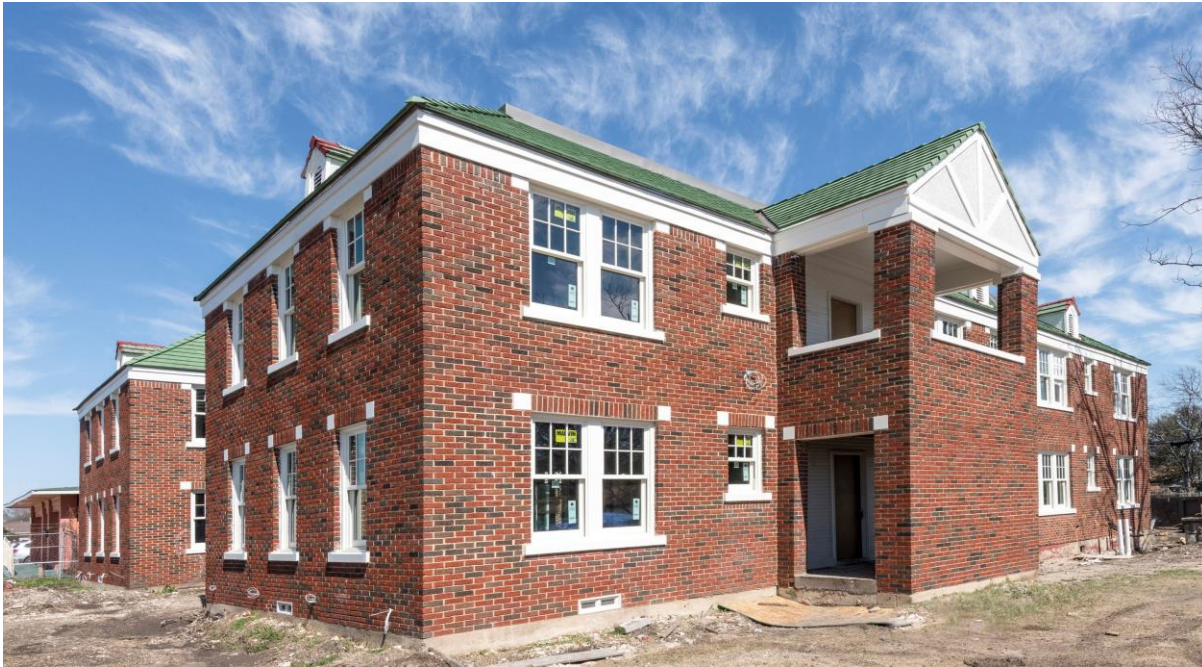
Photo 9

West façade (left) and south elevation (right), camera facing northeast.
Photographed by Stacy Lueckner, March 3, 2018

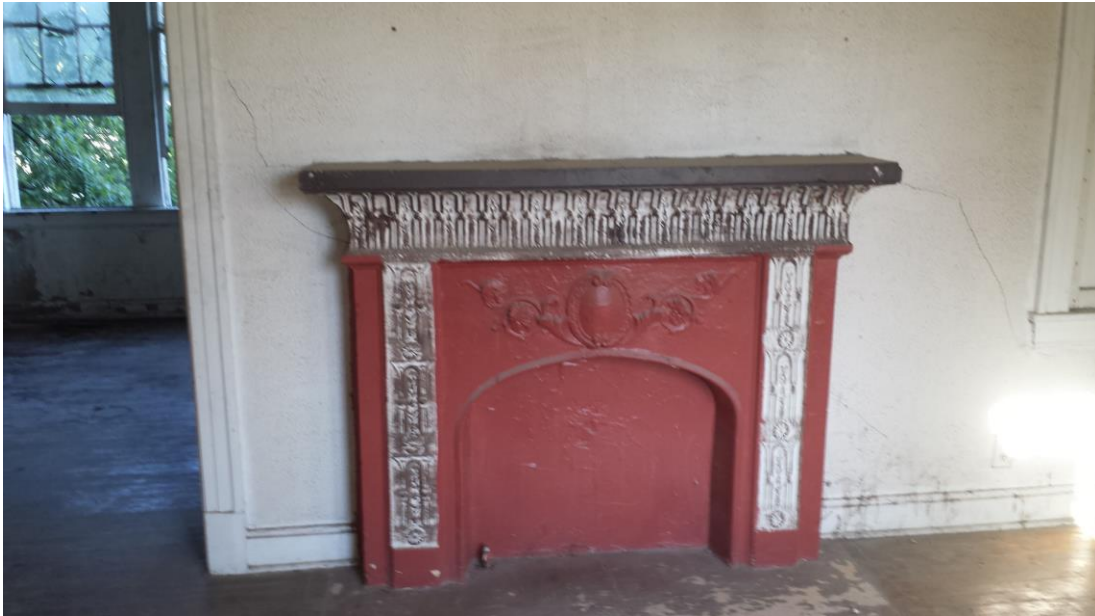
Photo 11
Second floor north rear apartment living room, camera facing east.
Photographed by James H. Johnson, July 6, 2015

The apartment units mix common materials and trim of early twentieth century residential buildings—wood flooring, plaster walls, hexagonal tiled bathroom floors, and picture frame moldings around windows, doors and ceilings—with unusual features, such as ornate plaster gas fireplace mantles, Shaker style cabinet doors, and a compact central hallway with doorways into each room of the apartment. Embellishments are few, with the most noteworthy being the decorative plaster fireplace mantle with gas connection in the living room of each unit. The mantle design incorporates classically inspired details: an arched recess, above which is a raised shield pattern, flanked by vertical detailing and capped with an ornate frieze board supporting the mantle (Photograph 10). The element creates an air of formality in a room meant for welcoming visitors. In one of the units, the mantle was painted red with white highlights, creating a striking visual centerpiece (Photograph 11). In the other units, mantles were painted white. The

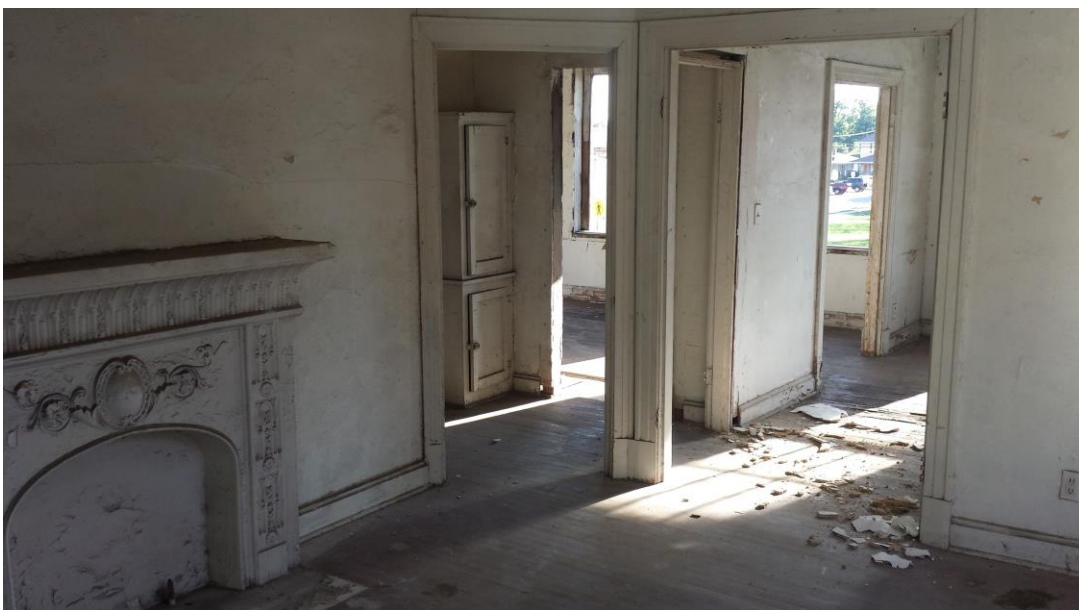
Photo 12
Second floor south front apartment living room, camera facing southwest.
Photographed by James H. Johnson, July 6, 2015

As originally built, every apartment's front door opened to the living room and the back door opened to the kitchen. Each of the three original floor plans had in common a compact central hallway opening into every room in the apartment (Photograph 12): living room, kitchen, bathroom, bedroom, plus in apartment plan A, a second bedroom, and in plan C, a dining room. The only exception is plan C where the kitchen was accessed through what was probably intended to be a dining room. The renovation reconfigures the interior space into eight larger, more open units (Figures 5 and 6). Existing demising walls are retained to the extent possible to maintain integrity of design and feeling. The interior perimeter of the building is restored to original, and all new elements define spaces with minimal if any connection to the perimeter walls, providing a clear distinction between old and new. The original compact interior stairwells built in a rectangular spiral pattern are maintained, and a fourth one added. There are no long corridors in the building, neither in the original plan nor planned in the renovation.

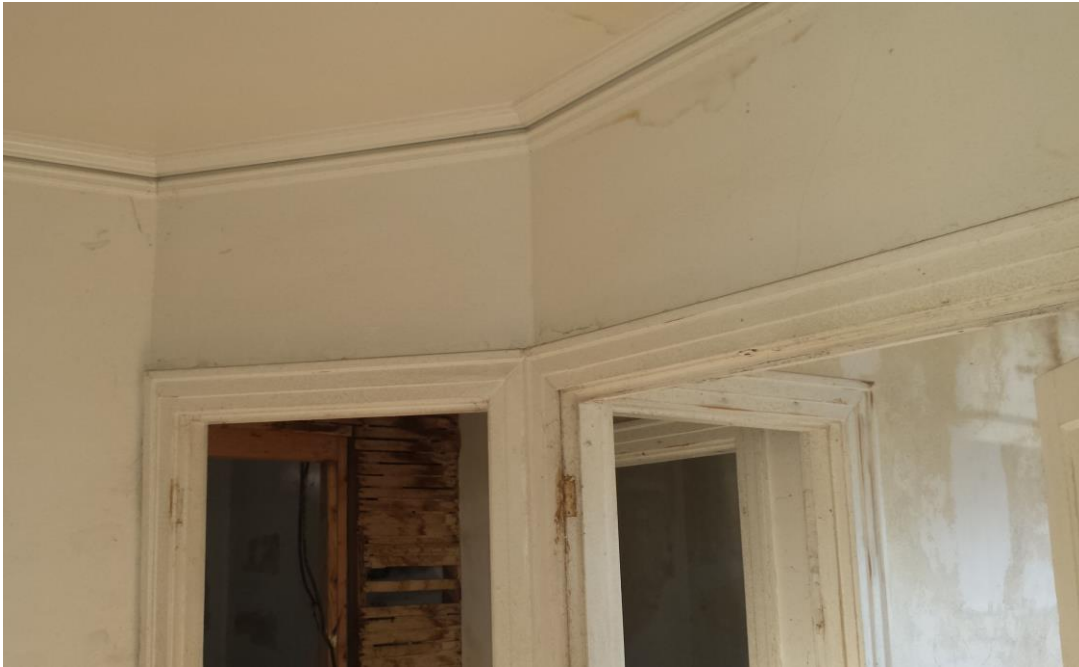
Photo 13

First floor south front apartment bedroom, camera facing southeast.
Photographed by James H. Johnson, July 6, 2015

The units' simple moldings around doors and ceilings (Photograph 13) are maintained in the renovation. All base, casing and crown moldings were reused. Oak flooring was reused where possible and replaced as necessary (due to significant water damage) with identical board patterns. Modern heating and air conditioning has been added with ducts installed in the basement for ground floor units and in the attic for second floor units. Condensing units are placed outside. Common areas have mini split systems.

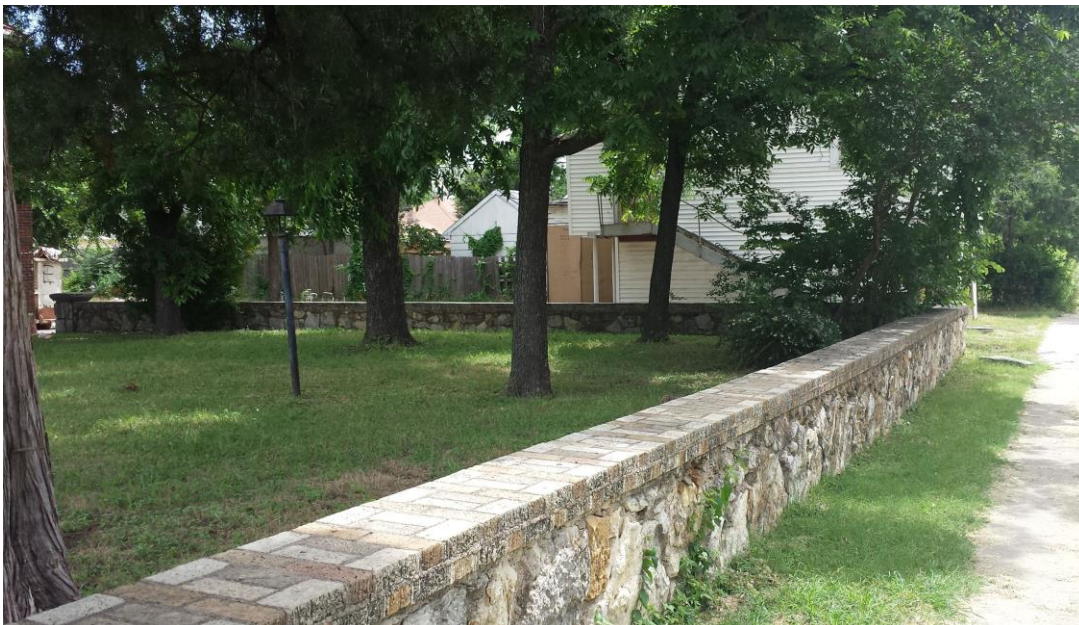
Photo 14

Low rock wall (foreground and background) outlining green space, camera facing east northeast.
Photographed by James H. Johnson, July 6, 2015

It is not known whether the low rock wall outlining the grassy area south of the building is original. However, its appearance and construction indicate longevity and weathering (Photograph 14). It functions, along its eastern portion, to denote the driveway to the rear parking area, and along its southern portion, to denote the property line along Lowden Street. Based on these functions, the rock wall is a contributing feature of the property, as it outlines the large grassy area south of the apartment building. Adjacent to the property near the intersection of Hemphill and Lowden Streets is a red brick gateway structure signaling the primary entrance to the Jennings-May-St. Louis neighborhood (Photograph 15). According to neighborhood sources, this and similar structures throughout the neighborhood were built in the late 1990s. This element is not a feature of the property, despite its similar materials and color.
