# National Register of Historic Places Registration Form

historic name Viets Block (KHRI # 015-437; 015-438)

street & number 427, 429, & 431 State Street ☐ not for publication

city or town Augusta ☐ vicinity

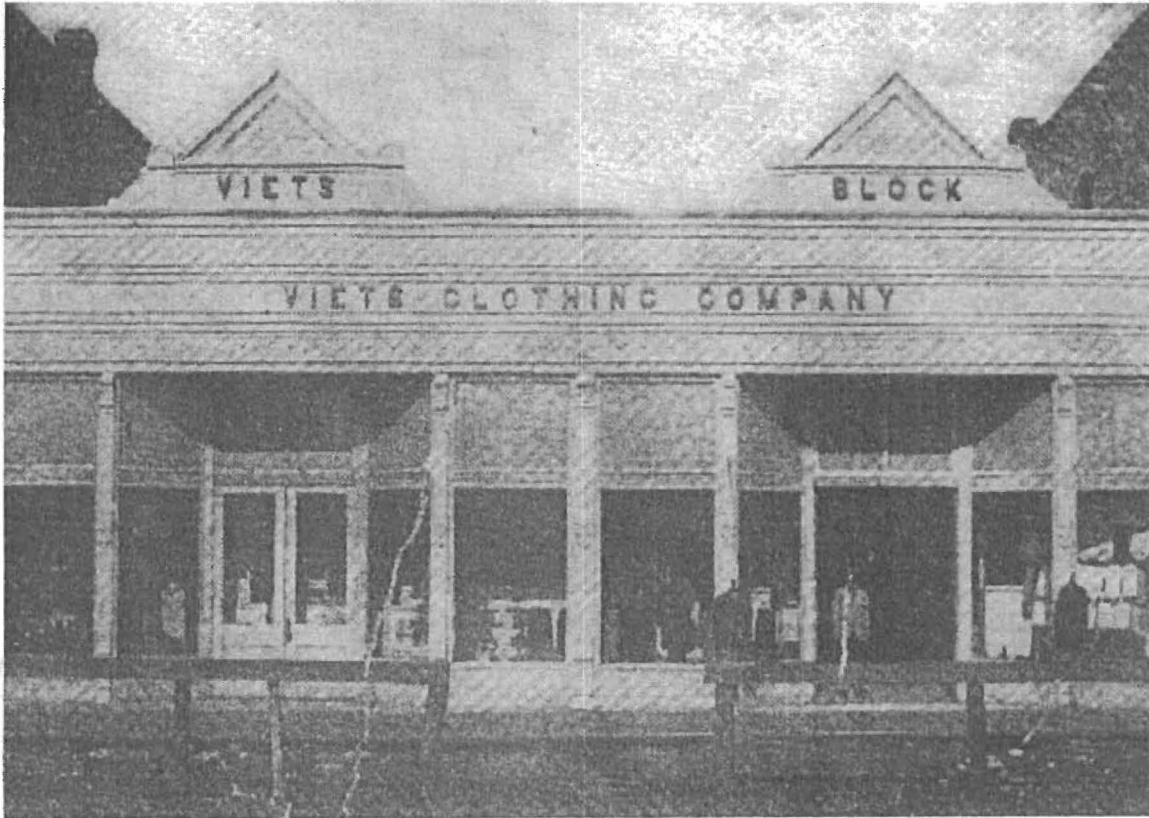
Figure 7: Early 20<sup>th</sup> century photograph of the Viets store, Augusta, KS

Charles Viets' building evolved over time to reflect its current appearance. The earliest known photograph of the building is an undated photograph from the early 1900s that depicts a one-story building with two storefront entrances housing the Viets Clothing Company. An advertisement in the *Augusta Gazette* in 1900 noted the building had been recently redecorated was a "Bower of Beauty."<sup>5</sup>

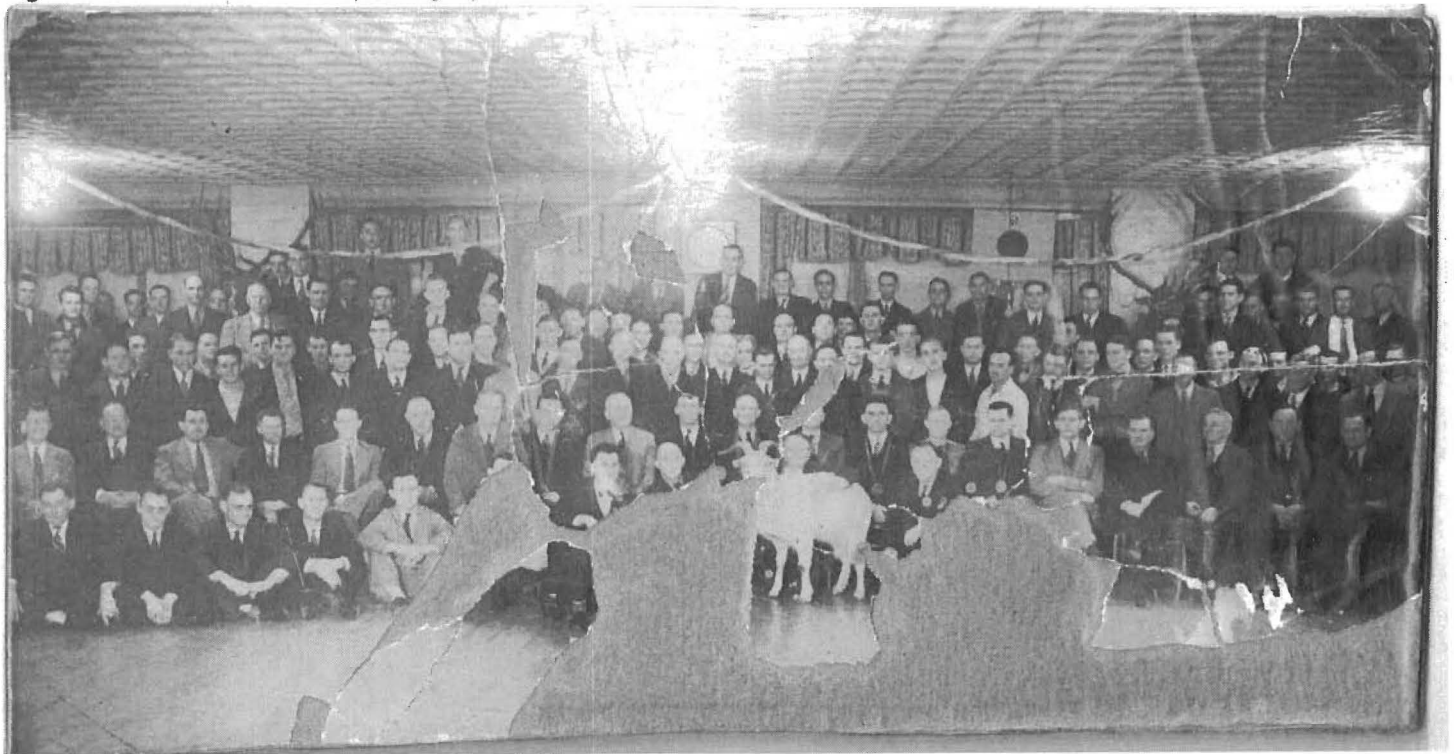
Figure 8: Undated historic photograph of second floor interior

The second floor was used as an Elks Lodge for many years. The link between this property and the Elks came in the historic record is the 1931 *Augusta Telephone Directory*, which notes the Elks address as 431 State Street. Historic photos of the downtown from the 1940s show a B.P.O.E. (Elks lodge) sign affixed to the building, and a Sanborn fire insurance map updated in 1944 documents the second floor as a lodge hall. The city directory provides a different address for the Elks beginning in 1953, so it is likely they relocated around this time. The building's second floor space was finished with plaster walls and wood floors and had a large open area in the south two bays that may have been suitable for lodge meetings. Currently, the second floor is accessed from the front sidewalk by interior stairs and from the rear alley by exterior stairs.
