**HISTORIC RESOURCES INVENTORY
BUILDING AND STRUCTURES**

1. BUILDING NAME (Common) (Historic)
Valentine Wightman House

2. TOWN/CITY VILLAGE COUNTY
Southington Southington, CT 06489 Hartford

3. STREET AND NUMBER (and/or location)
1112 Mount Vernon Road. (map 103, parcel 1) 3 acres

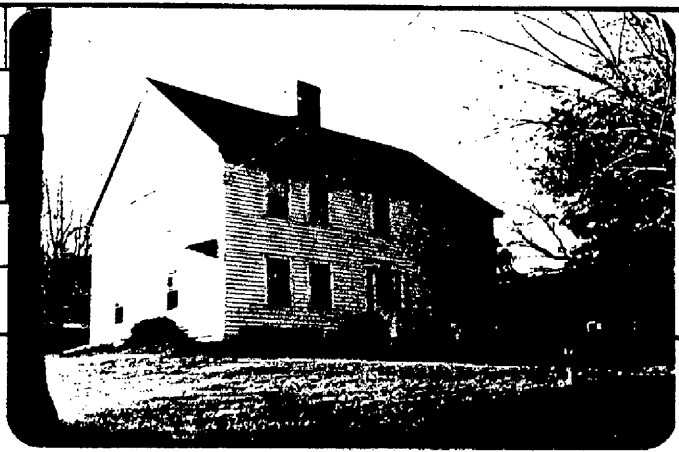
V-13

In the 5-bay front elevation, windows are spaced in a 2-1-2 rhythm. The central front door has narrow side lights but the doorway does not appear to be original. Windows are 1/1 on the first floor and 2/2 on the second. The third floor overhangs the second by an inch or two on the end elevations. The central brick chimney looks as though it is built of 20th-century brick. The WPA form reports that windows at that time were 2/2 at the first floor, 12/8 at the second floor. The interior was said to have three fireplaces on the first floor and old paneling.
