National Register of Historic Places Registration Form

Historic name: George Washington Rader House

Other names/site number: VDHR No. 011-0058

City or town: Fincastle State: VA County: Botetourt

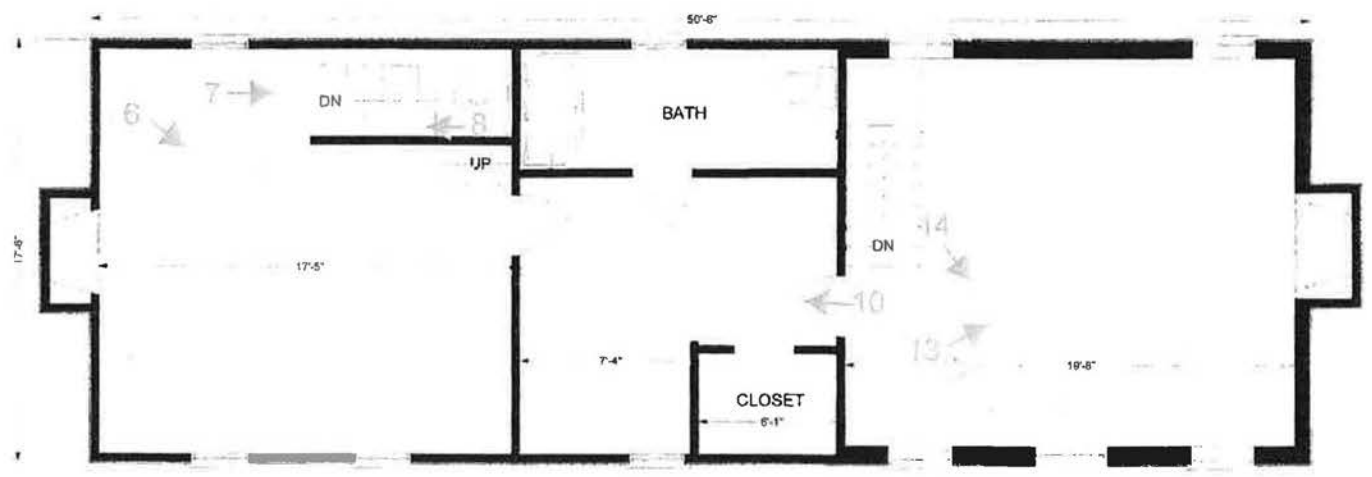
SECOND LEVEL FLOOR PLAN

Upstairs, the brick section contains a single bedroom. It has a nearly identical Greek Revival, faux-marble fireplace and faux-marble baseboards. The wood chair rail and window surrounds have been painted. In the center bay of the north elevation is a door, which would have opened onto a second story porch; however, it is no longer used as the porch roof was modified from flat
