**HISTORIC RESOURCES INVENTORY
BUILDING AND STRUCTURES**

STATE OF CONNECTICUT
CONNECTICUT HISTORICAL COMMISSION

1. BUILDING NAME (Common)		(Historic)	
Stephen Grannis House			
2. TOWN/CITY	VILLAGE	COUNTY	
Southington	Southington, CT 0648	Hartford	
3. STREET AND NUMBER (and/or location)			
1193 West St. (map 145, parcel 1B) 1.289 acres

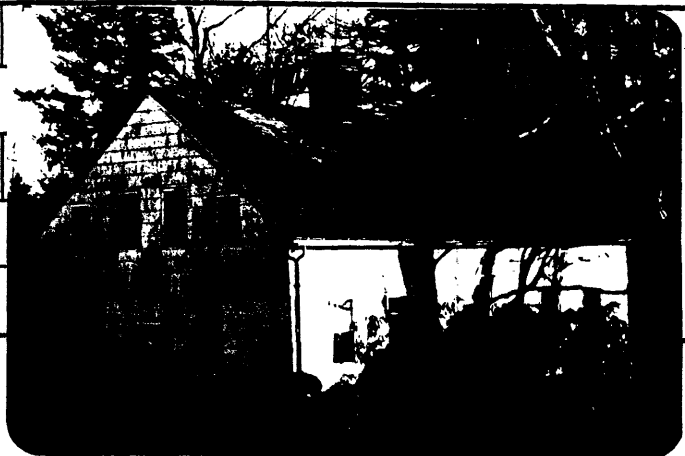
R-4

11. NUMBER OF STORIES	APPROXIMATE DIMENSIONS		
1	38 x 28' + wing		
12. CONDITION (Structural)		(Exterior)	
<input type="checkbox"/> Excellent <input checked="" type="checkbox"/> Good <input type="checkbox"/> Fair <input type="checkbox"/> Deteriorated	<input type="checkbox"/> Excellent <input checked="" type="checkbox"/> Good <input type="checkbox"/> Fair <input type="checkbox"/> Deteriorated

13. INTEGRITY (Location)		WHEN ?	(Alterations)
<input checked="" type="checkbox"/> On original site <input type="checkbox"/> Moved	N.A.	<input checked="" type="checkbox"/> Yes <input type="checkbox"/> No	Siding, porch, wing, sash

On the 5-bay front elevation, the windows are 1/1 and the central doorway has transom with Classic Revival convex/concave glazing under flat cap with dentil course. On the south side elevation there is an added porch. A jetty projects at the height of the top of the windows and there are four windows in the second floor gable end, an arrangement similar to that at 1137 West Street

Southeast
