**National Register of Historic Places  
Registration Form**

historic name The Bullard Farm

city or town Holliston N/A vicinity

## National Register of Historic Places Continuation Sheet

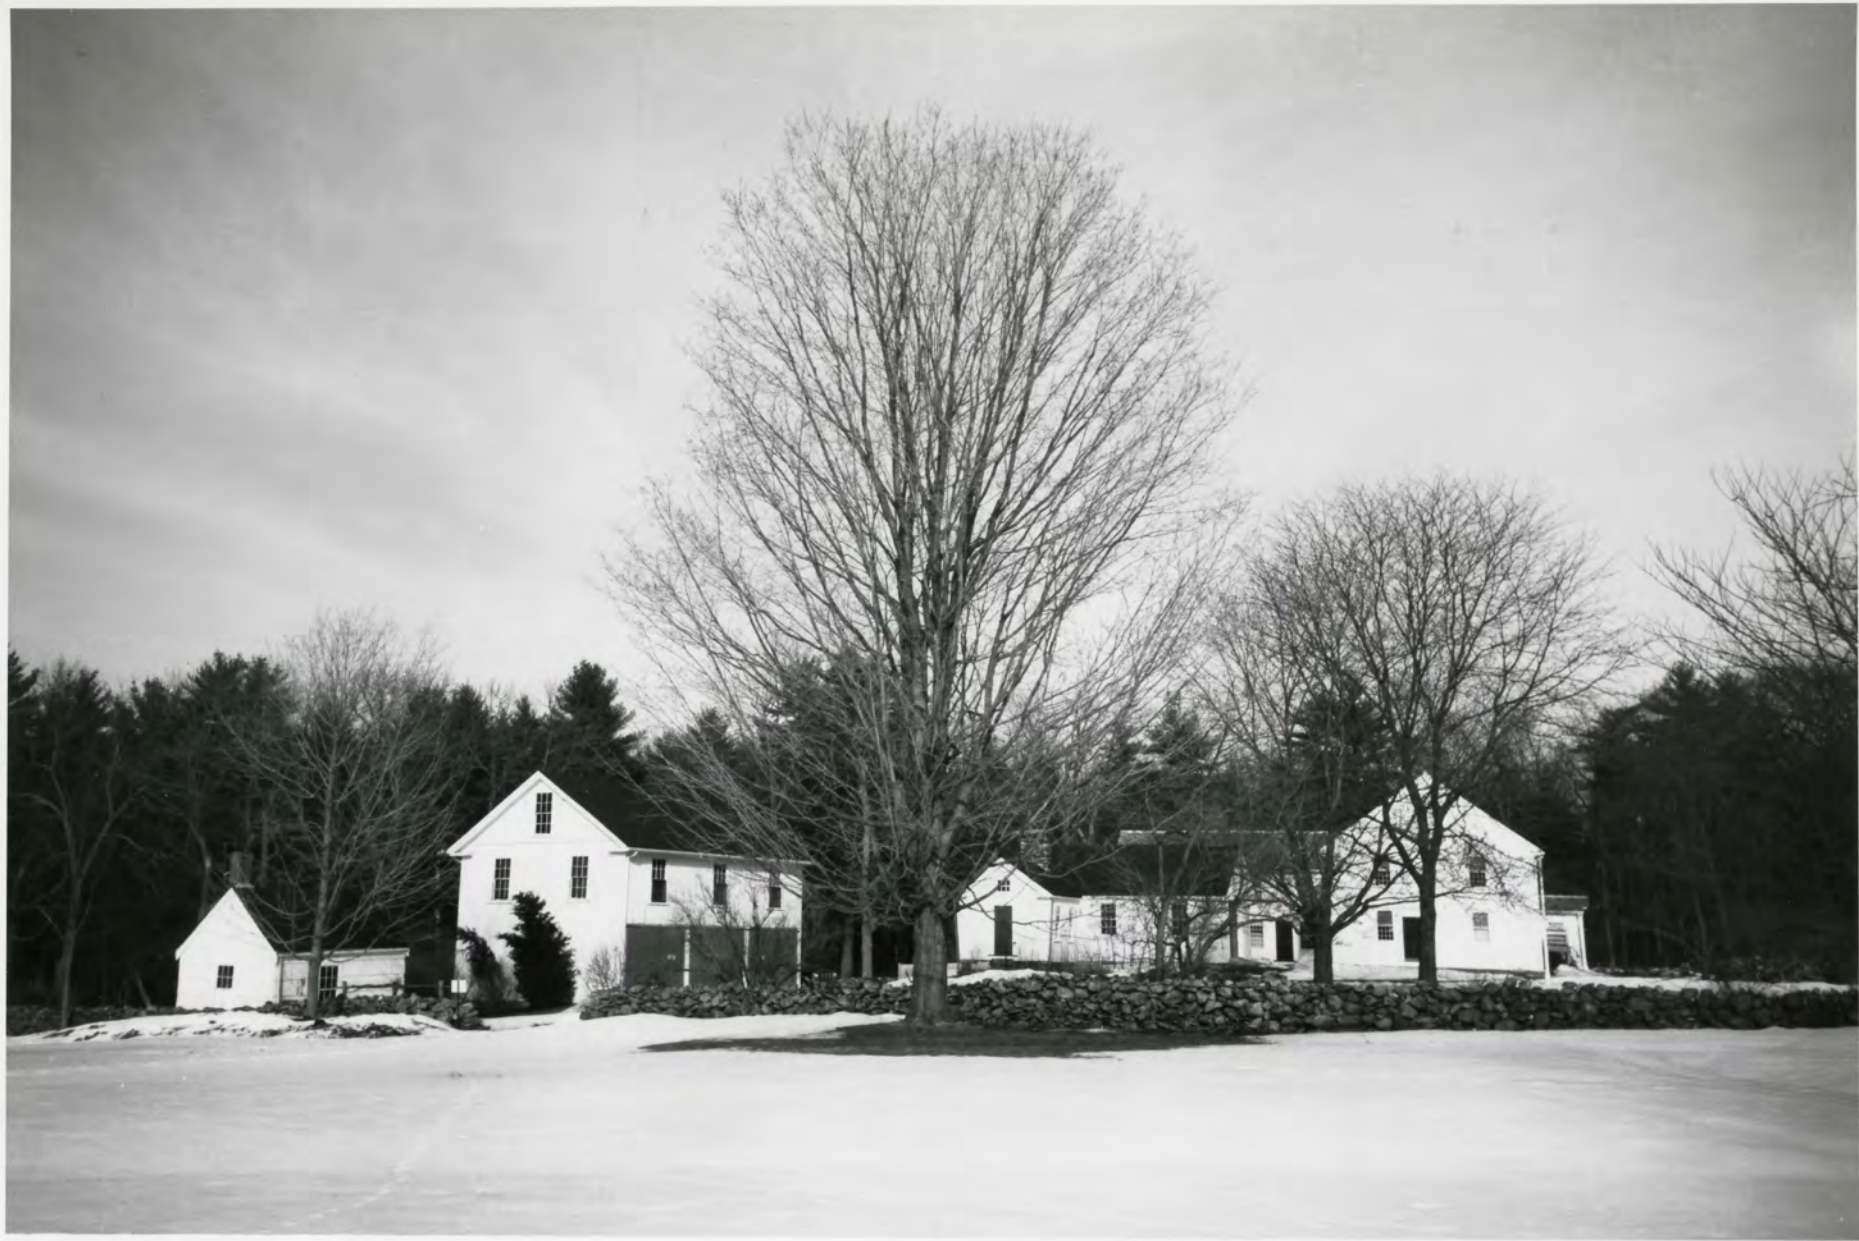
Photograph 1 of 7

View looking NE. From L to R: Blacksmith Shop, Vinegar house,  
Corn Crib, Cider House, Ell, Main House

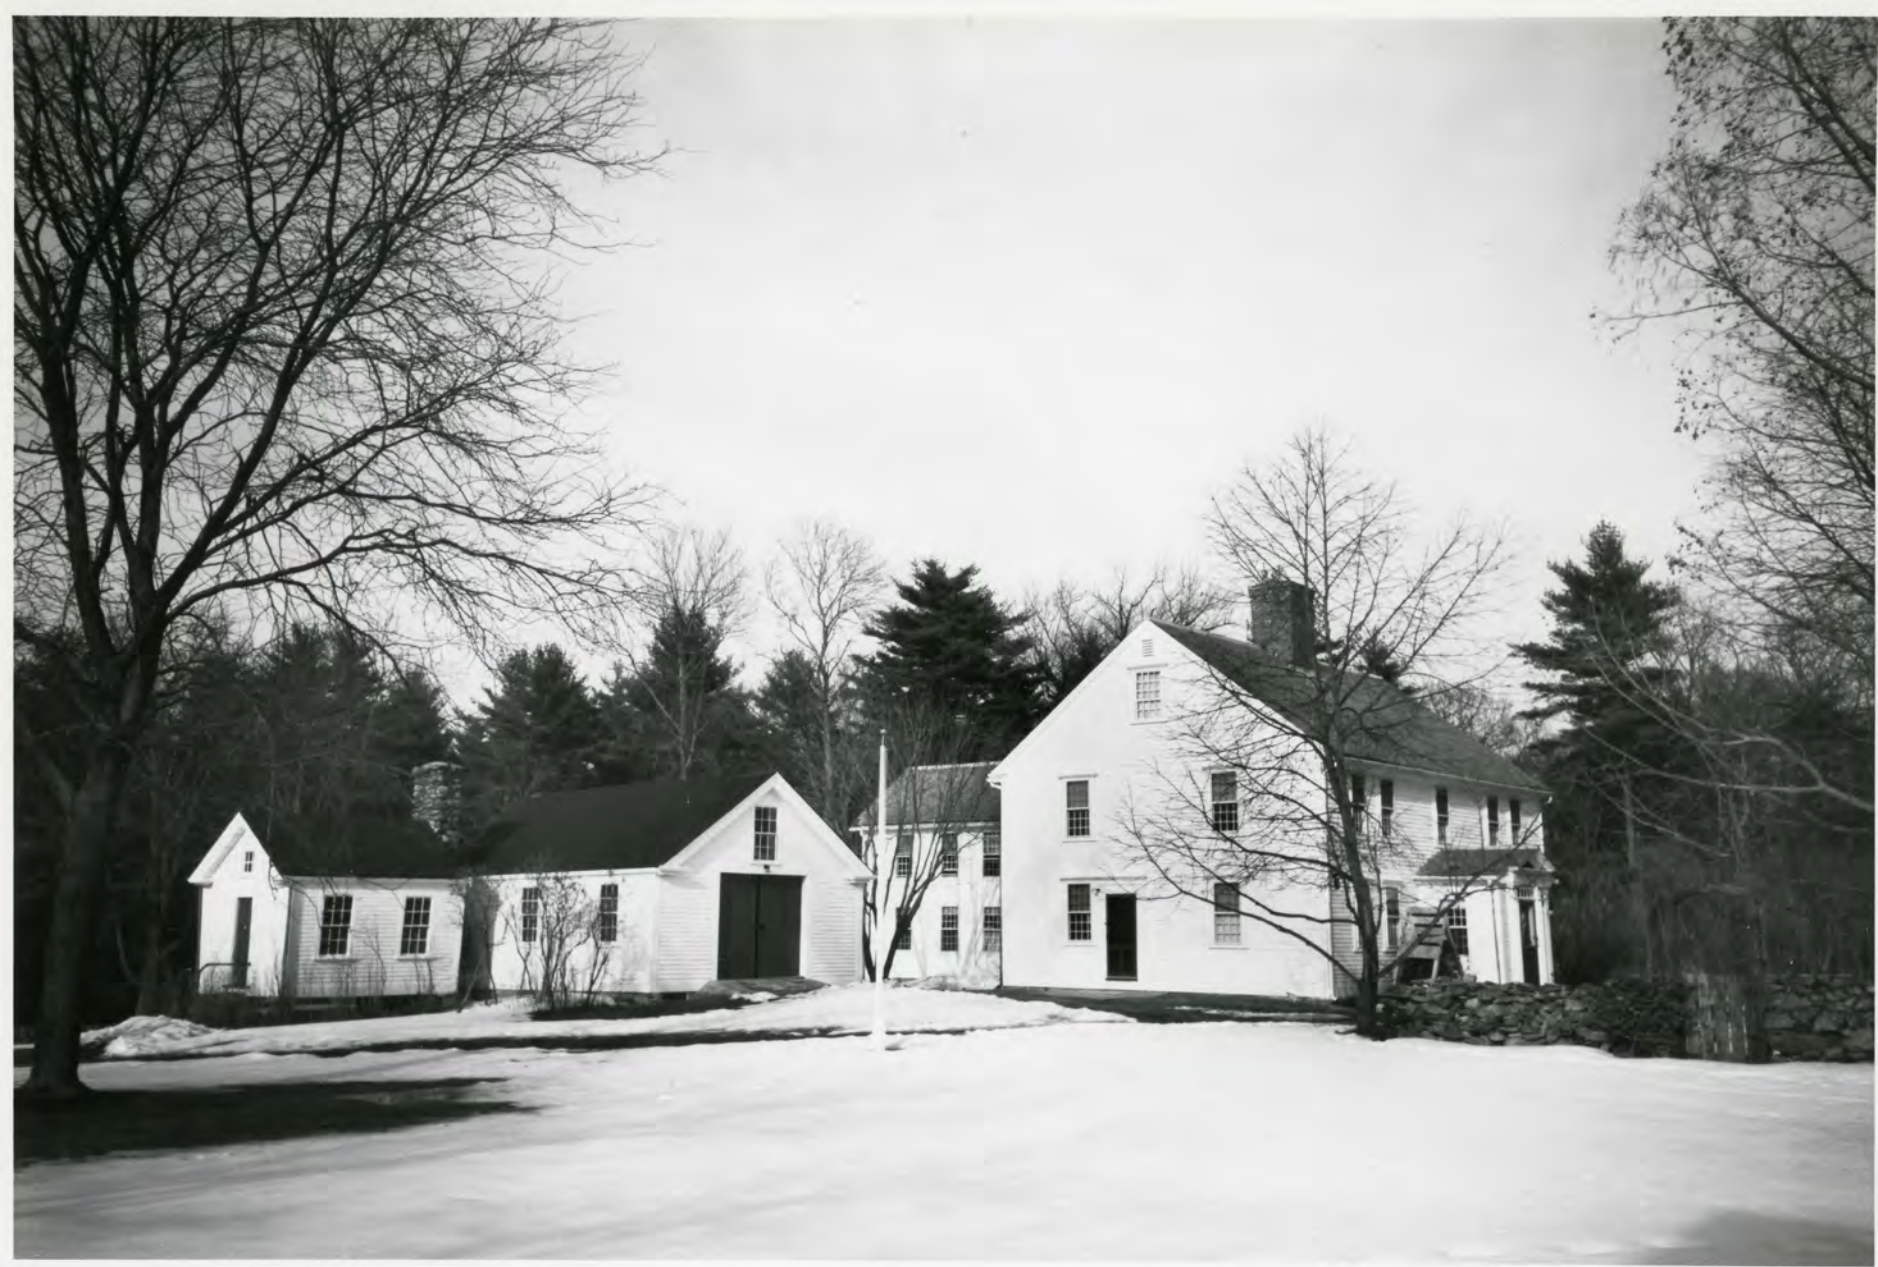
Photograph 2 of 7

View looking NE. From L to R: Corn Crib, Cider House,  
Back portion of ell, Main House

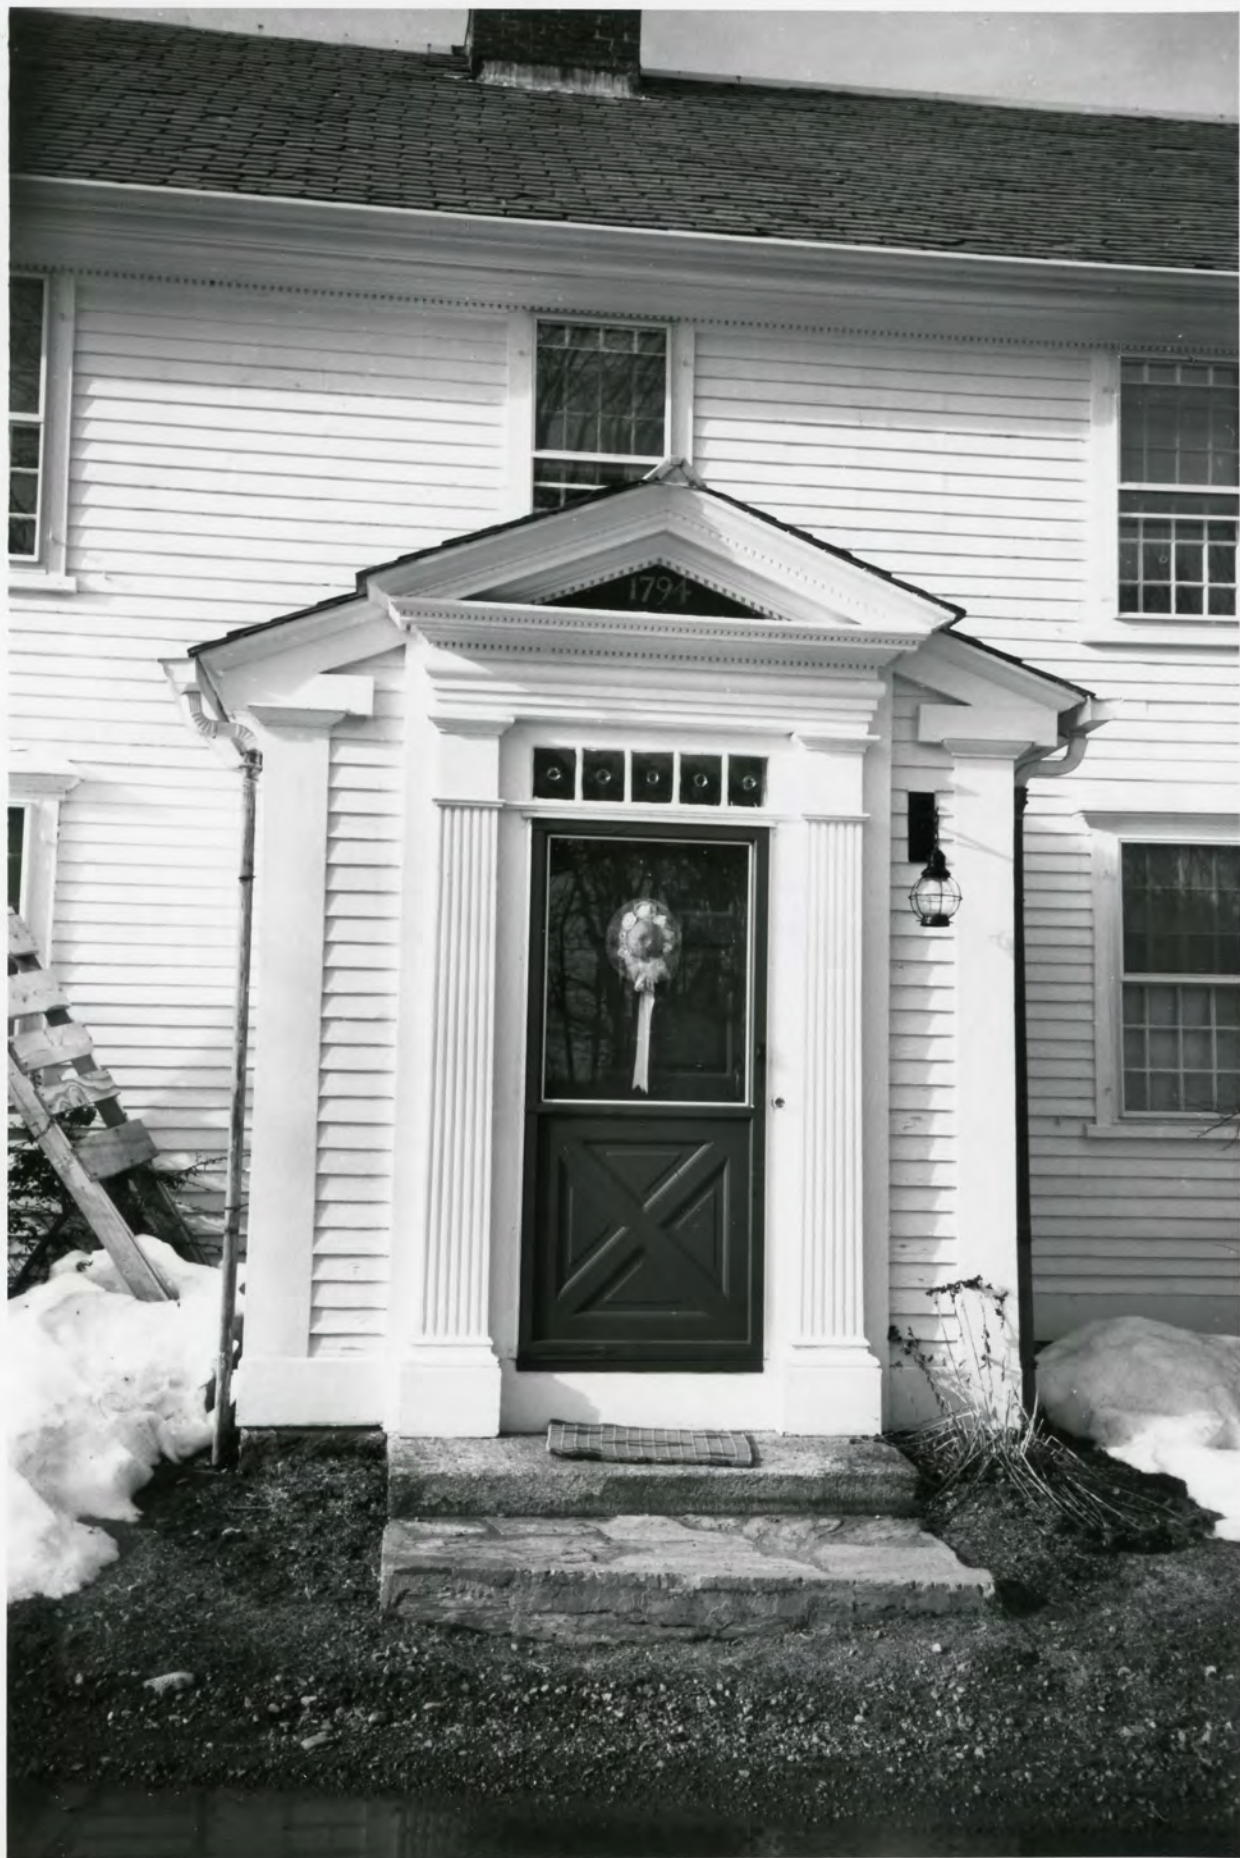
Photograph 3 of 7

View of vestibule, main house, looking north

Projecting from the center of the five-bay facade is a single story enclosed entrance porch. The six-panel door is capped by a transom consisting of five panes of bullseye glass while the surround consists of fluted pilasters with plain capitals supporting an entablature displaying a three part frieze, torus molding and dentil course, all of which is surmounted by a pediment decorated by dentils. Inside the pediment the date "1794" appears in gold letters on a black background. The sidewalls are clapboarded with a plain frieze, pilasters and cornice returns fashioned from 2 x 4 inch boards. A single twelve-over-twelve window lights each of the side elevations of the porch. The addition of a front porch appears to date to the 19th century, and late 19th century photographs in the possession of the Bullard family depict a broad pediment with plain frieze and pilasters. According to "Recollections and Reminiscences," the old pediment was carefully laid away and preserved in one of the farm buildings and was put back in place during the 1926 renovations.

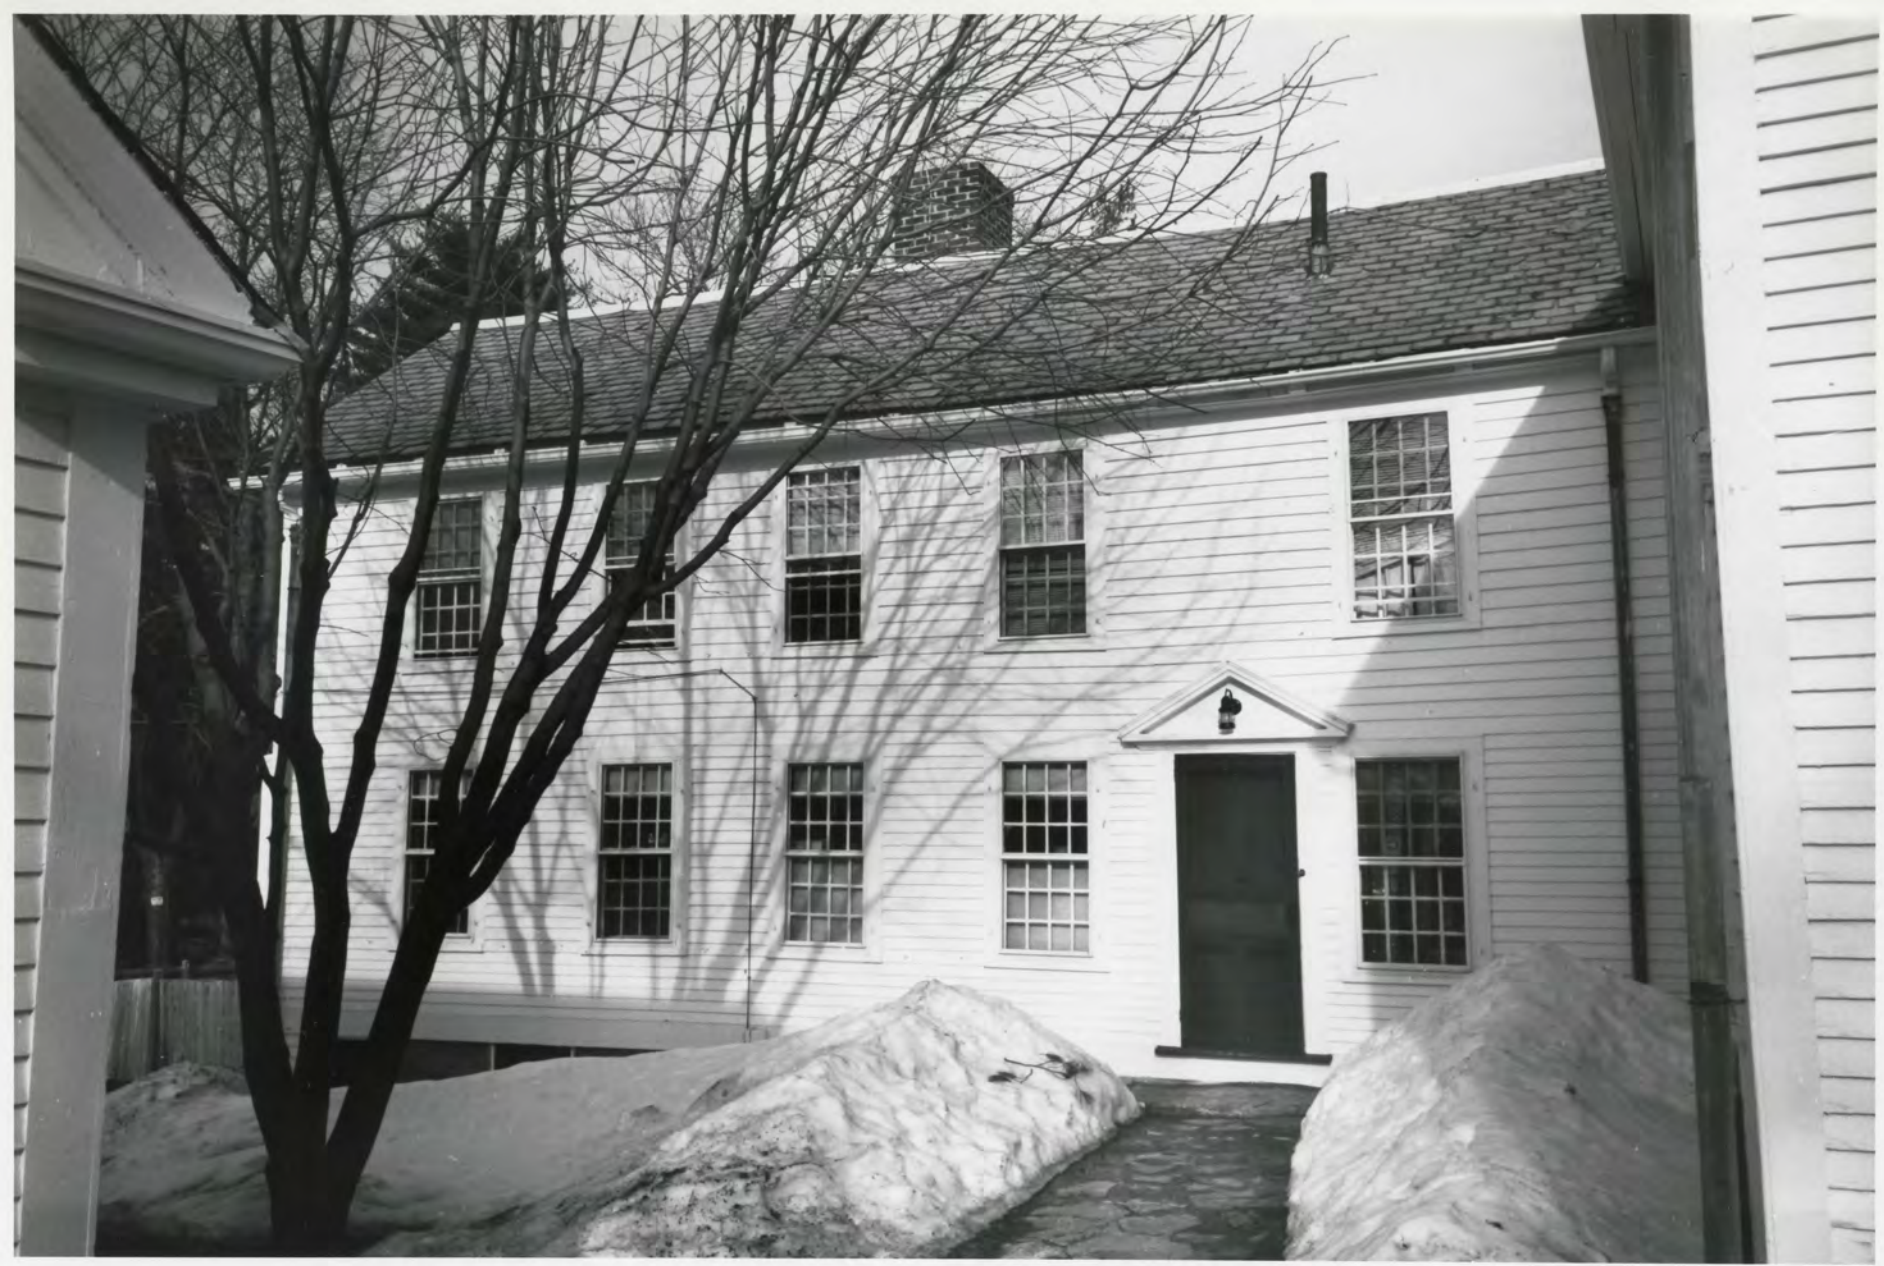
Photograph 4 of 7

View looking east at Main House ell

Extending behind the main house is a 2 1/2 story ell built in three stages and roughly aligned with the east wall of the main house. The ell is capped by a slate roof and punctuated by a tall, recently constructed chimney with arched cap, on the east slope. Prior to the addition of the back portion of the ell, this would have been an exterior chimney. The foundation under the portion of the ell closest to the main house is mortared fieldstone while that under the back portion of the ell is cut granite. On the eastern elevation, the mid section of the ell measures three bays wide. On the first floor there is a door with a surround decorated by channeled detailing and cornerblocks formed by paired narrow boards projecting from a wider board. Adjacent there are two individual twelve-over-eight windows while the second floor has three twelve-over-twelve windows, the tops of which extend to the plain frieze under the eaves. Projecting from the northernmost section on this elevation is a single story section lit by two twelve-over-twelve windows with plain surrounds. A gable wall dormer containing a single twelve-over-twelve window is centered on this section. On the west side, the ell

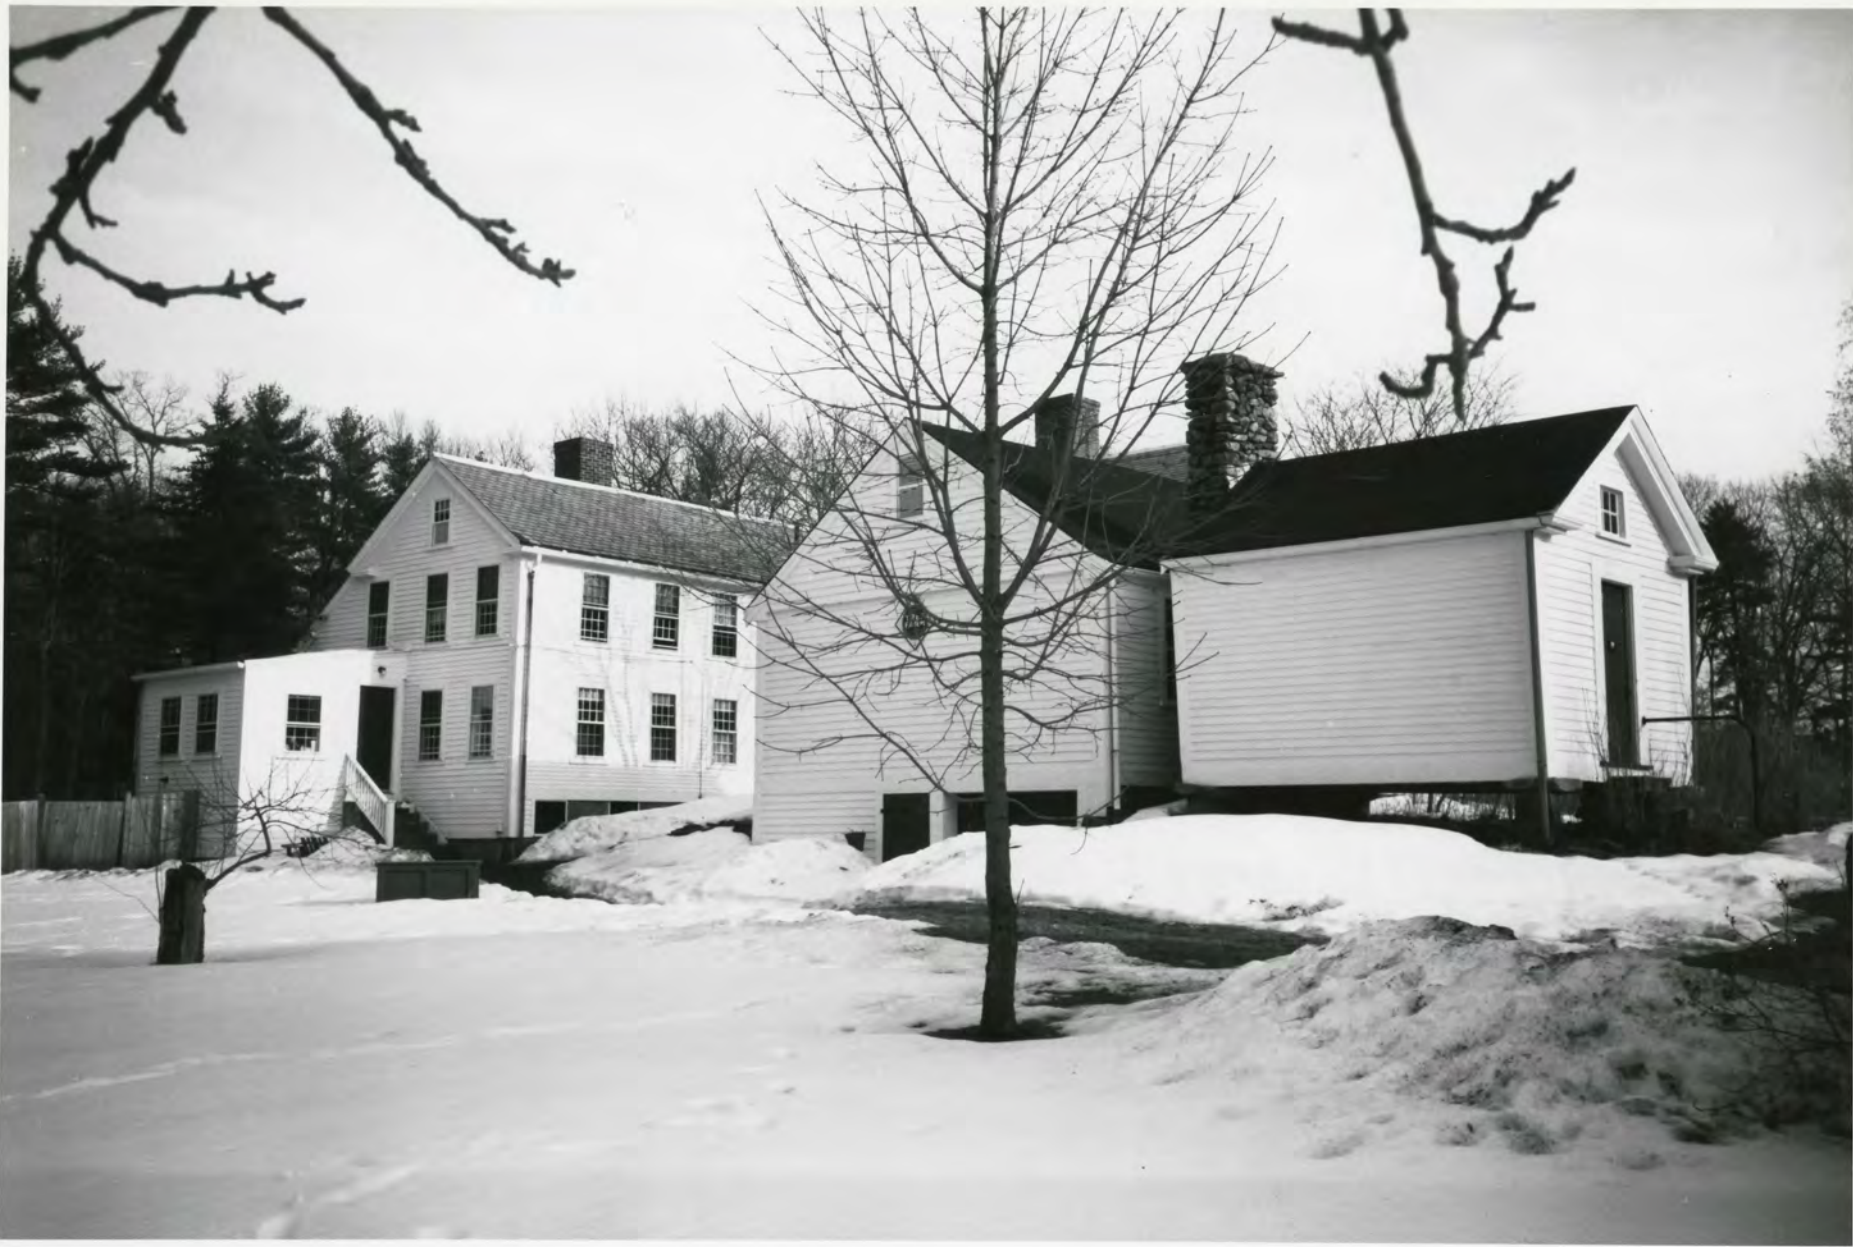
Photograph 5 of 7

View looking SE. From L to R: Closed in porch on back of ell,  
ell, rear of cider house, corn crib.

Behind the ell is a small porch addition thought to have been added in the early 20th century. The small shed roofed section consists of a single story raised above a basement level and rests on a concrete foundation. Both the east side and the back wall have two six-over-six windows while the west side features a single six-over-six window and a doorway atop concrete steps with a plain rail and square newel post.

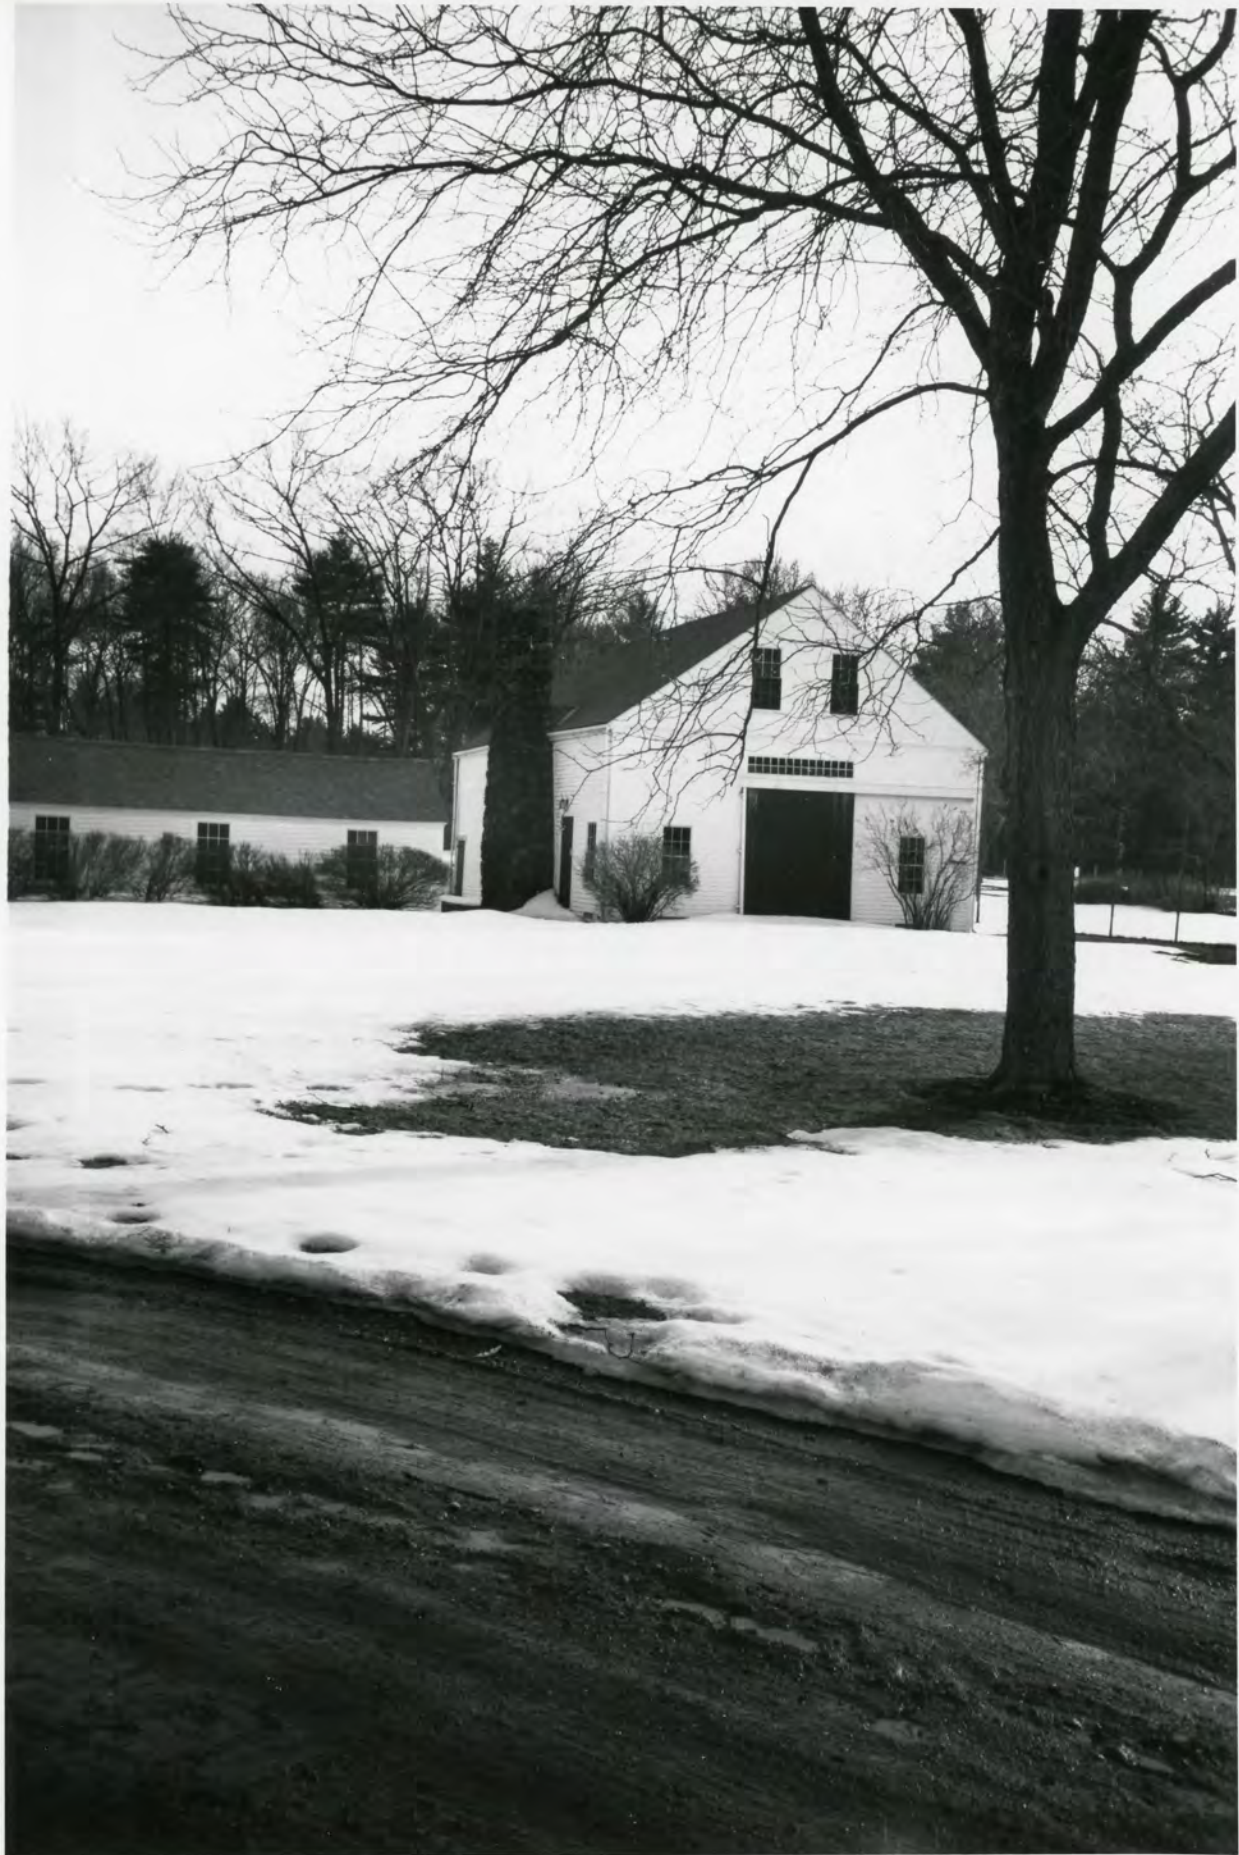
Barn; former chickenhouse (non-contributing) to left). View South-southwest.

Bullard Farm  
7 Bullard Lane  
Holliston, MA  
Photographer: John M. Kingsbury, March 1993  
Neg.: John M. Kingsbury  
Photograph 6 of 7  
View looking S-SW. From L to R: Locker House,  
Barn

Across the driveway from the main cluster of outbuildings is a large barn, of post and beam construction using hand-hewn white oak timbers. Originally located to the west of the main house, in 1926 the newer two-thirds of the existing barn was taken down and the remaining portion was moved about sixty feet south to its present location. The part which remains constitutes the older section, thought to have been built at about the same time as the main part of the house (1794). In its present appearance, the barn is oriented with its gablefront facing north. Dominating the facade is a large, central vertical board door capped by a two row transom light. The entrance is flanked by a six-over-six window on each side and two additional six-over-six windows in the pent end which displays flush eaves. On the west side there is an additional transomed central sliding door with two pairs of six-over-six windows to the north. The rear gable features three levels of windows including three long strips of multilight windows lighting the cattle stalls inside, two six-over-six windows above and two individual six-over-six windows in the pent end. The final elevation is dominated by a rubble exterior chimney, in addition to which there are two vertical board doors and two individual six-over-six windows. Inside, a hardwood floor and fieldstone fireplace corresponding to the stone chimney were added during the 1926 renovations. The original cattle stalls, including eight stanchions, were also retained and a bowling alley was added.

To the east of the barn, and set at right angles is a single story clapboarded structure constructed as a hen house and later adapted for use as a locker room in the early 20th century. A photograph taken about 1927, after the restoration, shows the locker building, much as it appears today. Measuring roughly twenty five feet by eleven feet the building rests on a fieldstone foundation and is capped by an asphalt roof. There are three six-over-six windows on both the north and south elevations. A vertical door on the south side accesses one locker room while the other is entered through a doorway on the east end.

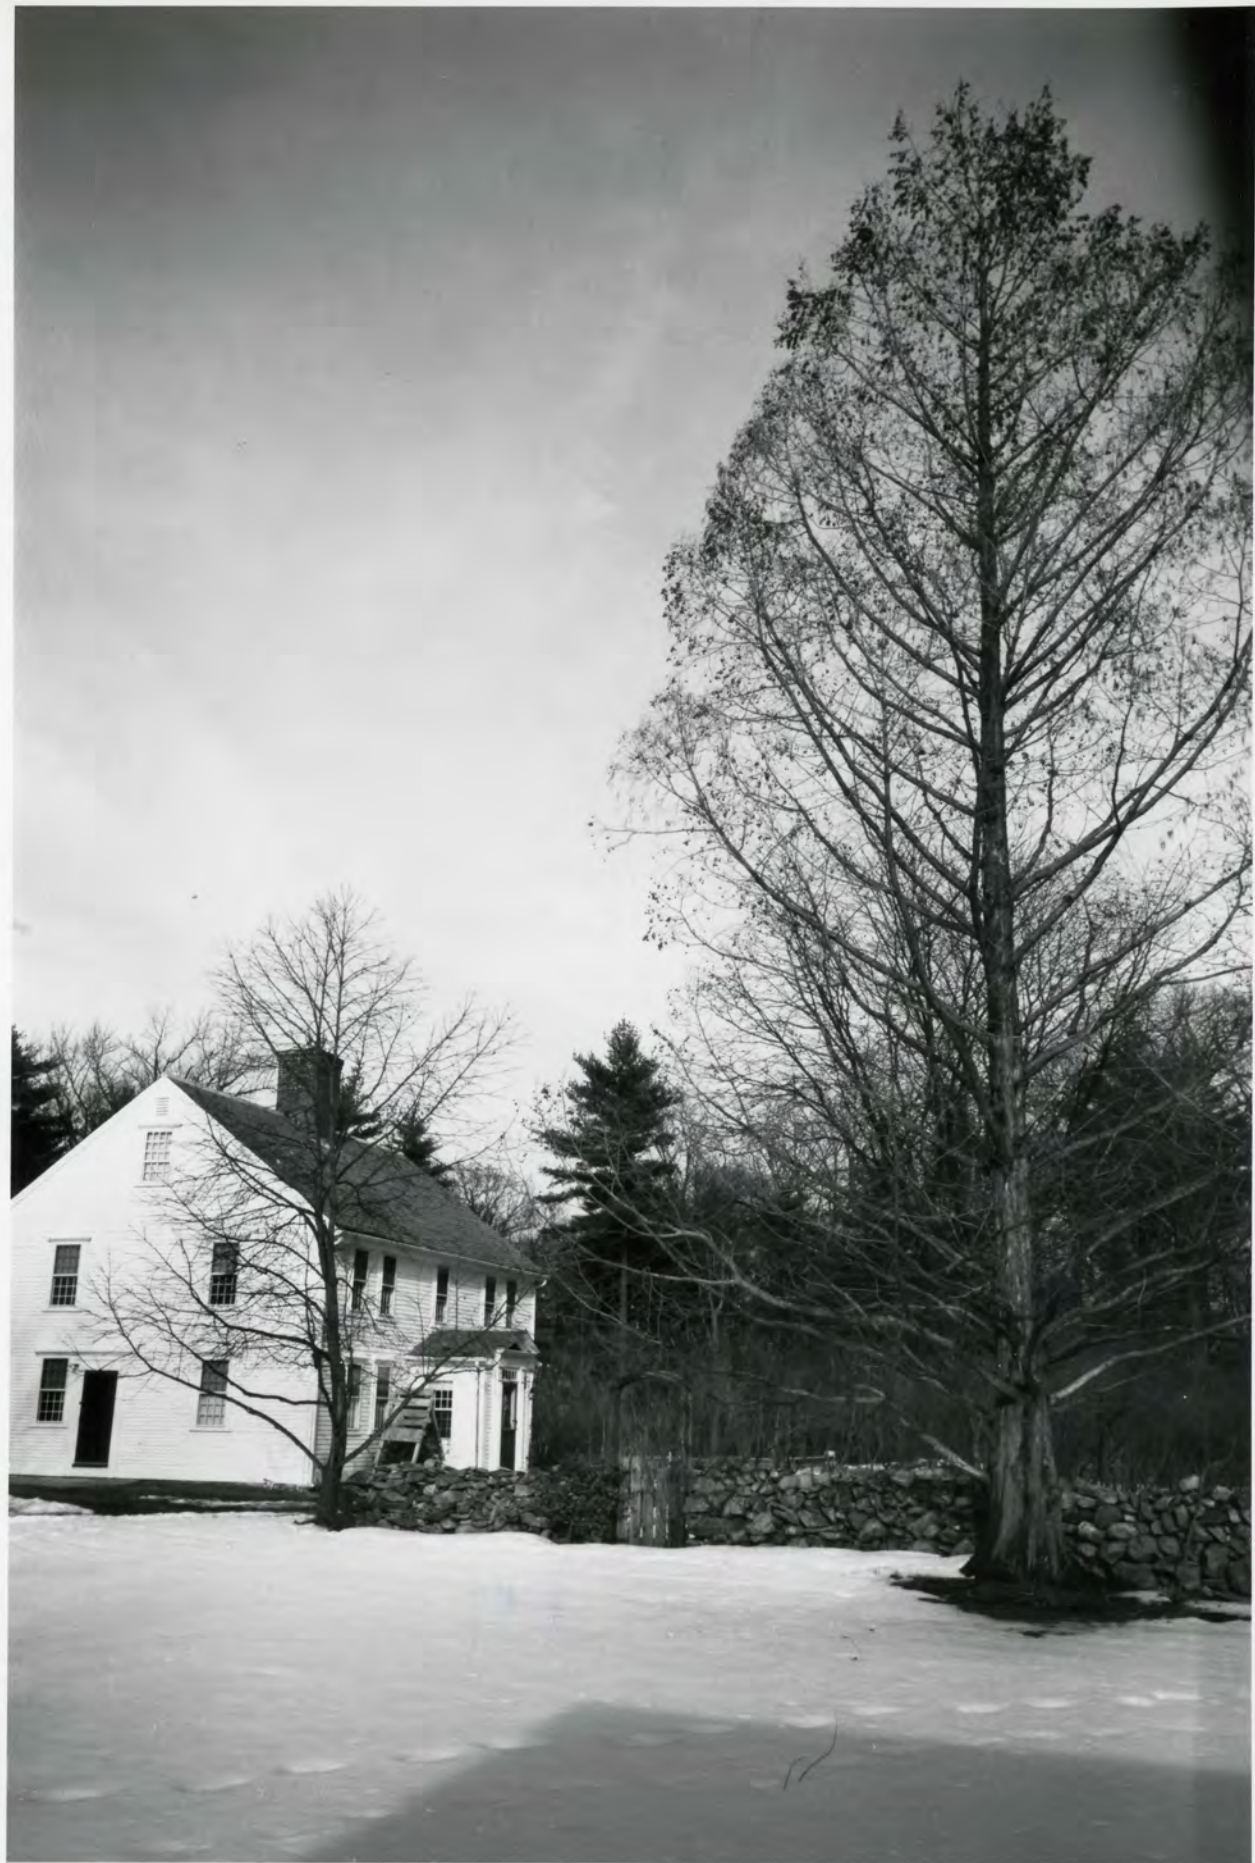
Photograph 7 of 7

View looking east-NE. From L to R: Main house, *metasequoia glyptostroboides* (Dawn Redwood from China) planted in 1948.
