National Register of Historic Places Registration Form

1. Name of property:	Beaver Mill	
historic name: N/A		
other names/site number:	N/A	
2. Location:		
street & number : West	Webster Road

BEAVER MILL Nicholas County, West Virginia

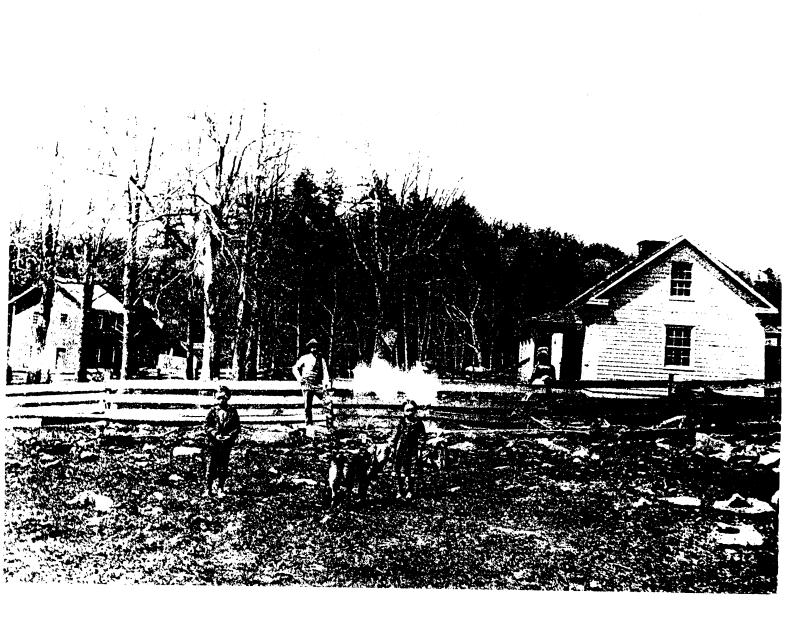
Beaver Mill and Farmhouse Historic Photograph provided by Nicholas County HLC

The building itself is also typical for mill construction of the period. It is a mortised and tenoned, timber frame building with wood studding on the exterior of the timber frame. Vertical board and batten siding is extant on the rear, water side, elevation and this may be the original siding. The other three sides have horizontal clapboard siding, which is visible in a historic photograph.
