National Register of Historic Places
Inventory—Nomination Form

Greenville Commercial Historic District

Greenville Commercial District - Individual Property Descriptions

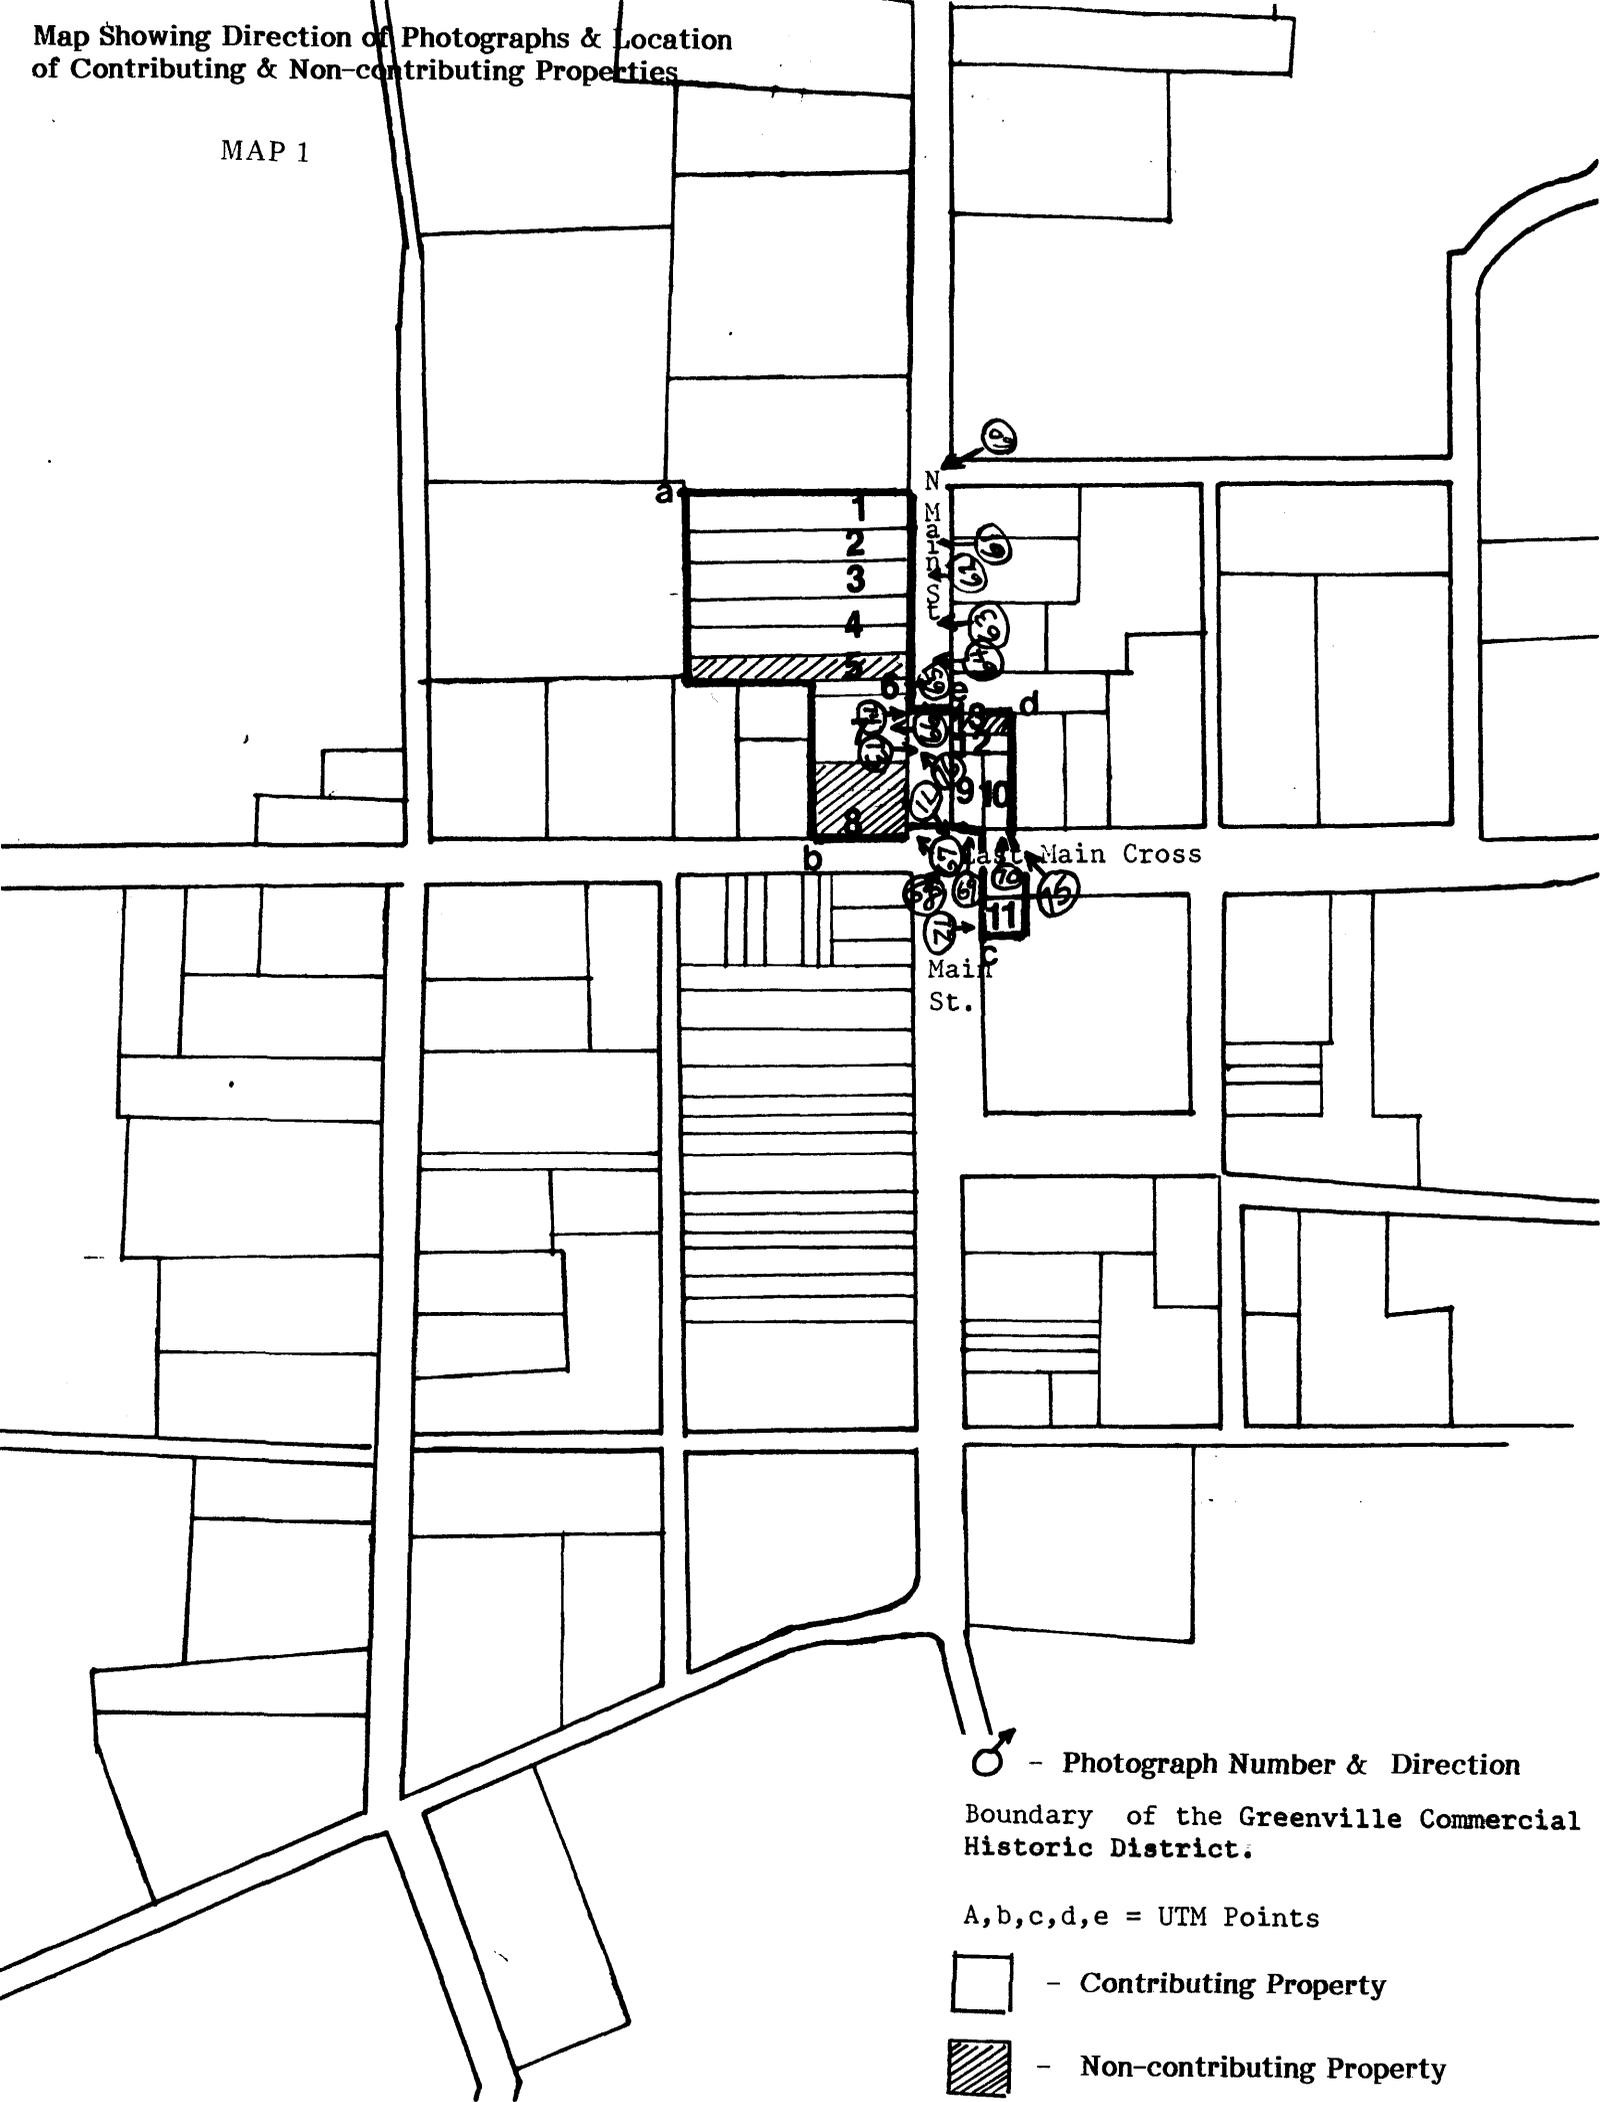
MAP 1

Map Showing Direction of Photographs & Location of Contributing & Non-contributing Properties
