National Register of Historic Places
Registration Form

historic name Walker Bank Building

Walker Bank Building, Salt Lake City, Salt Lake County, UT

The Walker Center Building is a 16-story steel frame skyscraper of the three-part vertical block type. The exterior is clad in granite, terra cotta, and tan brick, and the foundation is granite. Above the 16th story is a three-story tower inset from the main tower, containing the elevator shaft, an observation platform that is 225 feet above sidewalk level, and the neon Walker Center sign. Construction on the building began in November of 1911 and was completed in 1912. Upon its completion, the building was the tallest in Salt Lake City. Located on Main Street, in the heart of downtown Salt Lake City, the building occupies the northeast corner lot of the Main Street and 200 South Street intersection. The principal façade fronts west onto Main Street, with the secondary façade facing south on 200 South Street. The base part of the building is rectangular in shape with the upper parts above the fifth story forming an “L” shape. Constructed for the Walker Brothers Bank, the building was known as the Walker Bank Building until 1981. The

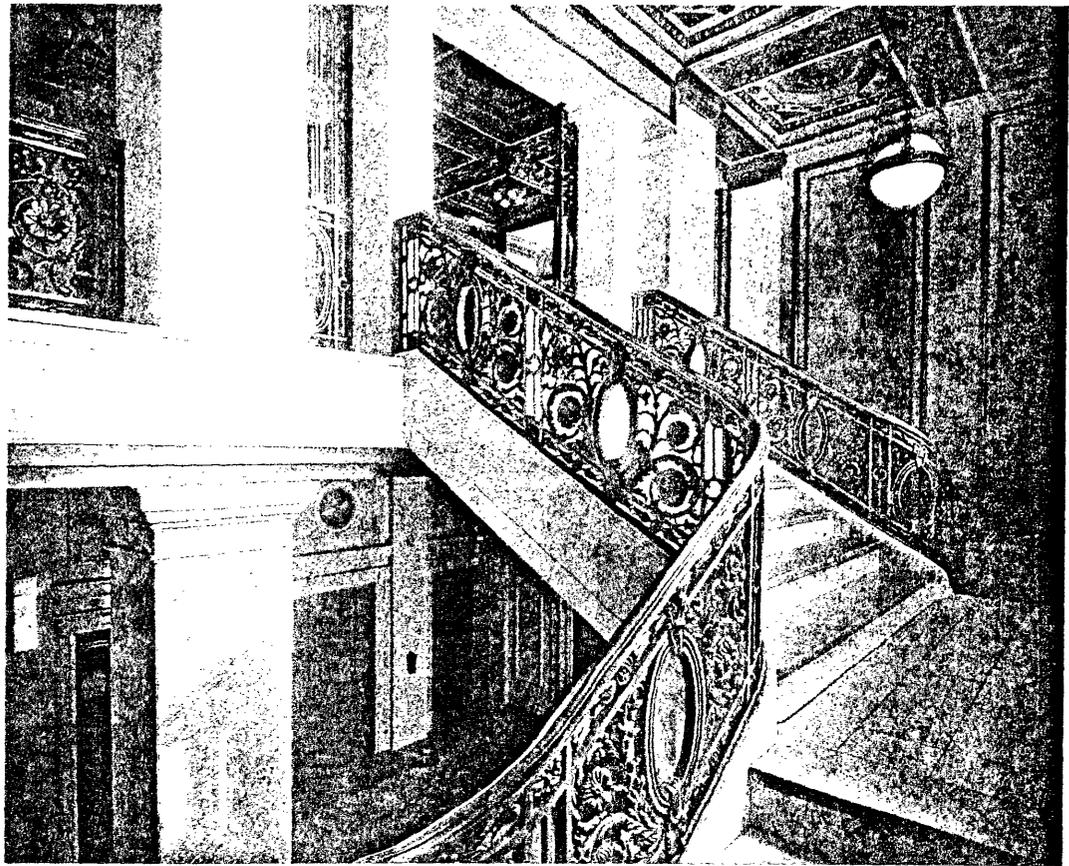
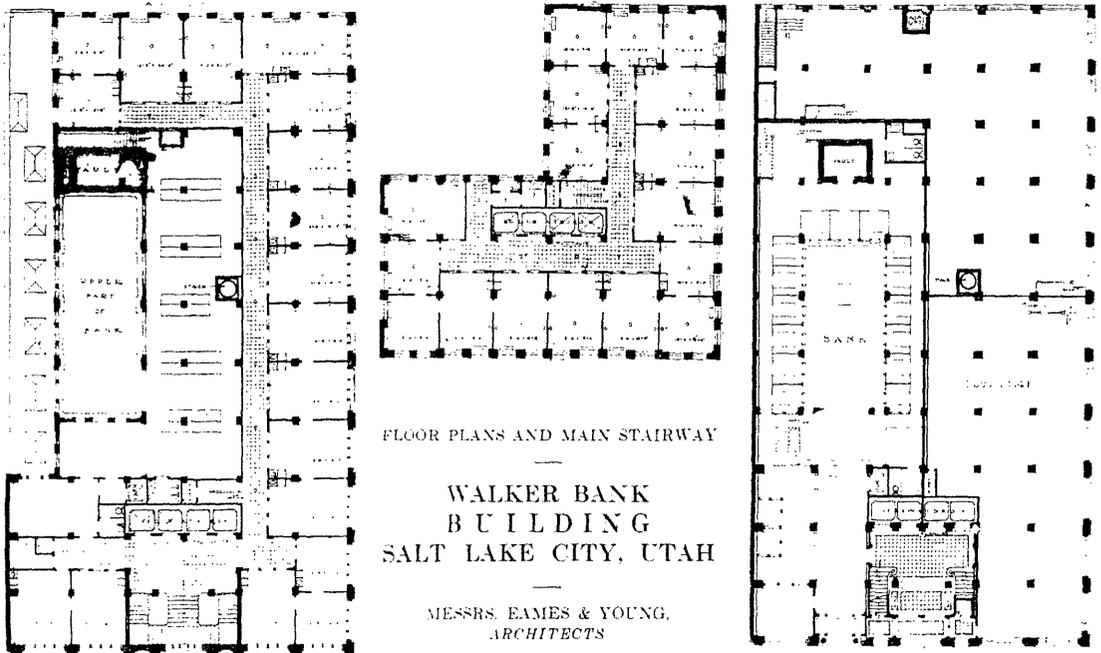
FLOOR PLANS AND MAIN STAIRWAY

WALKER BANK
BUILDING
SALT LAKE CITY, UTAH

MESSRS. EAMES & YOUNG,
ARCHITECTS

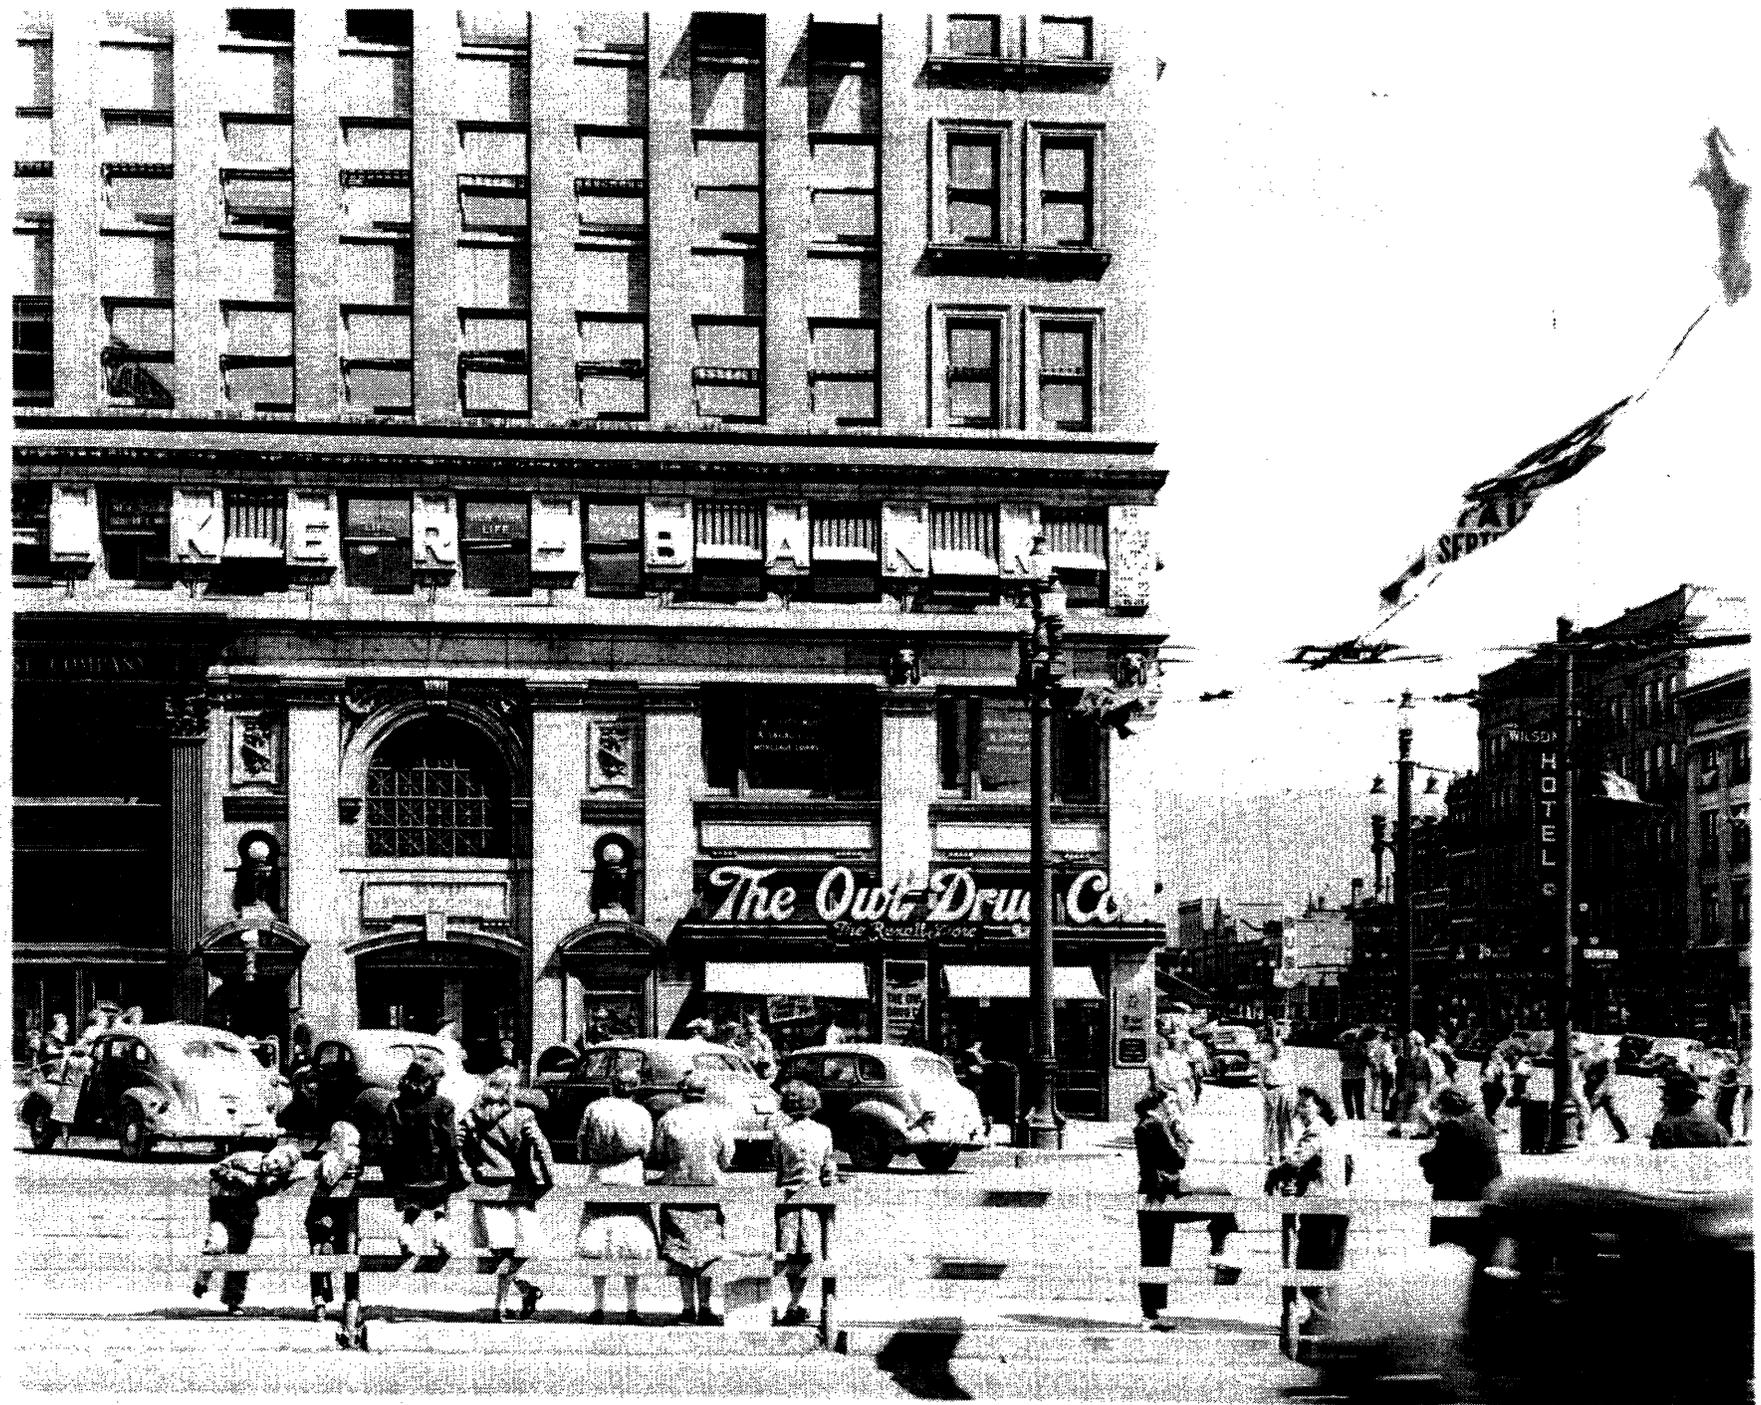
26104

Main Street showing buildings
from The Owl Drug to Walker
Bank, Aug. 30, 1943.
Shipler Comm. Photog. #39845.

⁴ Photographic documentation, Shipler Commercial Photograph Collection, #39845 and #39846, Utah State Historical Society

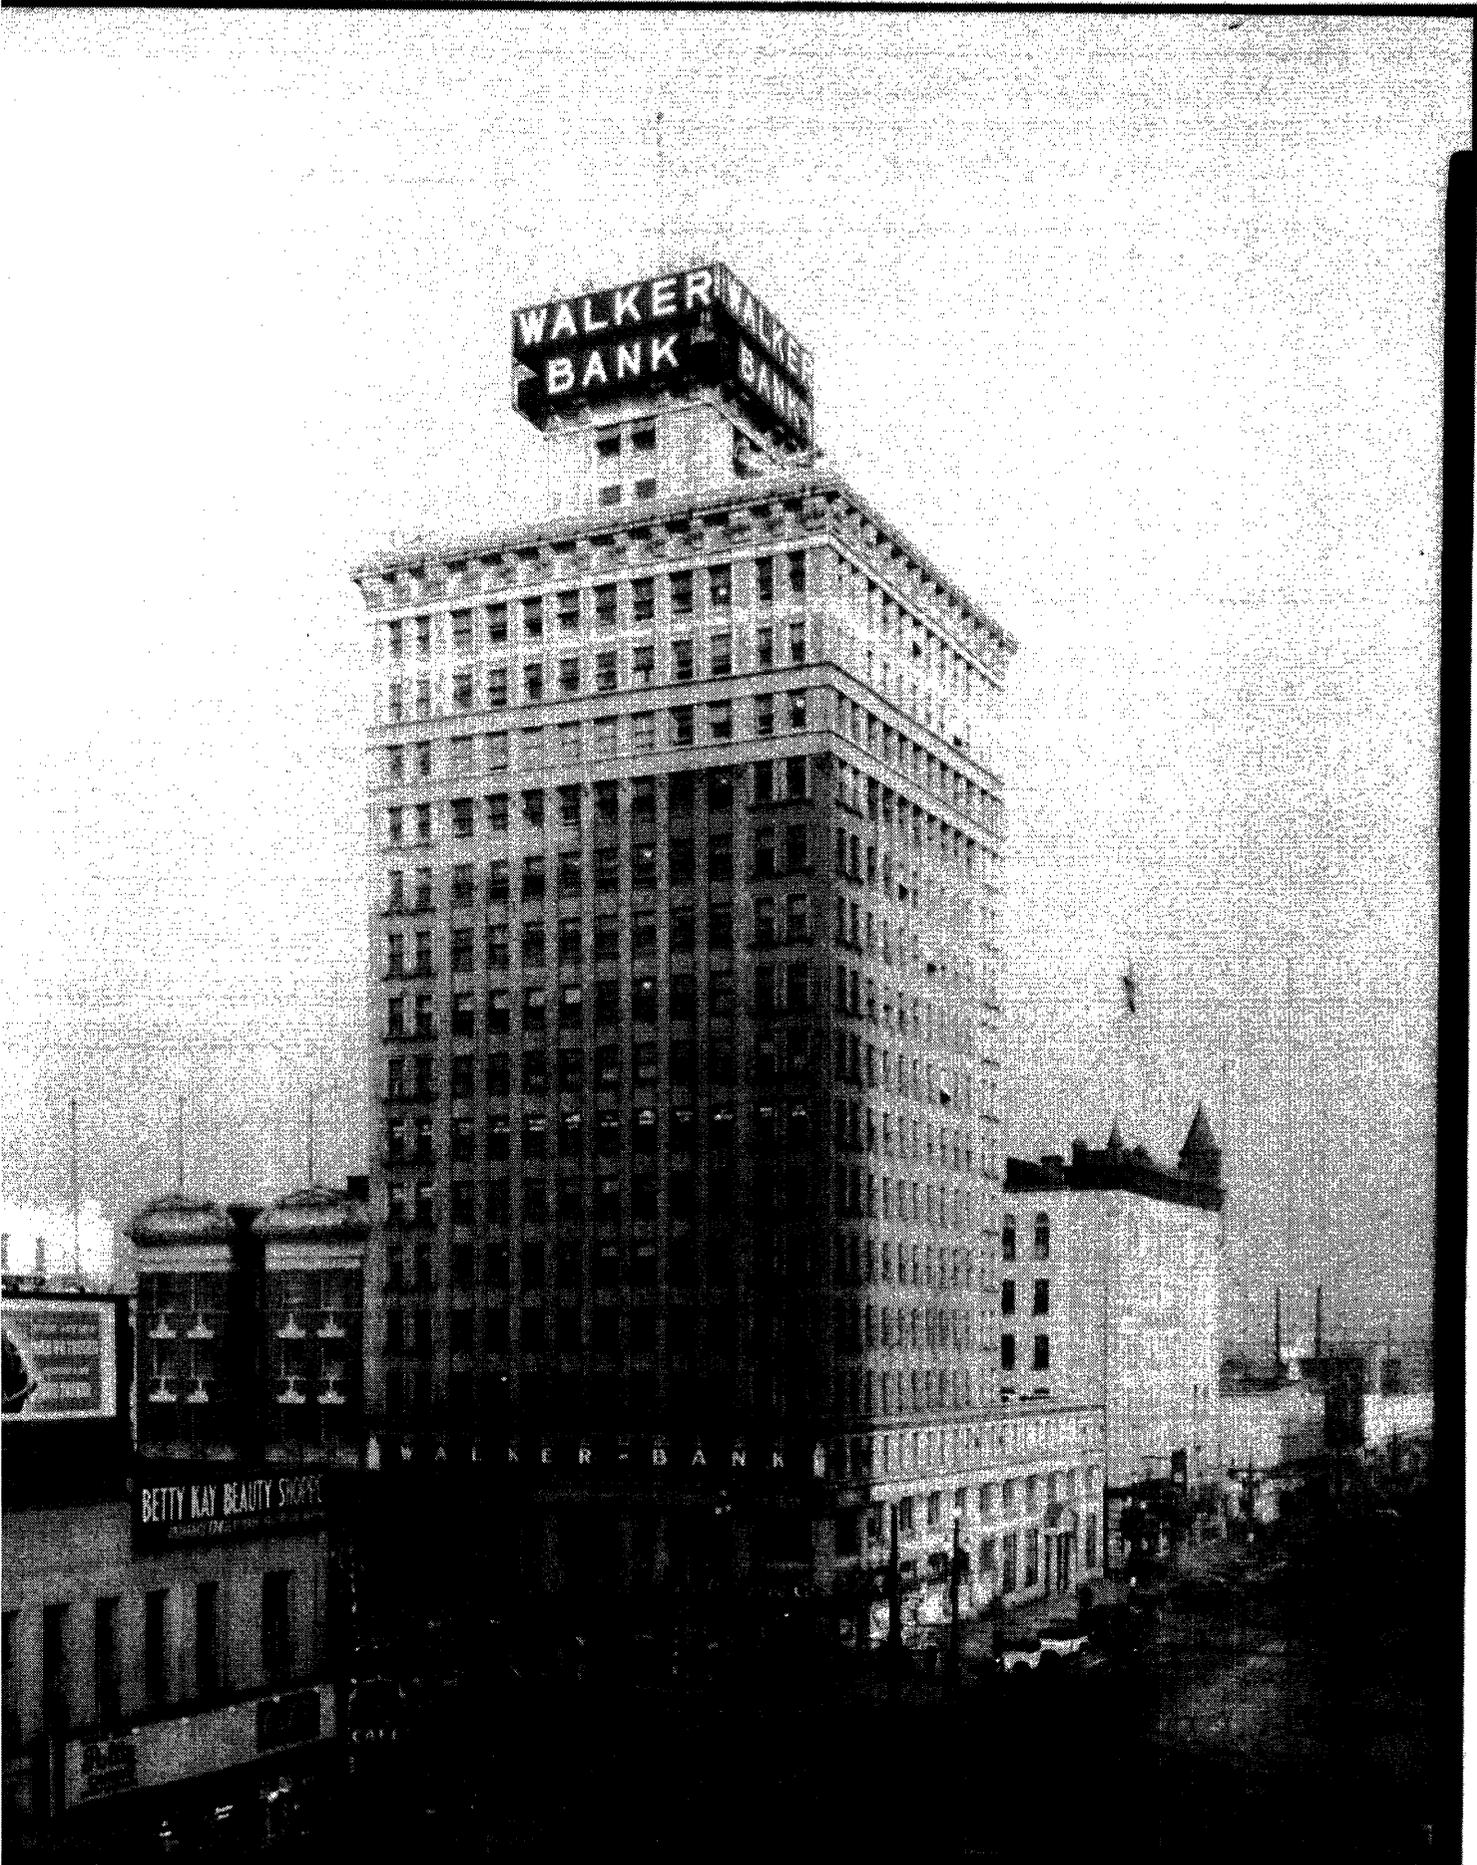
26356
Walker Bank Building, March,
1938.
Bray Photog. #1148-D.

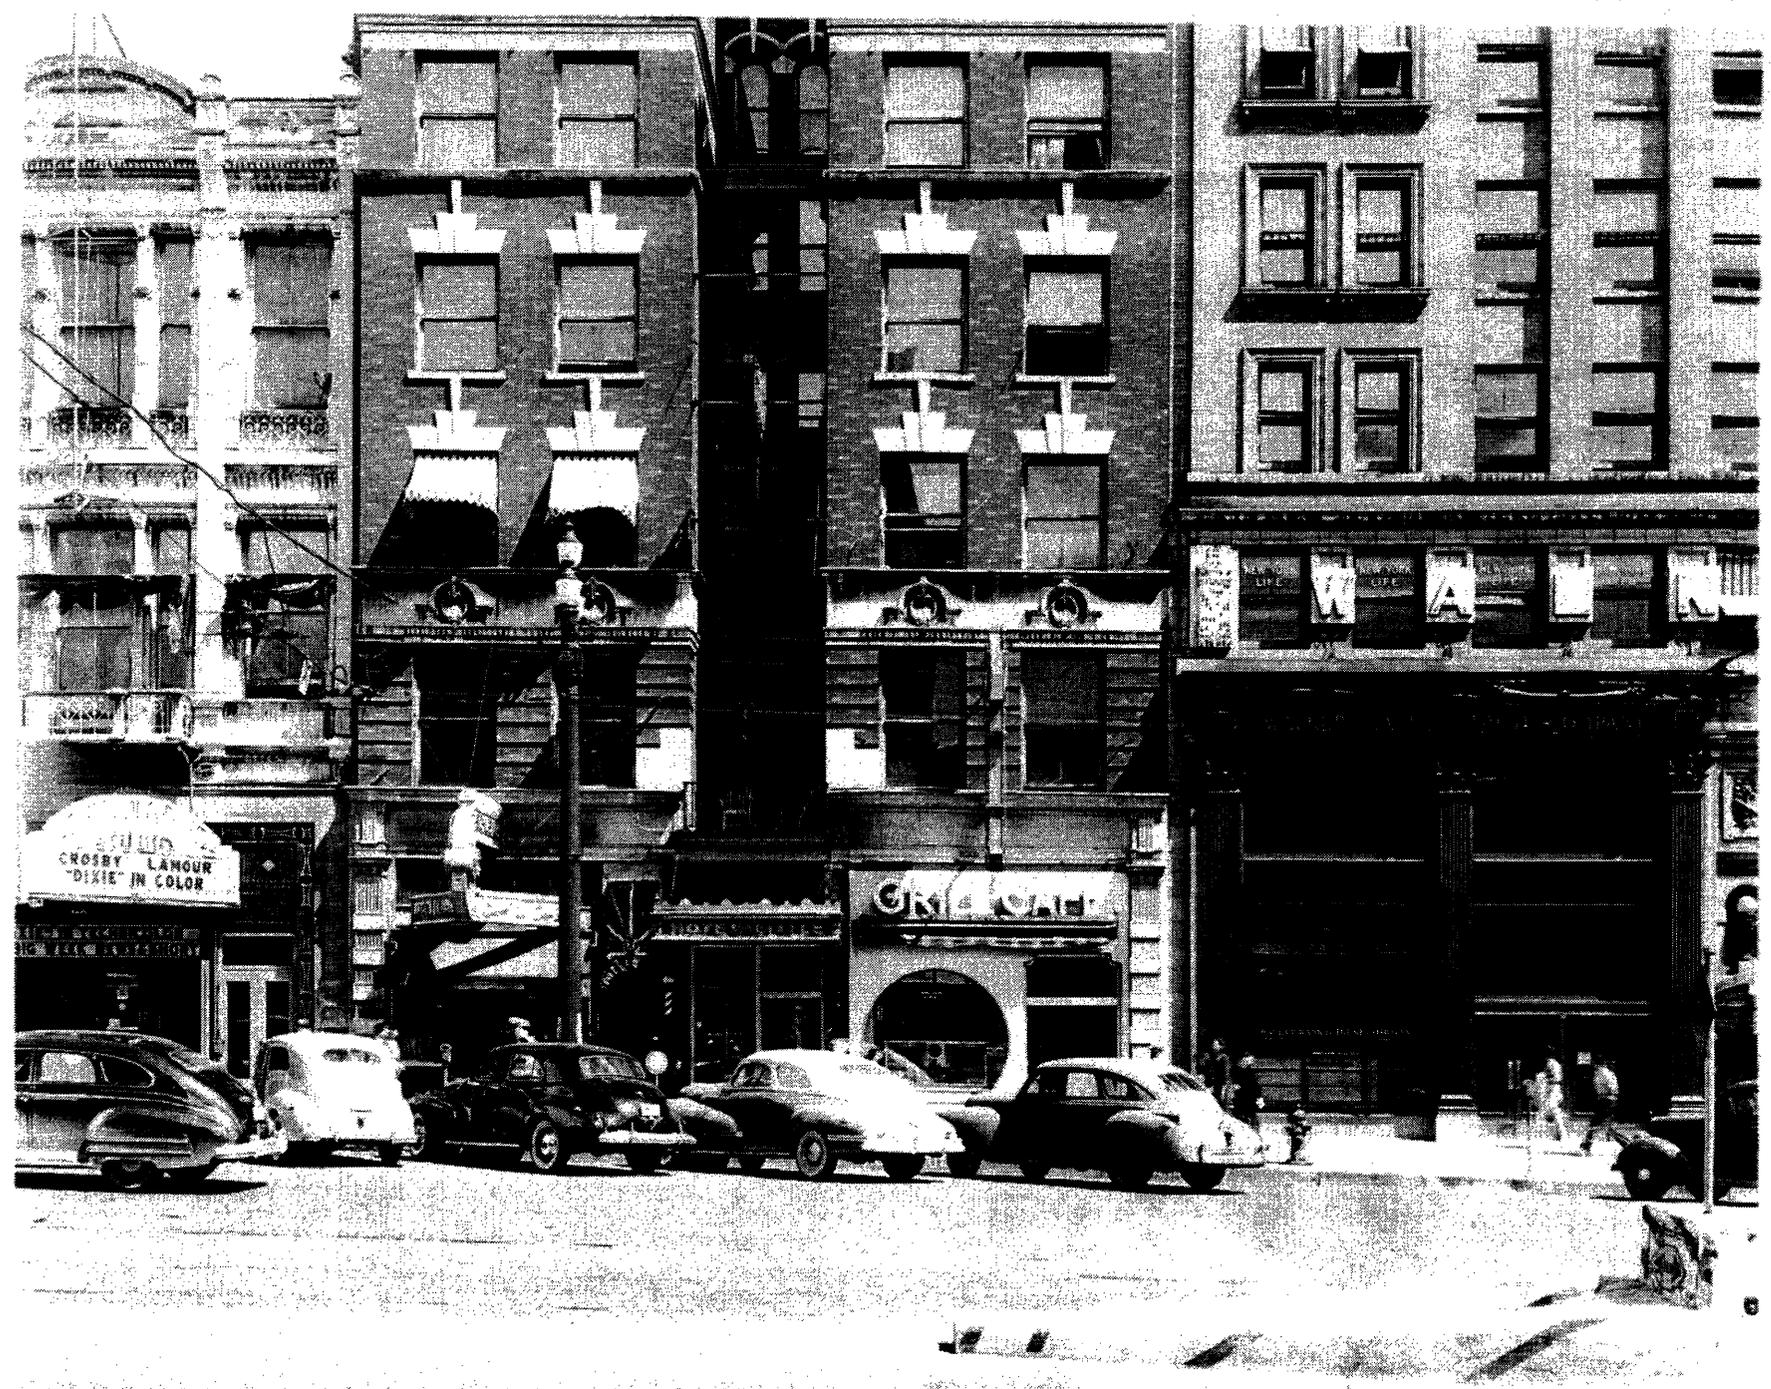
26103
Main Street: Walker Bank to
the Studio Theatre, Aug. 30,
1943.
Shipler Comm. Photog. #39846.
