Name: Eratt House

Location: Near Bridgeville, Sussex County, DE

Photographer: Richard B. Carter

Date: Dec., 1981

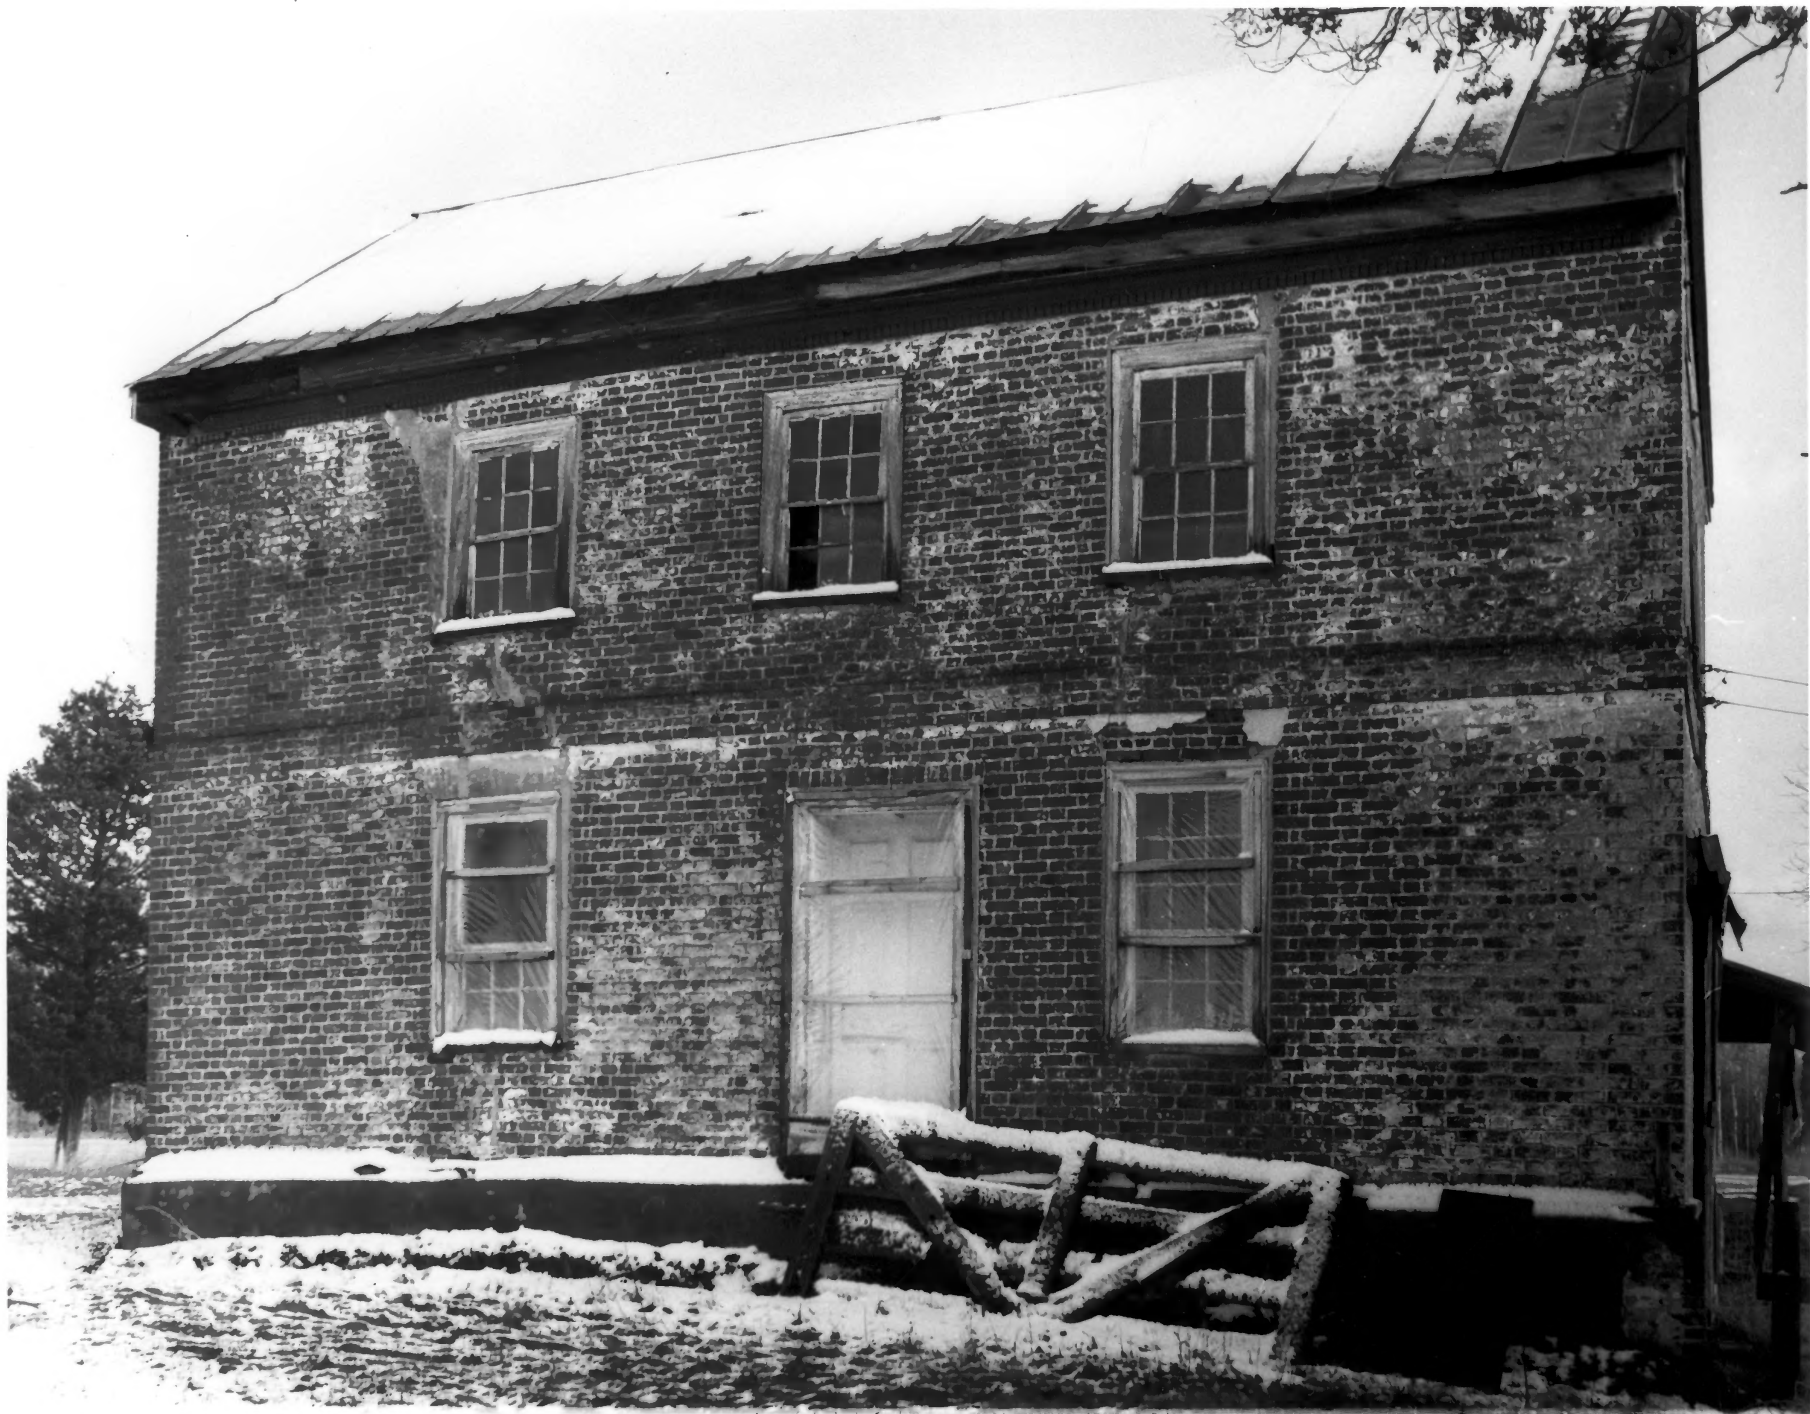
Photograph Number: 1 of 7

Description: Facade view of the Eratt House

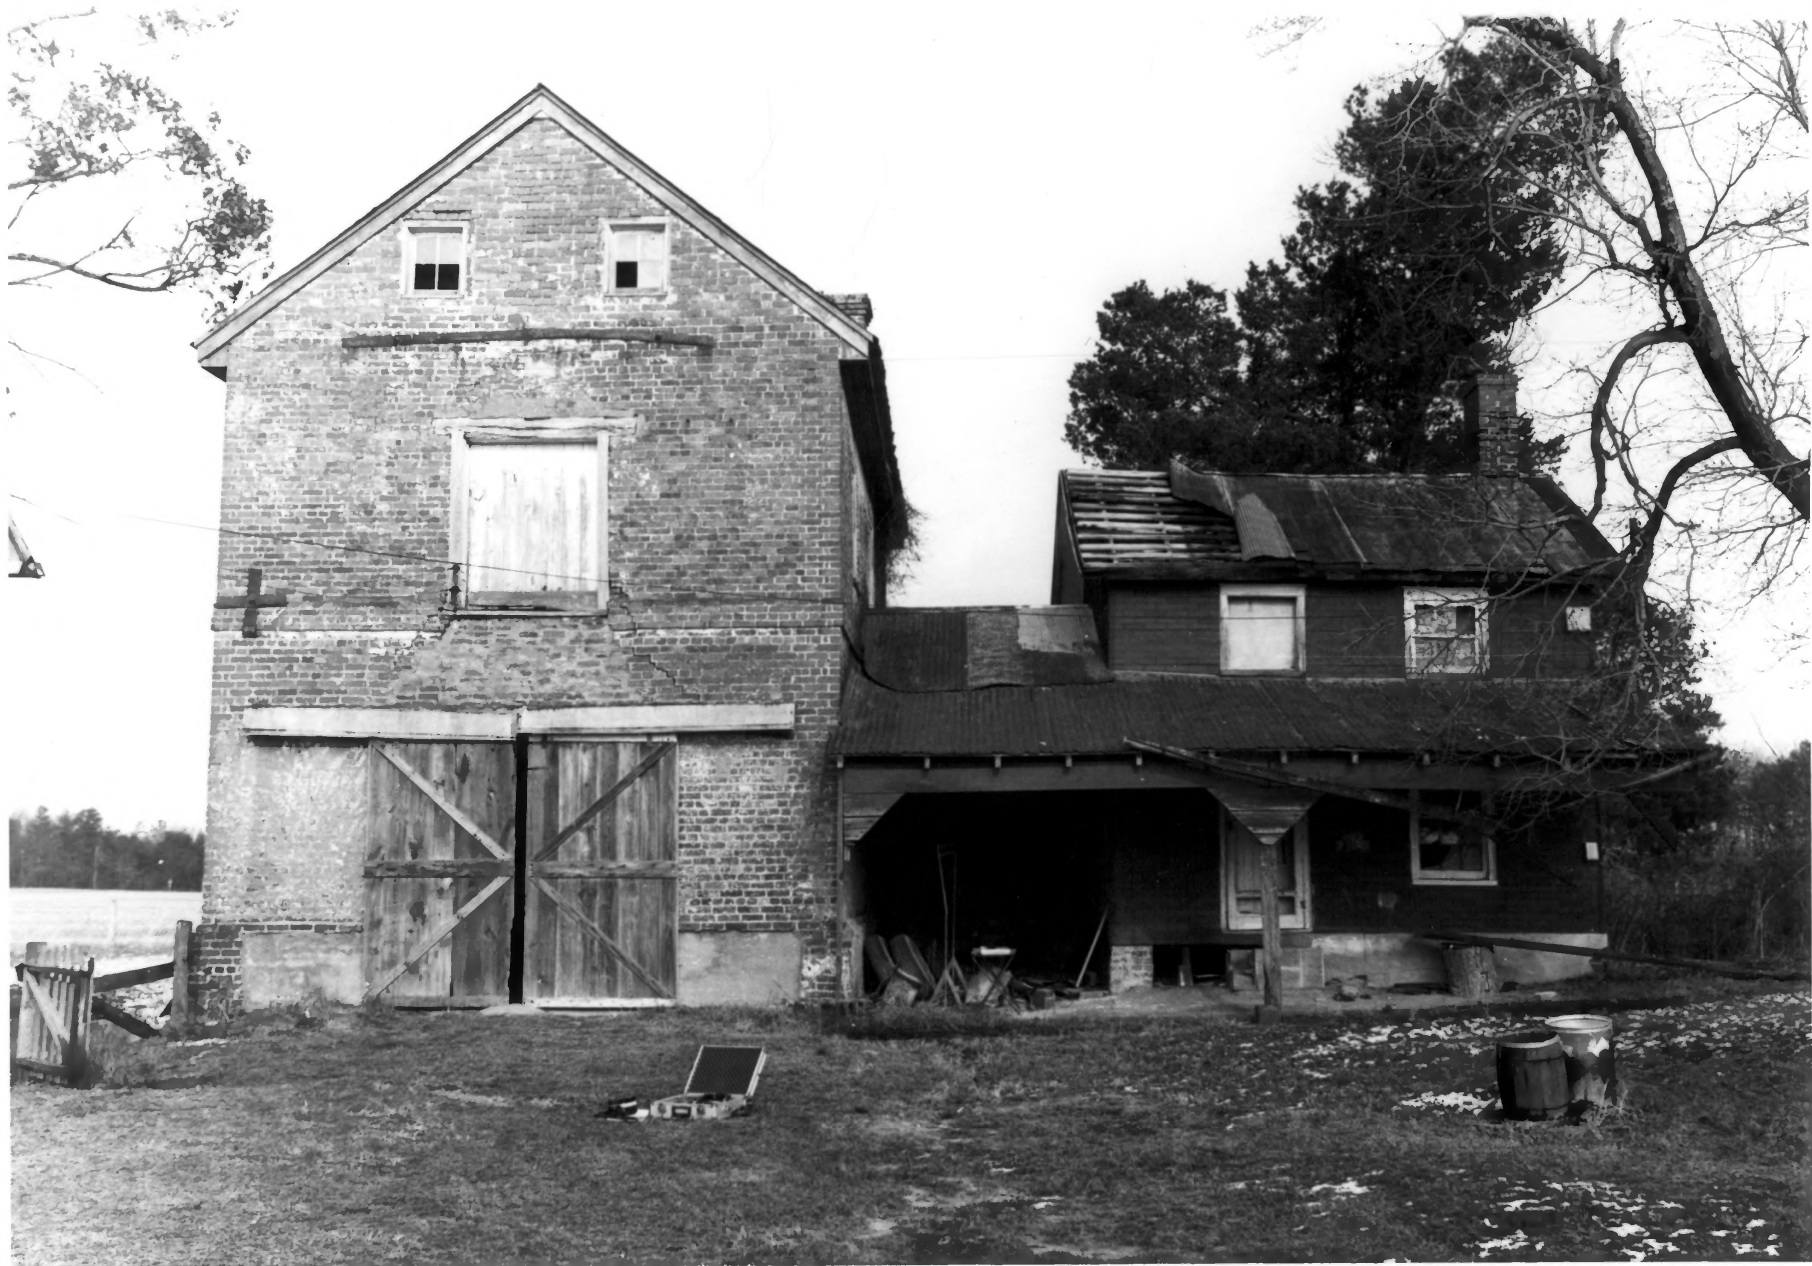
Photograph Numbers: 2 of 7

Description: View of south side of house showing conversion of first floor to a garage, and rear frame wing.

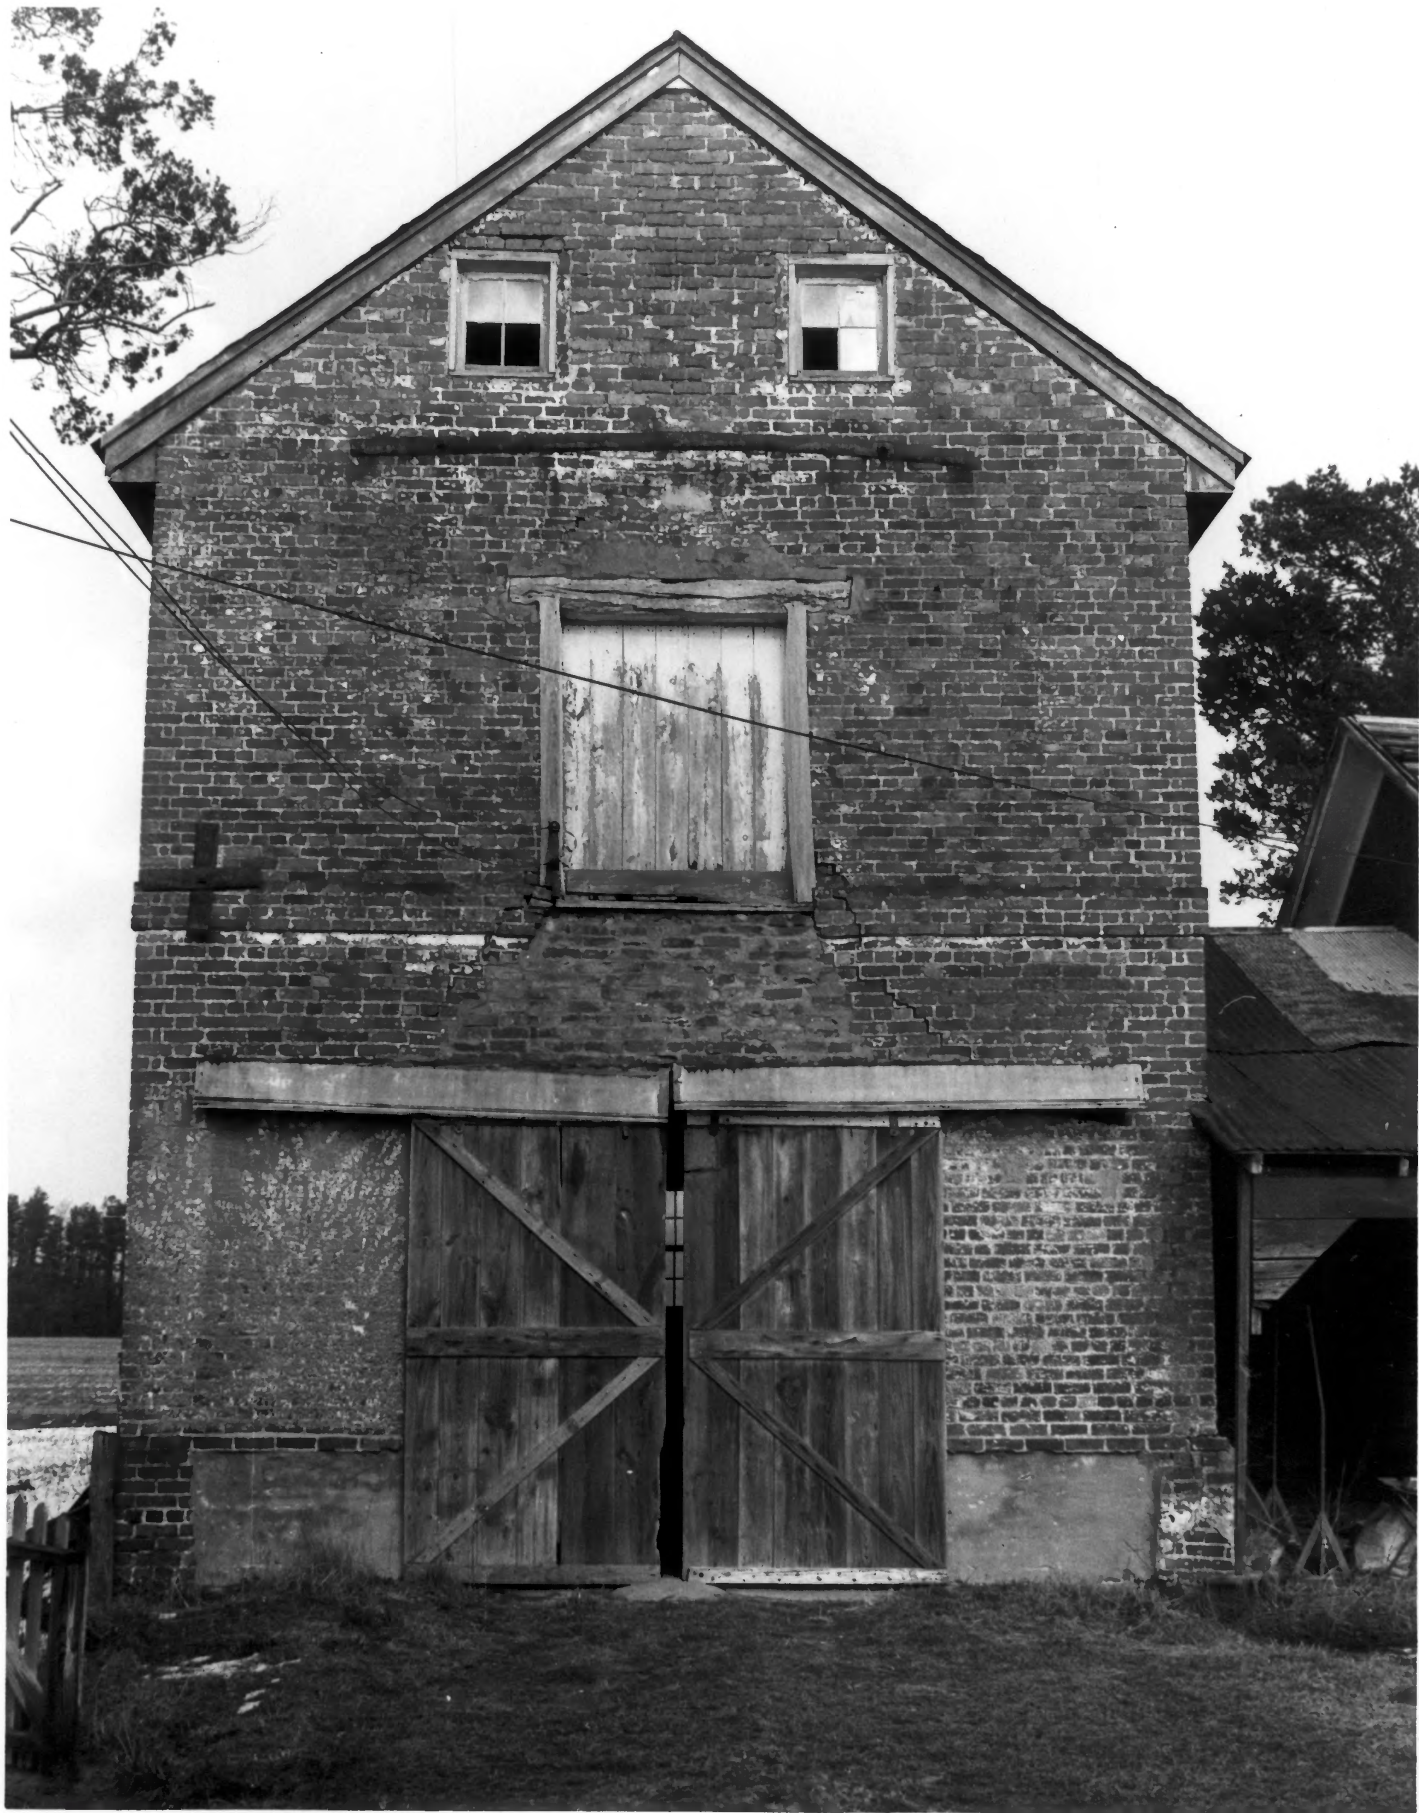
Photograph Number: of brickwork.
3 of 7

Description: View of south side of house
showing details of major
alteration to house and details

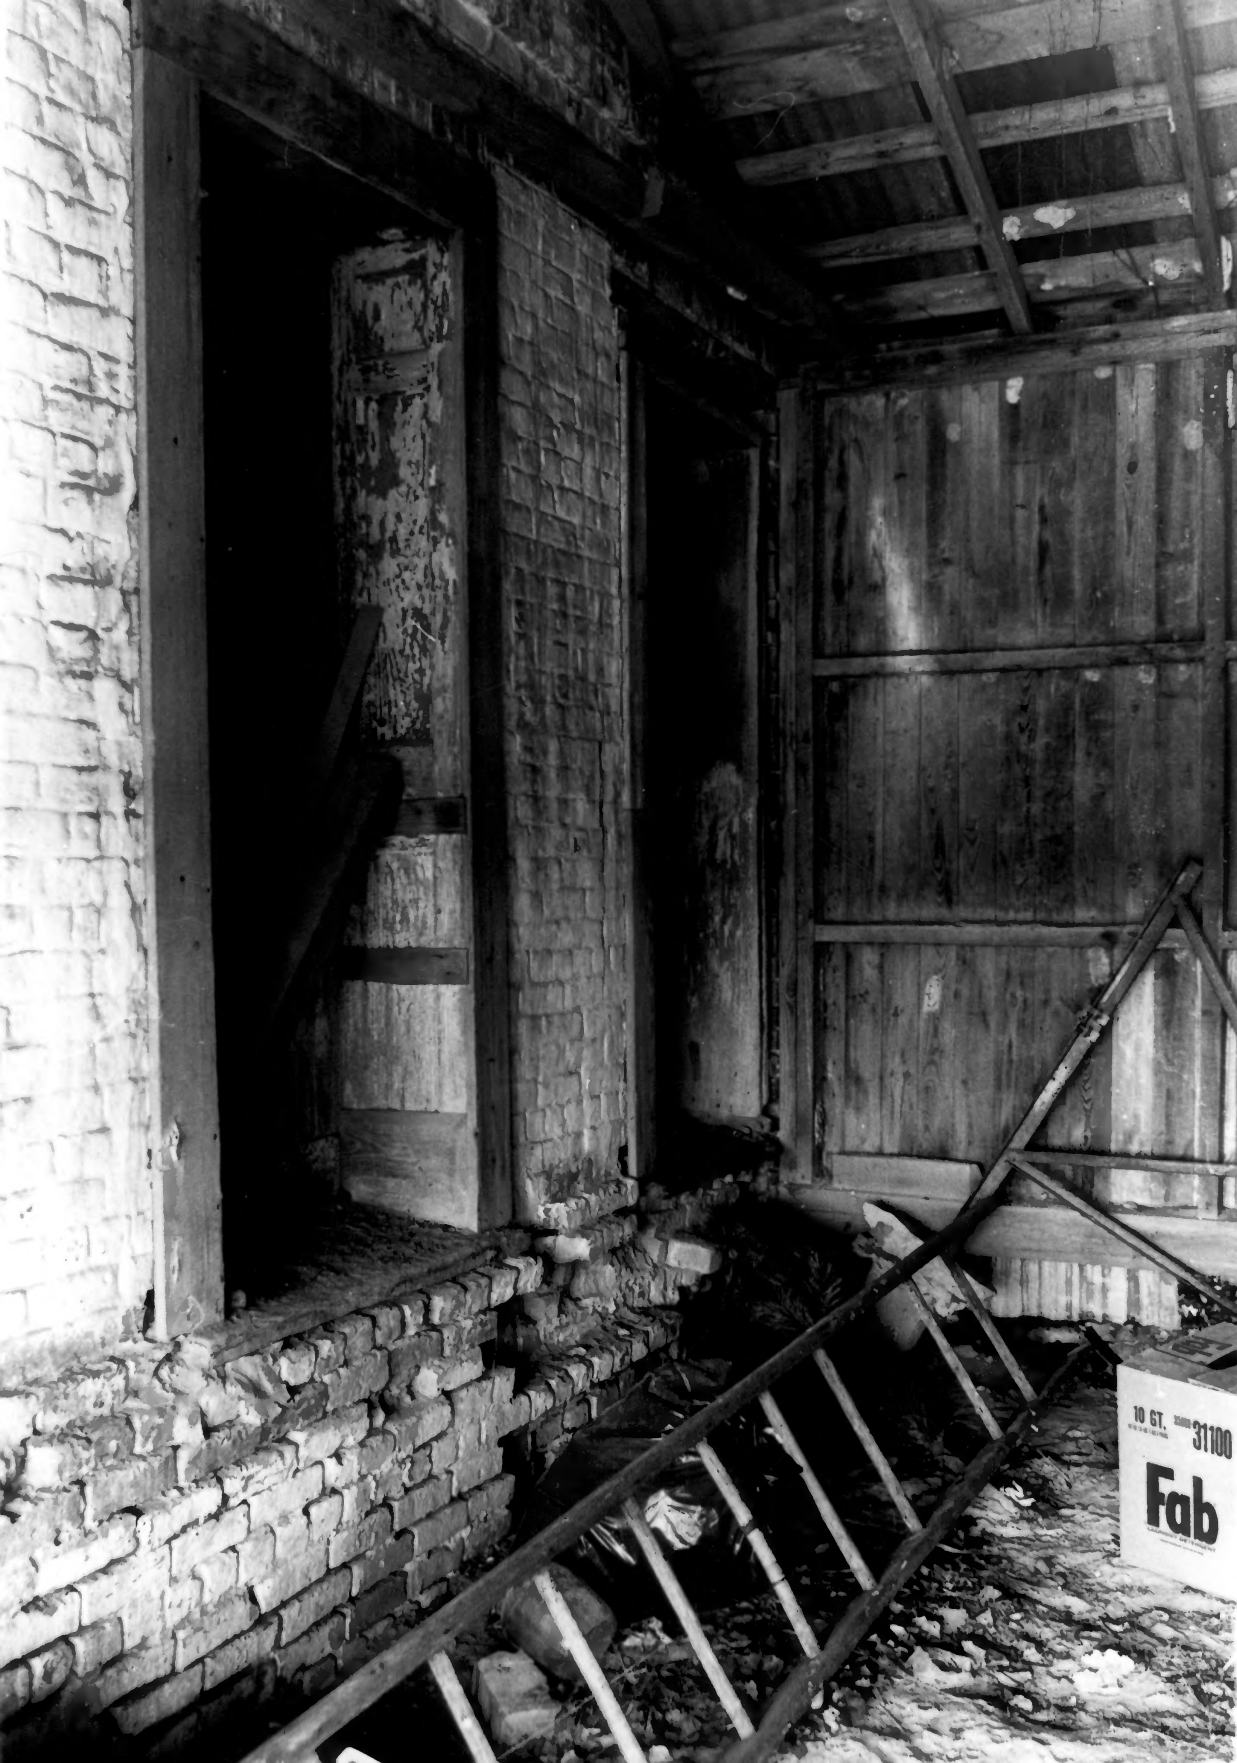
4 of 7

Description: View of rear of house under
wooden shed addition, showing
two rear doorways.

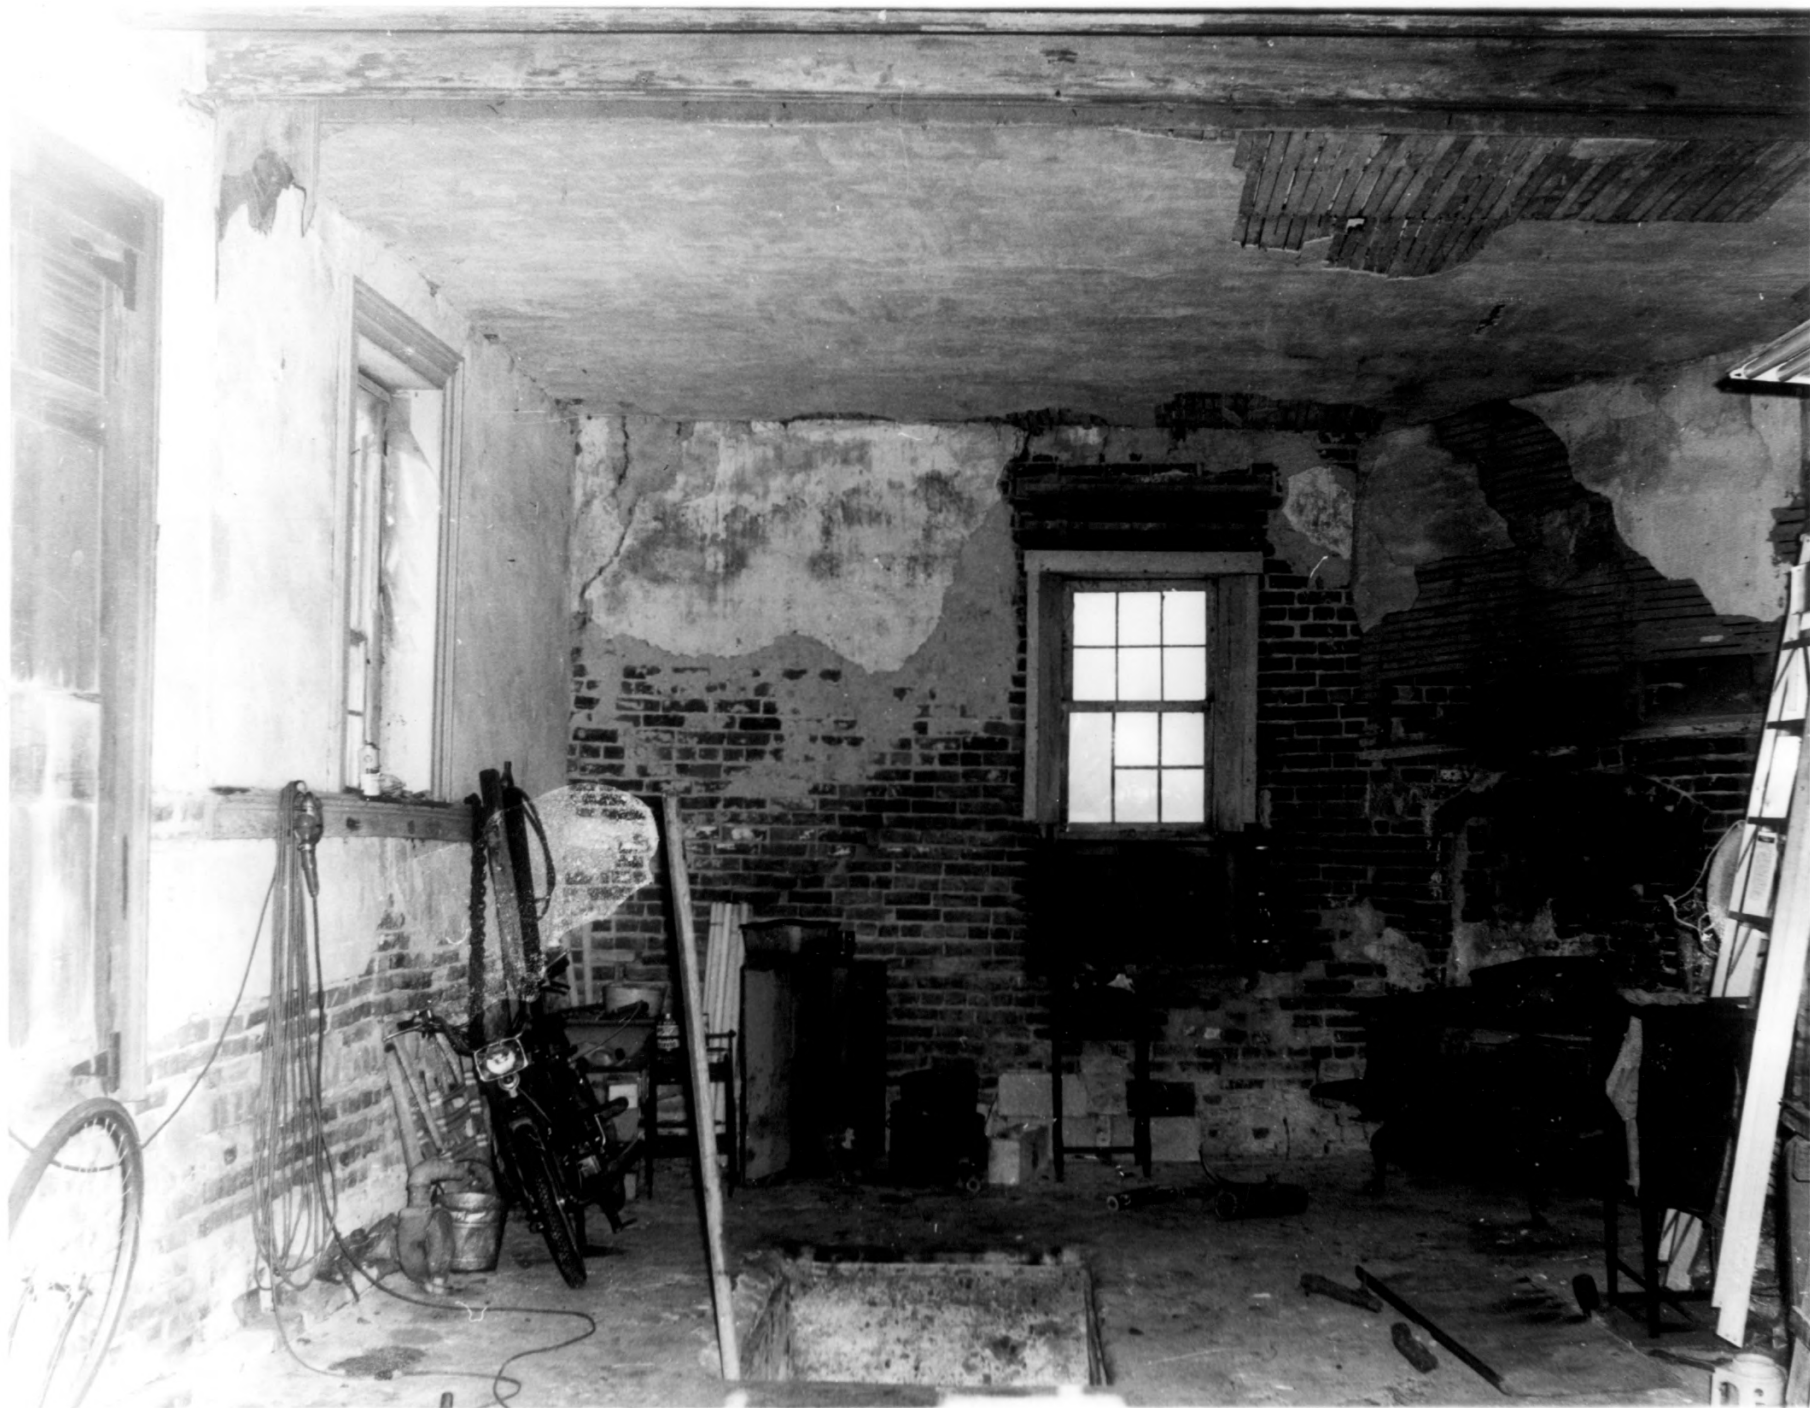
Photograph Numbers 5 of 7

Description: View of first floor interior of house showing what was once the parlor (with grease pit in bottom foreground).

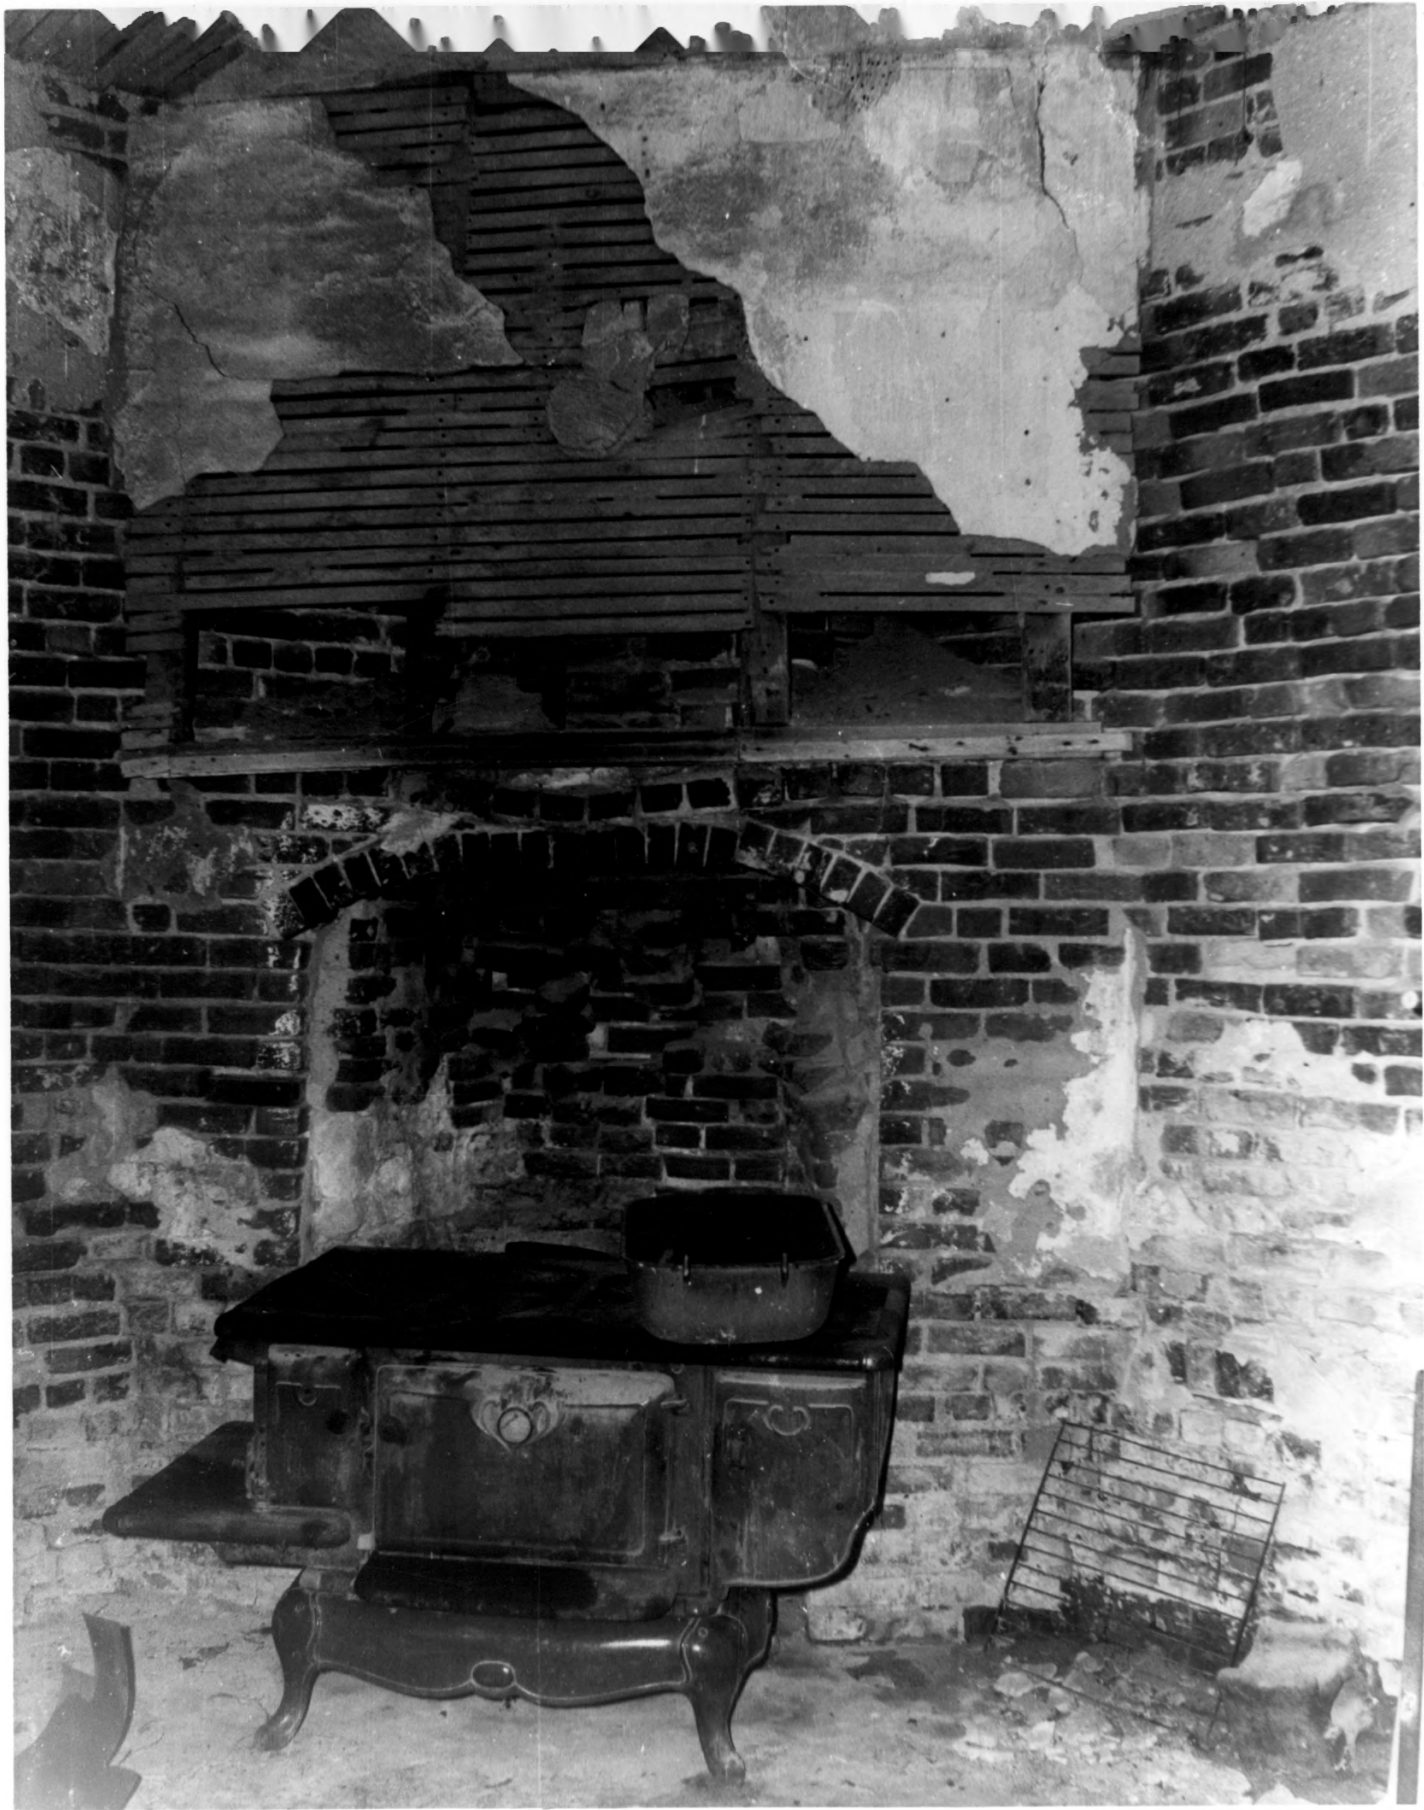
6 of 7

Description: View of diagonal fireplace in
parlor (from which original
paneling has been removed).

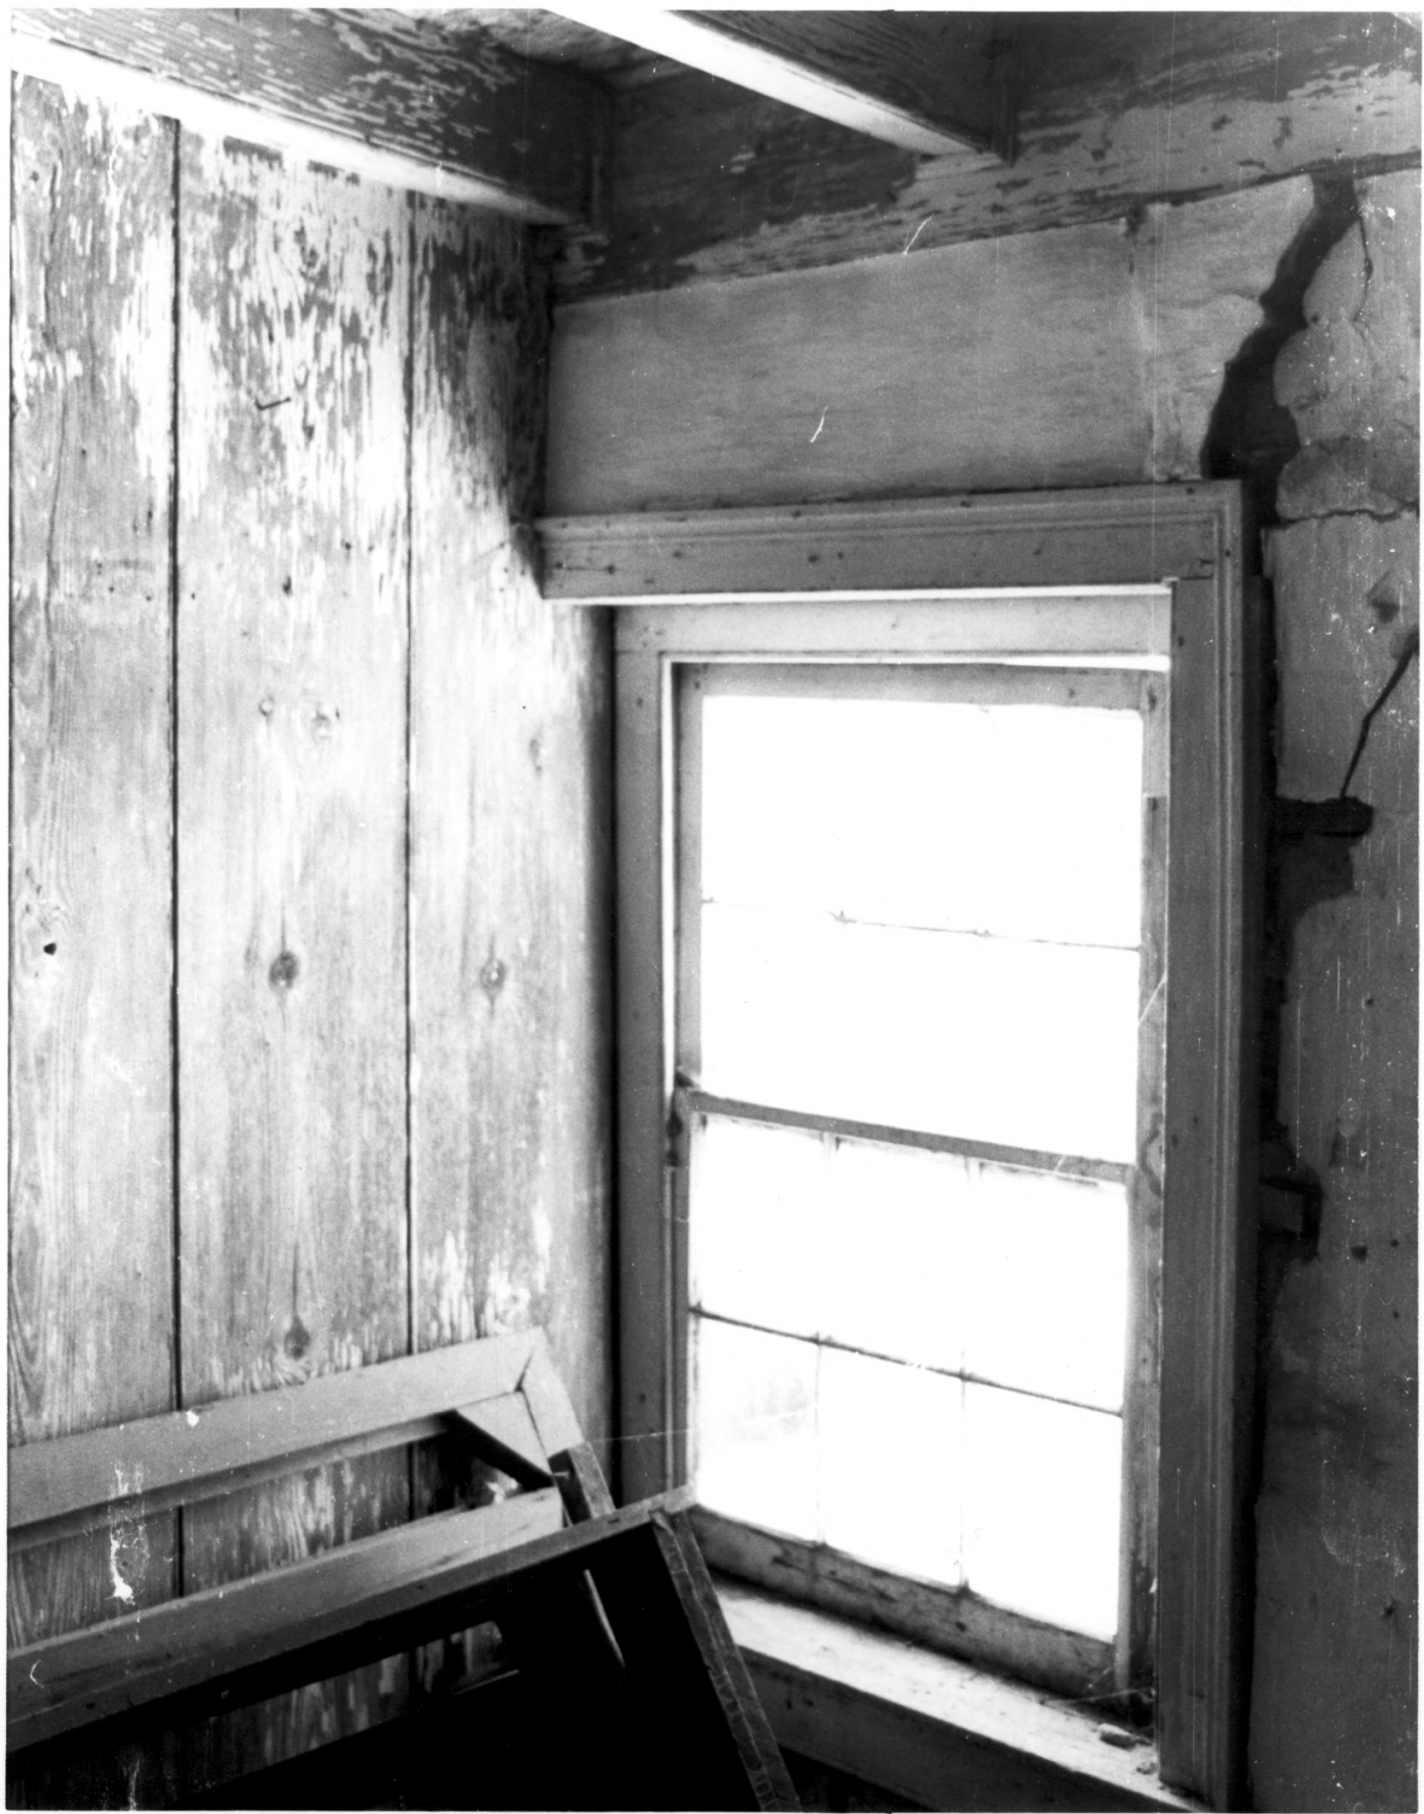
7 of 7

Description: Detail view of second floor interior showing window, plank partition wall, and exposed beam ceiling.
