National Register of Historic Places Registration Form

Historic name O'Sullivan, John and Anna, Farmstead

Name of related Multiple Property Listing Historic Agricultural-related Resources of Kansas

State Kansas Code KS County Douglas Code 045 Zip code 66524

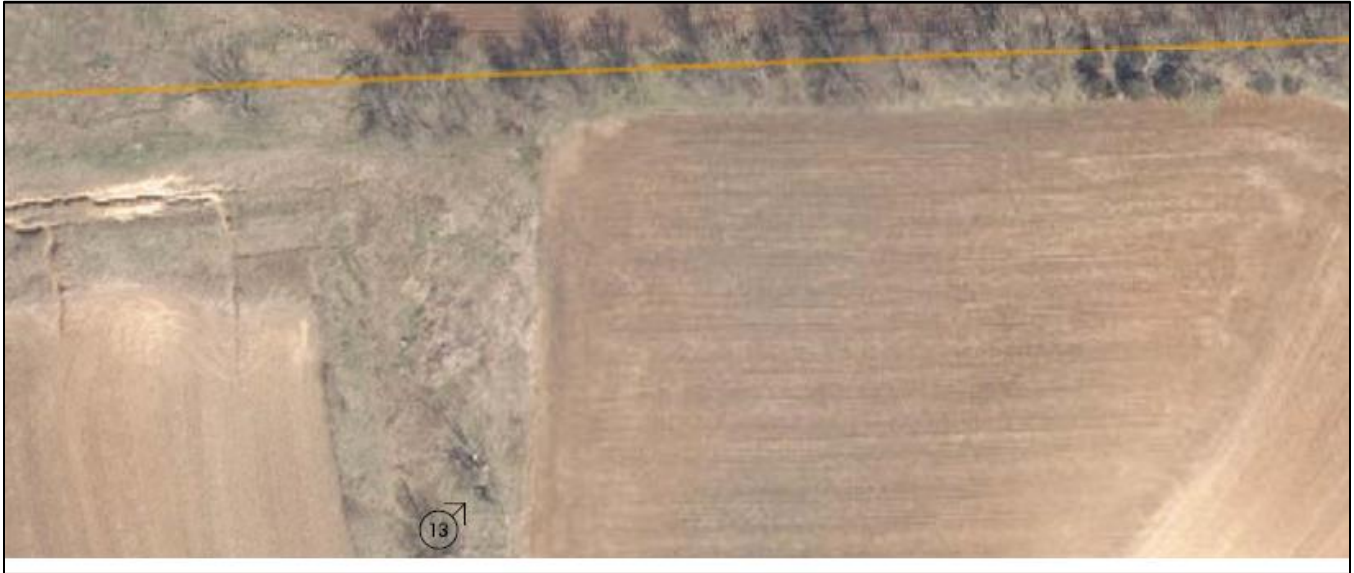
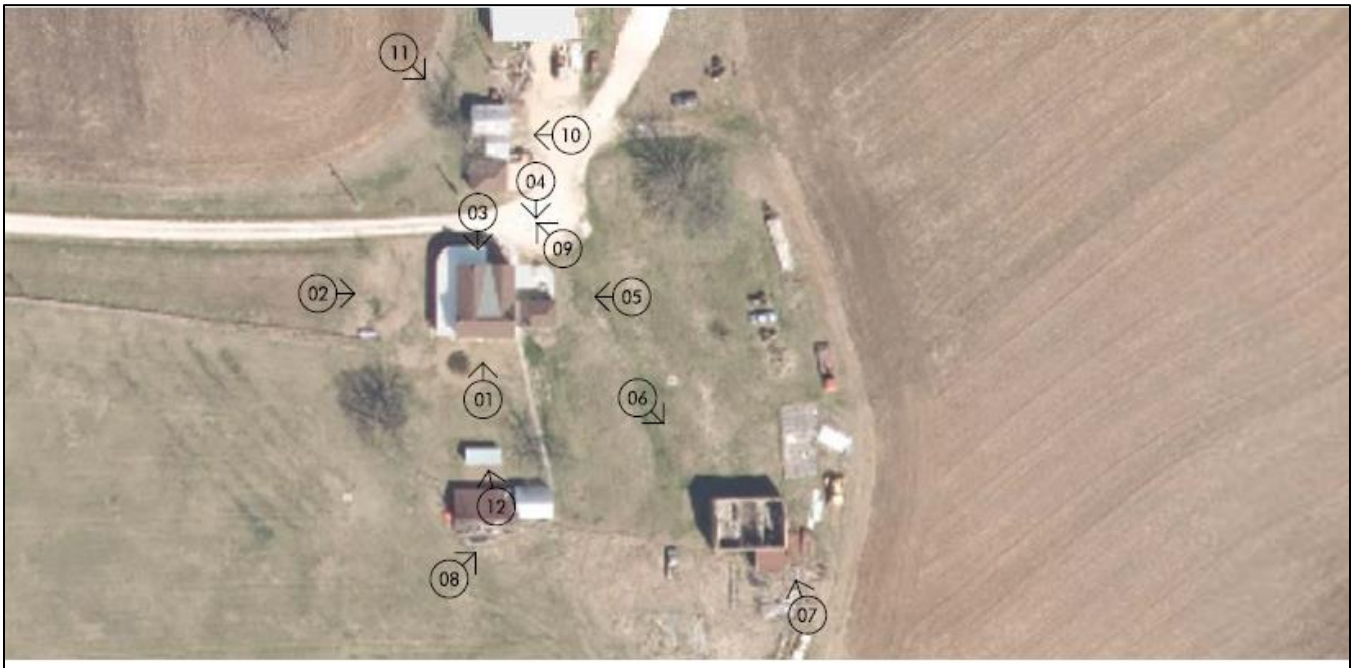
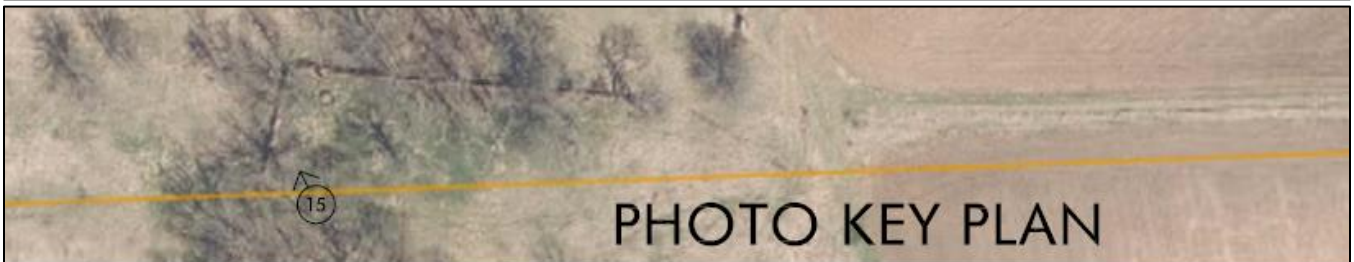
2013 Aerial image from: <https://dgco.douglas-county.com/propertymap/index.html>

Approximately 150 feet southeast of the farmhouse is the Stone Barn Ruin (Fig. 3). This is a Primary Farm Structure constructed circa 1866 on the property. Historically it was a Gable-Roof Barn in a three-bay side-gabled form. A new metal roof was installed on the barn in 1991 and it was blown off in a storm in 2001; the roof is still laying overturned on the ground to the northeast. The barn ruin is 42-feet east-west by 30-feet north-south and is two stories tall. The exterior walls are constructed of limestone, dressed roughly square, and laid in rough courses of varying height. Stones range in height from 4" to 12". Stones at the four corners are turned with their broad faces outward, engaging two or three courses, and laid in alternately opposite directions creating a rough quoin pattern. The barn had an east-west ridge, and a central north-south corridor with broad-side drive-thru door openings centered on the north and south sides. The north side has a tall pair of horizontal sliding wood doors constructed of vertical tongue-and-groove car-siding; historic photos show a previous pair of swinging doors at this location (Fig. 16). The south side opening has been infilled with wood framing and vertical corrugated metal siding. The center drive-thru bay is full height of the structure. The drive-thru bay openings have exposed timber headers. The north and south facades also have two window openings approximately 24" wide by 36" tall each approximately 48" from the corners; only the northeast opening still has the interior hinged wood panel cover on the opening. The east and west facades each have a centered single door opening (for people and livestock) and two smaller ventilating window openings near the corners. The window and smaller door openings have stone lintels. The east bay and west bay were livestock pens on the first story and hay lofts on the second story. The livestock pens were separated from the center bay with wood stanchion walls between the wood post-and-beam system supporting the wood-framed lofts. The lofts could be loaded from wagons in the drive-thru bay.

Approximately 45 feet north of the farmhouse is a wood-framed garage (Fig. 3). George O'Sullivan purchased a Ford Model T, in April 1915,⁶ and it is likely this garage was built at the same time, though documentation for this has not been found. The Garage appears in the background of circa 1917 and 1920 photographs (Figs. 11, 12, 14, 17). The Garage is 20-feet east-west by 16-feet north-south. It has concrete foundations and floor slab, and an asphalt-shingled hip roof with an approximate 8:12 pitch and 12" overhangs. It has wood horizontal 1x6 ship-lap siding, 1x4 corner trim, 1x6 fascia, and flat soffits, all painted. There is a wood double-hung window centered in each of the south, west, and north facades; these are 1/1 pattern, except for the bottom sash of the west window which has two panes. Historic photos show the south window previously as 2/2 pattern, and it is likely that was the pattern for all the windows. The east façade has a 10-foot-wide modern sectional overhead garage door and a modern insulated-steel half-lite man-door. A circa 1917 historic photo shows a single inward-acting approximately 8-foot-wide bifold garage door centered in the east façade (Fig. 11, bottom left). Circa 1920 historic photos show either two doors or a wider single garage door in the east façade (Fig. 12). The interior of the garage is finished with original 1x4 tongue-and-groove beaded-board wood siding installed on the ceiling and on the walls horizontally, all painted. The Garage is well constructed and is generally in good condition.

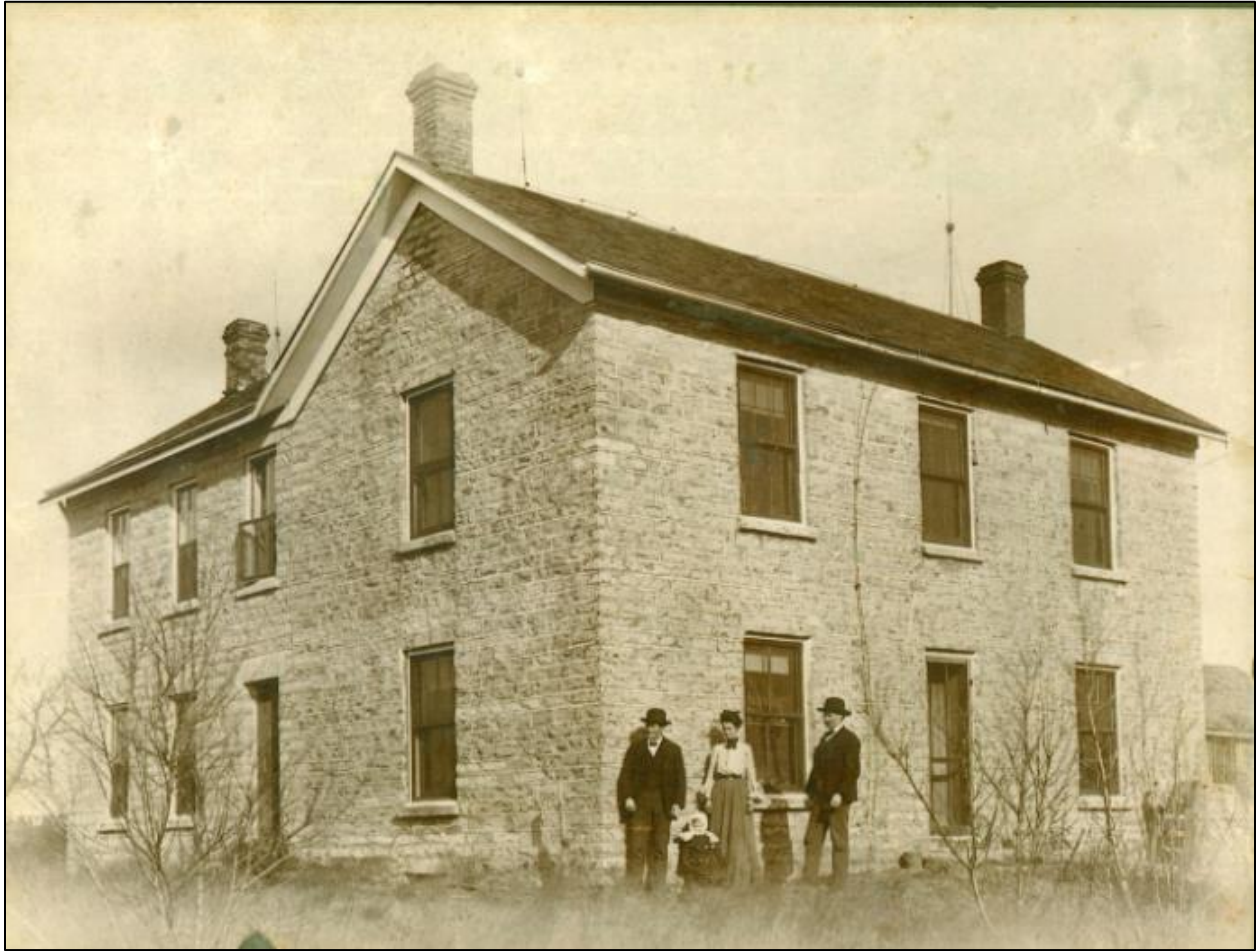
Figure 6: Circa 1902 photo of house, looking NE at west and south elevations.

The original two-story stone house's low-eave south façade has three bays and was the original "front" of the house. The middle bay has a six-over-six double hung wood window on the second story and an entrance door on the first story; unless otherwise noted, all windows are historic. The sill of the door is approximately 18" above a large stone paver set flush to the ground (1902 photo shows an additional stone step up to the door (Fig. 6)). The west bay has a two-over-two double hung wood window on the first story and six-over-six

The circa 1920 single-story wood-framed porch spans the entire width of the combined west facades of the original house and stone addition in three bays. The porch was a favored background for many family photographs, and its absence or presence in these dates it to approximately 1920 (Figs. 6 through 11, 13). The porch wraps the northwest corner of the stone addition with a quarter-turn single-bay plan form, including a curved porch rail and curved porch beam. The porch extends across the entire north side of the stone addition in a single bay. There are two sets of wide two-step concrete stairs to the porch, one near the center of the west side and one at the east end of the north side. The porch piers are masonry stack-bond one-piece stone-formed-face hollow concrete masonry units which extend from below grade to just above guardrail height. These are capped with slightly overhanging smooth solid concrete tops that are half-height of the stone-faced units below. Square tapered wood posts extend up from the masonry piers to a simple wood-trimmed porch beam above. At the west side, an additional masonry pier near the middle serves as a rail post for the south half of the center bay, and does not have a wood post above. At the north side, an additional masonry pier near the middle serves as a rail post for the west half of the bay, and does not have a wood post above. The wood posts have stepped two-tier square bases slightly wider than the post bases, and square caps slightly wider than the column tops with simple ogee crown molding at the post-to-cap juncture. A wood guardrail approximately 24" tall wraps around the entire porch except for the step locations. The guardrail consists of a bottom rail, 1x3 flat spindles spaced approximately 3" apart, skirt rails, and a flat bevel-edged top rail. The porch roof overhangs the porch beam approximately 12". The matching height flat porch ceiling and soffit overhang is finished with tongue-and-groove beaded-board. The porch has a low-pitch roof with metal roofing and built-in gutter.

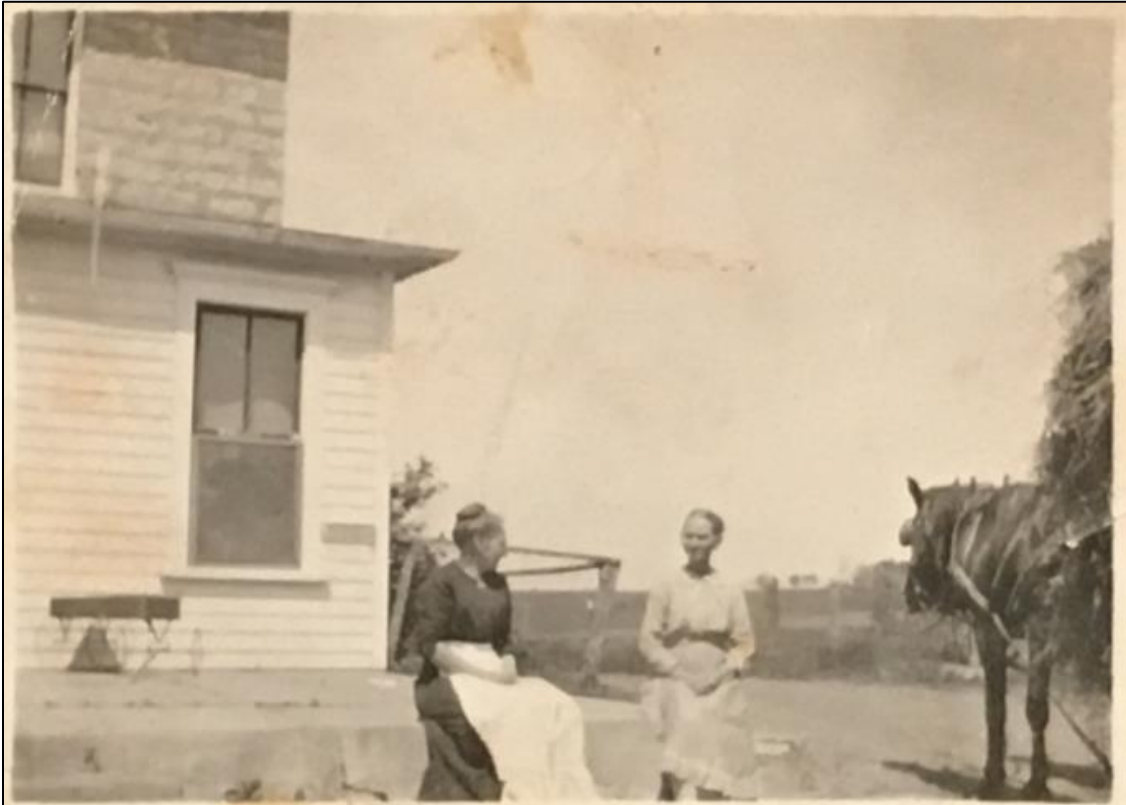
Figure 8: Circa 1917 photo of north side of house, looking WNW and showing one-story wood-framed porch where 1999 addition currently is located. The Craftsman porch had not yet been constructed.

The 1999 addition replaced a one-story wood-framed addition with screened-in porch seen in several historic photos (Figs. 8 & 11). The north gable-end façade of the 1999 wood-framed addition is flush with the north façade of the 1880 stone addition. The façade is a single bay with nine-over-nine double hung wood windows

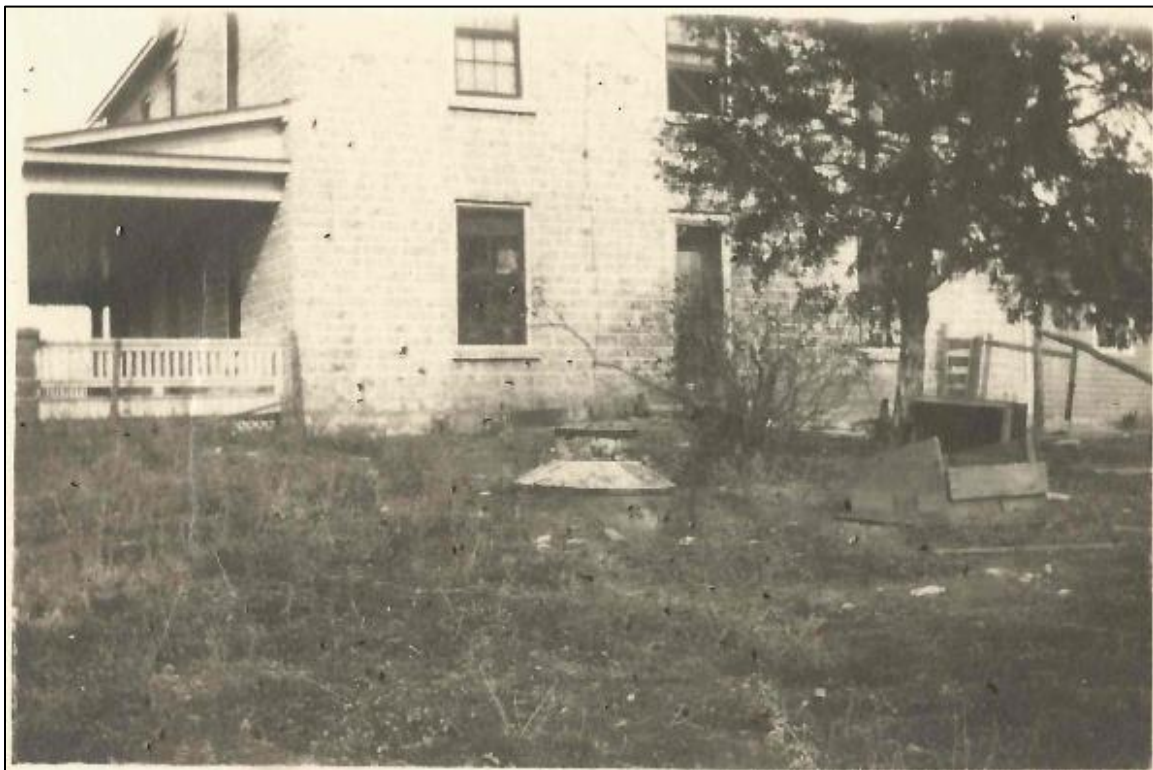
Figure 9: Circa 1920 photo of house, looking NE at south elevation and showing Craftsman-era porch.

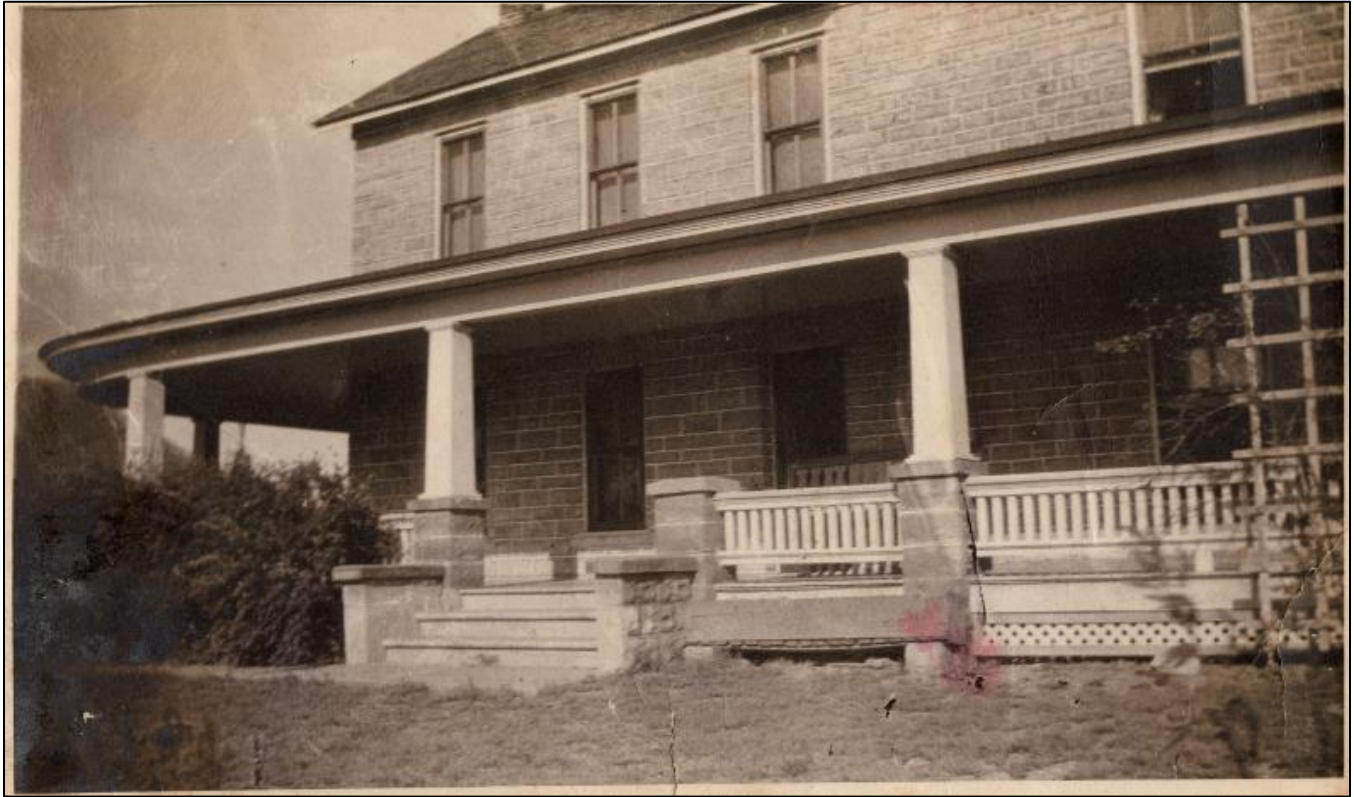
Figure 10: Circa 1930 photo of house, looking east at west elevation and showing Craftsman-era porch.

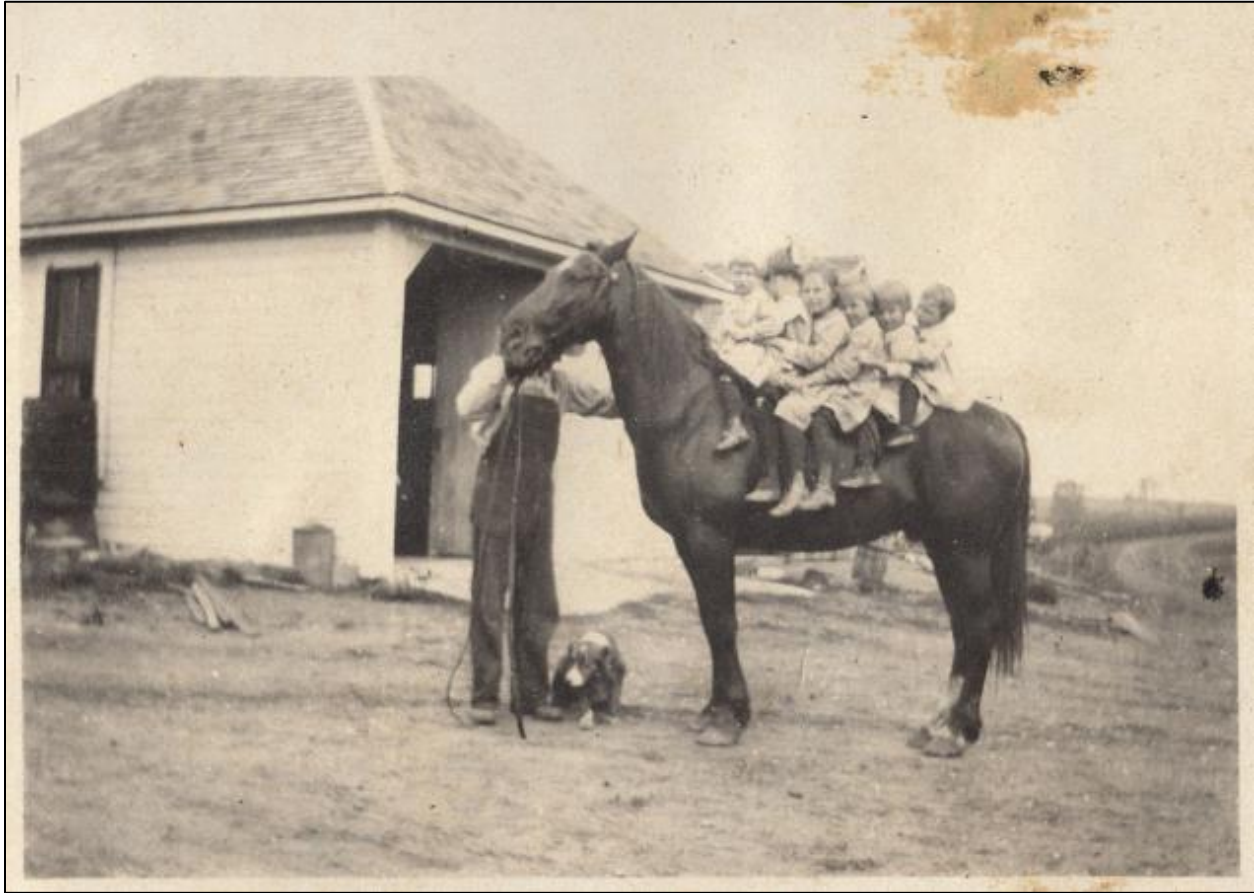
Figure 12: Circa 1920, showing garage in background.

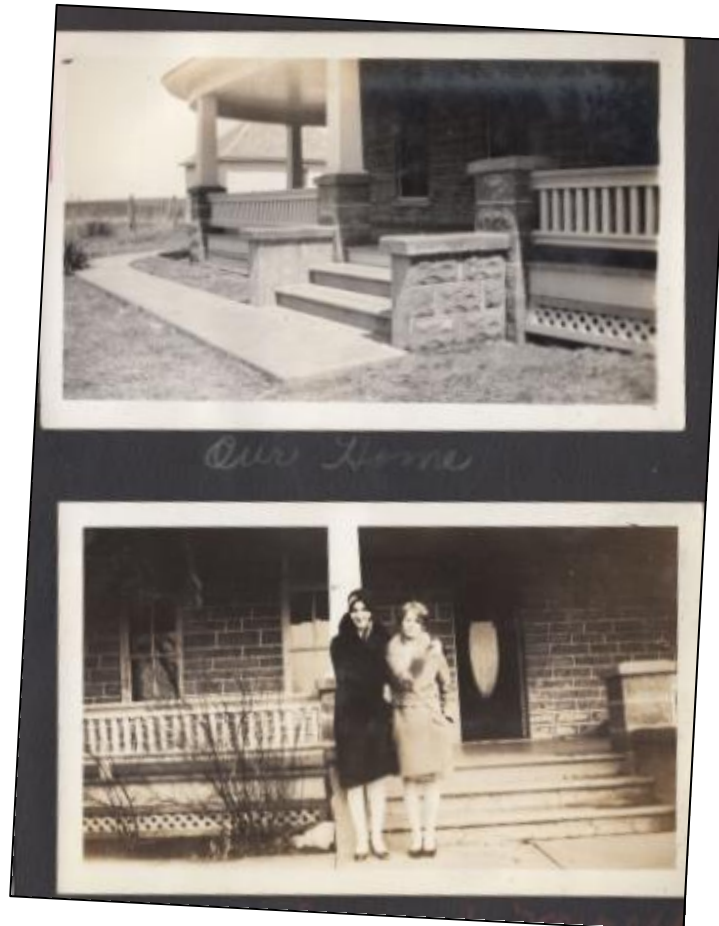
Figure 13: Circa 1939 photos showing house porch.

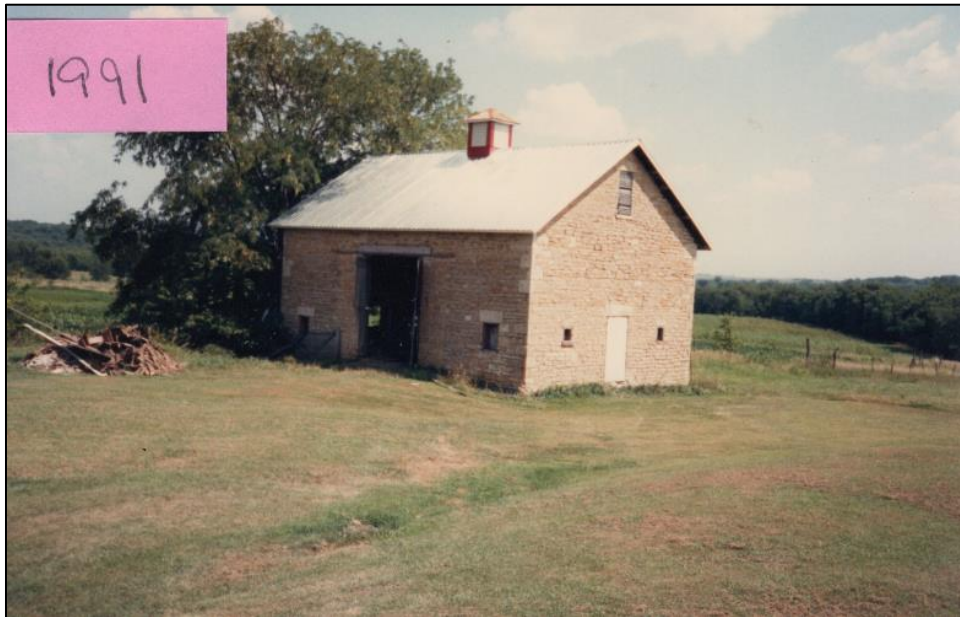
Figure 16: View NE at barn, 1991.

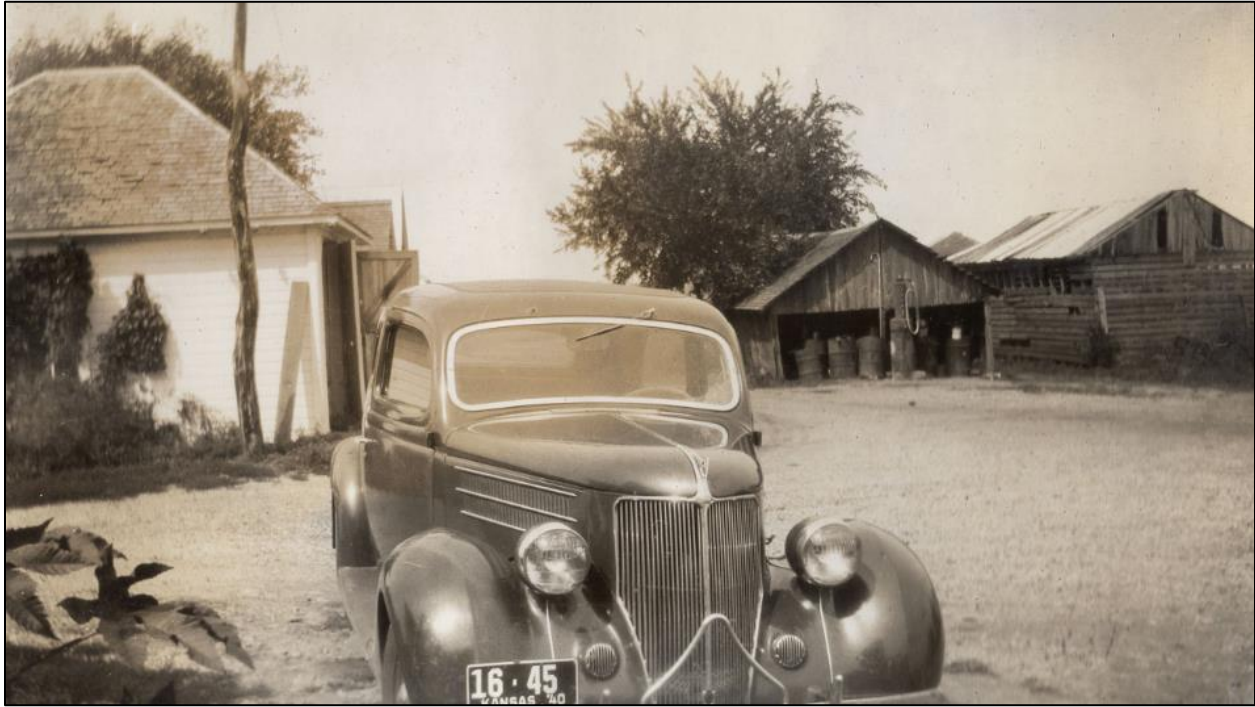
Figure 17: Photo of farmstead, 1940.

Shed 2 is located approximately one-foot north of Shed 1. The first photographic evidence of this structure is in the background of a 1940 photograph (Fig. 17). It is a single-story wood-framed building approximately 20 feet east-west by 16 feet north-south. It has concrete foundations and floor slab, and an approximate 8:12 pitch gable roof (east-west ridge) with 12" overhangs. The east façade is in line with the east façade of Shed 1 and the Garage. The walls are framed with a combination of widely spaced 2x4 studs, horizontal 2x4 girts, double 2x4 top plates, and 2x4 diagonal braces integrated at the top and bottom building corners and near the middle of the wall planes. The siding is vertical wood 1x6 tongue-and-groove car-siding with a center groove on the exterior face. The roof is framed with 2x6 joists at 24" on-center, 2x6 purlins laid-flat, and corrugated metal roofing. The east façade is mostly a single large opening with only a wall-plane and siding in the gable-end of the roof. A 4-foot-wide by 1-foot-tall horizontal section of the gable-end wall is cut out near the northeast corner of the building, most likely to accommodate the vertical exhaust pipe of a tractor or other farm equipment. There is a single double-hung wood window centered in the north façade and in the west façade. These are covered over with plywood on the exterior; they do not have glass and the bottom sash is missing at the north window. The windows are counter-weight and sash-cord type, and may have been salvaged windows when installed. Shed 2 is in fair condition.

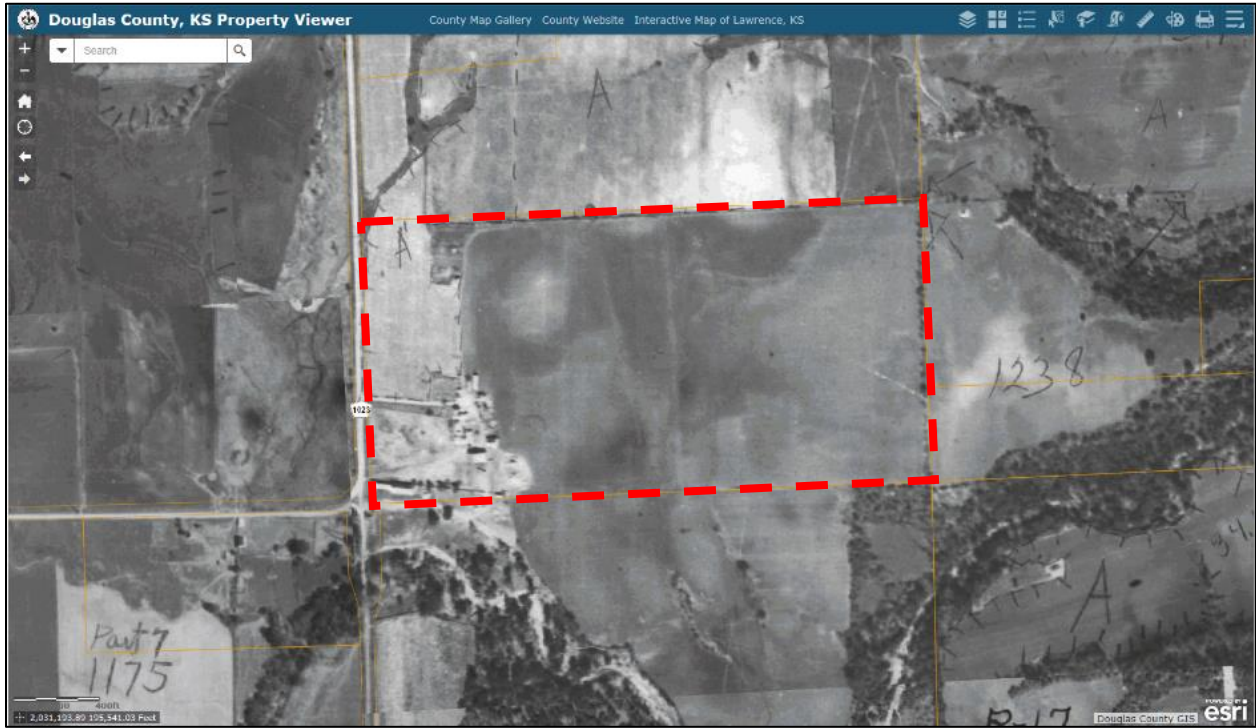
Figure 18: 1937 aerial of O'Sullivan farm vicinity. Dashed line is current boundary of nominated farmstead.

No documentation has been found to determine the construction date of the Stone and Concrete Storm Shelter. Historic aerial photos show structures in the vicinity of this building as of 1937 (Fig. 18). The current owner recalls there was housing for farmhands on this portion of the property and that this shelter was intended for their use. It is possible the stone foundation pre-dates the concrete barrel-vault roof construction, as it seems an incongruous combination to construct a stone foundation at the same time that cast-in-place concrete was used for the upper portion of the structure. For that reason, the estimated construction date for the stone foundation is ca. 1900 and the construction date for the concrete barrel-vault roof is estimated as ca. 1930.
