National Register of Historic Places
Registration Form

historic name W. P. Fuller Paint Company Office and Warehouse

street & town 404 West 400 South not for publication

W. P. Fuller Paint Company Office and Warehouse
Salt Lake City, Salt Lake County, UT

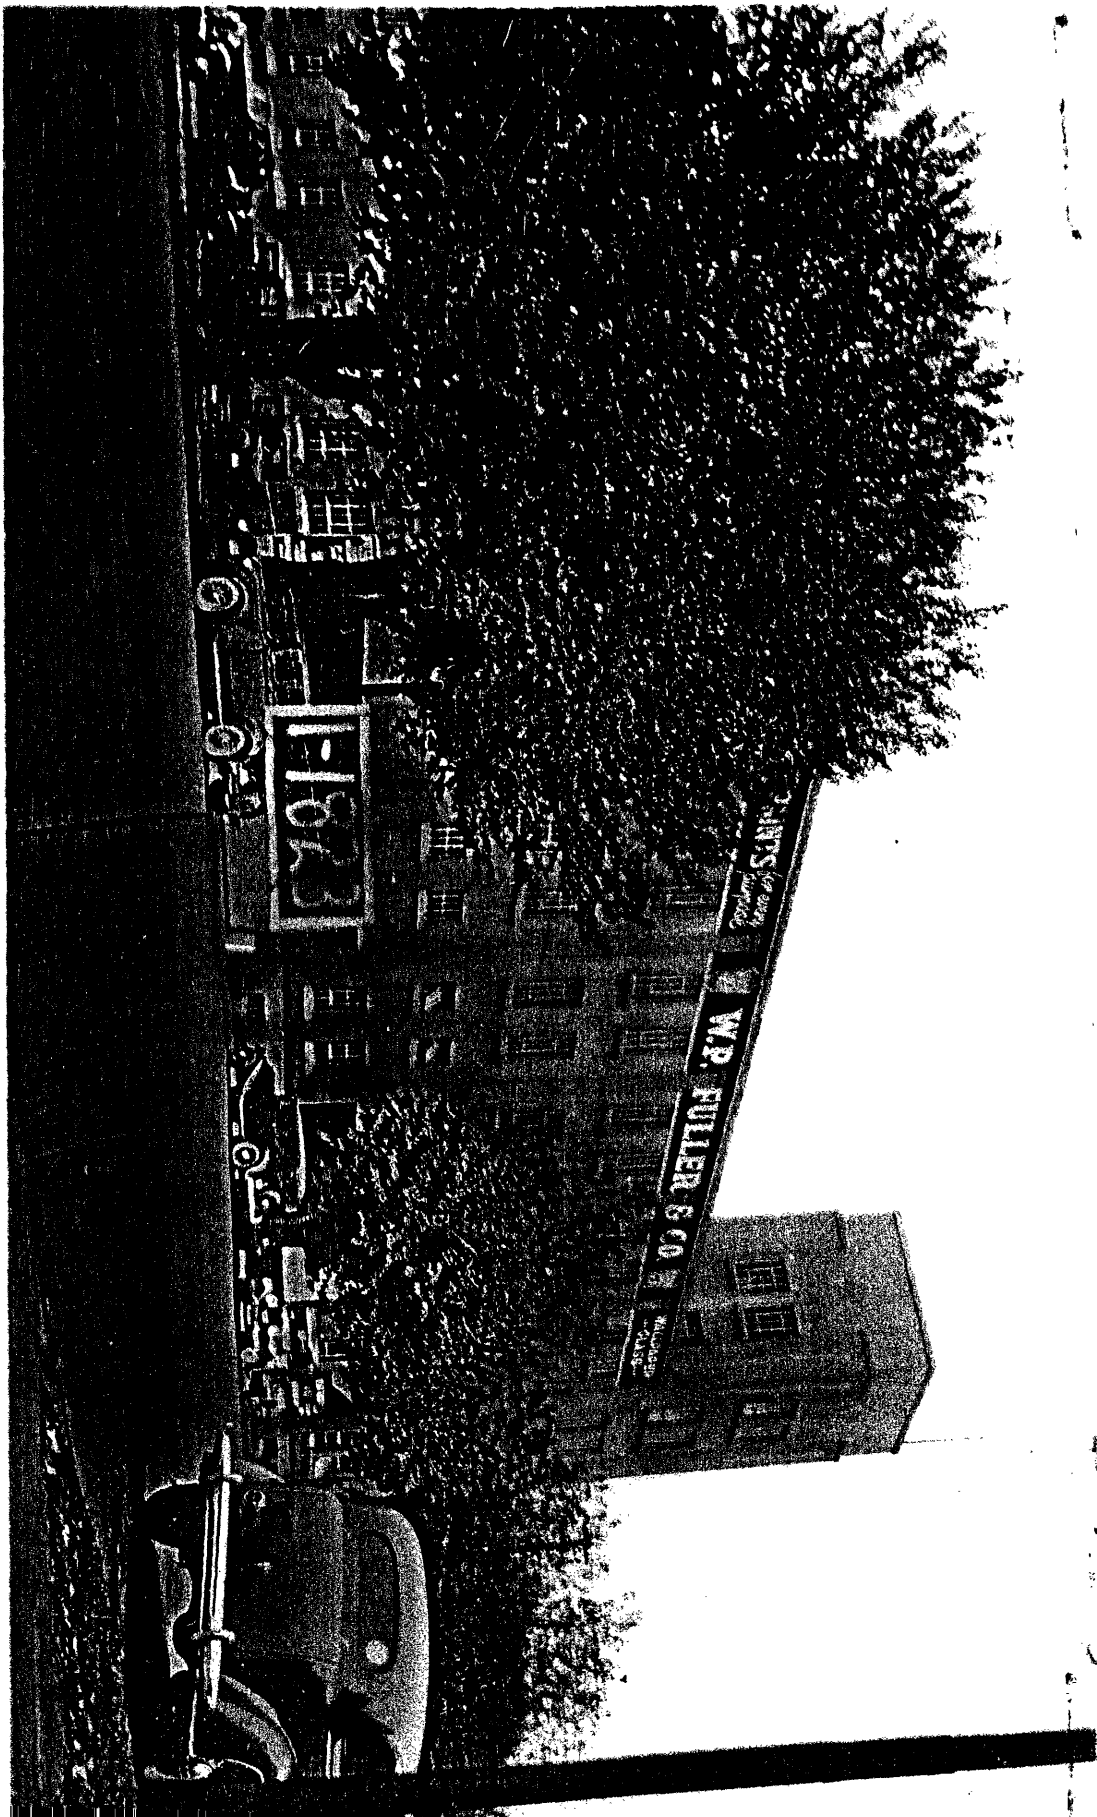
13.

W. P. Fuller Paint Co. Office & Warehouse
404 W. 400 South, Salt Lake City, Utah
Tax photograph, 1937

By the 1930s, rail activity in the area had decreased, but a 1937 tax photograph of the south elevation shows the truck docks in use. In 1941, the seamed metal and frame addition was built on the west elevation. It was used as a glass warehouse. A lunch stand was built on the southwest corner of the property in 1949. There was also a service station in the yard. In the early 1950s, the interior was substantially remodeled. Historic photographs taken in 1951 by the Shipler photographers of Salt Lake City indicate the offices were expanded and modernized on the second floor and mezzanine levels. The exterior was probably painted at the same time. The large corrugated metal shed was added to the property in 1951. By the 1950s, the company had moved their retail store to 211 South State Street. A full-page advertisement in the 1951 Salt Lake directory read "W.
