NATIONAL REGISTER OF HISTORIC PLACES PROPERTY PHOTOGRAPH FORM

The Reverend James McGready House AND/OR COMMON

Old Poorhouse

Russellville, Kentucky

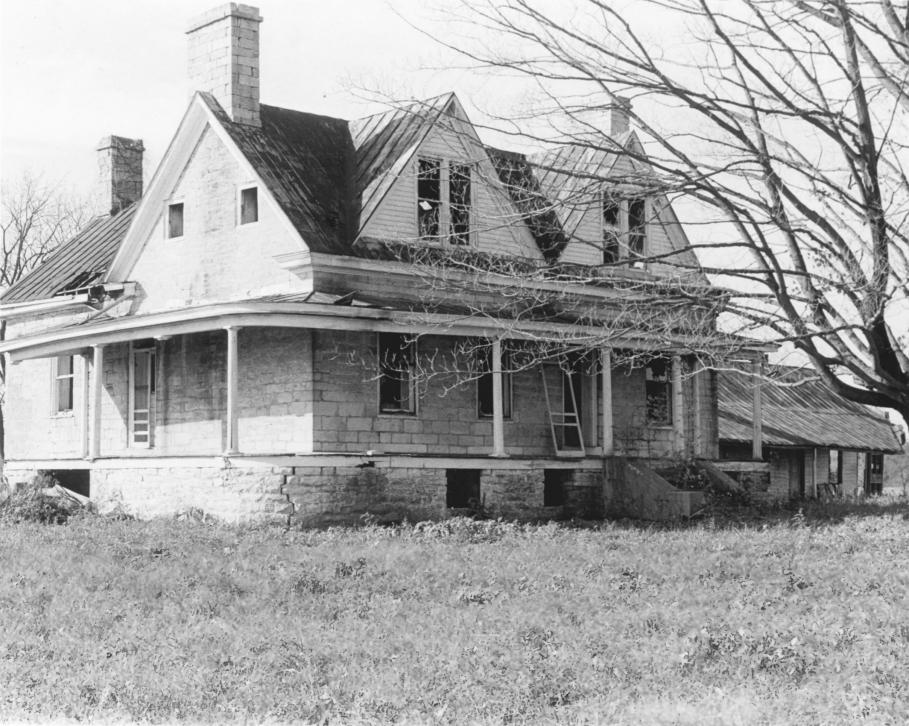
DESCRIBE VIEW, DIRECTION, ETC. IF DISTRICT, GIVE BUILDING NAME & STREET View from northeast showing rear ell of stone house at left. PHOTO NO.

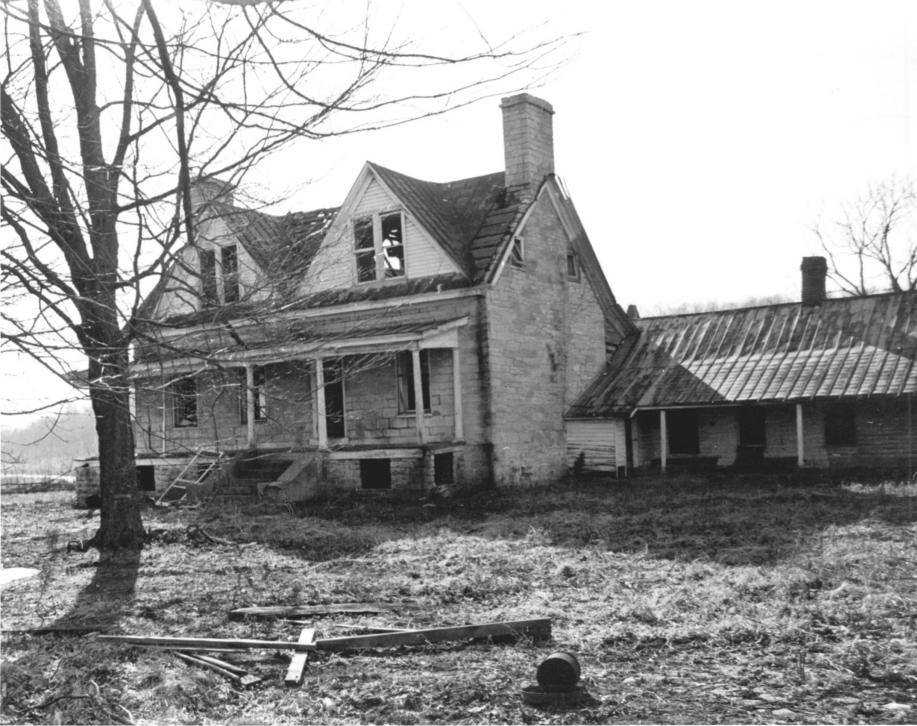
PHOTO NO 2 =

View from northwest. Ca. 1870 poorhouse wing is at right. Porch, second-story

gables, and eaves of stone house are later additions

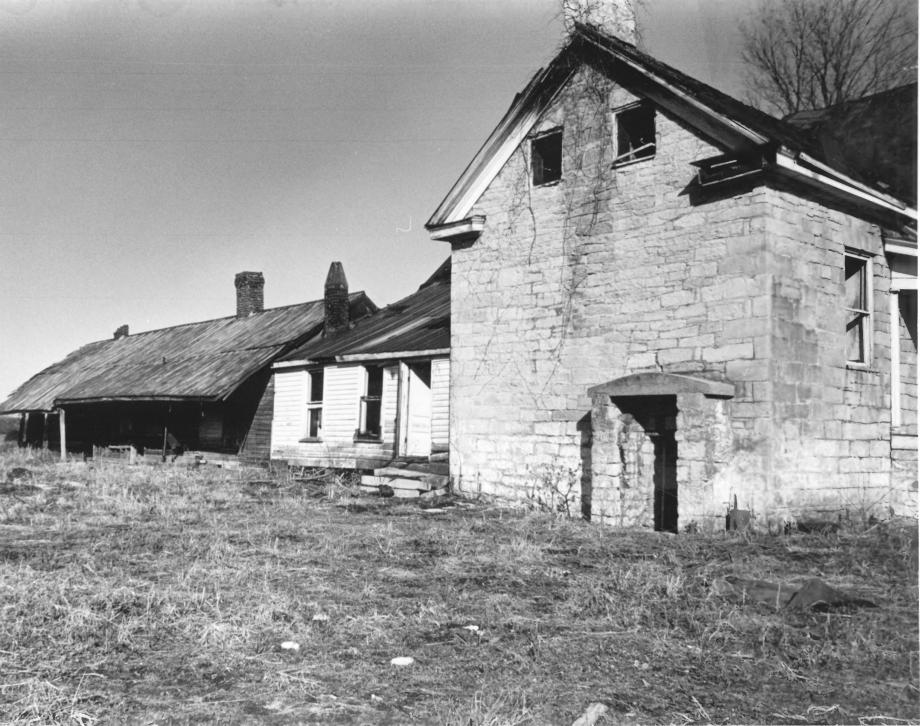
PHOTO NO

View from southeast. Rear ell of house at right; poorhouse wing at left; later additions in center. Note unique stone hood over basement entrance.

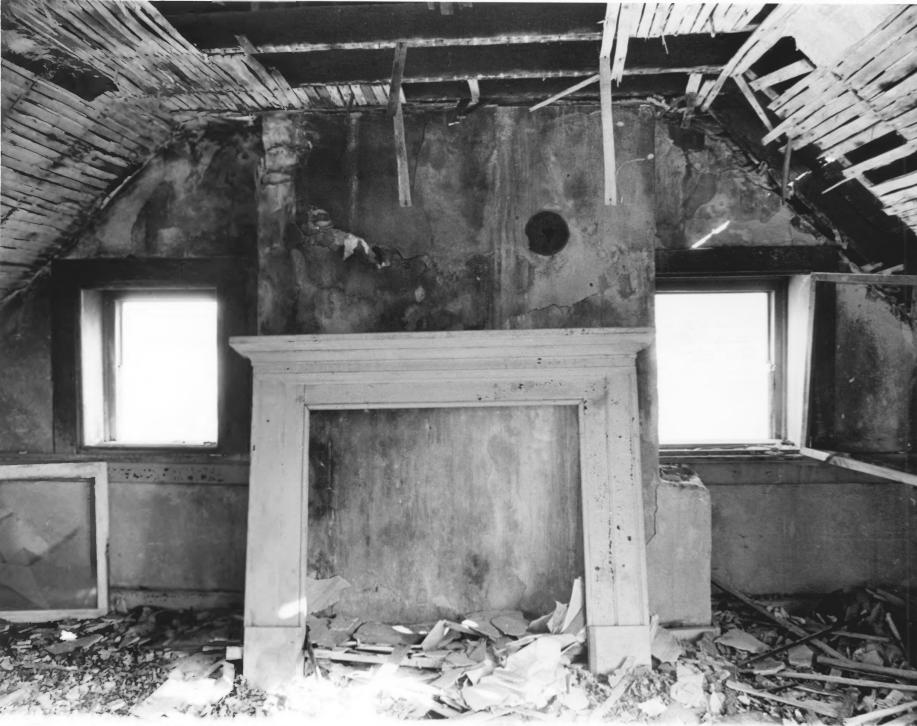
PHOTO NO. 4

Original mantel and chair-railing in second-story chamber. Note original split lath. Mantel has partially reeded band between shelf and frame of fireplace opening.

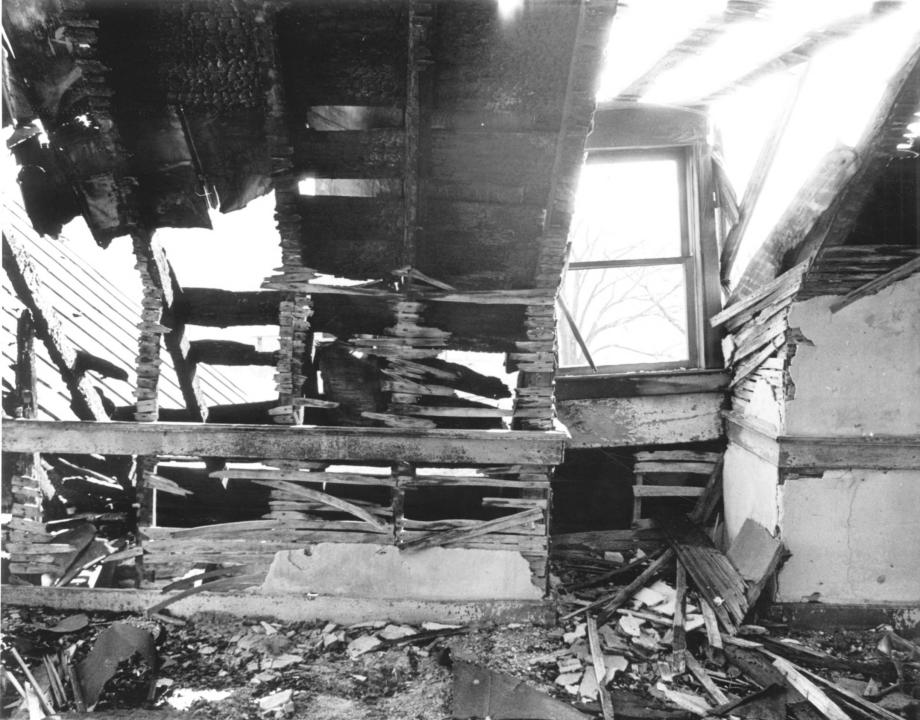
PHOTO NO. 5 View is burned-out second-story west chamber showing original chair-railing extending

into south dormer (window frame is not original). Roof of rear ell is at left.

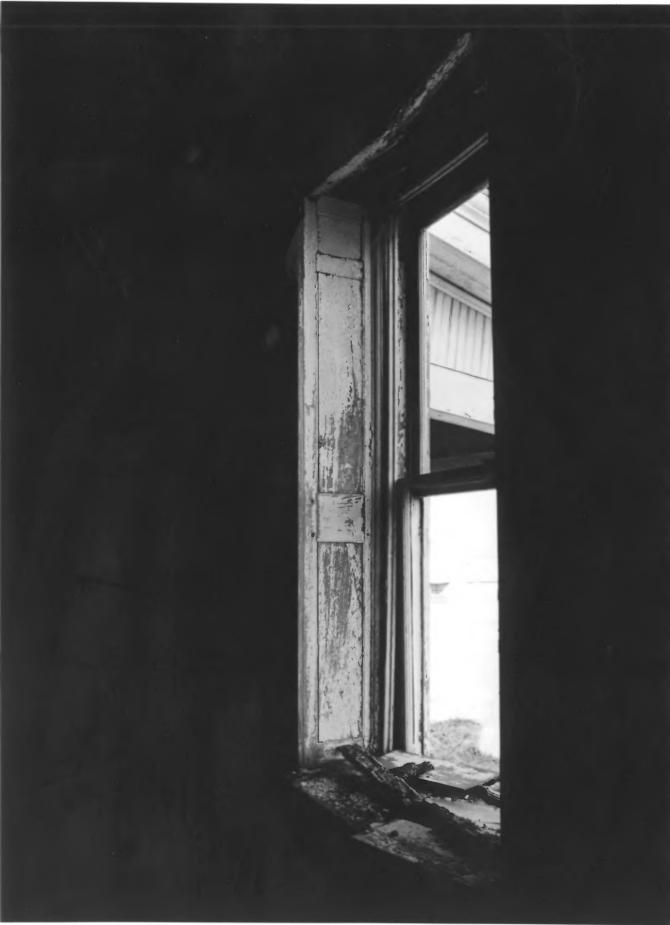
PHOTO NO.

Panelled window frame on east side of rear ell.

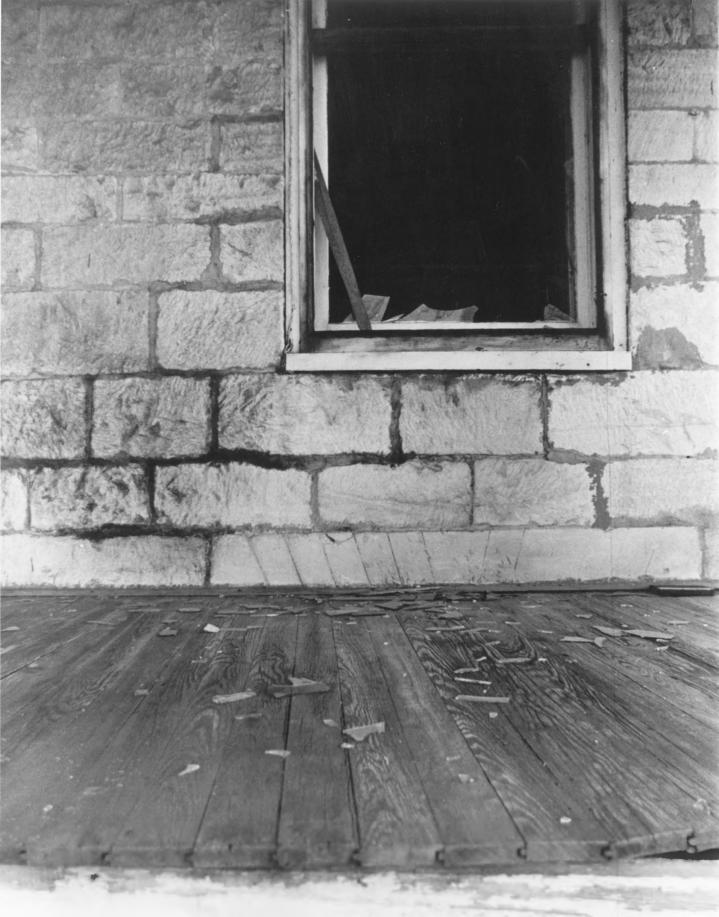
PHOTO NO. 7

Stone lintel of original basement visible above modern porch floor. Lintel appears to be a single large stone scored to give illusion of jack arch with keystone.

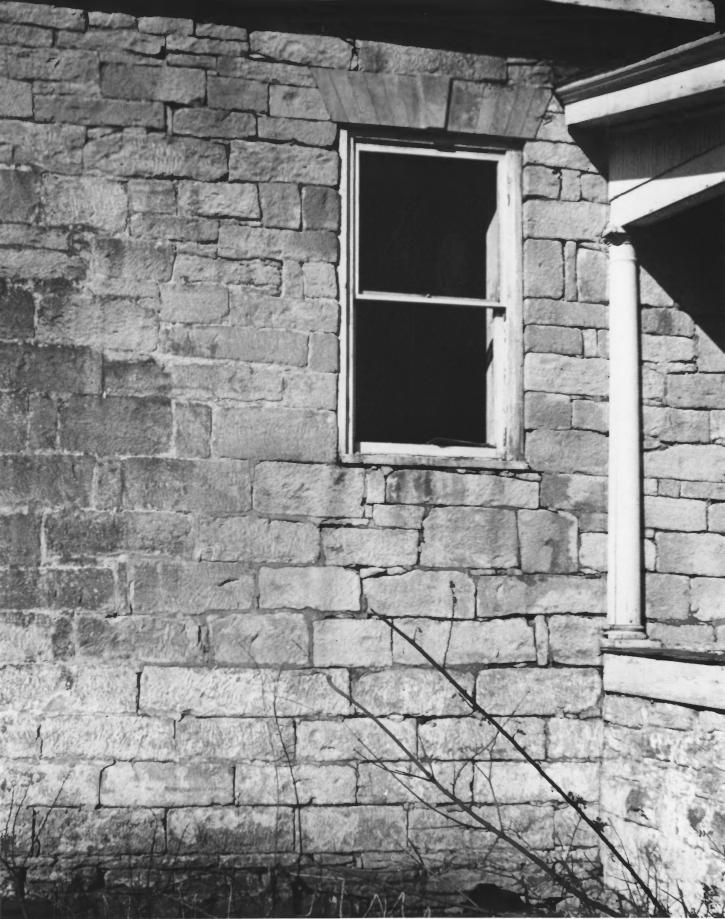
PHOTO NO. 8

East window of rear ell. Again, lintel may be a single stone scored to suggest arch and keystone.

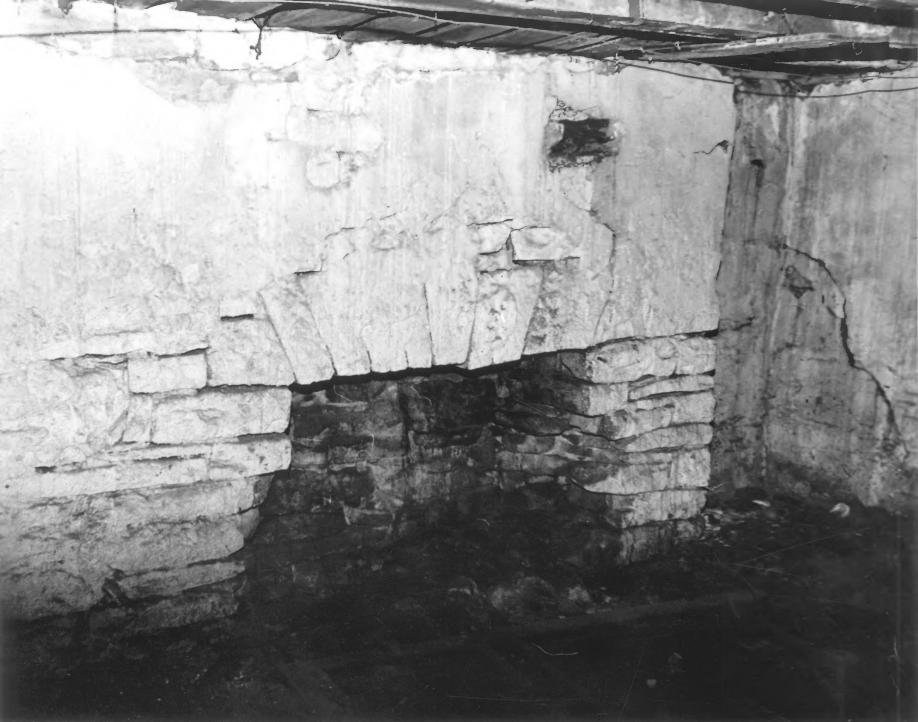
9

Fireplace opening in basement.

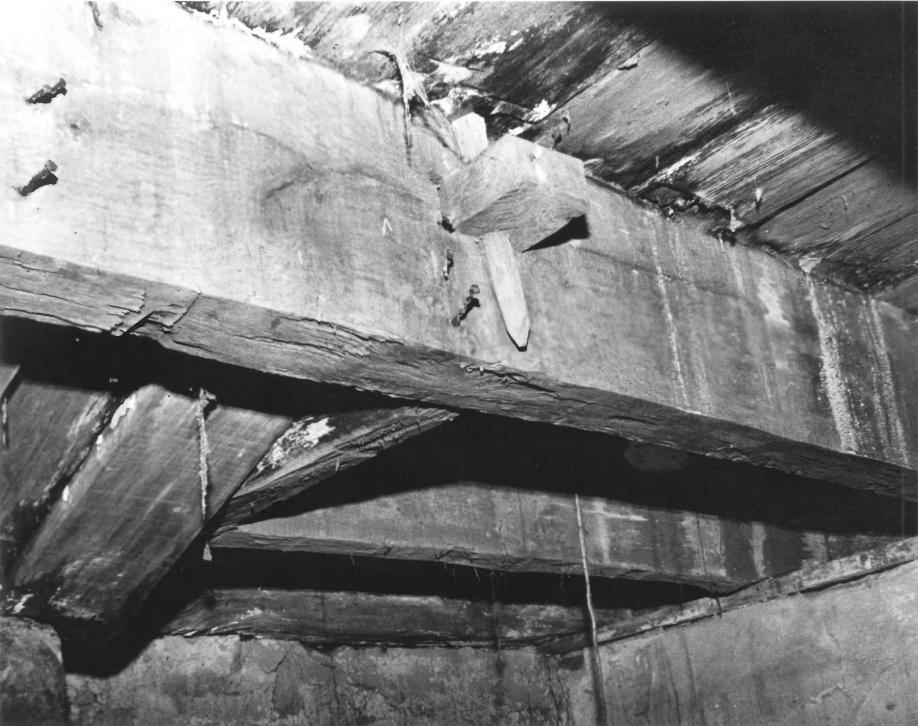
РНОТО NO. 10

Hand-hewn floor joists in basement with mortised and pegged hearth support.

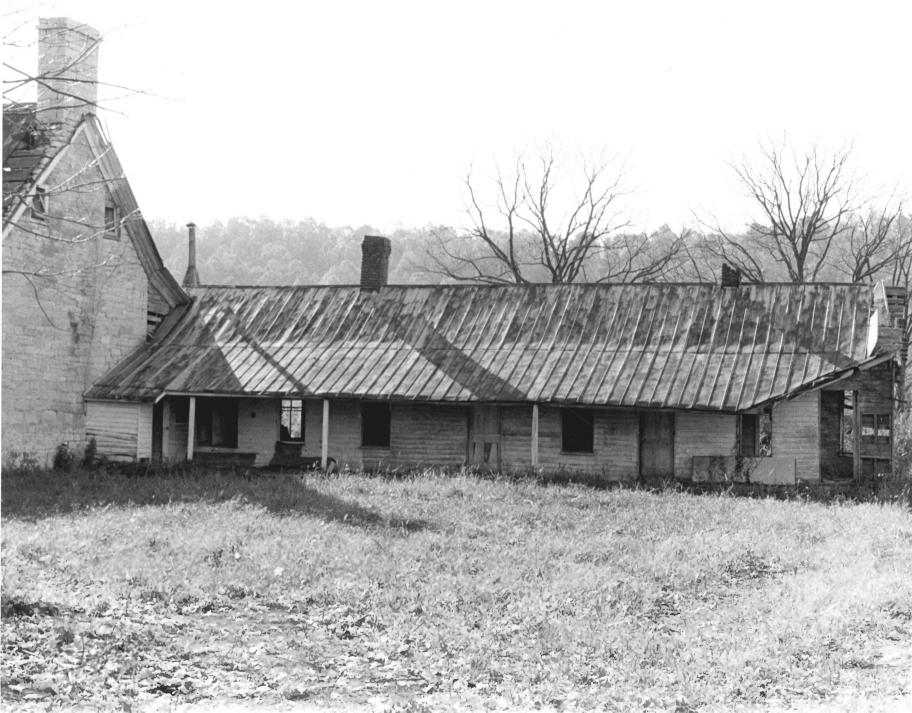
рното NO. 11

Poorhouse wing from north.
