**HISTORIC RESOURCES INVENTORY
BUILDING AND STRUCTURES**

IDENTIFICATION	1. BUILDING NAME (Common) (Historic)	
	Private Residence Edward Frisbie House	
	2. TOWN/CITY	VILLAGE COUNTY
	Branford	New Haven
	3. STREET AND NUMBER (and/or location)	
	699 East Main Street Map J4, Block 2, Lot 6; 5 acres

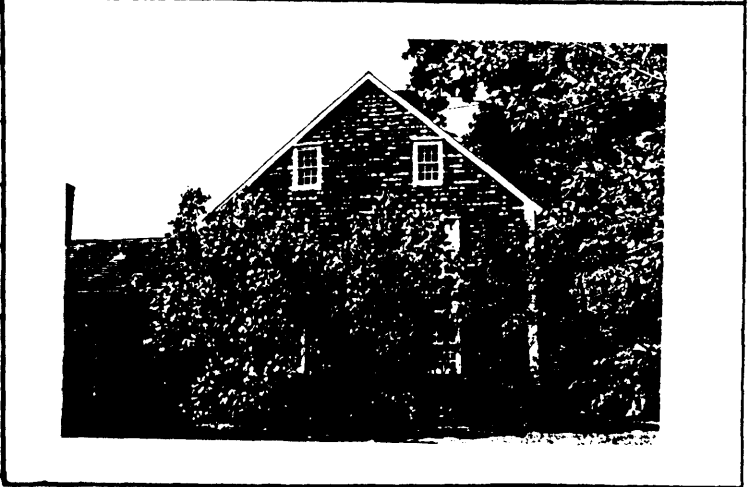
VIEW
 East Elevation

Constructed on a rectangular plan with its ridge parallel to the street, this structure has a steeply-pitched roof (45° or 12:12) with a brick center chimney which straddles the ridge. The house has a five-bay, nine-window facade with twelve-over-twelve sash. The entry has a pair of paneled doors flanked by wide molded casings which flare out above the door. A glazed transom features six arched lights. The gable ends have six windows. Those at the attic story have six-over-six sash; the others have twelve-over-twelve sash. All gable windows have projecting cornice moldings. The west gable features a porch, probably a twentieth-century addition, which is constructed with chamfered posts. The exterior is finished with clapboards on the street facade (north elevation), wood shingles on the east, west, and south elevations, and smooth sheathing boards with beaded edges at the porch.
