National Register of Historic Places Registration Form

Historic name U.S. Inspection Station—Canaan, Vermont
Other names/site number Canaan Inspection Station; Canaan Border Inspection Station

*U.S. Inspection Station—Canaan
Essex County, Vermont*

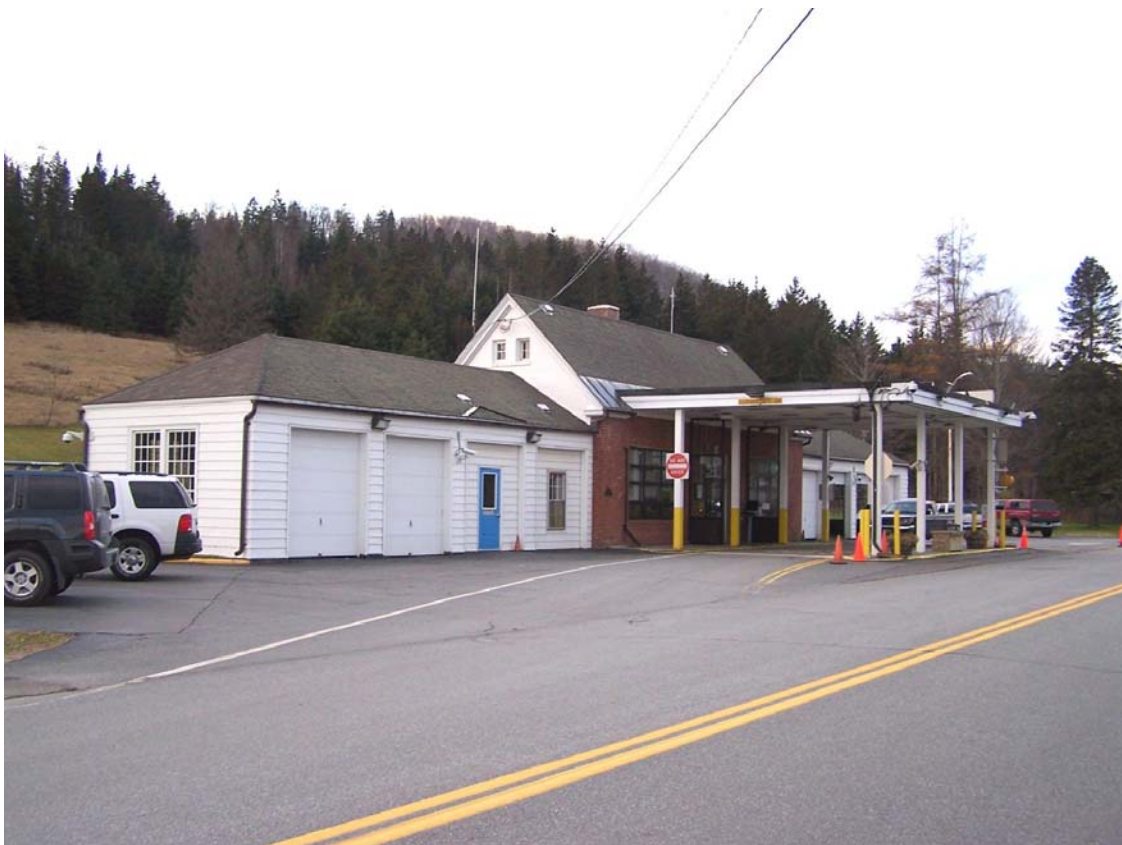
Photo number: VT_EssexCounty_CanaanBorderStation1.tiff

Description of view: front and side elevation, view: northwest

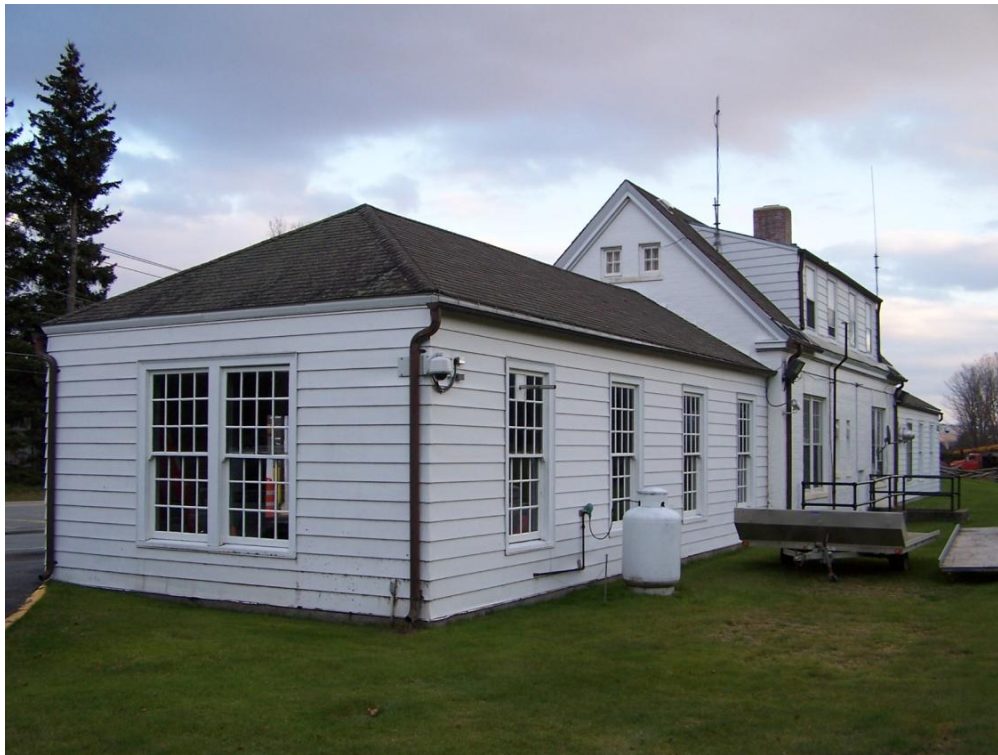
Photo number: VT_EssexCounty_CanaanBorderStation2.tiff

Description of view: rear and side elevation, view: southeast

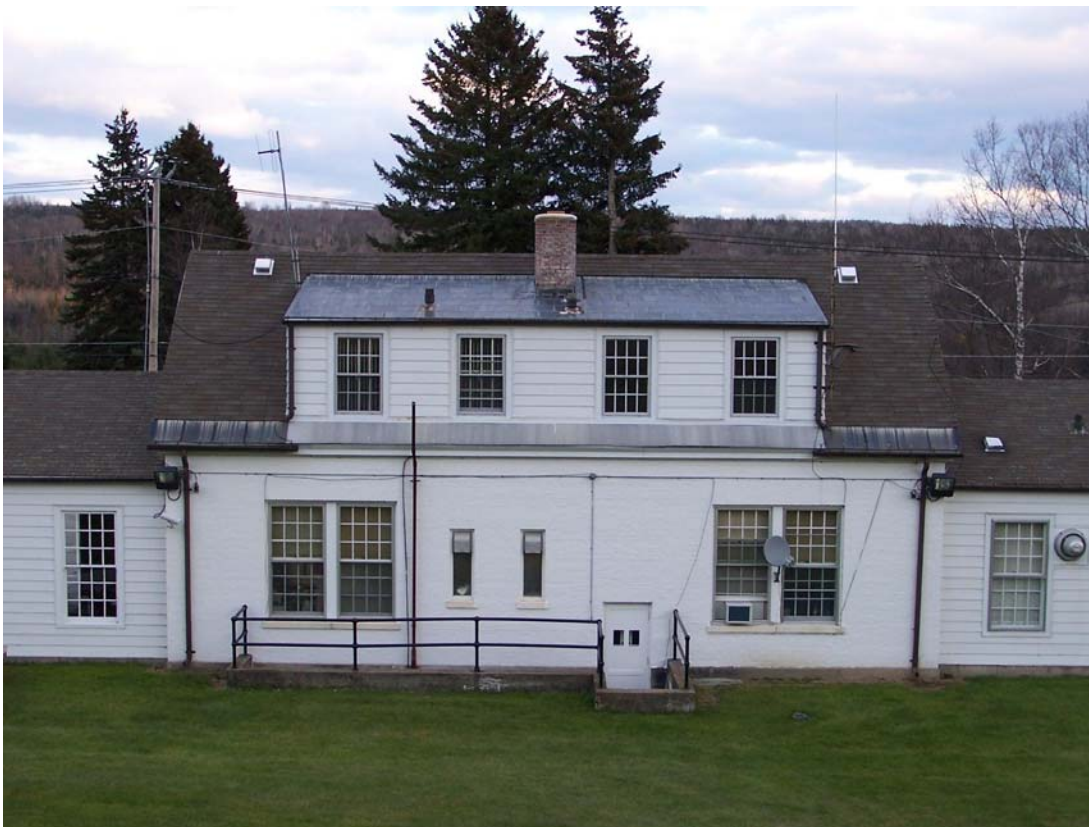
Photo number: VT_EssexCounty_CanaanBorderStation3.tiff

Description of view: rear elevation, view: east

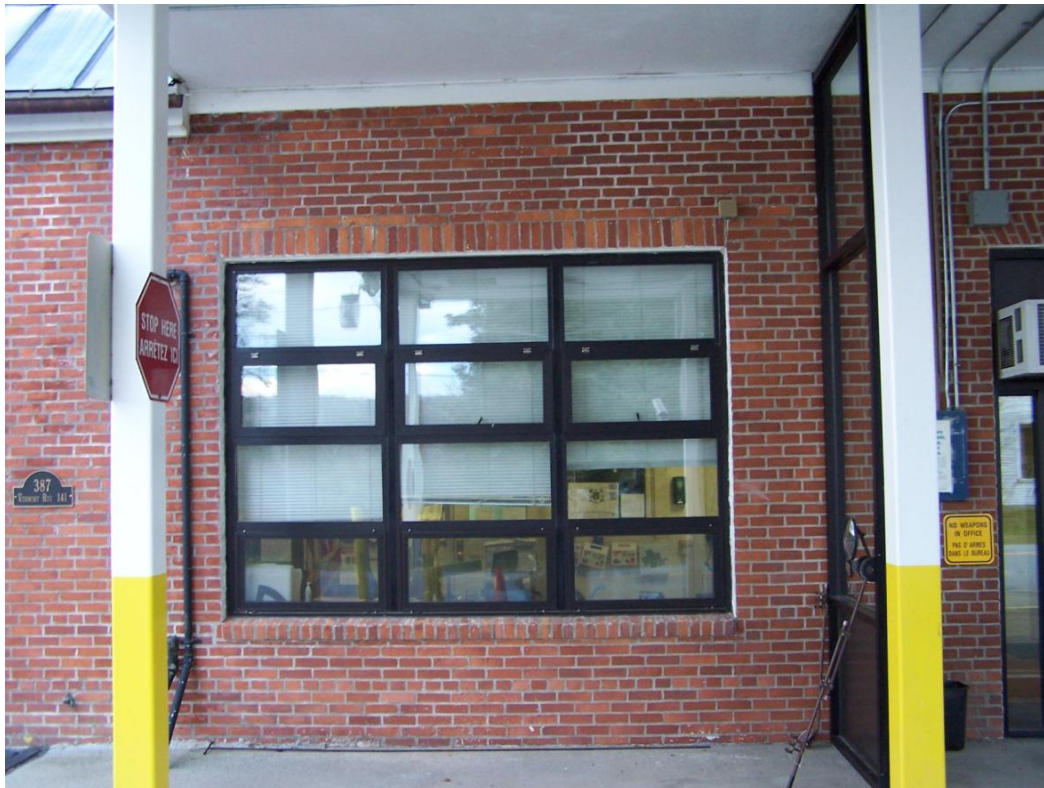
Photo number: VT_EssexCounty_CanaanBorderStation4.tiff

Description of view: altered front window, view: west

The primary alteration to the Canaan Inspection Station is the replacement of the front elevation windows with extruded aluminum frame multi-glazed units. In the process of replacing these windows, the crown and keystone detail above them was altered, and the original pairs of windows in the outer bays were consolidated into single units, thereby changing the overall configuration of the primary façade from five bays to three bays. Aluminum cladding is present on the garage wings and dormers. Within these garage wings, two of the former garage door openings at the south wing have been transformed into pedestrian entries. However, the profile and frame of the original garage openings are still present. A non-original porte-cochere, taller than the original, is also present.

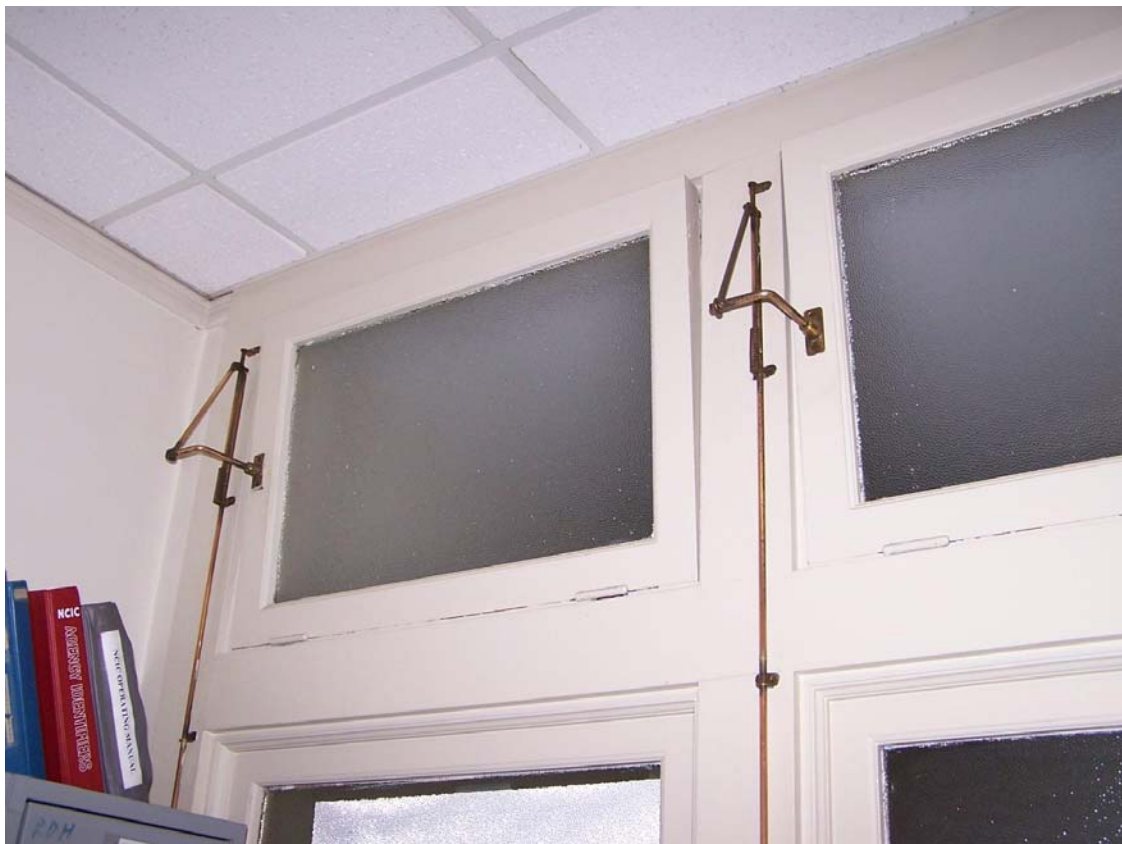
Photo number: VT_EssexCounty_CanaanBorderStation6.tiff

Description of view: operable window hardware, view: east/northeast

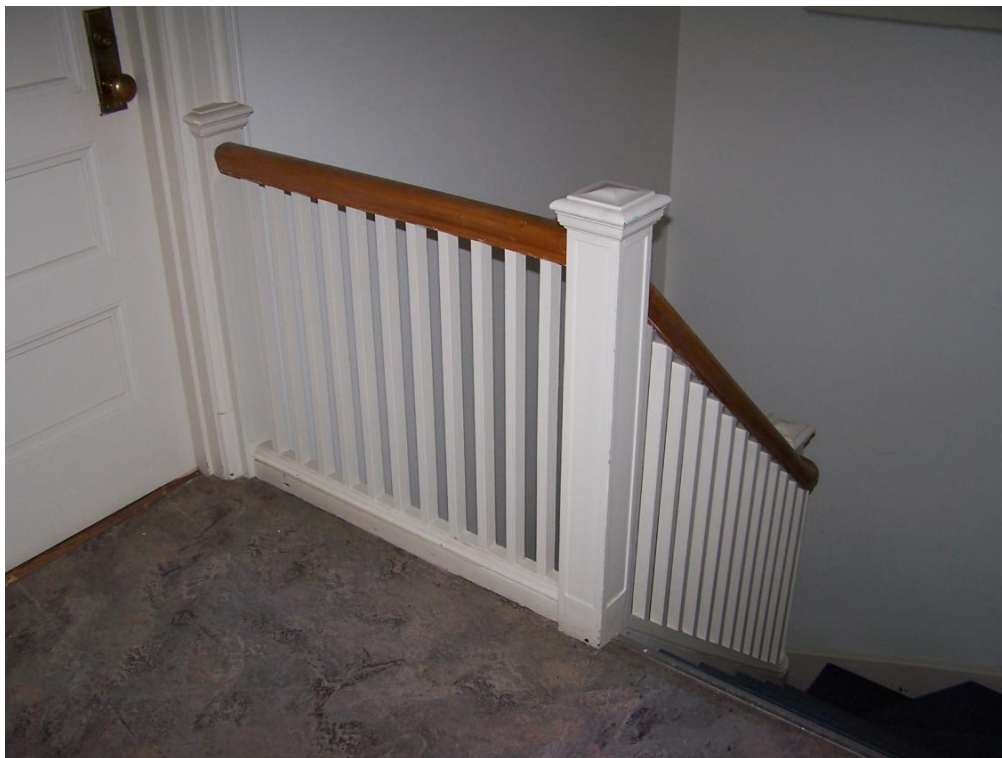
Photo number: VT_EssexCounty_CanaanBorderStation7.tiff

Description of view: stair rail, linoleum, view: southwest

The stairs from the first to second level have cement finish treads and risers, metal balusters, and square shaped metal newels each featuring a cornice molded crown detail and. Wood trim runs along the base of the stairway, and the handrail is of a blonde colored, stained hardwood. A rear landing, with a door to the back of the property, is present within the stairway. The basement level is divided into three separate rooms for the boiler, coal storage and the plumbing machinery. One section of the basement has a desk and functions as a workspace. The basement rooms are unfinished and feature painted concrete walls and floors. The doors separating each of these three rooms are paired, two-panel, metal safety doors featuring a diagonal board pattern within each of the rounded-corner panels.

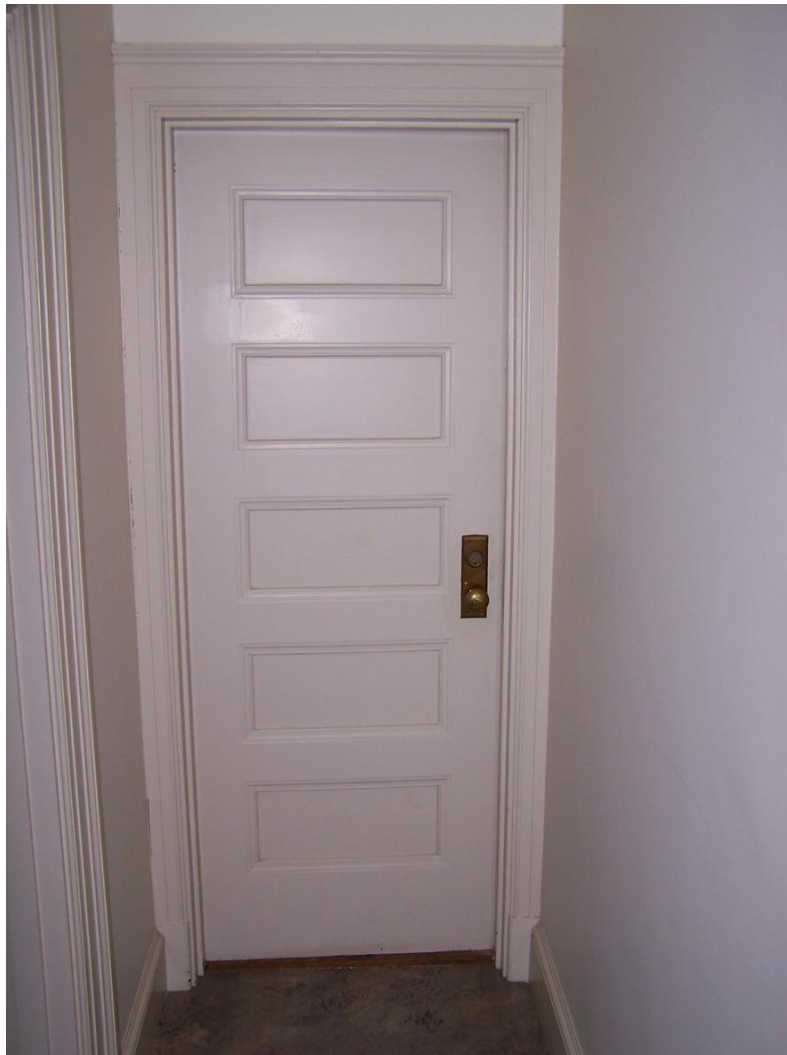
Photo number: VT_EssexCounty_CanaanBorderStation8.tiff

Description of view: original door off second level corridor, view: north

The upper level of the Canaan Inspection Station features two detention cells along the west wall, a detainee restroom, various storage rooms, and a hallway centered in middle of the second floor that runs north-south. The doors of the two detention cells are clad in sheet metal, and contain a small viewing portal with wrought iron bars. The windows within the detention rooms are also covered in steel bar. Original sink and toilet fixtures are present in the restroom on the second floor, as is original pink and gray marbled linoleum flooring at the second floor landing and hallway. Most of the doors on the second level are 5-panel wood doors. Original lighting fixtures are also present.

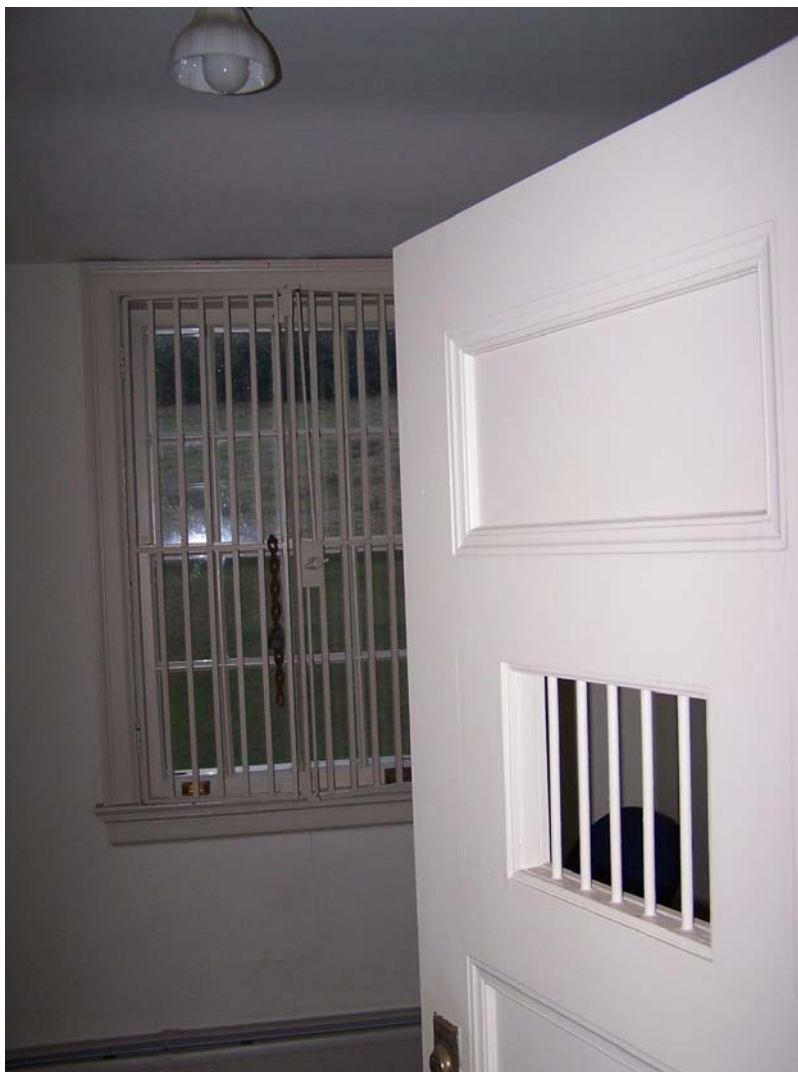
Photo number: VT_EssexCounty_CanaanBorderStation9.tiff

Description of view: detention facility with original lighting fixture, view: west

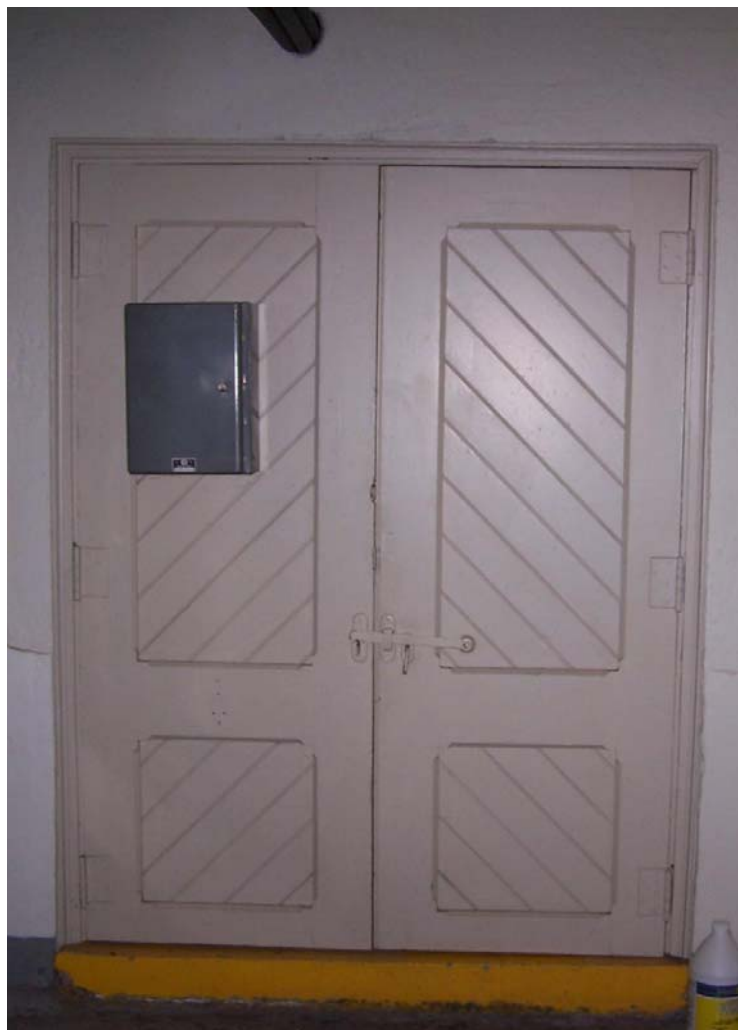
Photo number: VT_EssexCounty_CanaanBorderStation10.tiff

Description of view: doors within basement, view: south

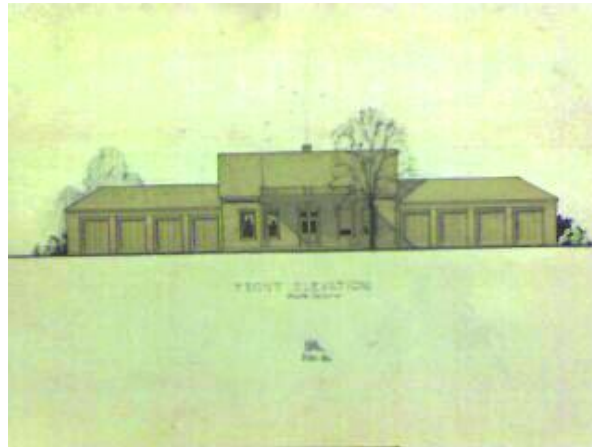
Description of view: front elevation

¹² Images 12 and 13: U.S. Department of the Treasury. Cabinet Sketch No. 29. United States Inspection Station—Canaan, Vermont in Records Group 36, at the National Archives and Record Administration in College Park, Maryland.
