# M. E. HELME HOUSE FURNISHING CO.

HELME-WORTHY RESIDENCE AND STORE  
513-519 Walnut Street and 128 Sixth Street  
Huntington Beach, Ca 92648  
Orange County

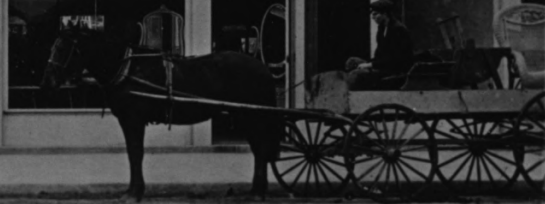
Front facade of store taken in 1907. The only changes from this photo are the sign across the top of the cornice and the plain doors in the center which replace the original.

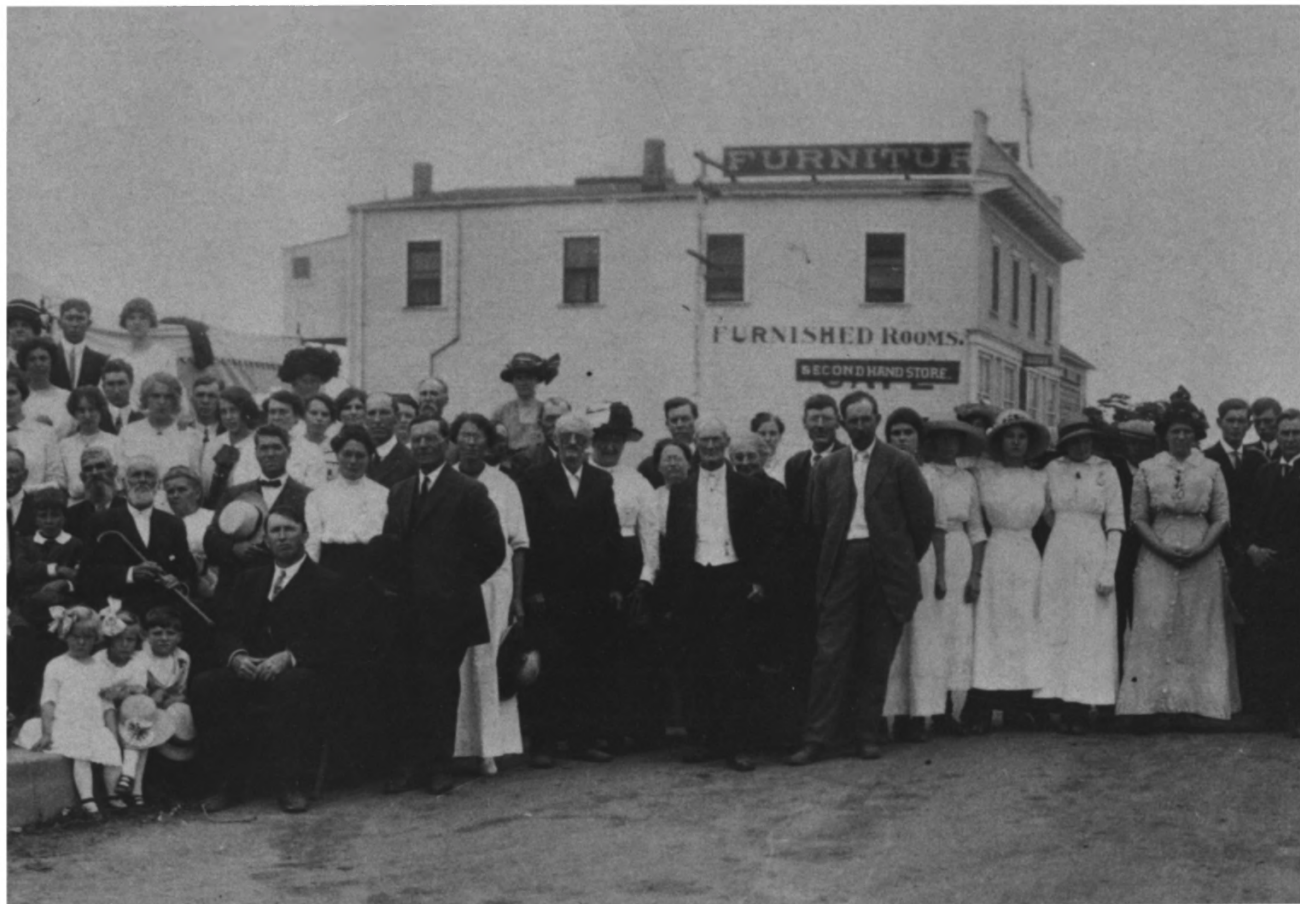
1912 photograph of the Helme House Furnishing Company taken in 1912. Event and persons in picture unidentified. Note back of store with second floor porch. The sign "furnished rooms" refers to the second floor of the store building

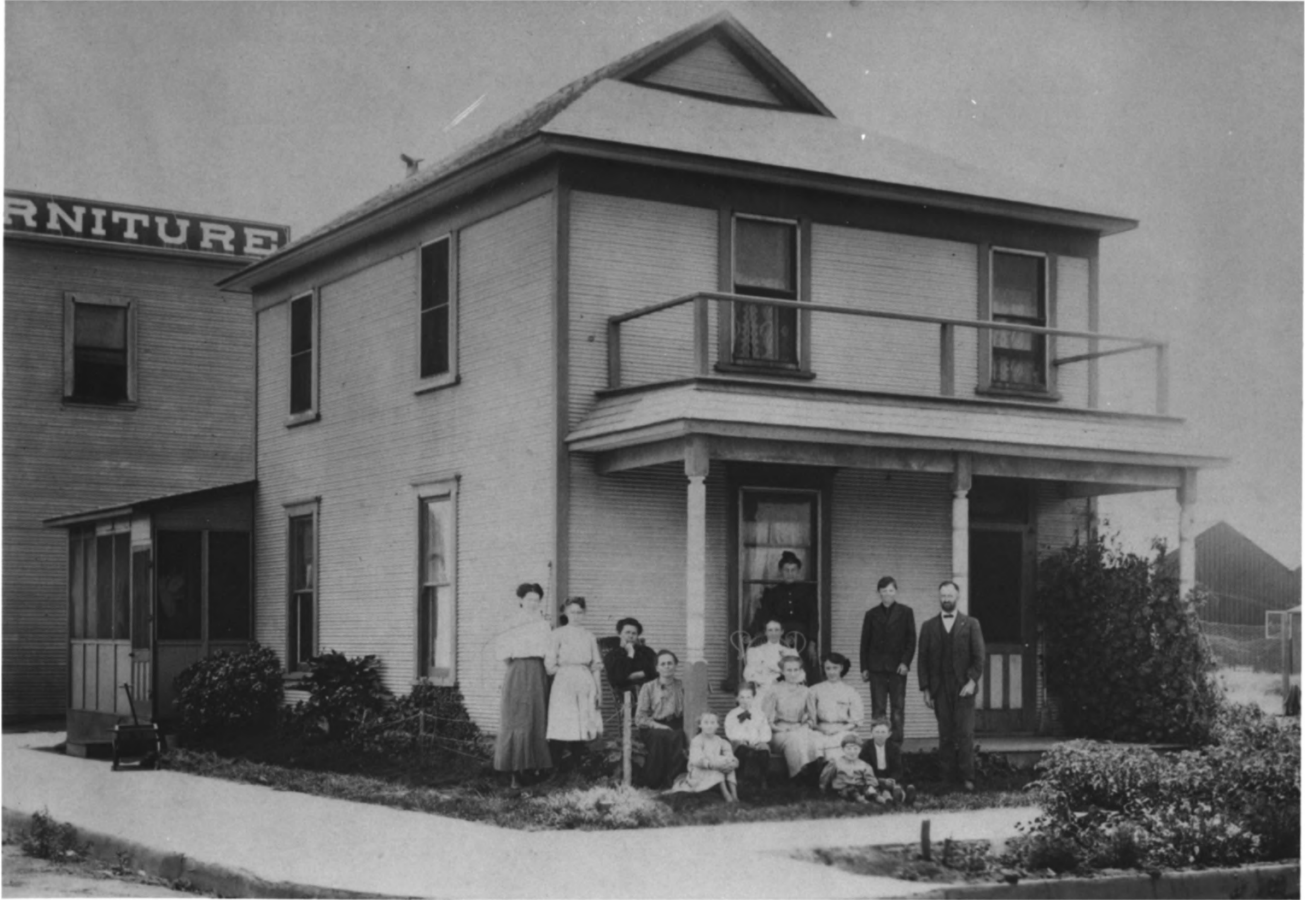
Front (Sixth St.) facade on right with Walnut facade on left. Store at rear faces Walnut. At this point, the front porch of the house had not been enclosed and the bay window built on the Walnut side. Porch at rear had not been enclosed yet and manufactured-stone-fronted addition to store had not been built yet.

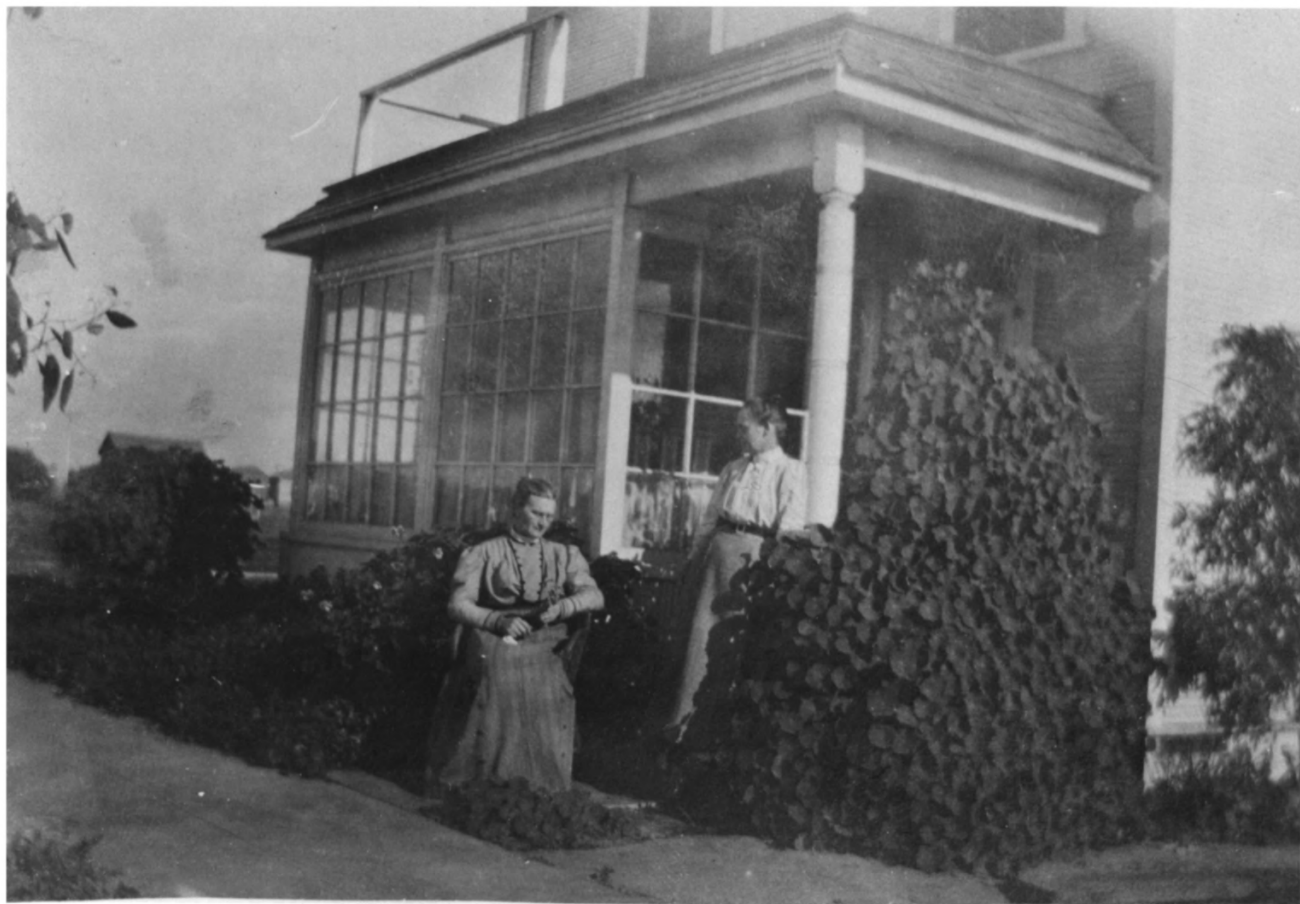
View of front porch from northwest. Front facade with porch enclosed. Mollie Helme (seated). Side of porch nearest west side (right side) has been enclosed with louvers which will soon be removed. A fence has been added to the right (west) side yard.

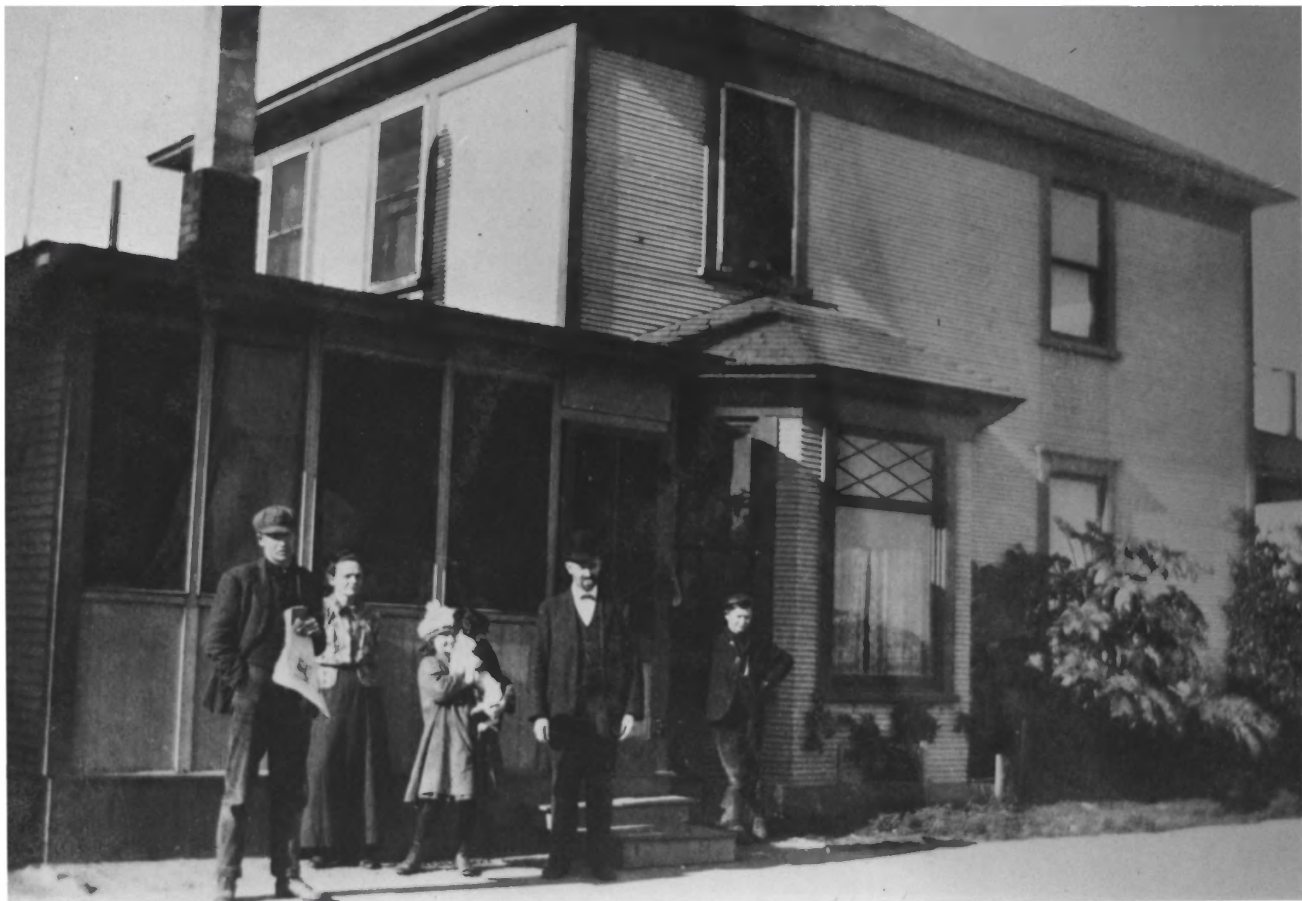
Walnut Street side of house approximately 1907. Bay window was a then-recent addition to existing house. Back porch had not been enclosed at this time. Yard and setting were about the same as they are at present.

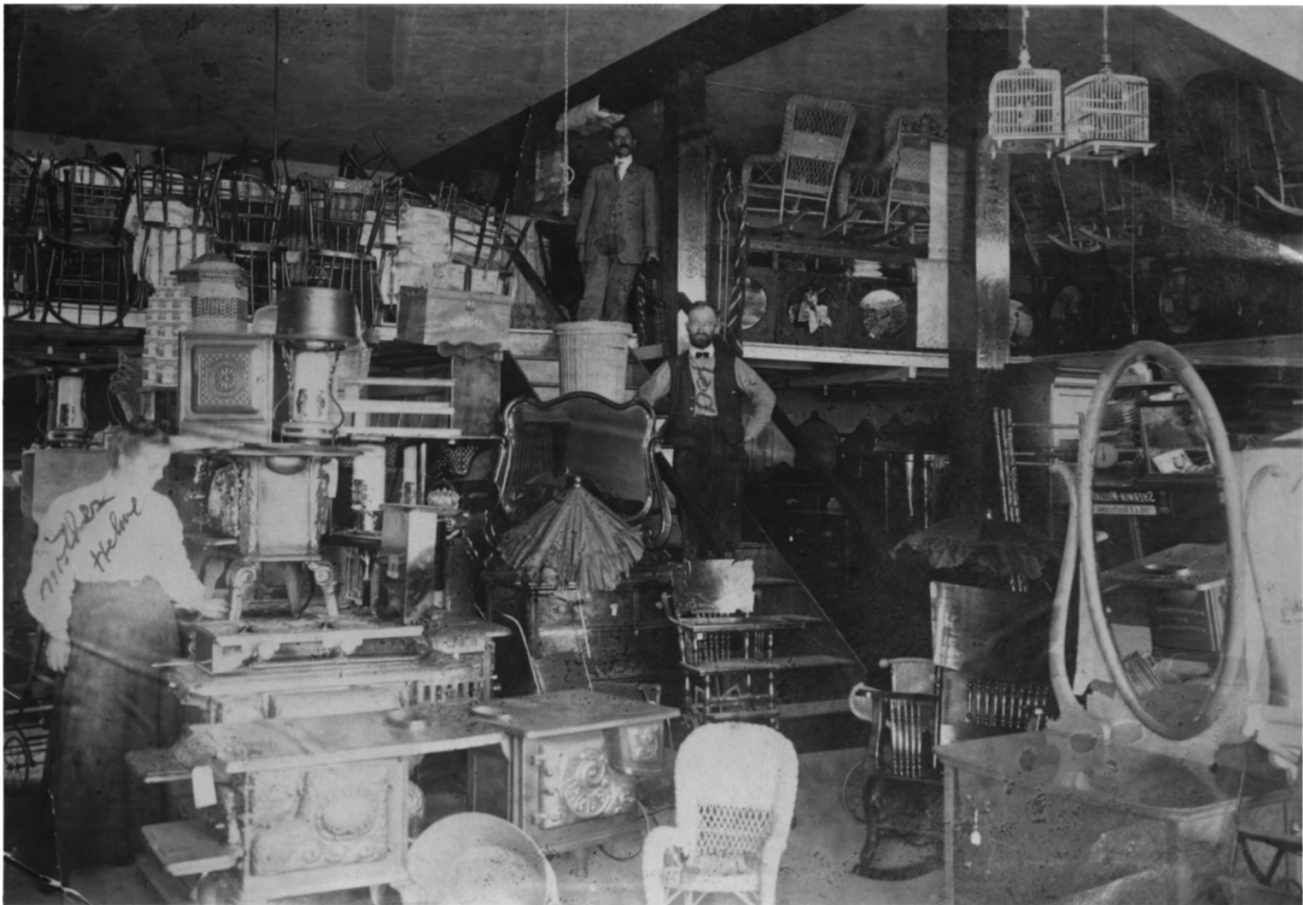
Interior of store ca. 1906-08. Mollie Helme  
on left and Matthew Helme on stairs in center.  
Walls have been built where the structural  
supports are visible on the right, and in  
front of the balcony.

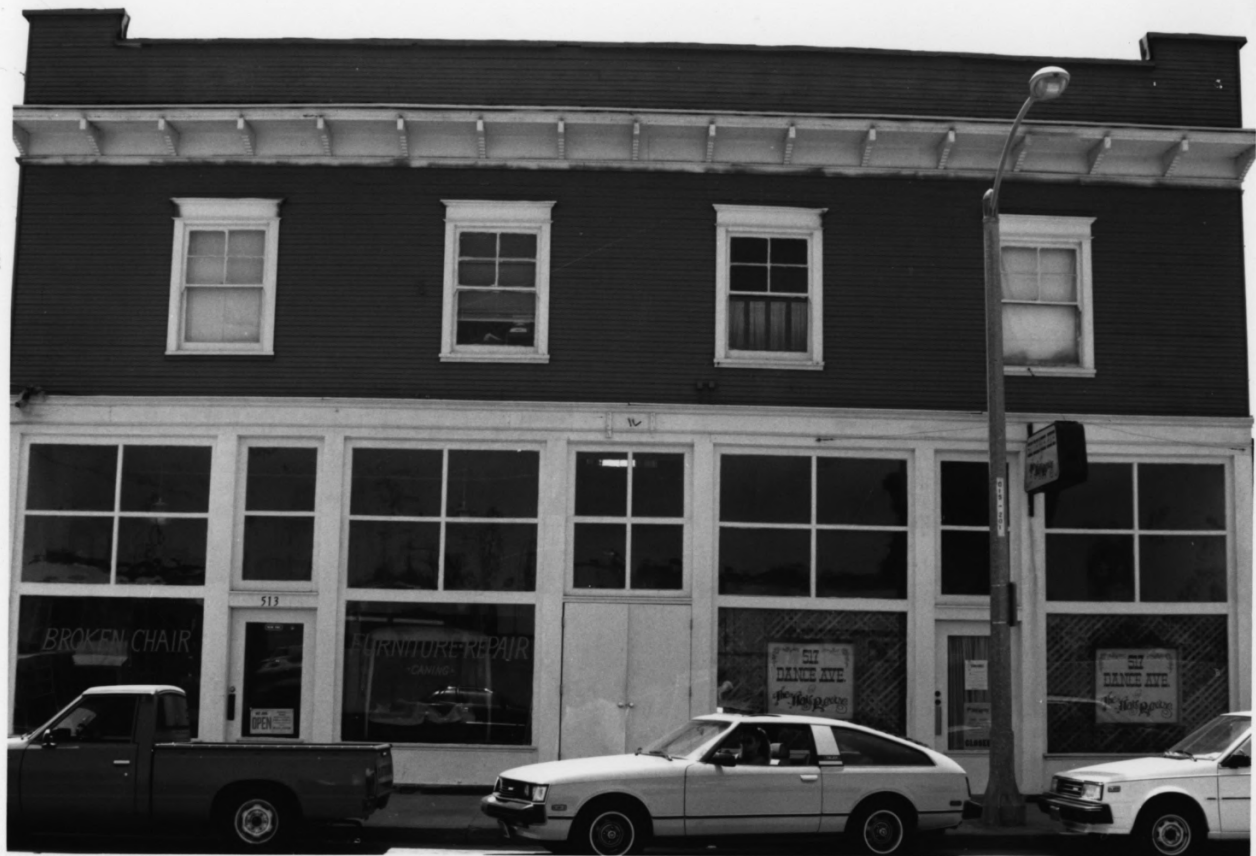
Front facade of store building, from east.

All architectural elements are original except center front doors.

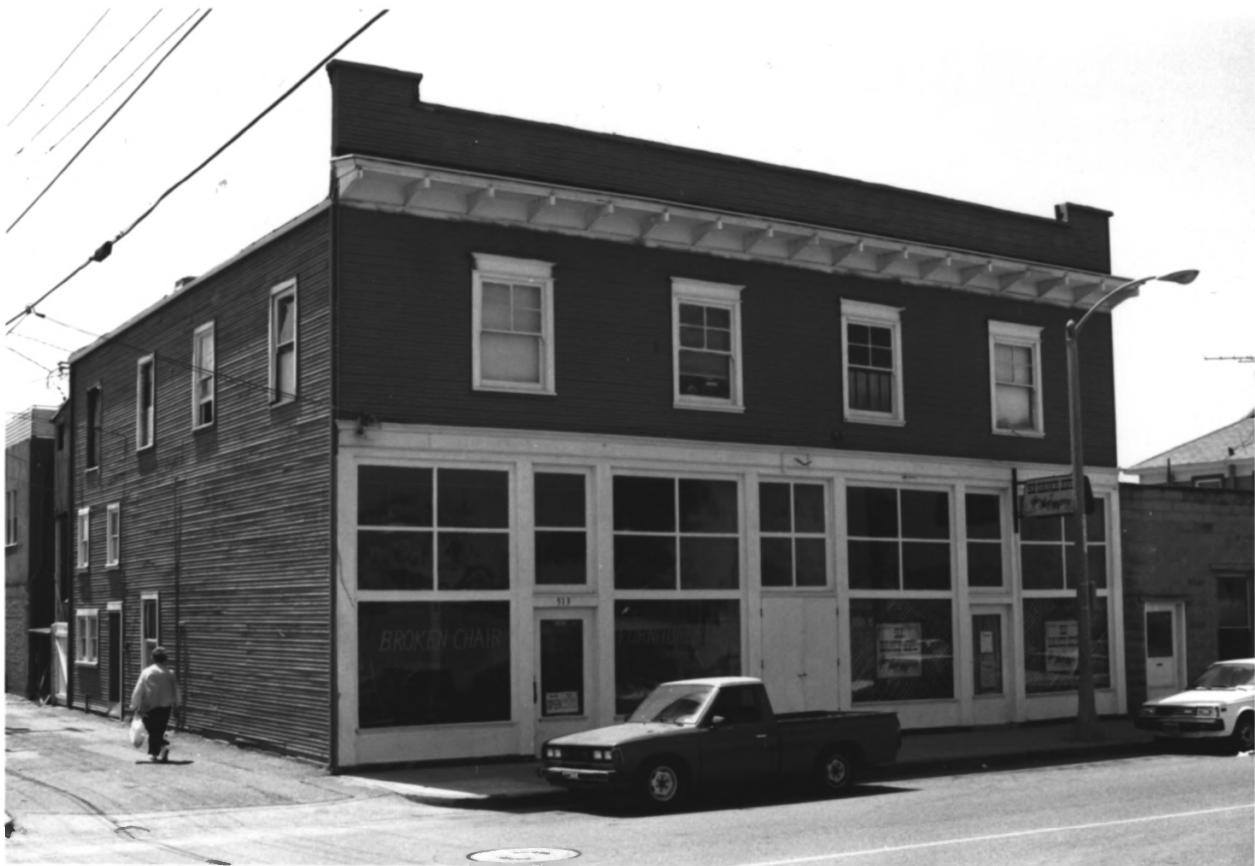
Front facade of store (on right) faces east.

side facade (on left) faces south, on the  
alley

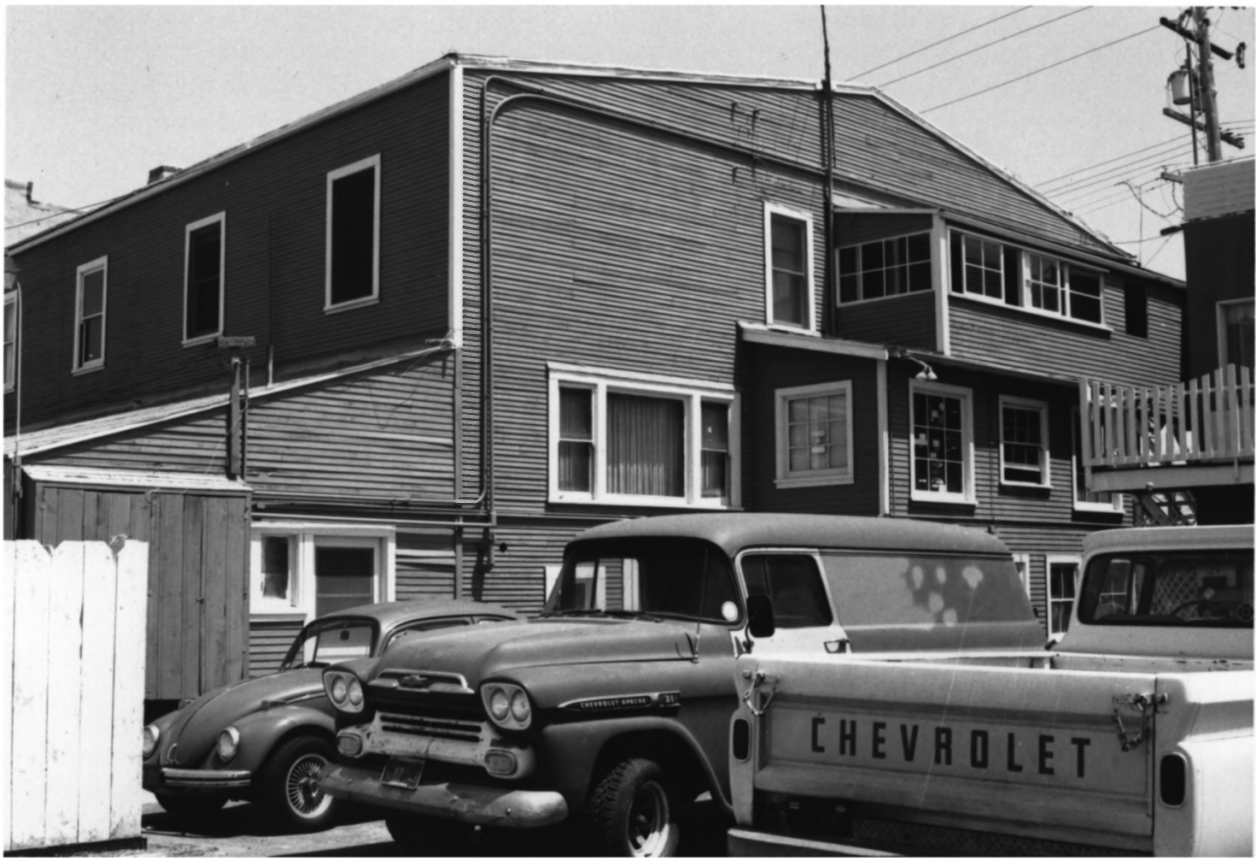
Rear facade of store taken from northwest. Single-story shed-style addition on right is back end of manufactured-stone-fronted addition. Porch at top level is original with two additional enclosed porches on the first and second levels added at a later time. Edge of 1949 garage/apartment seen on right.

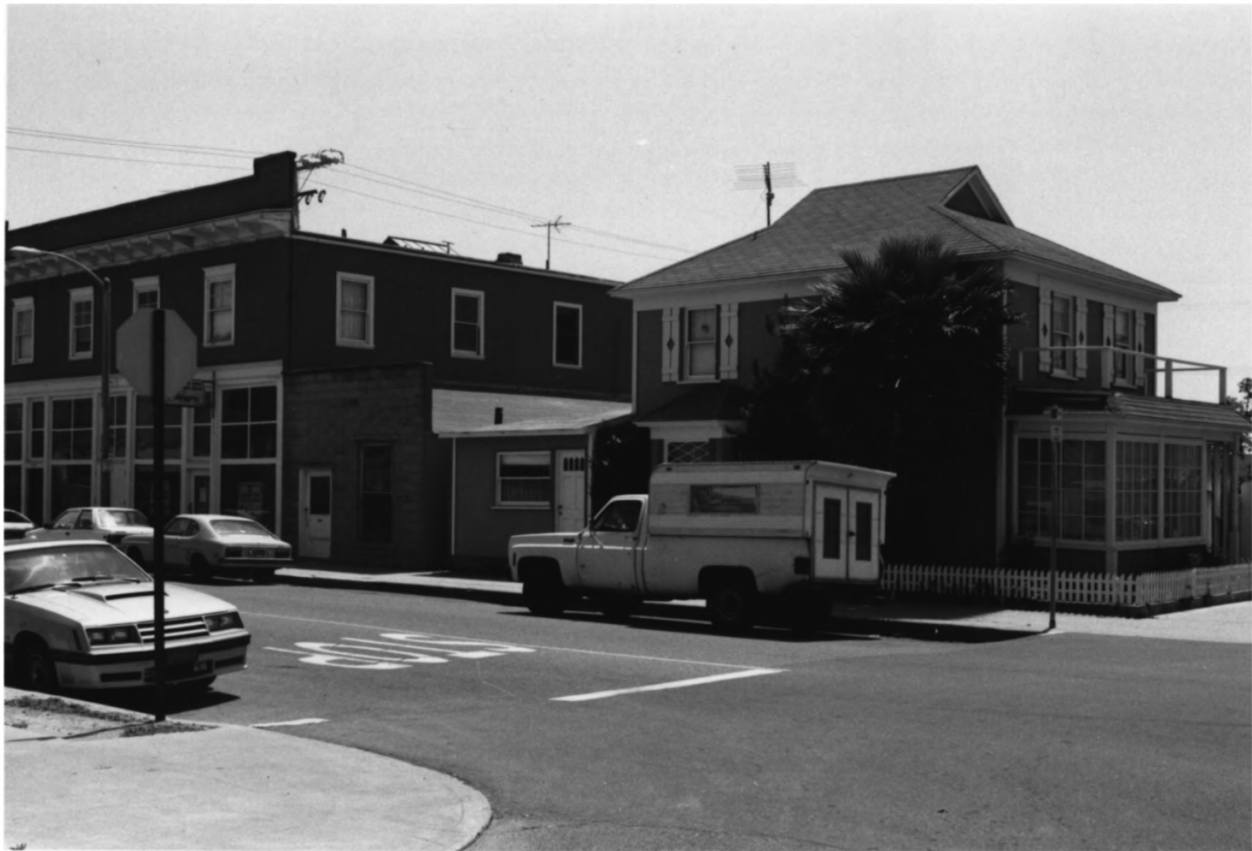
View from corner of Walnut and sixth, looking southwest. Front and north side of store and front and east side of house, with the manufactured stone front between,

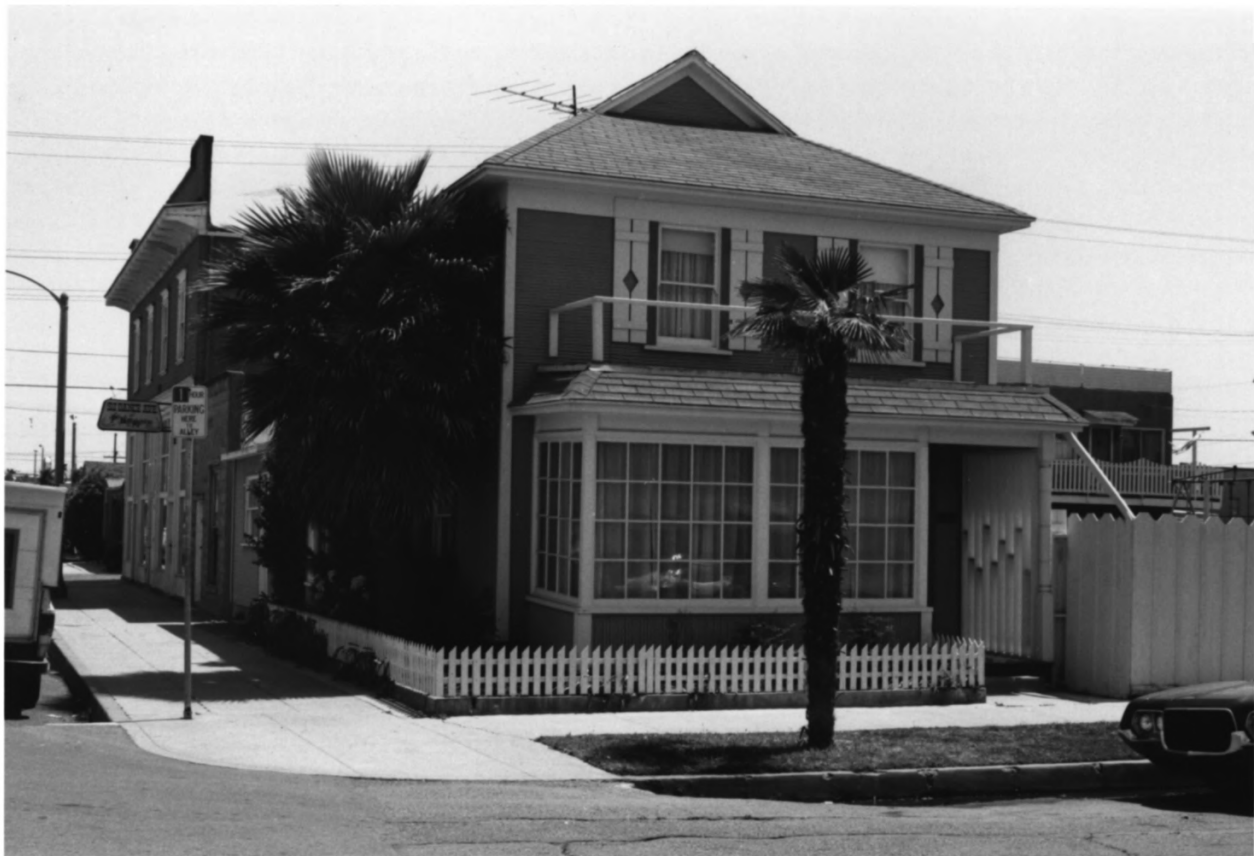
Corner of Sixth and Walnut (along left side)

Porch glassed in before 1917. Shutters and  
louvers on side of porch will be removed soon

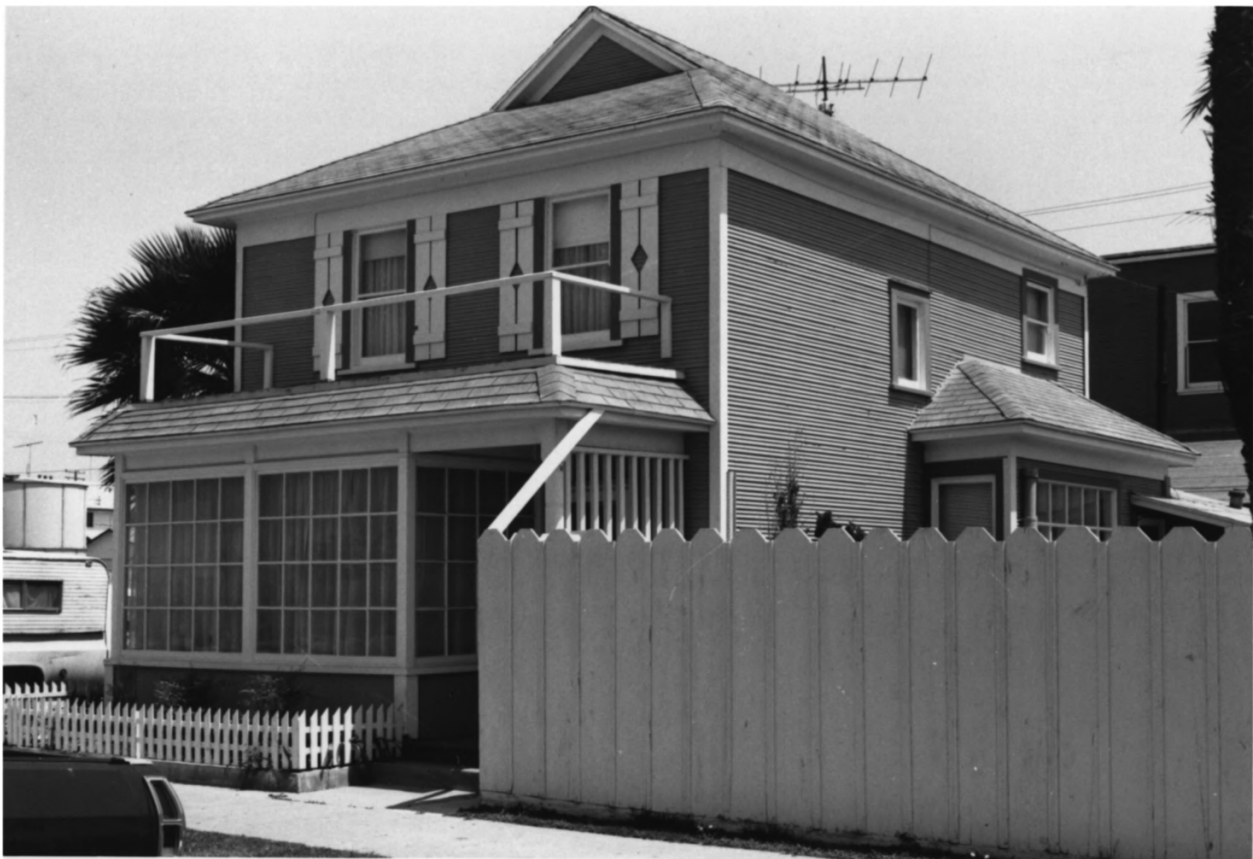
Front and west (right) side of house, looking southeast from Sixth Street. Side of store can be seen in background. Glassed in porch on house was done before 1917. Shutters and louvered wood on side of porch will be removed in the near future. "Back" yard is on west side of house.

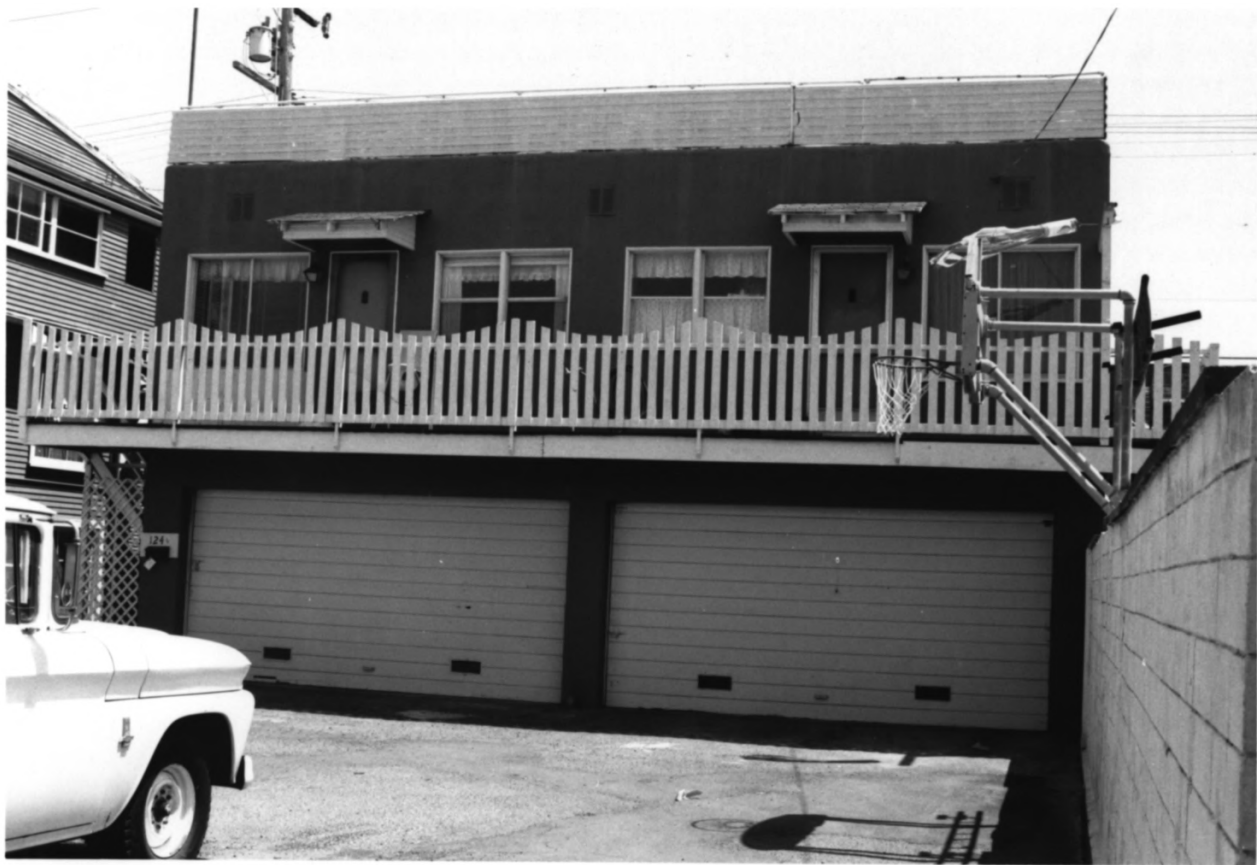
Garage/Apartment at rear of property is not visible from front (Walnut Street) and mostly hidden by the wooden side-yard fence to the west of the house on the Sixth Street side.

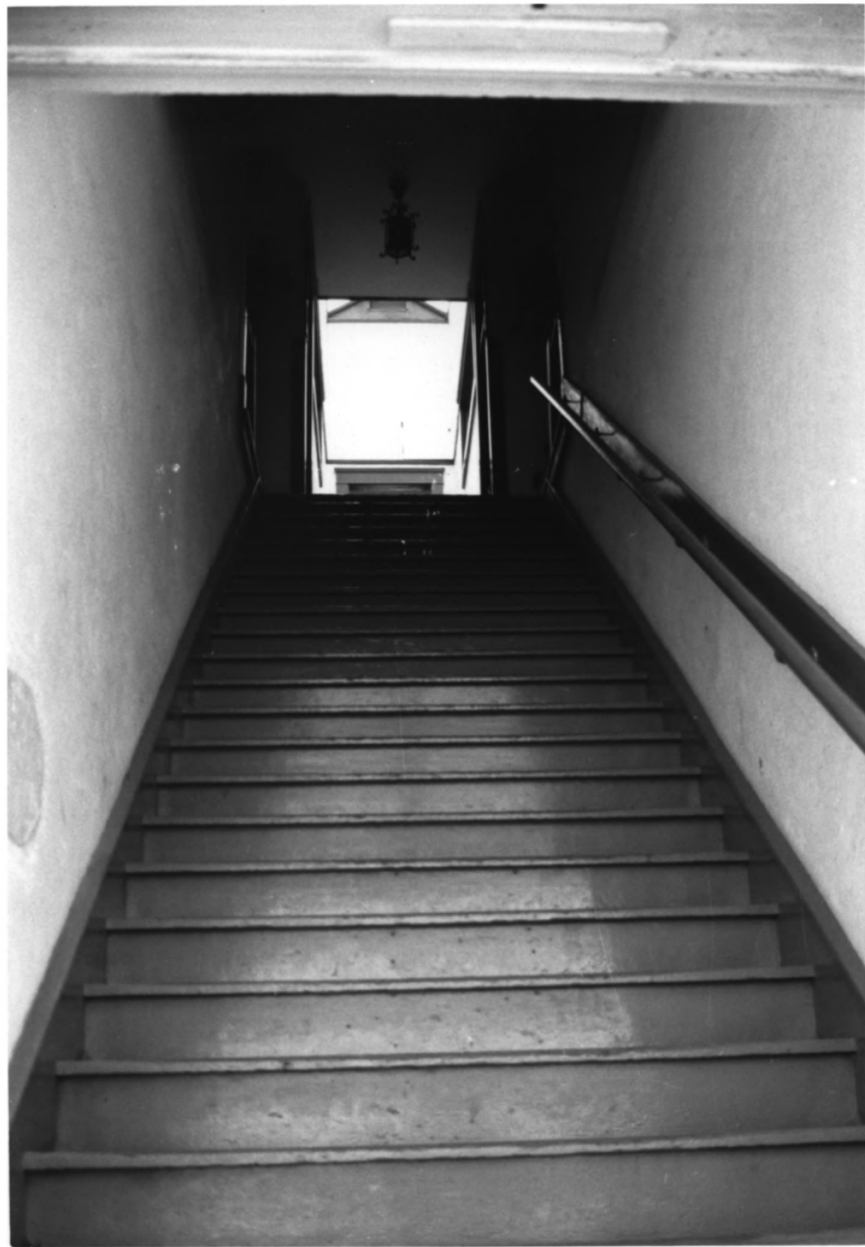
Stairway in store building, looking west  
from bottom. Stair is in center of building  
and runs front to back

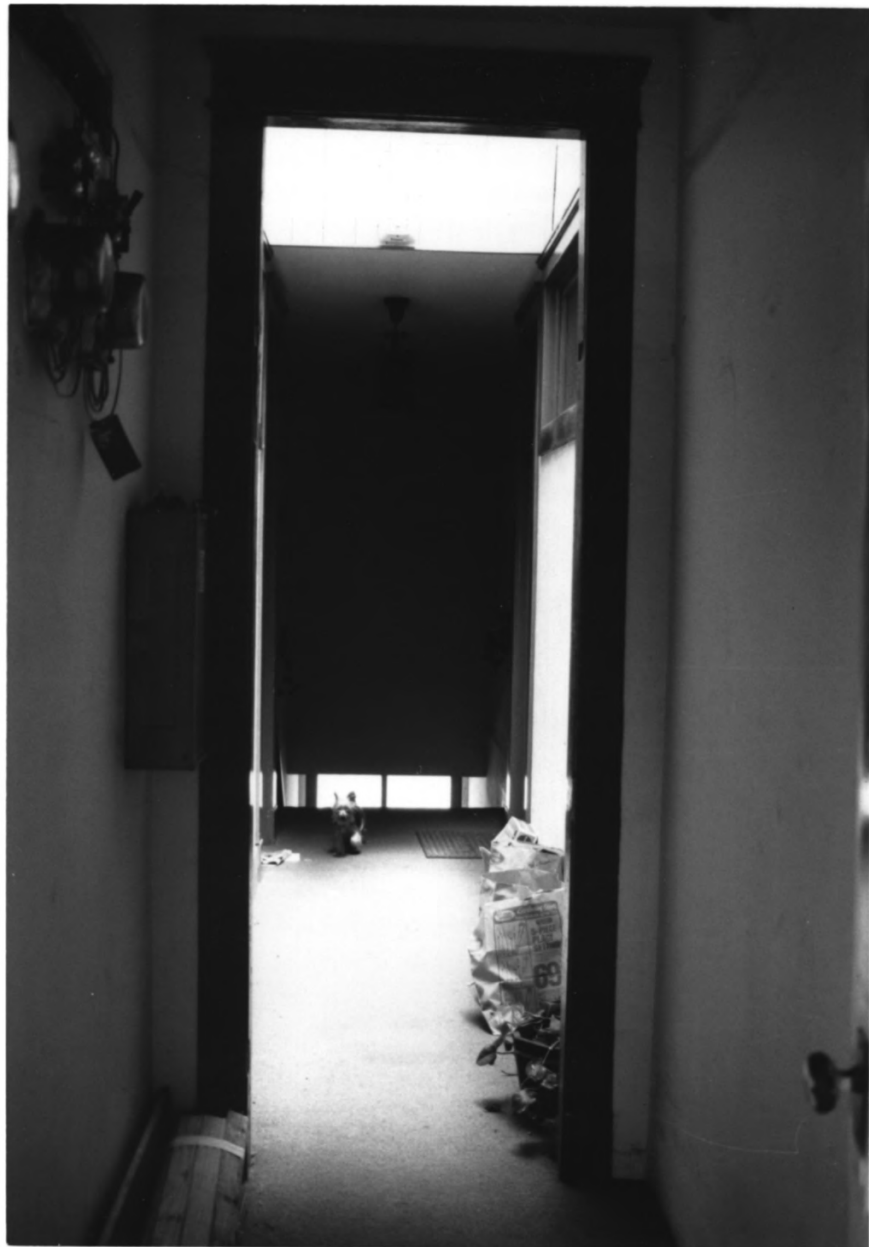
Second floor hallway, looking to the rear,  
with porch at rear and skylight above, center  
(Looking west)

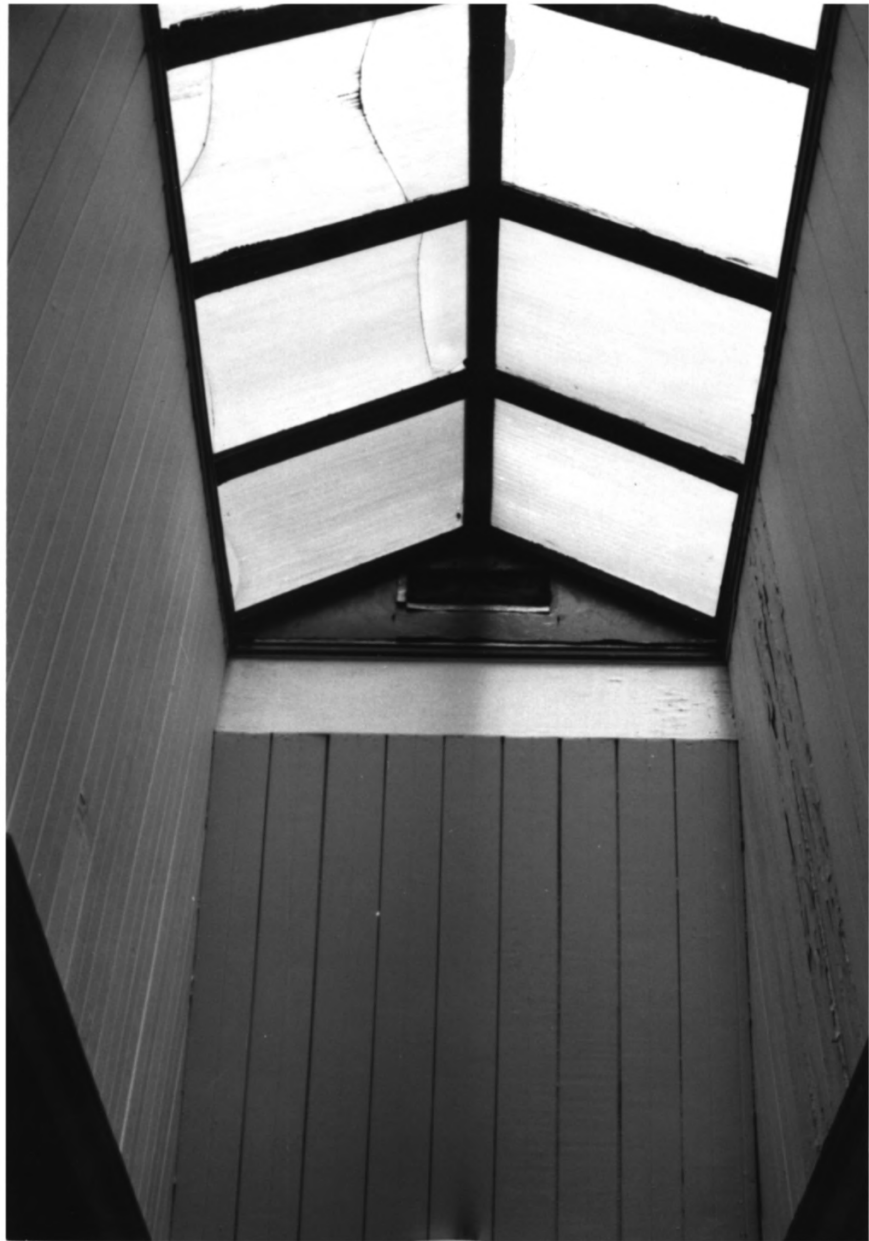
Skylight in center of second floor of store  
building is original, and made of wire glass  
in metal frames. Looking west

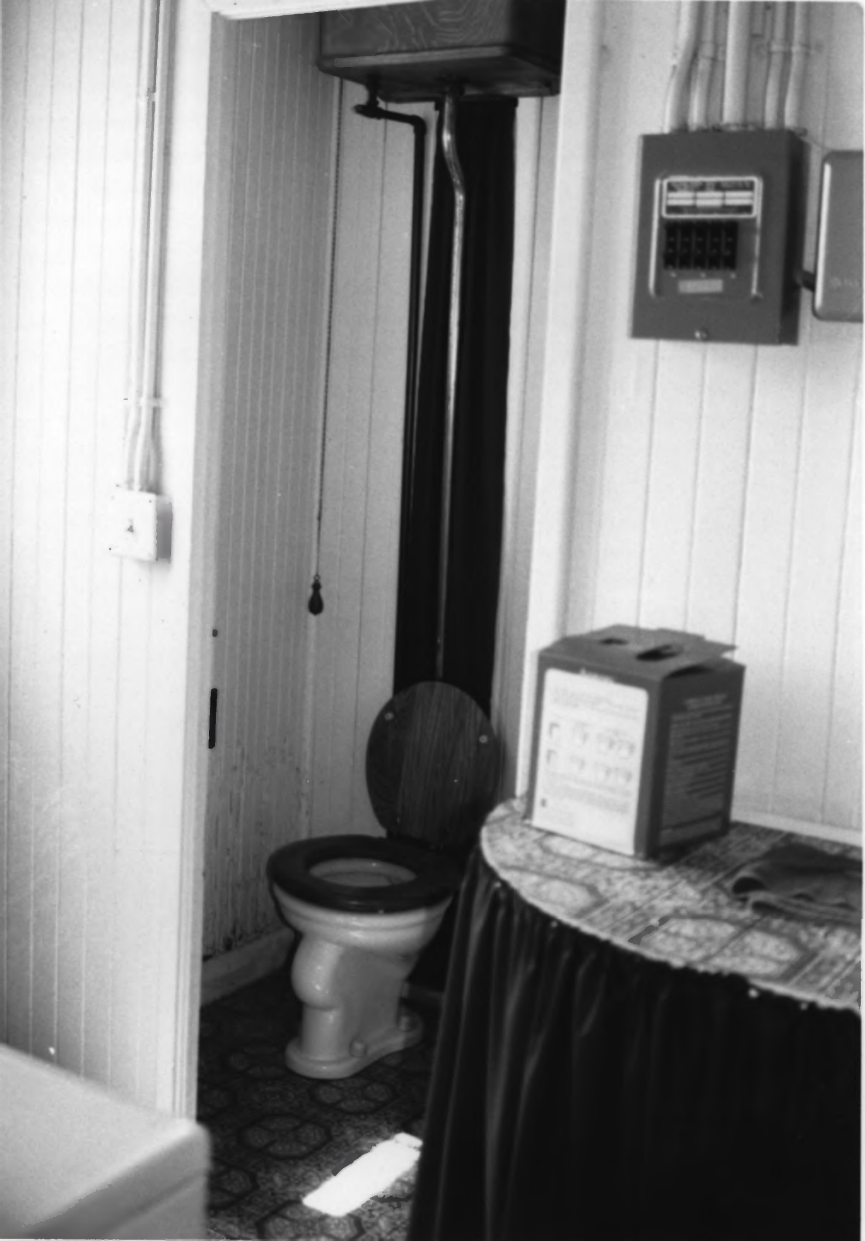
In store building, original bathroom, looking northwest, in rear corner of building.
