Lynchburg Hosiery Mill #1  
Name of Property

Lynchburg, Virginia  
County and State

## 7. Description

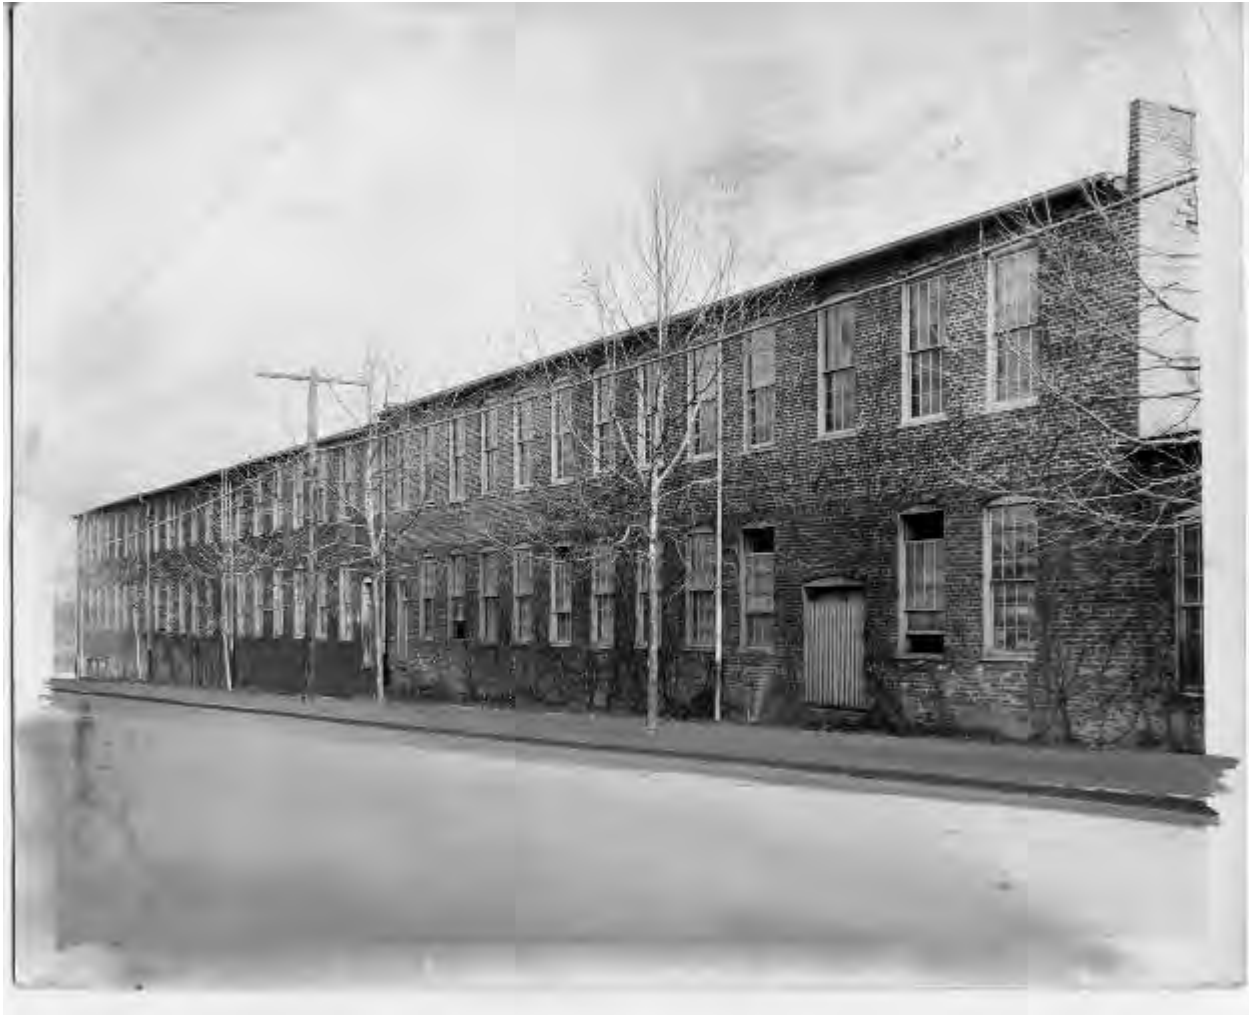
Historic Photo 1: Lynchburg Hosiery Mill, Circa 1900s.  
Unknown Photographer. Source: Lynchburg History.

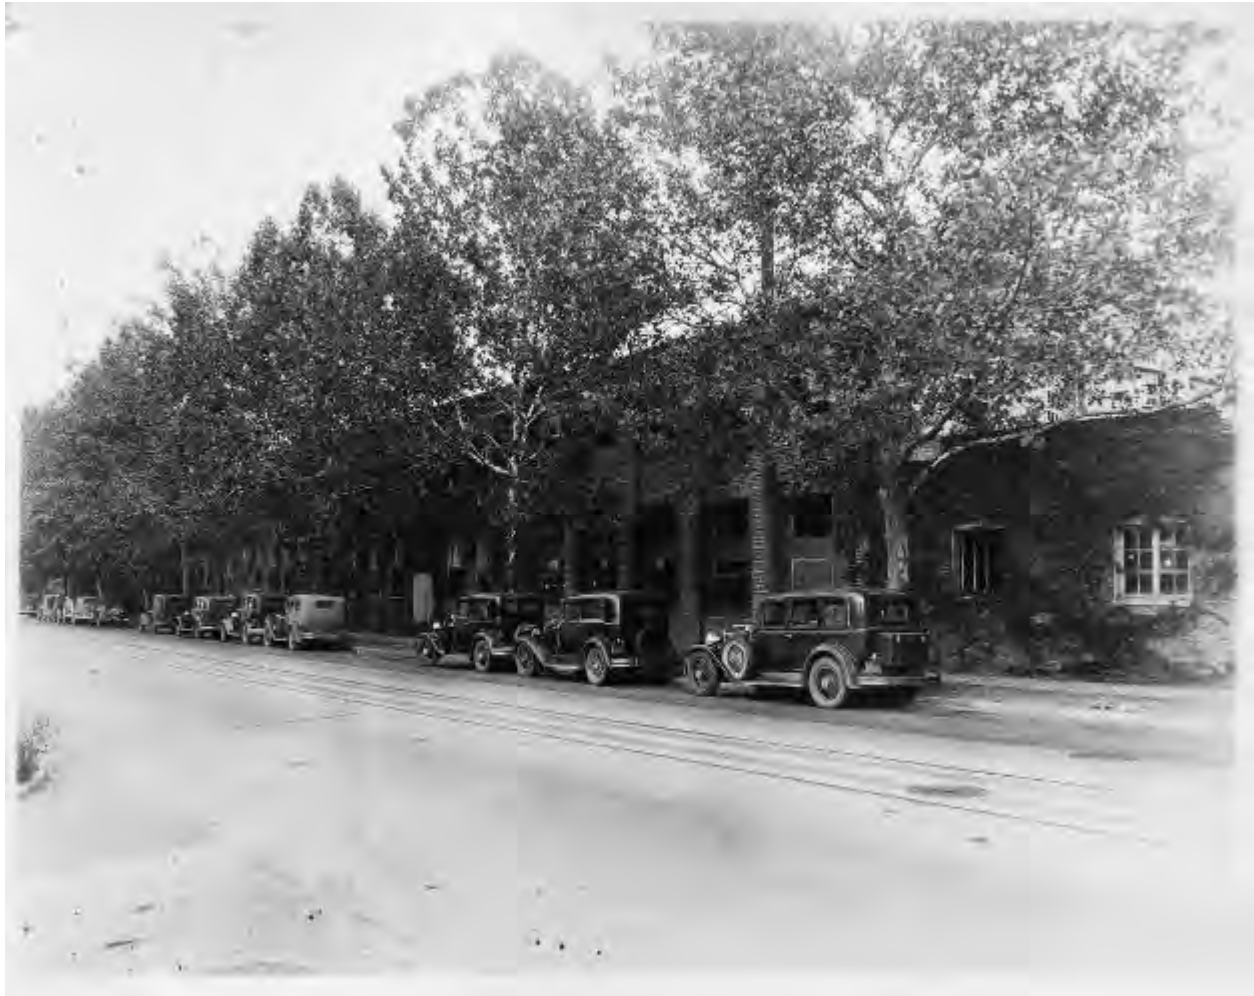
Historic Photo 2: Lynchburg Hosiery Mill, Circa 1920s.  
Unknown Photographer. Source: Lynchburg History.

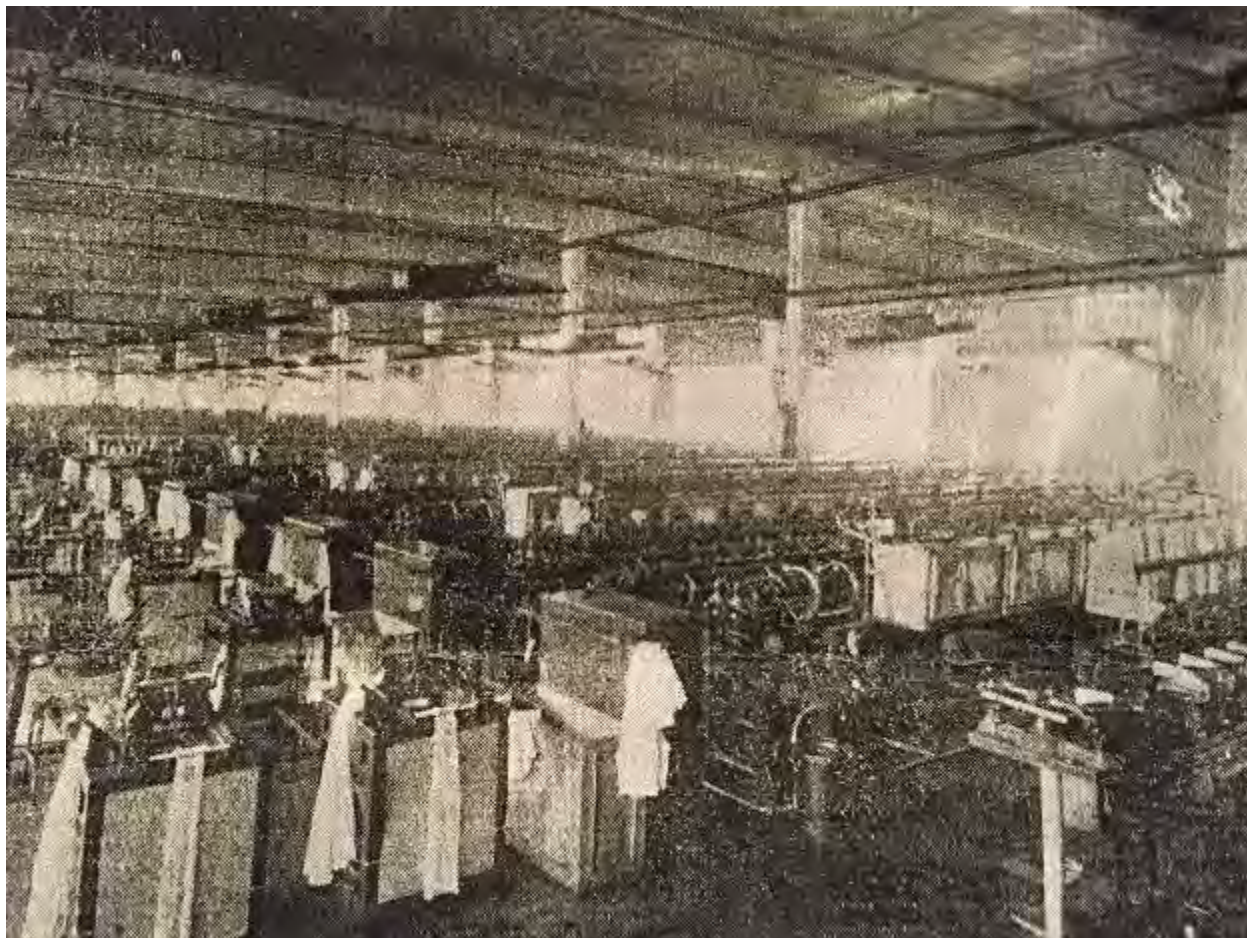
Historic Photo 3: Lynchburg Hosiery Mill Interior, 1946.

Although the interior of Building A historically held a large amount of machinery related to the operation of the mill, all of this was removed when it ceased operations. Equipment would have included pressing and knitting machines, as well as dyeing equipment as the dye house for the mill complex was located in this building.

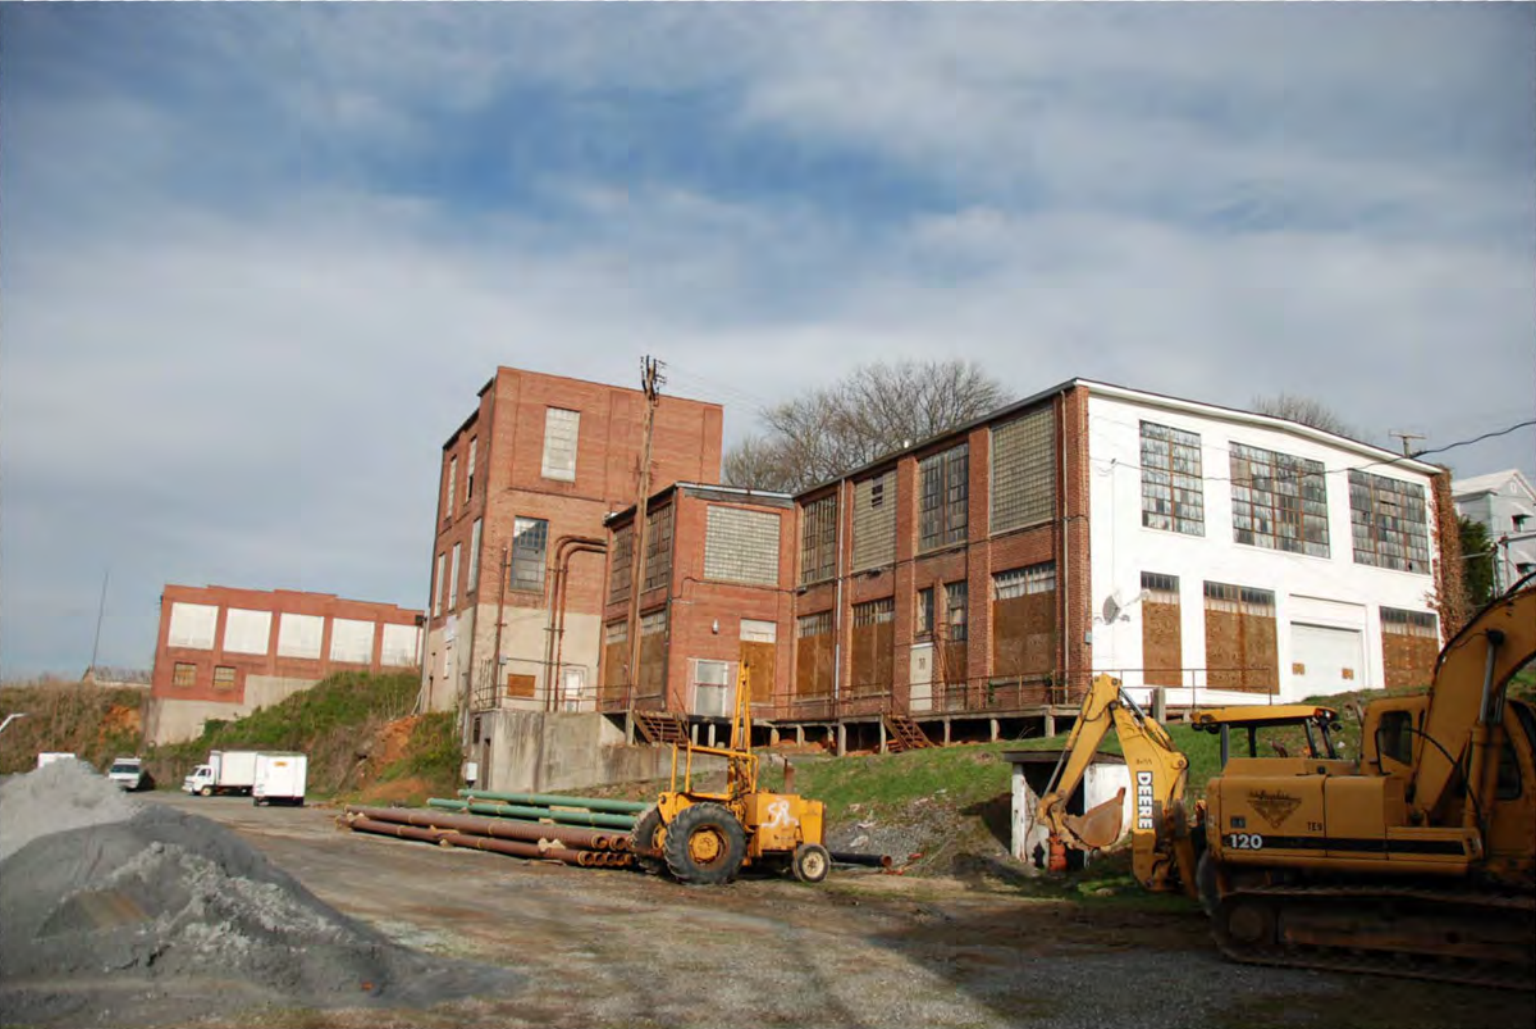
Industrial building under renovation or demolition. The structure features a combination of red brick and white siding. Large windows are boarded up with plywood. The building is situated on a slight rise.
