**National Register of Historic Places
Inventory—Nomination Form**

historic Fort Concho Historic District

2. Location

city, town San Angelo _____ vicinity of

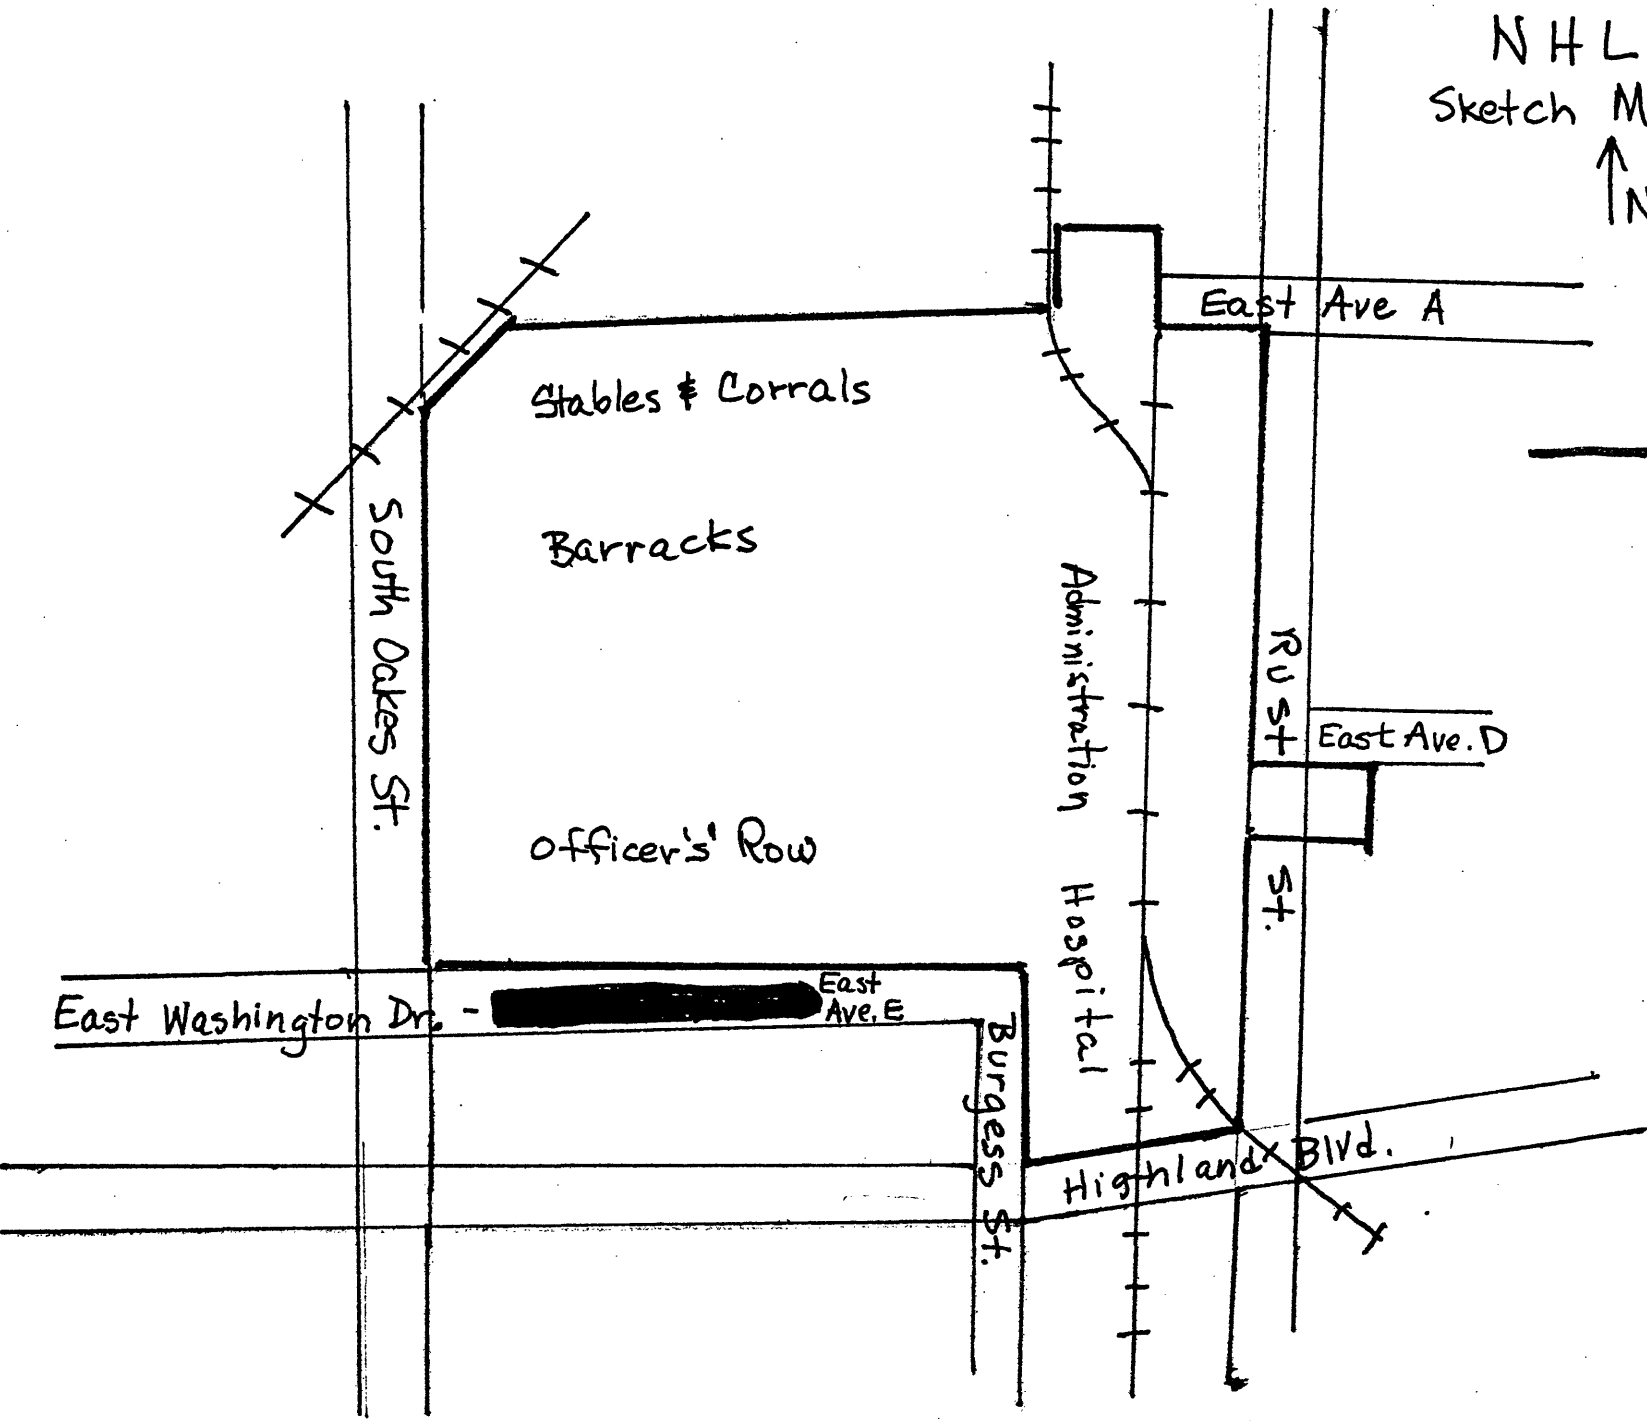
Sketch Map - not to scale

Fort Concho
NHL
