ARCHITECTURAL/HISTORICAL COMPONENT FORM

- 1) Resource No. _____ 2) Temp No. 8 3) Name Lewis House
 4) Address 108 E. Simpson, Lafayette, CO 5) District Name Lafayette Coal Mining Era Buildings
I. INTEGRITY: 6) Condition: Good Fair _____ Deteriorated _____
 7) Original Use residence 8) Present Use museum
 9) Original Site Moved Date(s) of Move: 1910-1913
 10) Unaltered Altered Explain: A small addition has been built onto the rear (south) of the structure during Elmo Lewis' tenancy.

Lewis House
Lafayette Coal Mining Era Buildings

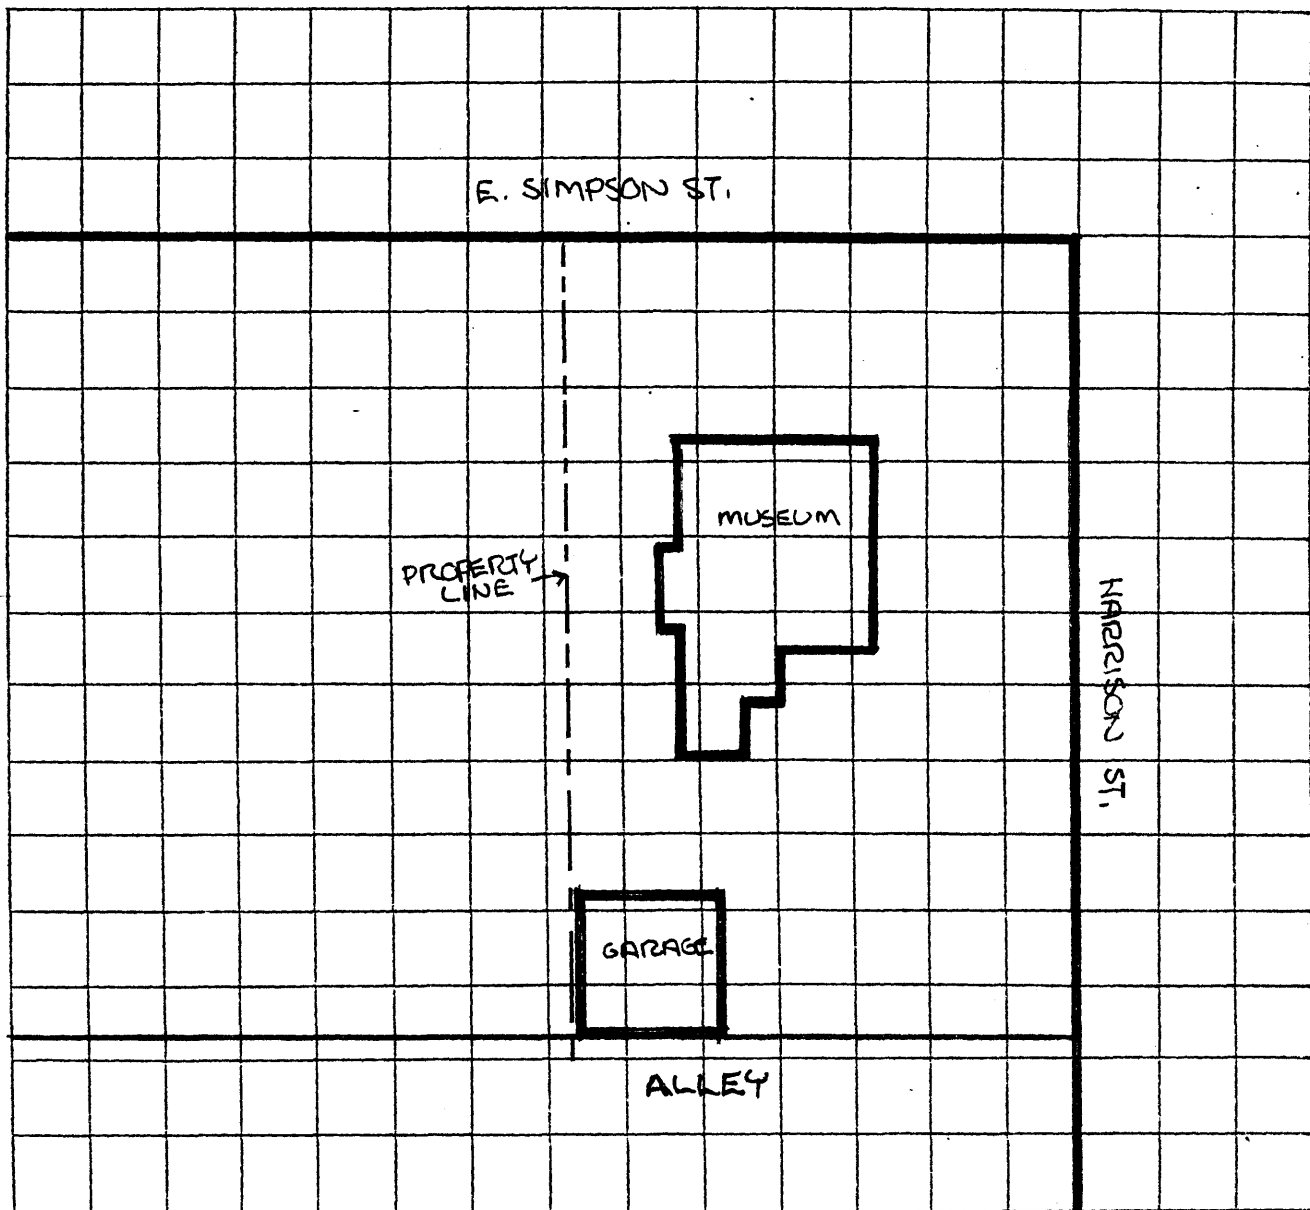
V. SKETCH MAP: Map all features and show the boundaries of the resources. Show all major topographic features, permanent modern features, and vegetation zones as appropriate. Give names of features, streets and addresses if known. Provide scale, key and direction.

scale:
□ =
3 meters

28) Location/Access: From the intersection of Hwy. 287 and East Simpson, drive east one block. The structure is situated on the southwest corner.

29) Boundary Description: Lot 1, block 6, Lafayette, Colorado

30) Boundary Justification: Limited to the lot occupied by the structure.
