**HISTORIC RESOURCES INVENTORY
BUILDING AND STRUCTURES**

1. BUILDING NAME (Common) (Historic)
 Urbana Woodruff House

3. STREET AND NUMBER (and/or location)
 1096 East Street (map 88, parcel 8) 3 acres

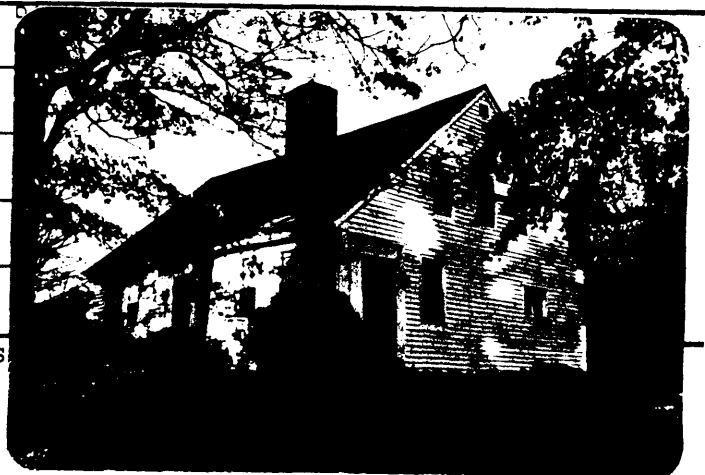
In the 5-bay front elevation of the house, the central door is flanked by 2/2 windows. The plain surround of the door is edged with band molding. A door at the front corner on the right side elevation is treated similarly. There is a central brick chimney. The siding is in excellent condition and therefore may not be original.

Northeast
