National Register of Historic Places Registration Form

Historic name U.S. Inspection Station—West Berkshire, Vermont
Other names/site number West Berkshire Inspection Station; Berkshire Border Inspection Station

*U.S. Inspection Station—West Berkshire Franklin County,
Vermont*Section 7 Page 1*MPS: U.S. Border Inspection Stations, States Bordering Canada and Mexico*

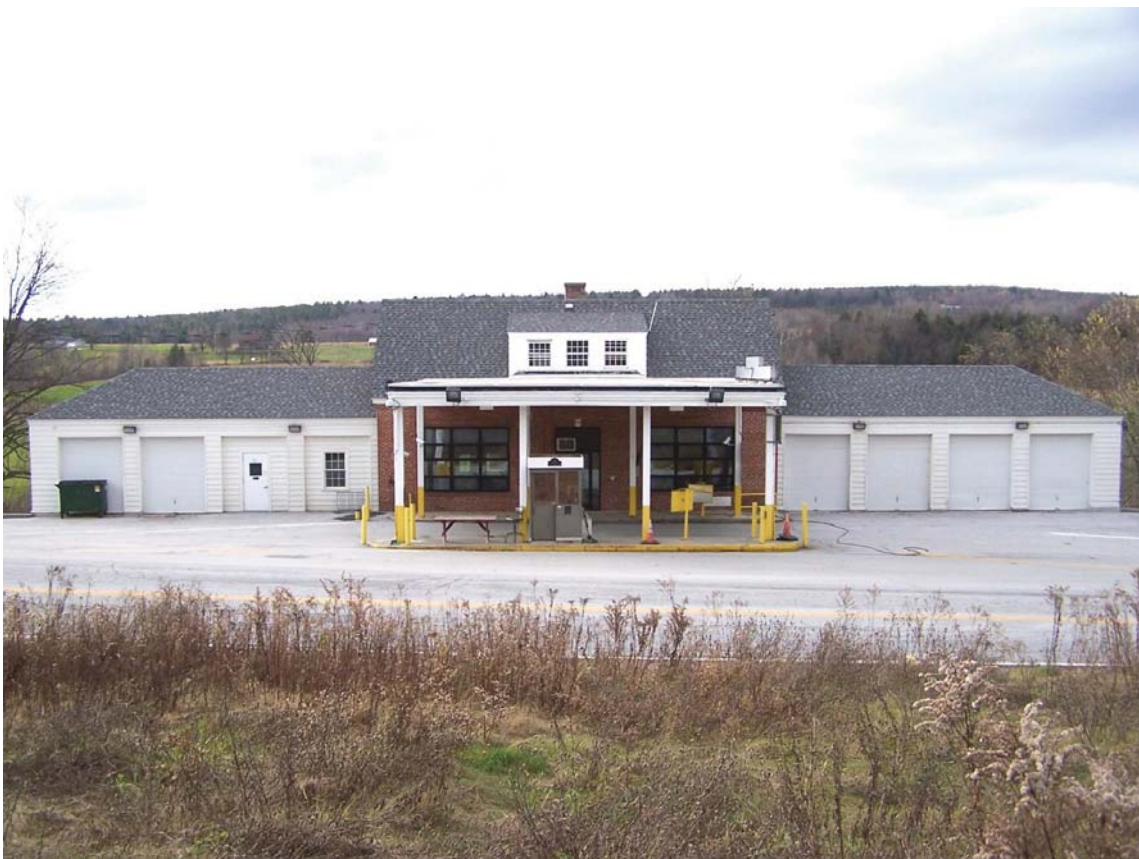
Photo number: VT_FranklinCounty_BerkshireBorderStation1.tiff

Description of view: front elevation, view: west

The U.S. Inspection Station—West Berkshire is a rectangular plan, 1½-story, side gabled woodframe building clad in American bond brickwork, and designed in the Colonial Revival style. Flanked on either end of the building are 1-story, 4-bay garage wings with aluminum clapboard siding, and eaveless hipped roofs underscored by a wood fascia and simple cornice molding. Centered in front of the inspection station is a flat roofed, metal porte-cochere that is supported by square shaped metal posts. The front elevation of the West Berkshire inspection station is of three bays. These three bays are placed in a symmetrical arrangement, with two outer window bays on either side of a centered entrance. The centered entrance features a glass panel, aluminum framed single leaf door topped by a paneled transom that now houses an air conditioning unit. Above the entry and the transom is a gauged brick jack arch pattern with a centered marble keystone. The modified, large window bay on either side of the entrance features 12-unit glazing set in dark stained aluminum frames. Above each window bay is a brick soldier course and below each window bay are brick sills. At the northern portion of the front elevation in lower corner is a marble informational plaque. The porte-cochere, which is a replacement, covers a large center portion of the front eave of the building. On either side of it upon the building is a wood fascia with simple cornice molding that wraps around the front corners.

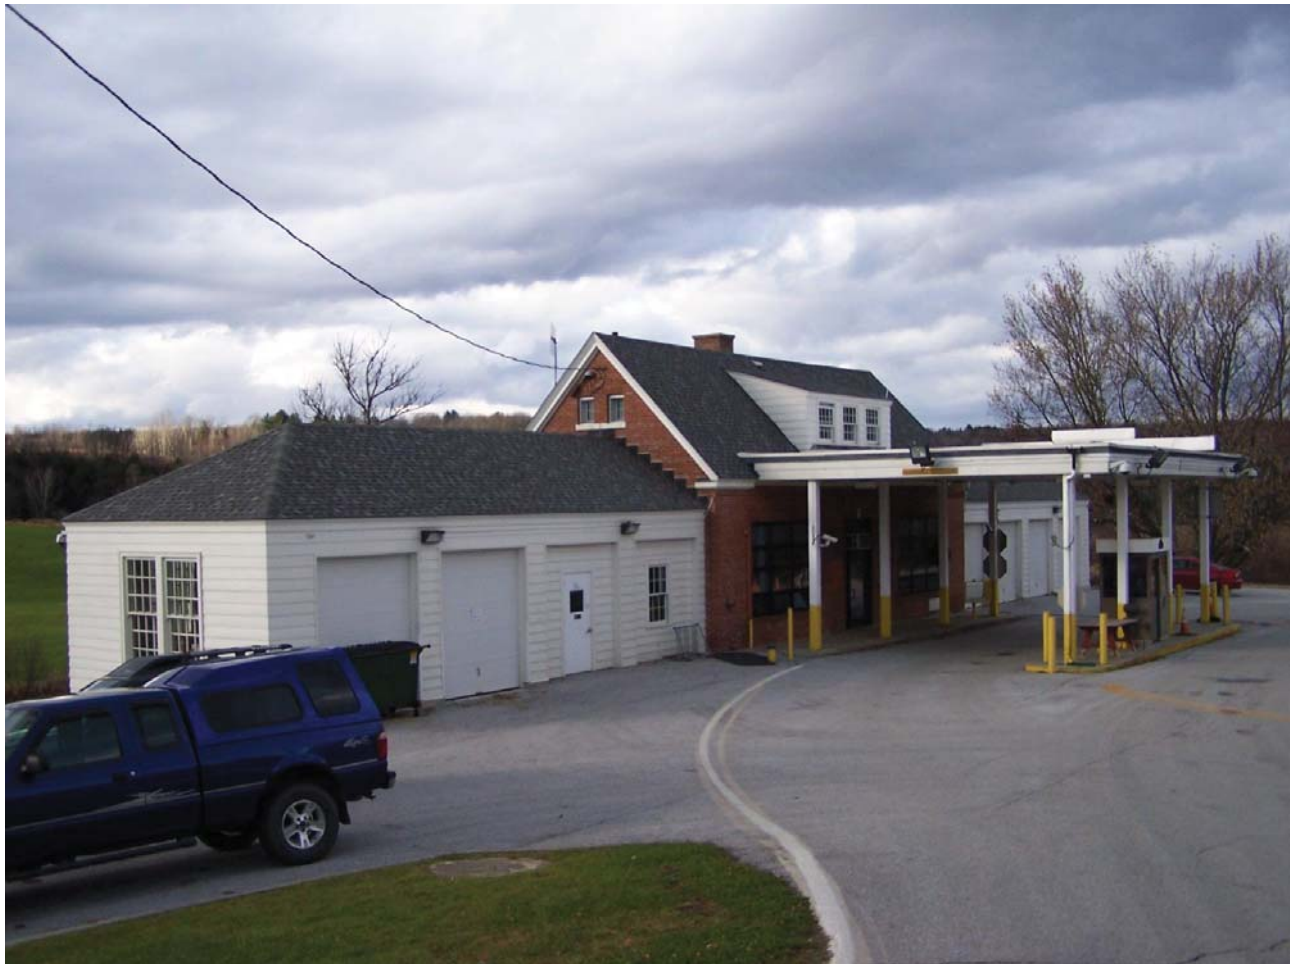
Photo number: VT_FranklinCounty_BerkshireBorderStation2.tiff

Description of view: front and side elevation, view: northwest

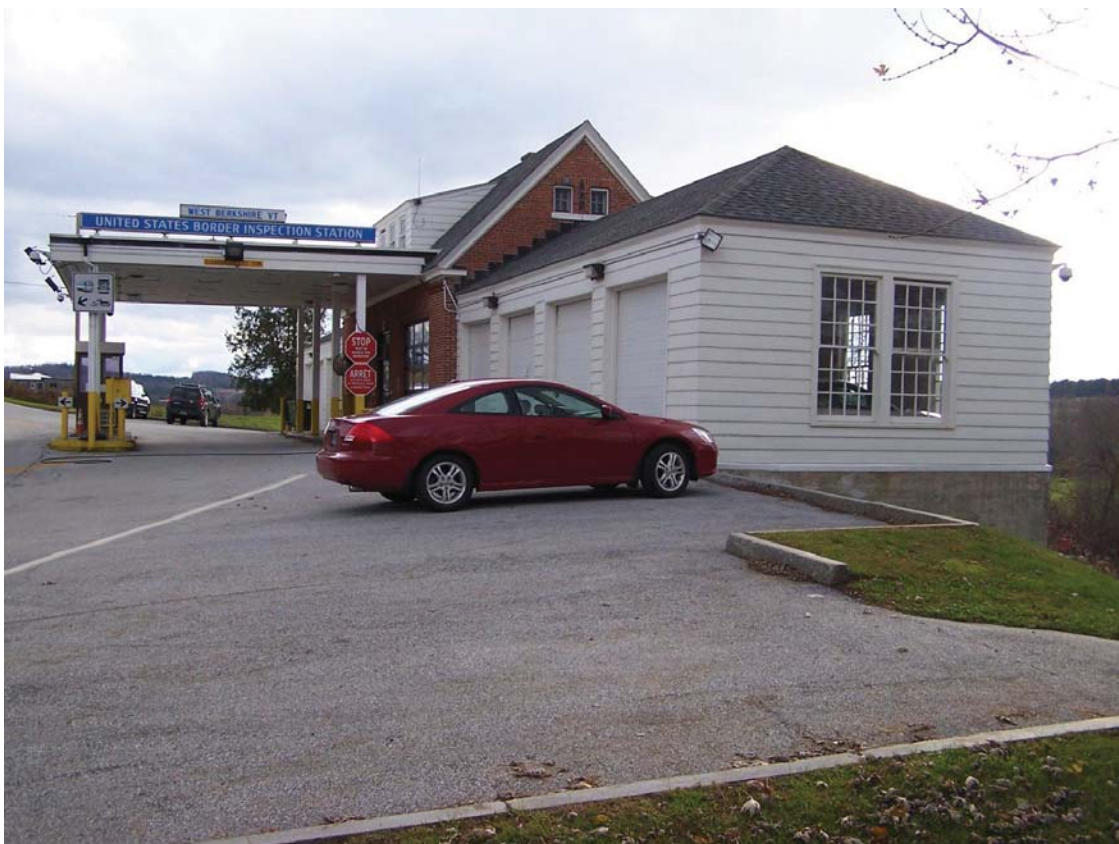
Photo number: VT_FranklinCounty_BerkshireBorderStation3.tiff

Description of view: porte-cochere and inspection station, view: south/southwest

At West Berkshire, protection from inclement weather was provided by a porte-cochere, garage and inspection wings, inspection pits; and the efficient placement of combined functions within the office building. While the porte cohere has been replaced, the garage and inspection wings altered, and much of the interior altered, the U.S. Inspection Station--West Berkshire is the only station in Vermont to still retain one of its detached residential buildings. As a result, the property still retains an adequate level of integrity **of design and materials** to convey its original function and range of proper facilities.

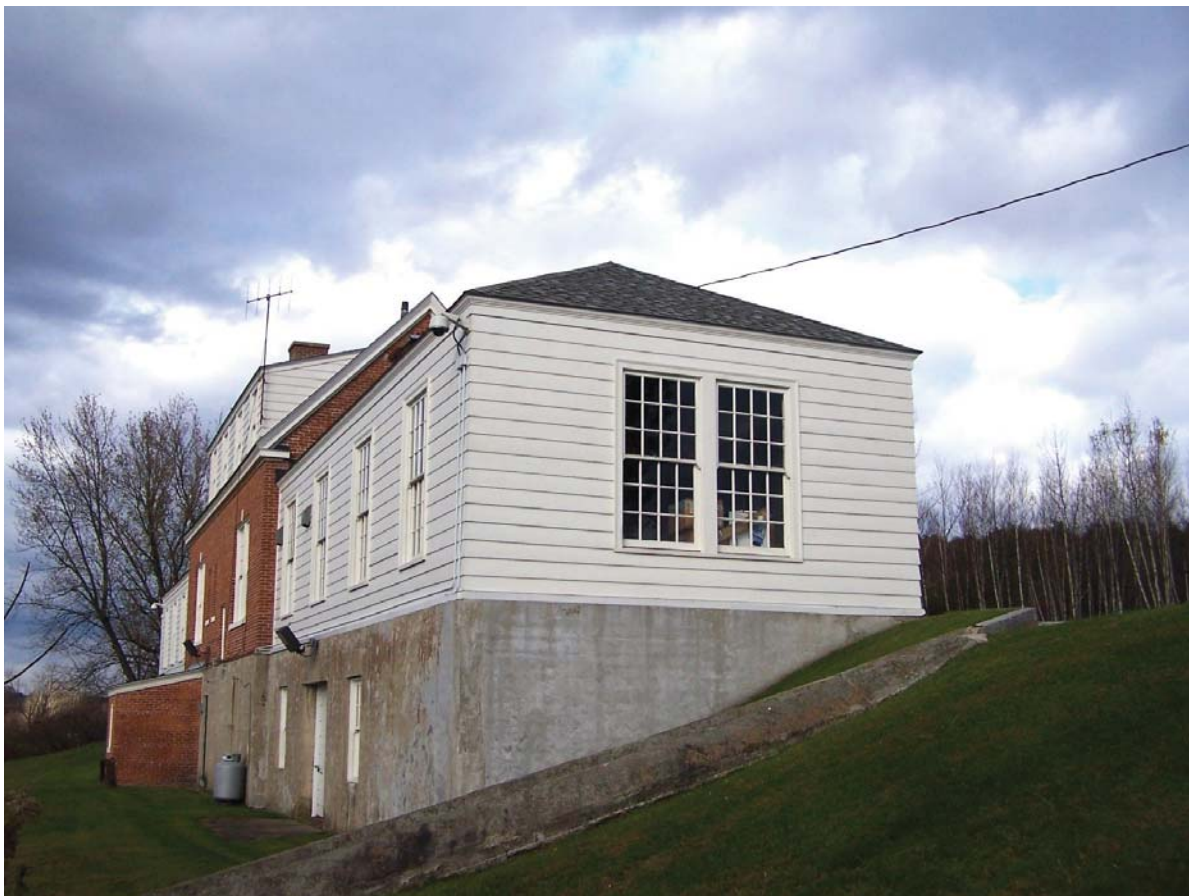
Photo number: VT_FranklinCounty_BerkshireBorderStation4.tiff

Description of view: rear and side elevation, view: northeast

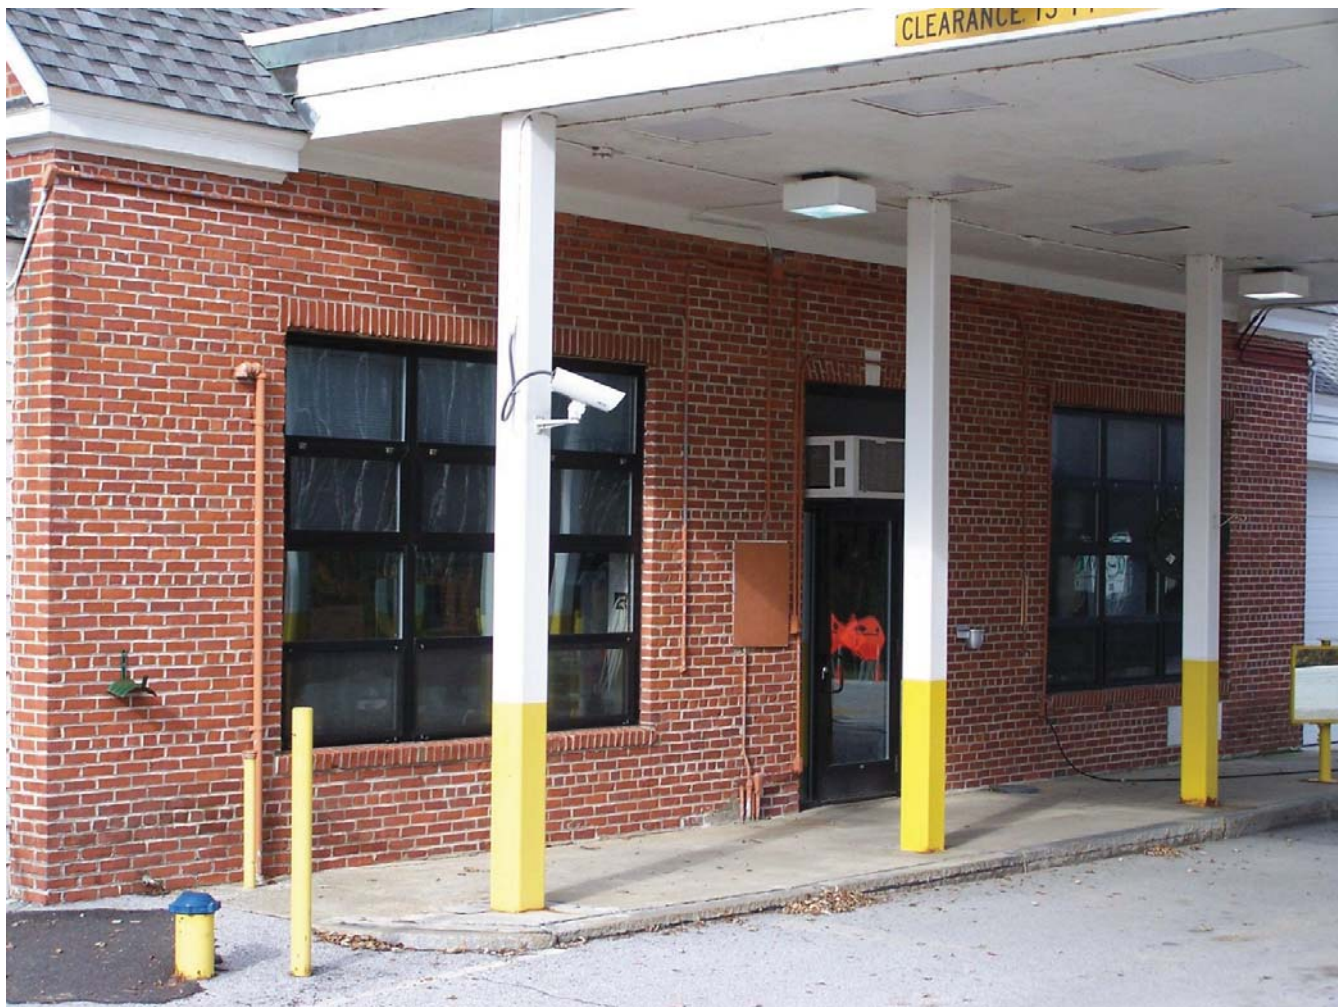
Photo number: VT_FranklinCounty_BerkshireBorderStation5.tiff

Description of view: front elevation, view: northwest

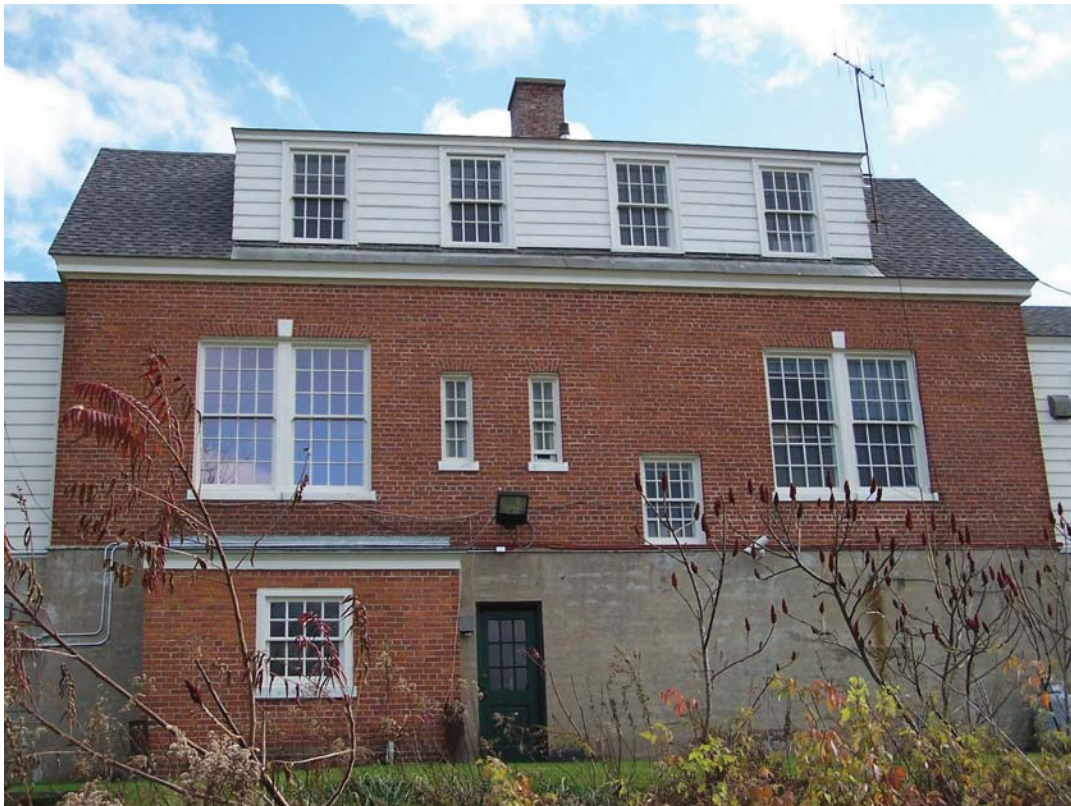
Photo number: VT_FranklinCounty_BerkshireBorderStation6.tiff

Description of view: rear elevation, view: east

the inspection station building features symmetrically placed 12/12 wood frame double hung windows topped by gauged brick jack arching and a centered marble keystone. Placed in a pairing off center in the northern portion of the rear elevation are two thin 4/4 wood frame double hung windows topped with gauged brick jack arching. A single 8/8 woodframe double hung window is also present at the rear elevation and runs flush with the bottom of the first level. All of the first level windows at the rear elevation feature marble sills. The rear elevation of the West Berkshire Inspection station correlates to the sunken grade of this section of the property, revealing a tall plinth course of poured concrete, which also underscores the two garage wings at the rear elevation. Within the basement level of the inspection station is a 2-panel painted wood entry door, its upper section consisting of nine glazing units. A brick clad shed-roofed bumpout is present at the rear elevation basement level. Centered within it is an 8/8 wood frame double hung window underscored by a marble sill. A wood fascia and simple cornice molding underscores the roof of the bumpout. Within the roof atop the rear elevation of the inspection station is a vinyl clapboard clad shed dormer with four bays of 8/8 woodframe double hung windows. Centered above this dormer behind the ridgeline of the roof is a rectangular brick chimney with a concrete capital.

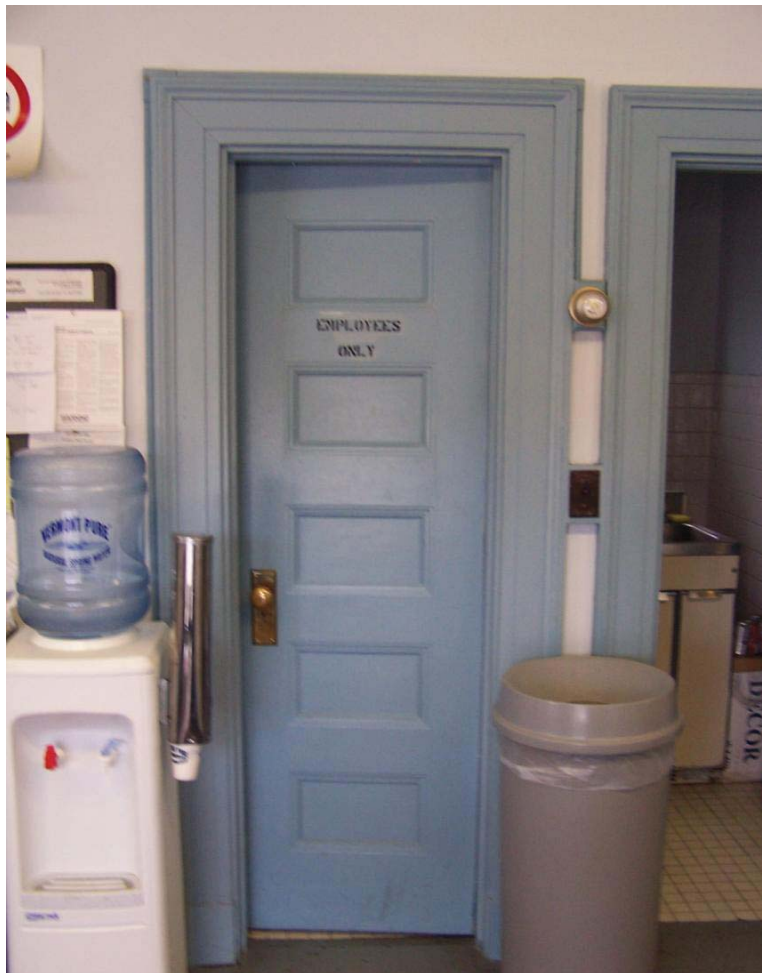
Photo number: VT_FranklinCounty_BerkshireBorderStation7.tiff

Description of view: bathroom door, first level, view: west

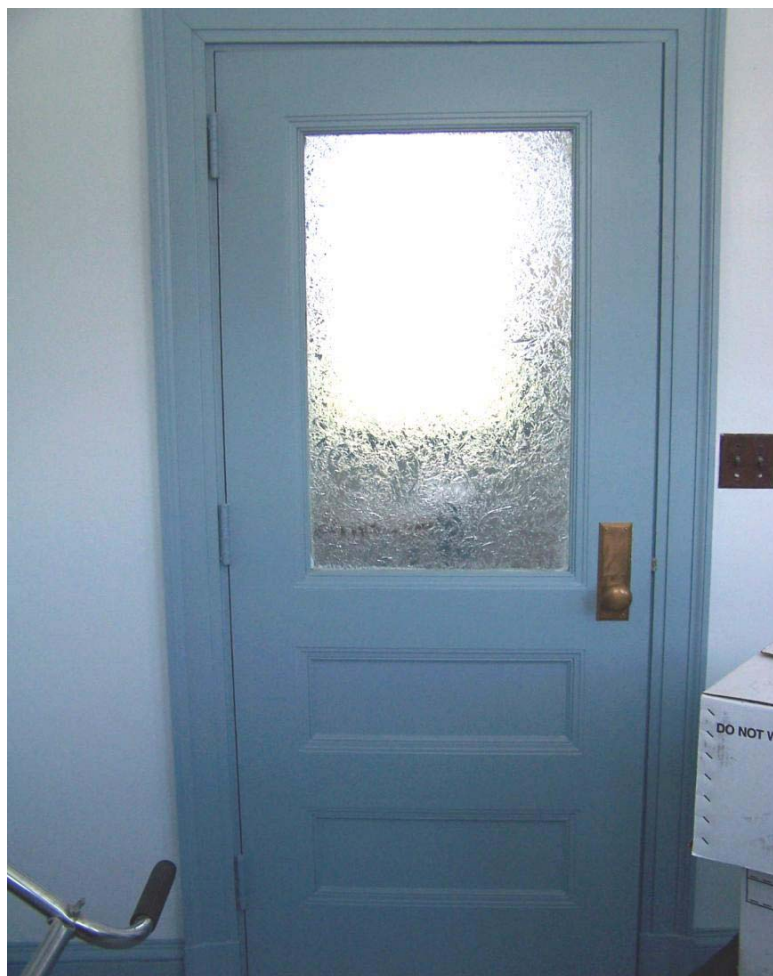
Photo number: VT_FranklinCounty_BerkshireBorderStation8.tiff

Description of view: office door, first level, view: west

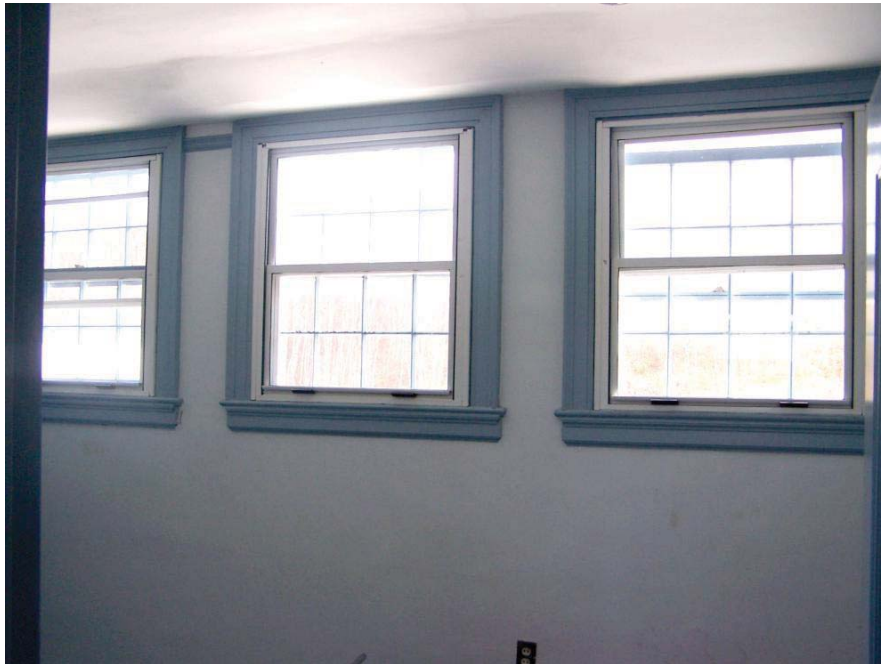
Photo number: VT_FranklinCounty_BerkshireBorderStation9.tiff

Description of view: window sills and frame, second level, view: east

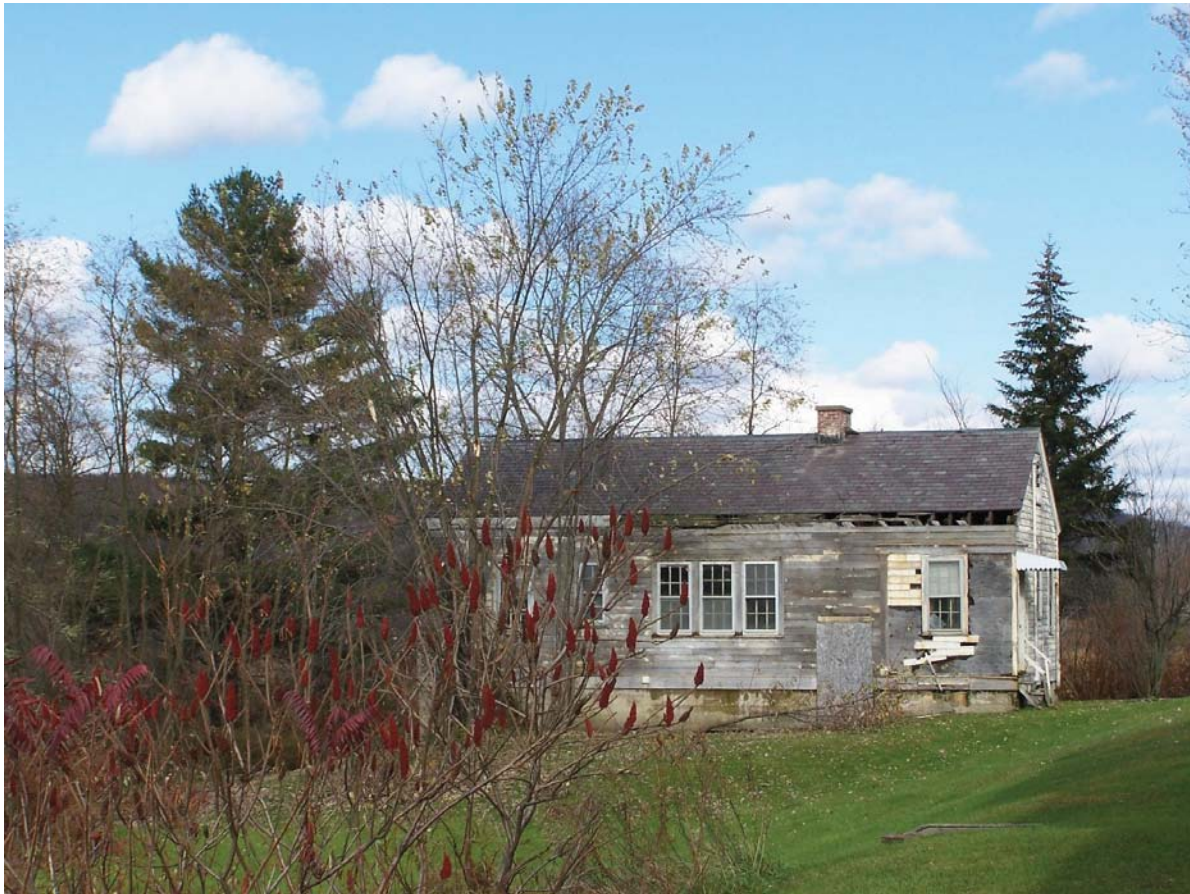
Photo number: VT_FranklinCounty_BerkshireBorderStation10.tiff

Description of view: residential dwelling within setting, view: north/northwest

Due northwest behind the U.S. Inspection Station—West Berkshire is an abandoned 1-story rectangular plan residence with wood shiplap siding and a medium pitch side gabled roof. The residence is designed in the Cape Cod variation of the Colonial Revival style. The centered, primary entrance faces north and is fronted by an elevated rectangular porch fully enclosed in screen paneling. Triplicate, square shaped engaged columns are present at the outer corners of this porch enclosure, which itself is topped with a flat roof and wood balustrade railing. The residence rests on a concrete foundation that contains 3-unit woodframe horizontal windows at the east and west side elevations that provide light to the basement. Across all elevations of the residence are 6/6 and 4/4 woodframe double hung windows. At the west facing side elevations the 6/6 windows are symmetrically placed, each underscored by the 3-unit basement windows previously mentioned. At the south elevation, the 6/6 windows appear in a triplicate formation in the center of that elevation. On either side of them is a pair of 4/4 windows to the west, and a 6/6 window to the east portion of the south elevation. The east facing side elevation is of three bays, featuring a 6/6 window on the north end, a canopied side entrance on the south end, and a 4/4 window in the center. Each side of the residence features a gable end. Within the apex of the gable is a triangular attic vent, and below these vents are 4-part lunette windows framed in simple cornice molding and underscored by wood sills. A rectangular brick chimney with a concrete crown straddles the ridgeline off-center due east.

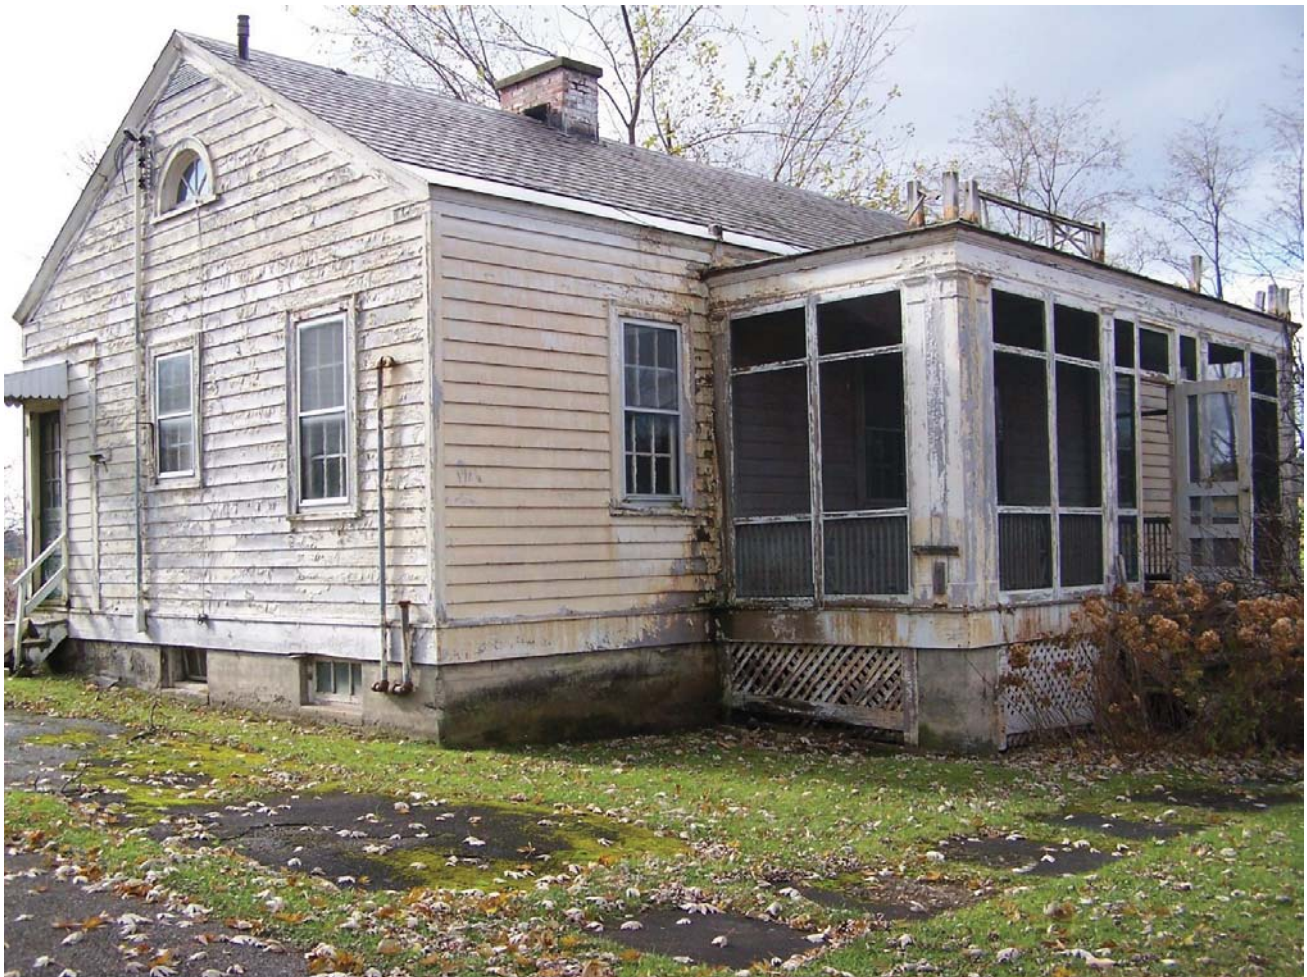
Photo number: VT_FranklinCounty_BerkshireBorderStation11.tiff

Description of view: residential dwelling, front and side elevations, view: southwest

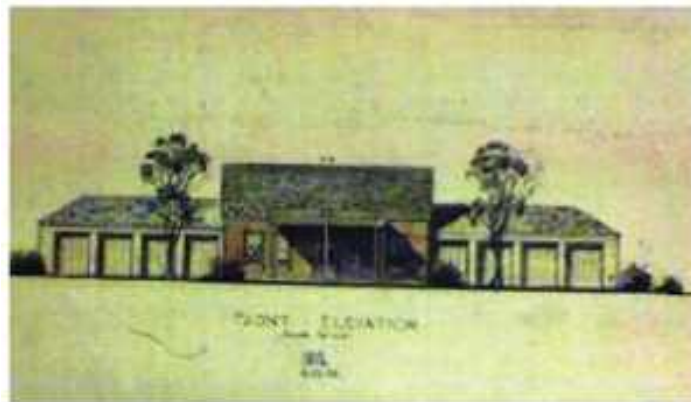
Description of view: front elevation

¹² Images 12-13: U.S. Department of the Treasury. Cabinet Sketch No. 9. United States Inspection Station—West Berkshire, Vermont. in Records Group 36, at the National Archives and Record Administration in College Park, Maryland.

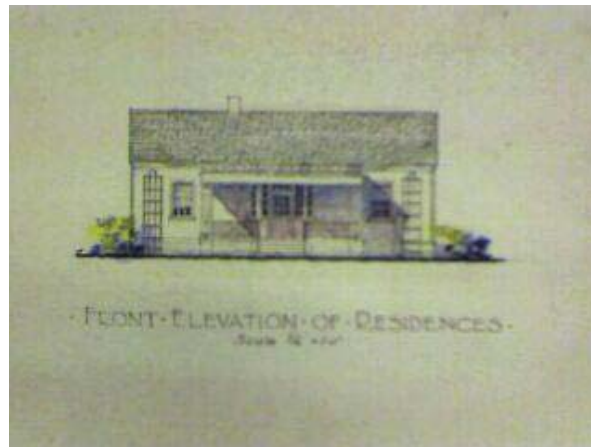
Description of view: front elevation, residences

¹⁴ Images 12-13: U.S. Department of the Treasury. Cabinet Sketch No. 9. United States Inspection Station—West Berkshire, Vermont, in Records Group 36, at the National Archives and Record Administration in College Park, Maryland.
