PNRO INVENTORY

NORTH CASCADES NATIONAL PARK

NAME(S) OF STRUCTURE/SITE <i>(Building)</i> PURPLE POINT/STEHKIN RANGER STATION RESIDENCE		
SITE ADDRESS/LOCATION <i>Stehekin Landing</i>		
DISTRICT <i>Stehekin</i>	COUNTY <i>Chelan</i>	STATE <i>Washington</i>
OWNER/ADMIN ADDRESS <i>National Park Service</i>

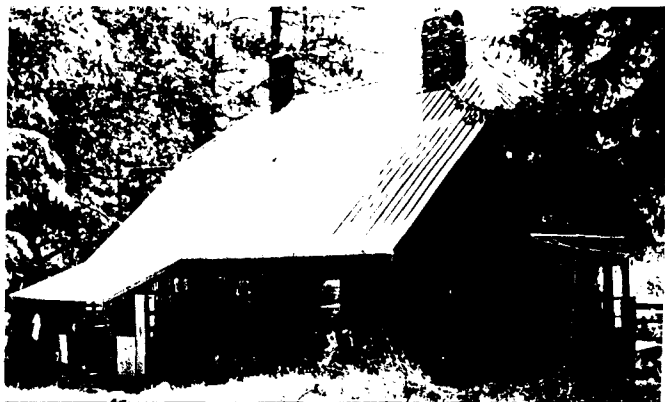
FROM N

DESCRIPTION AND BACKGROUND HISTORY INCLUDING CONSTRUCTION DATE(S), PHYSICAL DIMENSIONS, MATERIALS, MAJOR ALTERATIONS, IMPORTANT BUILDERS, ARCHITECTS, ENGINEERS, ETC.
Residence. Wood frame set on rock and concrete foundation; rectangle (26' x 30'); 3 bays wide; 1 1/2-stories; shiplap siding; metal-covered jerkin-head roof with slightly extended eaves and exposed rafter ends; center wood panel and glass entrance on east; 2 interior brick chimneys with arched caps. Exterior features include 1/1 double-hung sash with plain surrounds; knee braces; plain fascia boards; corner boards; shed-roofed overhang on south supported by knee braces and log posts with 2 wood panel and glass doors below; gable-roofed portico on east supported by knee braces; shed-roofed overhang on north supported by squared posts (7'x 15').

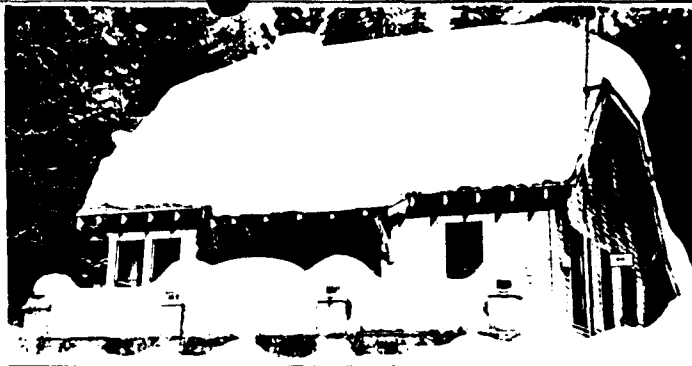
HISTORIC VIEW

This residence was built for the USFS ranger stationed at the Purple Point (later Stehekin) Ranger Station. It also served as an office (see historic view, reverse). E.O. (Jack) Blankenship was one of the early rangers located in Stehekin (the first station was located at head of lake; site now underwater). In 1939 W.O. Stambaugh was the Stehekin District Ranger and lived in this house. The complex at one time had a barn (removed c.1965), corral, and oil/gas house (removed by USFS); the office/warehouse, woodshed and bunkhouse are still standing. The CCC had a side camp stationed here in the 1930s and the USFS used these men to build trails, shelters, and the barn (c.1939). During WWII the USFS stationed personnel here as aircraft observers, but by the end of the war the station was no longer used year-round. It became seasonal housing until the NPS received the property and began using it for employee housing (Darrel Wilsey currently lives here). A new metal roof was installed over the wood shingles in 1979; an entrance overhang (on east) was added c. 1975.
