National Register of Historic Places
Registration Form

historic name The Security Building

other names/site number The Stampfer Building

street & number 800 Main Street [N/A] not for publication

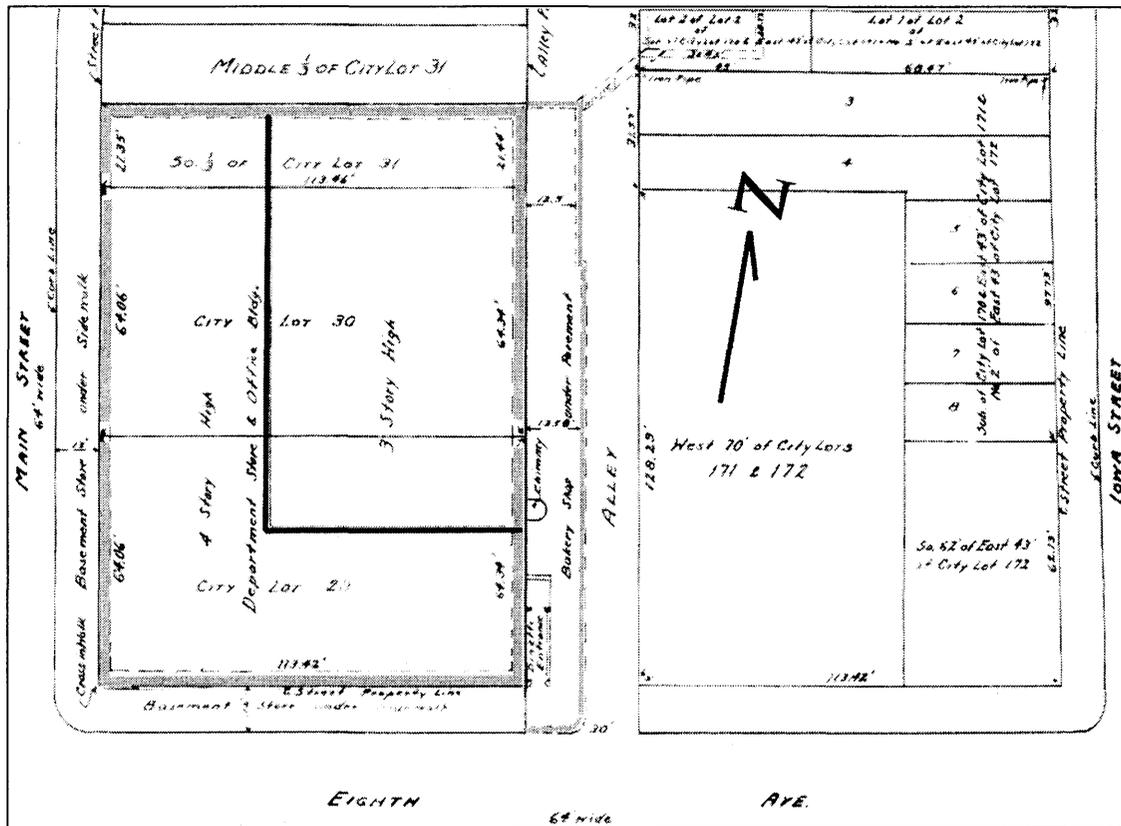
Figure 1: Property Diagram from Property Abstract, February 14, 1946

Gray line marks building perimeter, black line distinguishes original three and four story portions.

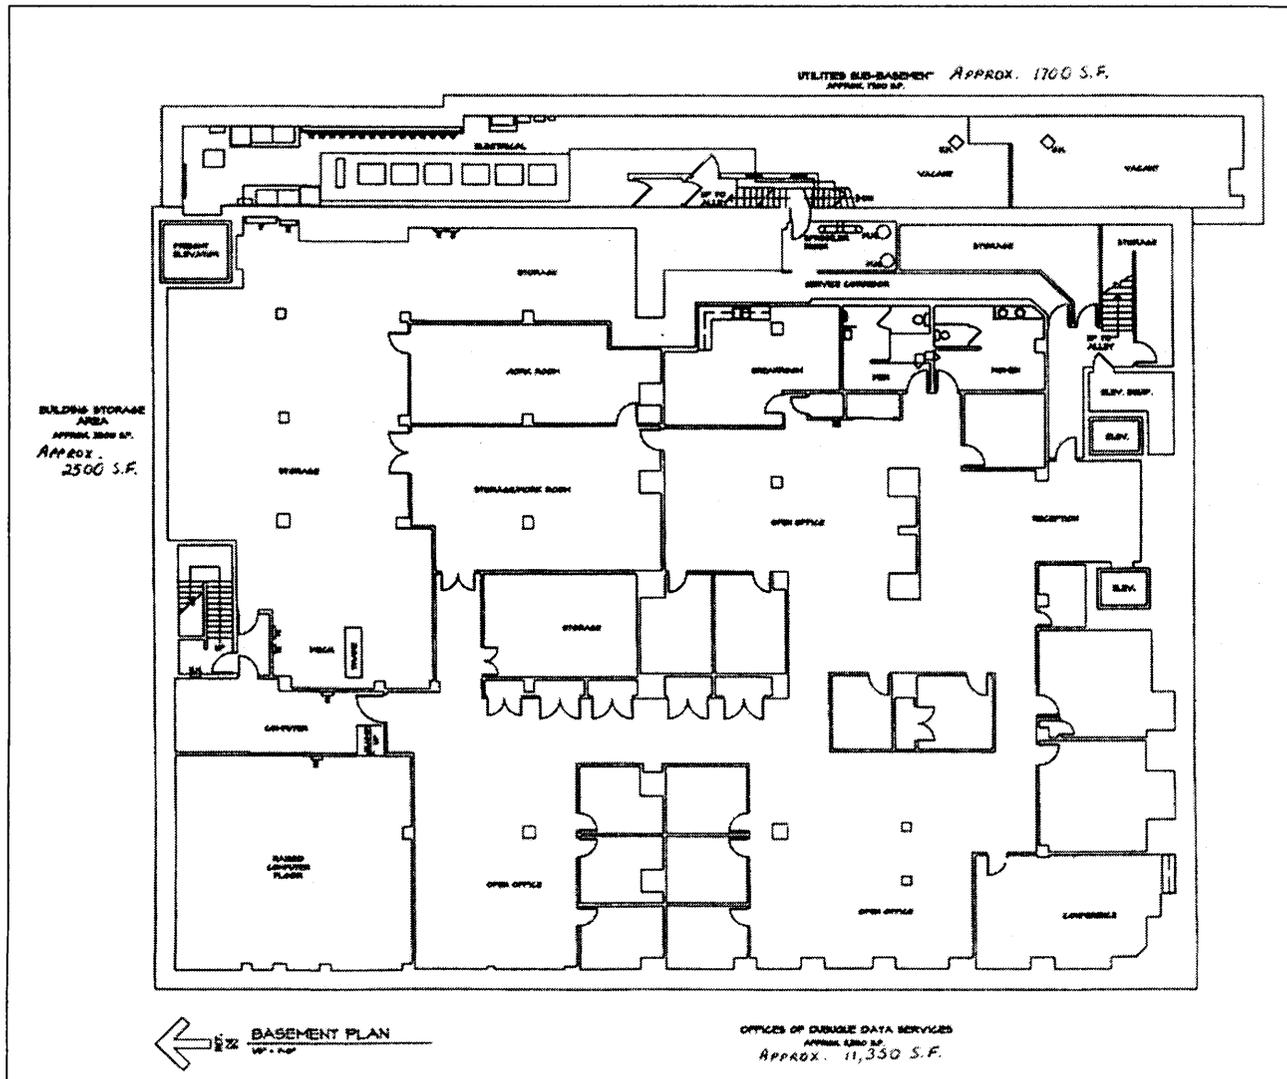
Figure 2: Current Basement Plan
(Cottingham & Butler, 2006)

This basement floor plan locates the former heating plant beneath the alley (now housing the electrical services on its north end). Note the absence of load-bearing walls even at this level. Not shown, is the subterranean passage to the Clock Tower Building to the west beneath Main Street (built in 2004-05). Elevator stacks are located on either side of the south or Eighth Street entrance and in the northeast corner of the plan. Staircases are located in the southeast corner (connecting only to the first floor) and at the midpoint of the north wall. Note how there is no standard column support pattern, although the pattern is more apparent in the newer 1907 (north) portion of the plan.

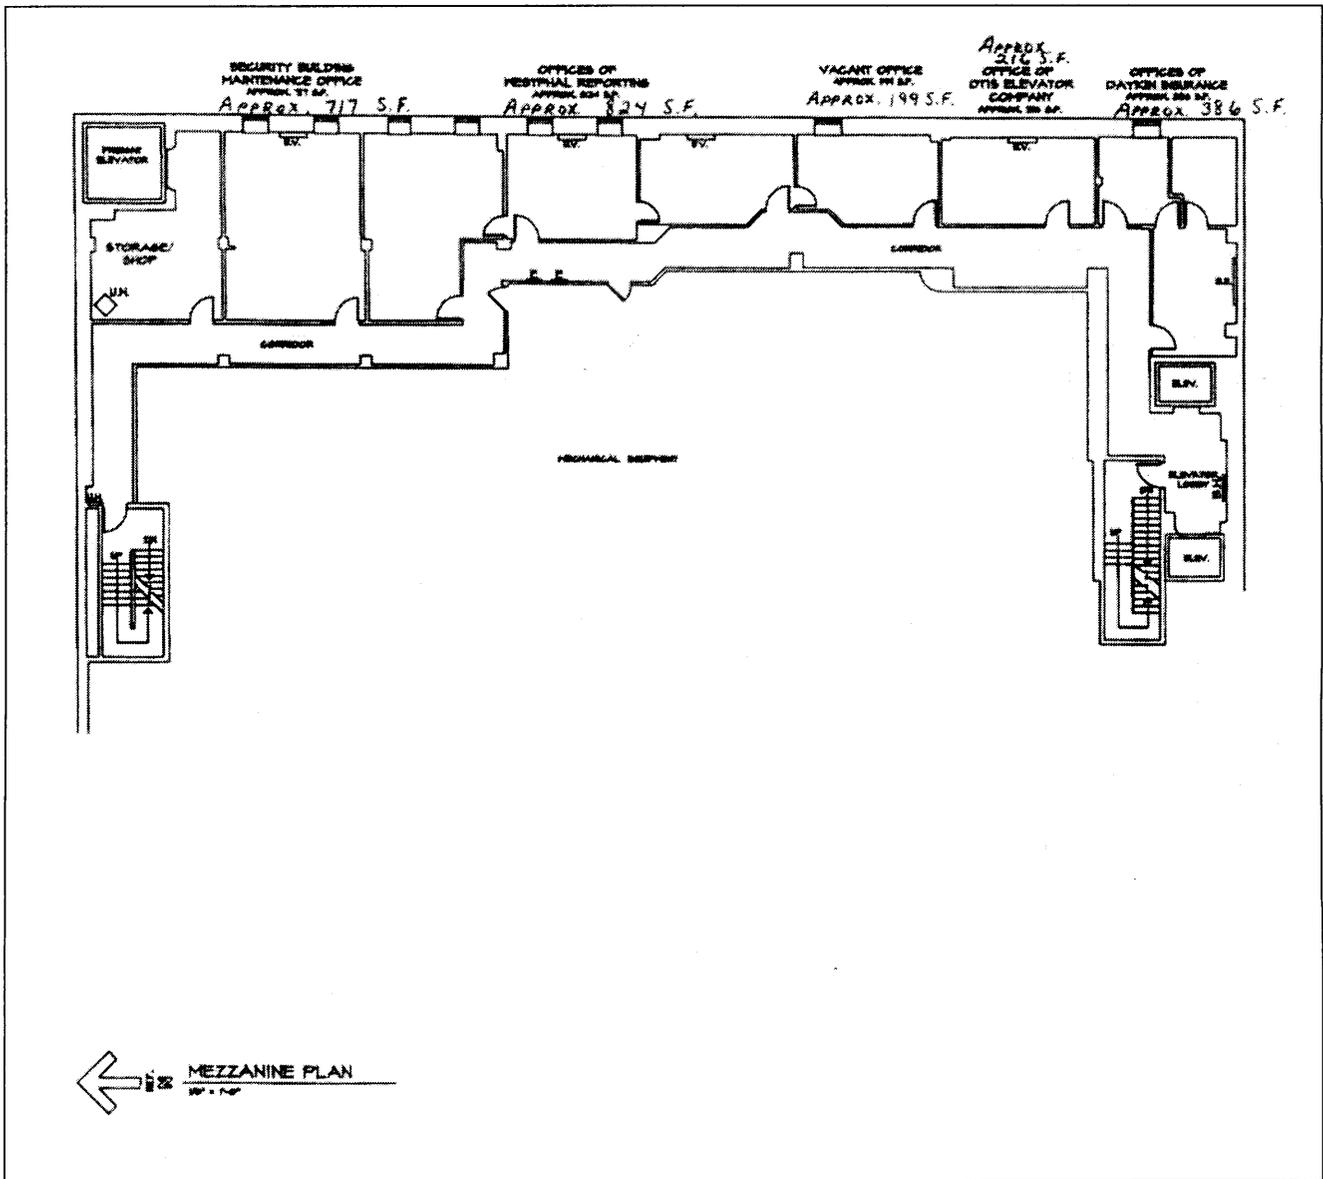
Figure 4: Current Mezzanine Floor Plan
(Cottingham & Butler, 2006)

This mezzanine area dates to 1938 and the present configuration is entirely closed off relative to the rest of the plan. Note how the mezzanine links the two stairwells centered on the north and south ends of the present plan. The mezzanine windows on the alleyway can be readily mistaken for second story openings.

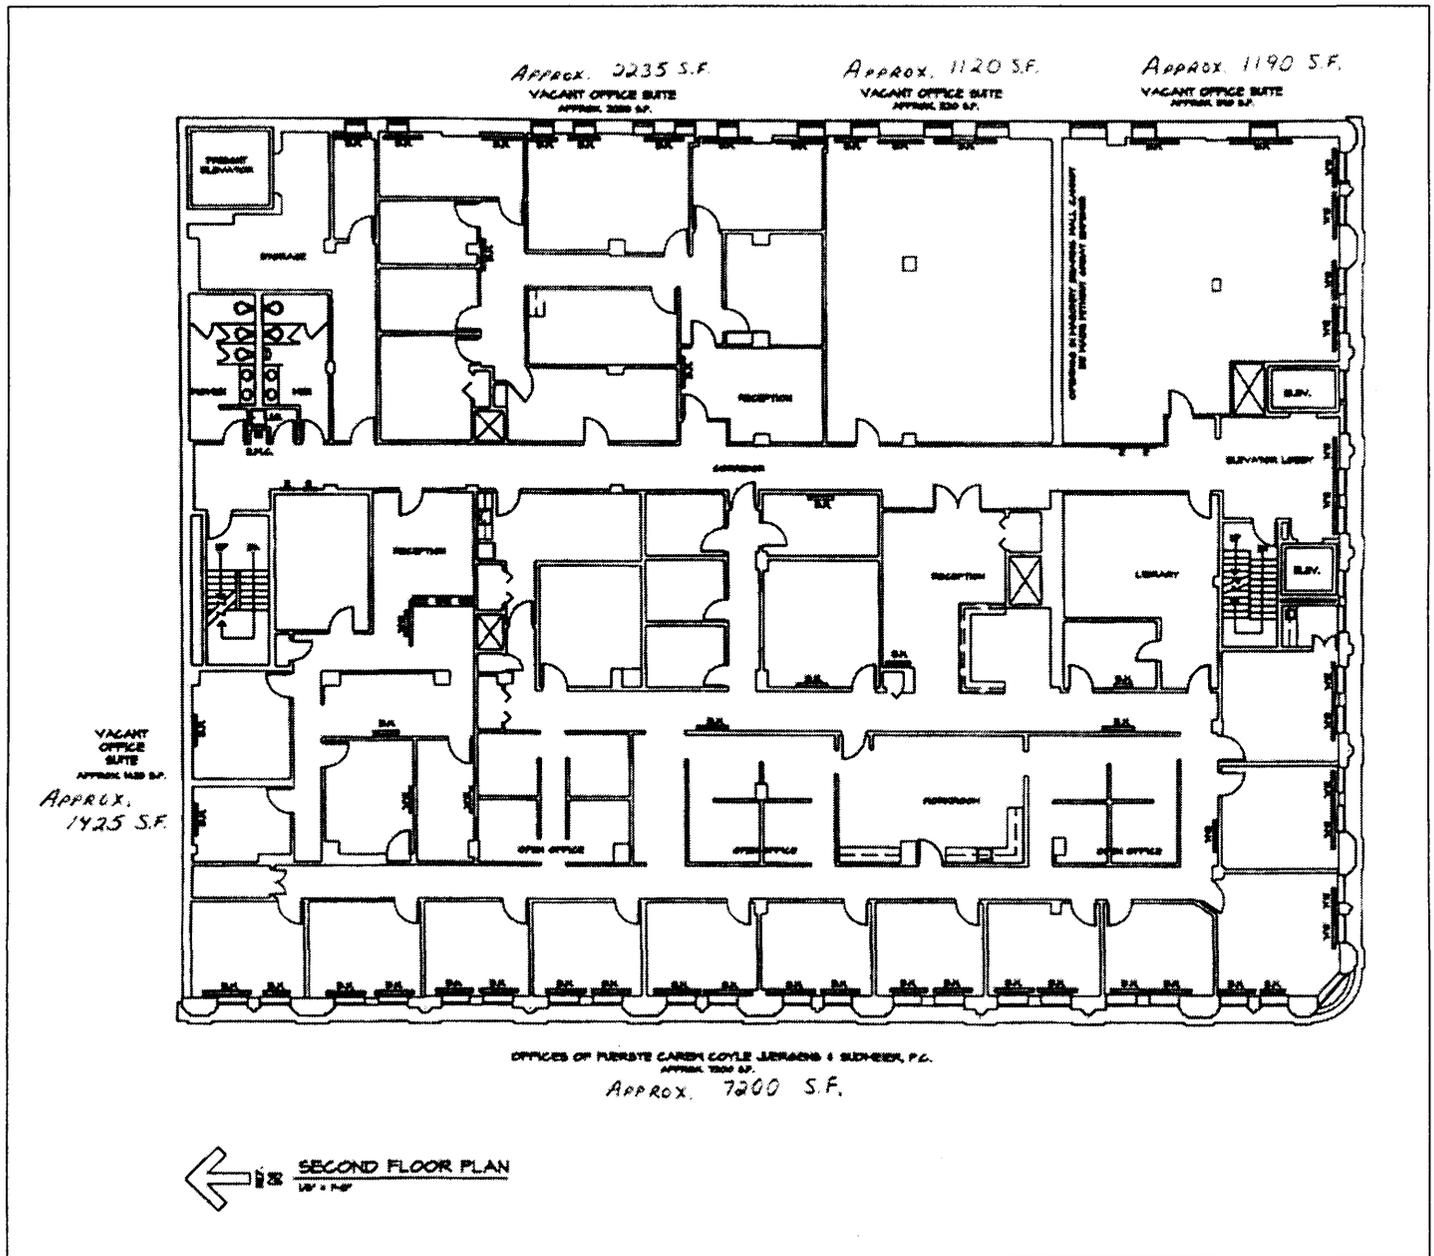
Figure 5: Current Second Floor Plan
(Cottingham & Butler, 2006)

The second floor plan provides a good sense of the extensive and open nature of this level of the building. On the second floor a single brick load-bearing wall is visible running east/west across the south/right side of the layout. Three elevators and two staircases are located on this level.

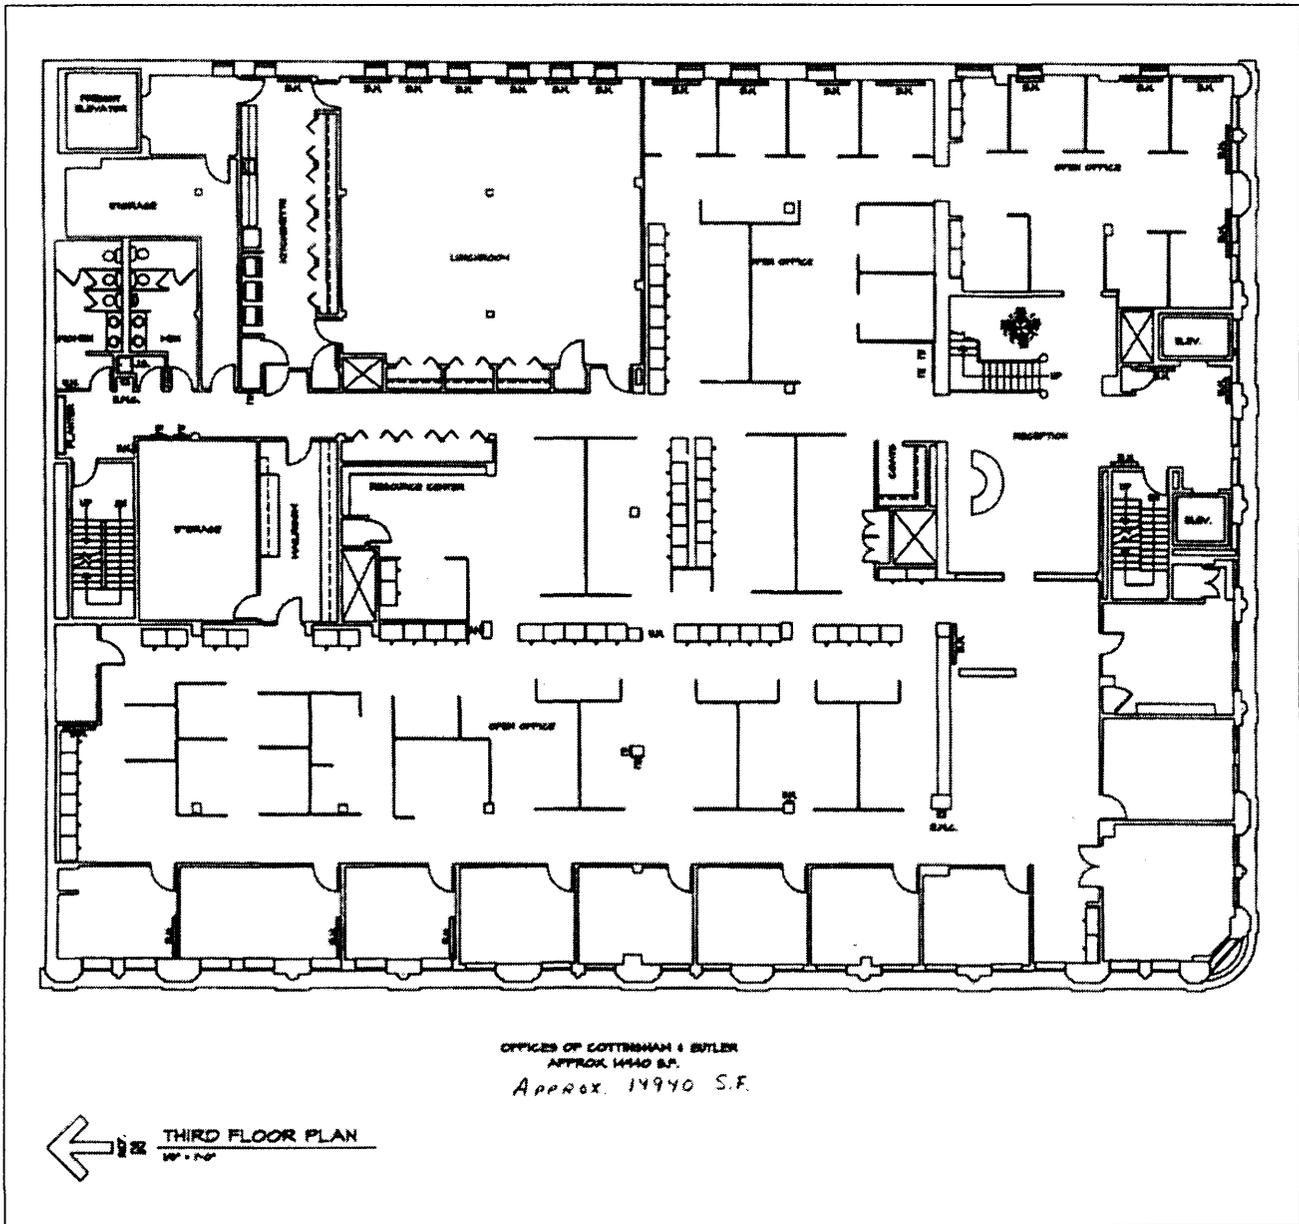
Figure 6: Current Third Floor Plan
(Cottingham & Butler, 2006)

On the third floor a single brick load-bearing wall is visible running east/west across the south/right side of the layout. Like the second floor, this level is largely unobstructed by columns and is extensively used.

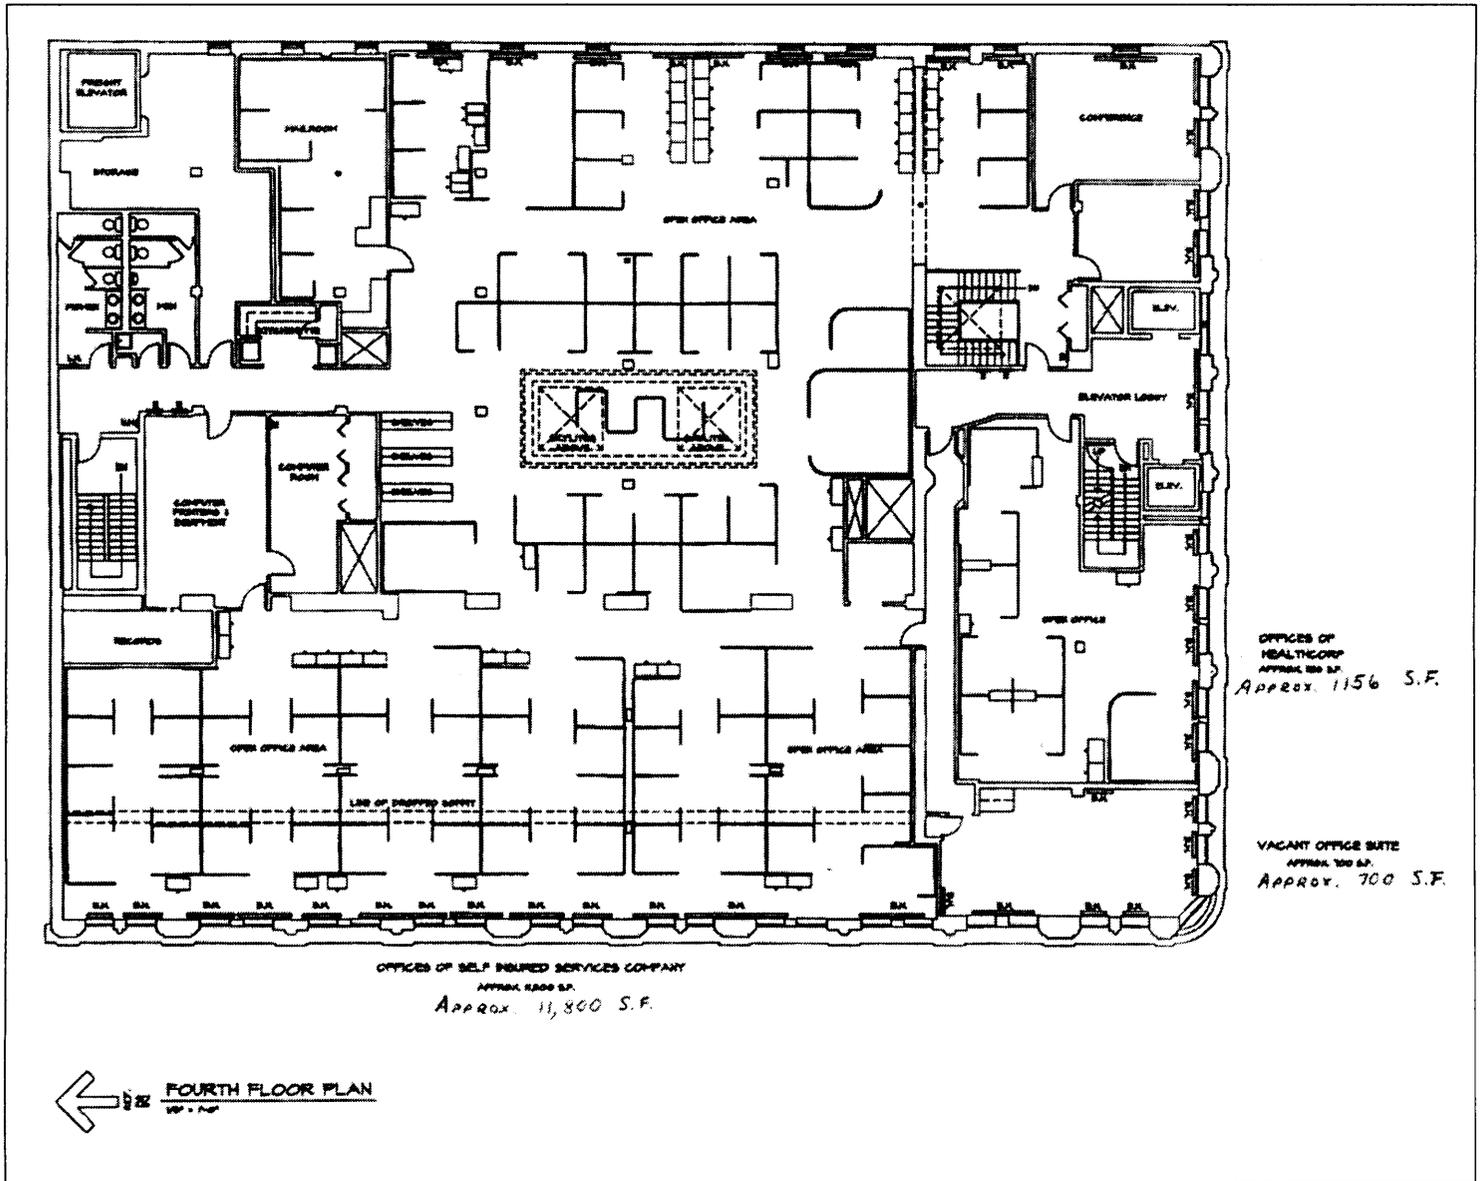
On the fourth floor brick load-bearing walls are visible running east/west across the south/right side of the layout and north/south from the west end of the north stairwell. These walls originally separated the higher front portions of this level from the rest of the building which reached only to the third floor level.

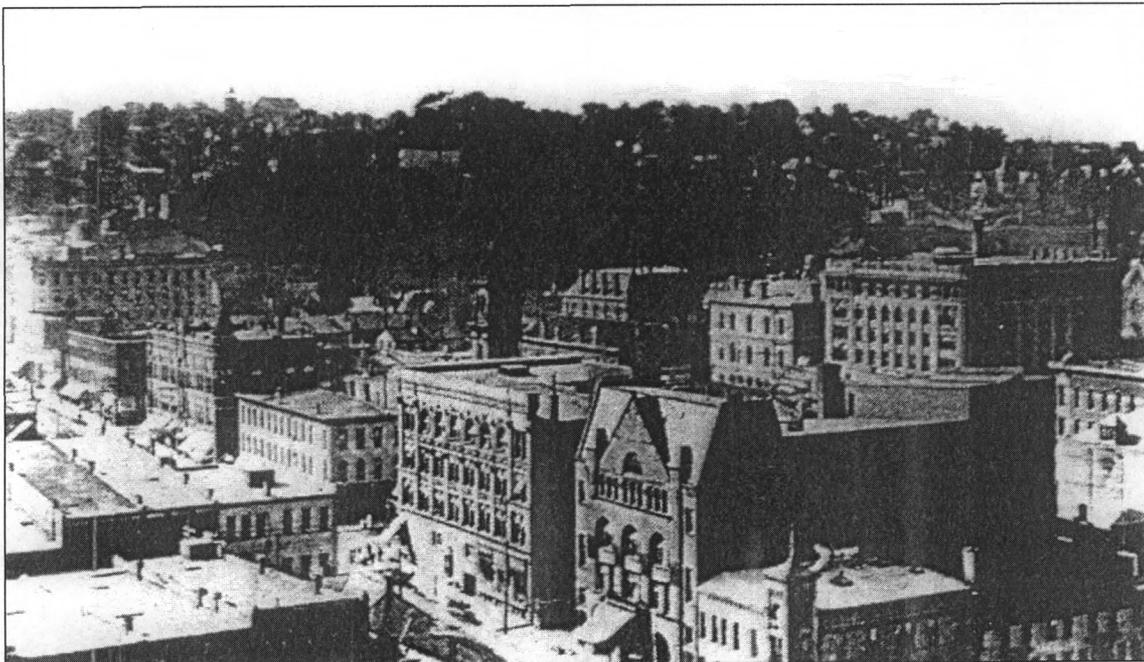
Figure 8: 1897 overview, looking northwest
(Loras College; Center for Dubuque History)

This panoramic view, taken from the Dubuque County Courthouse, shows the Romanesque style Grand Opera House (National Register of Historic Places) in the right foreground and the Security Building just to the west. Behind the Security Building is the Town Clock Building (National Register of Historic Places). The Bank and Insurance Building is visible at the far right. Note the chimney of the Security Building which projects from just behind the raised front of the Grand Opera House

The heating plant occupied the south end of an elongated chamber set beneath the east alleyway. A 65-foot high circular chimney was centered at the east end of the building. The top of this brick chimney is visible in Figure 8. The basement was unfinished at the time of the opening but was designed to be fully usable for commercial purposes. The Sanborn Map documents an open ground floor plan with a row of round iron posts running along the center line of the southern half of the plan. A row of iron posts also ran along the mid-point of the plan and supported brick walls on the three floors above. The original fourth floor was built to that height only along the Main Street and Eighth Street facades. Brick walls necessarily covered the east and north sides of this higher level on the original roof. Once the fourth floor was completely infilled these became interior walls. Another row of iron posts ran along the centerline of the north half of the plan (for a total of three rows of posts). There were two rooftop structures present by 1950 (Figure 23). A square rooftop building was located on the northeast rear corner of the south half of the plan,

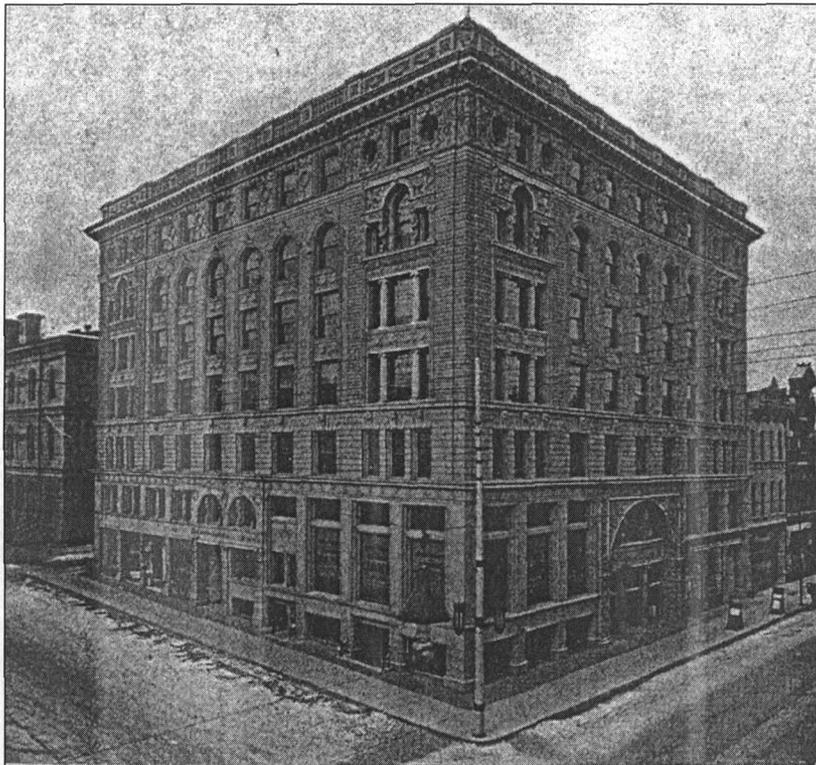
Figure 12: Bank and Insurance office building, Ninth and Main, view northwest (Beaux Arts style)
(Dubuque of Today, 1897, p. 20)

Dubuque was predominantly two and three stories in height and the first appearance of buildings taller than that were factories, hotels or wholesale commercial blocks. Just two buildings exceeded seven stories in height, the second example being Roshek's Department Store (nine stories, 1929). The Bank and Insurance Building stood seven stories high. While fourteen buildings were five stories high, just one of these was for commercial use (Bishop's Block, 1887, storefront, and warehouse, NRHP). Four story examples, including the Security Building, numbered at least 30 examples, but again, these were either purely commercial retail (Roshek's Department Store, 1907), were factories, or combined warehousing with retail trade. As a purely commercial example, the Security Building is massive, in terms of height and breadth, occupying as it does nearly an entire half block. It presaged other similarly large wholly commercial buildings in the city, being the second such example. As such, it is representative of developing building technologies (steel skeleton support systems, efficient elevators, heating and lighting systems, and ornamental terra cotta) (Phase III Dubuque Survey, pp. 147-151).

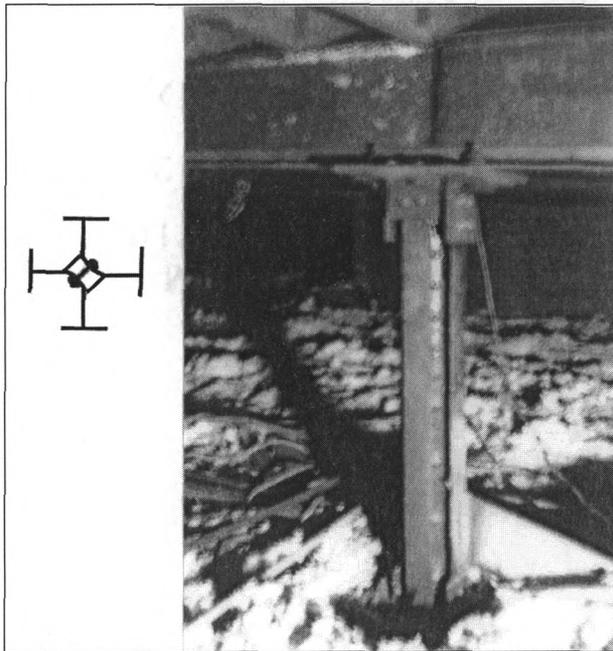
Figure 14: Attic column with cross-section sketch of column composition (photo by J. Jacobsen, 2006)

The observed steel columns are composite in their construction. They consist of at least two and possibly three parts. There are two main sections each having two I-beam edges set at ninety degrees, with a concave connecting center section. These were pre-drilled to receive hot rivets. The holes for these rivets do not have a consistent spacing however. It is probable that some sort of a boxed spacer was placed between the two half-sections before they were riveted together. Even more unusual is the apparent ad hoc system of connecting the columns with the steel beams.

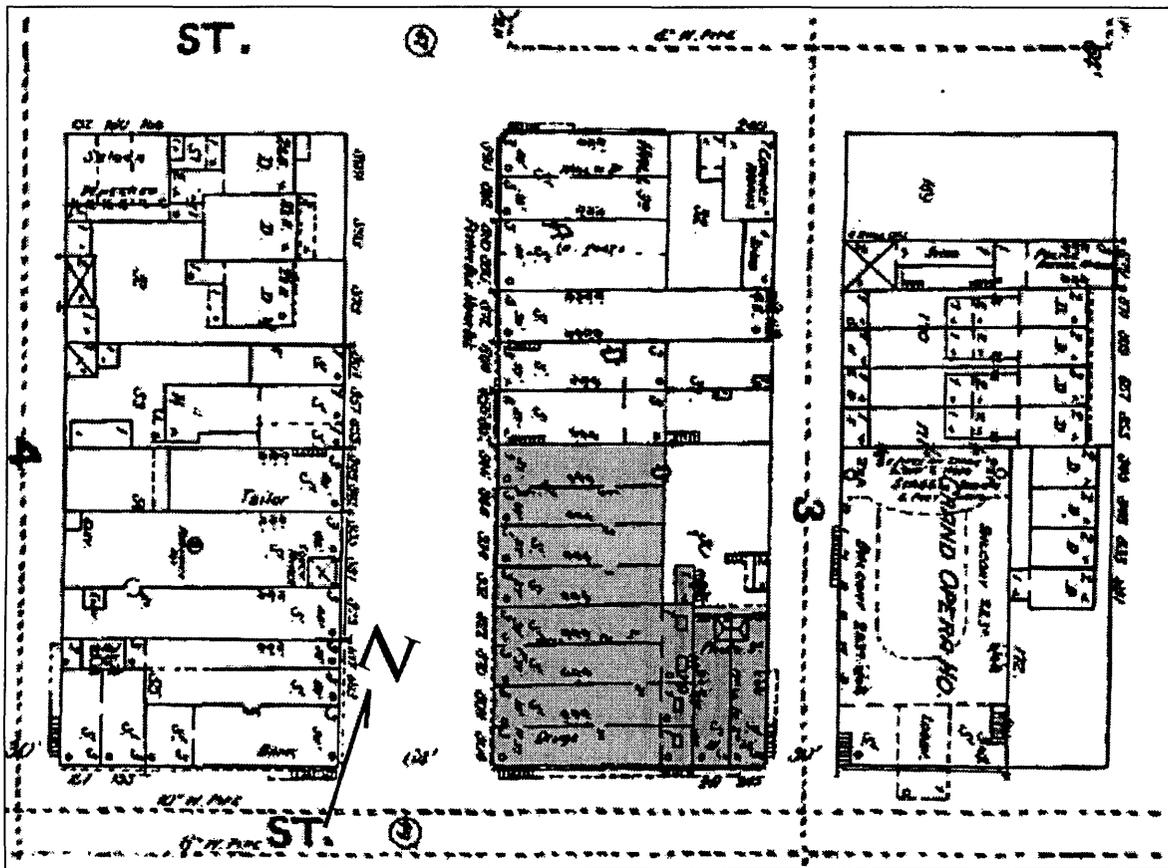
Figure 15: 1891 Sanborn Fire Insurance Map
Sanford Block is shaded gray

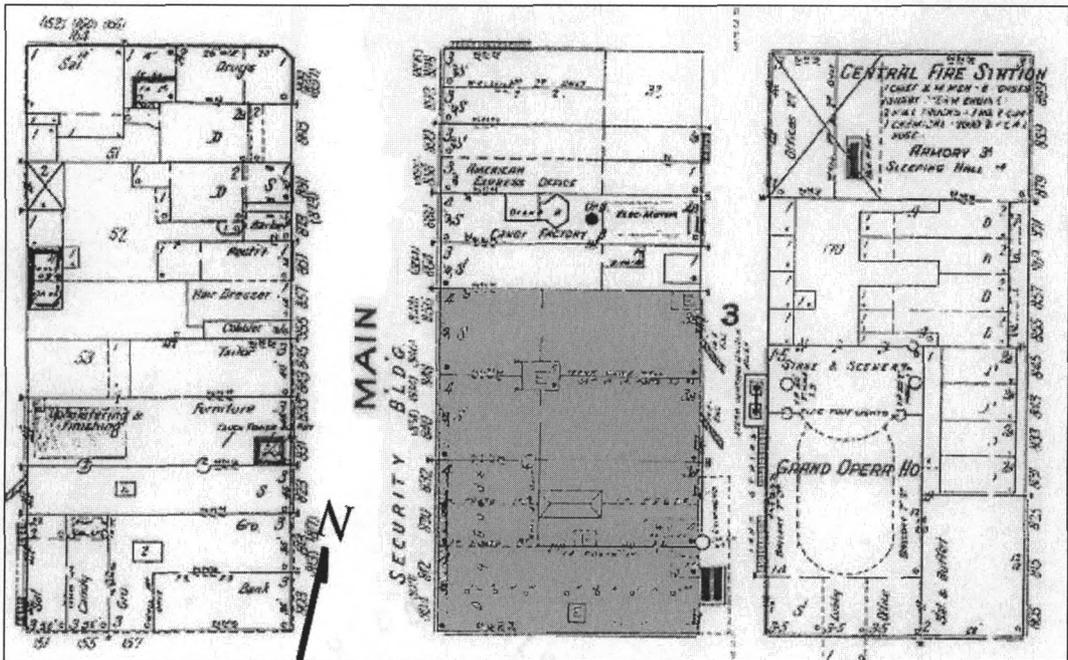
Figure 18: 1909 Sanborn Fire Insurance Map
Security Building is shaded gray

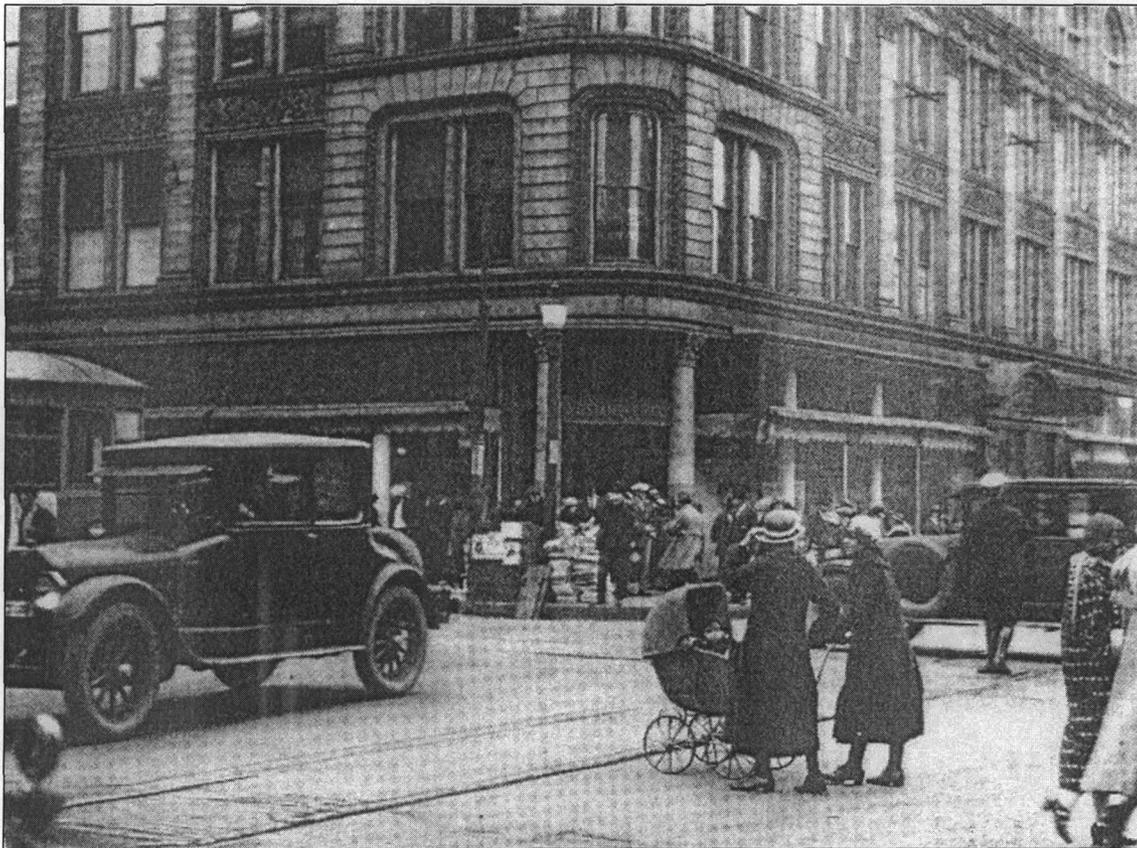
Figure 19: Storefront and corner detail, view northeast, c.1910-12
(Wilkie, p. 421 who credits First National Bank)
Note entrance canopy on new Eighth Street entrance

The Eighth Street (south side) storefronts were substantially rebuilt when the building was doubled. The terra cotta wall on that front was replaced with glassed storefronts. Two large stone columns replaced metal columns on the corner entrance and the entire storefront was given a continuous transom band of prism glass. The Main Street entrance was reduced in size and a major entrance with a shallow canopy was added on the south side.

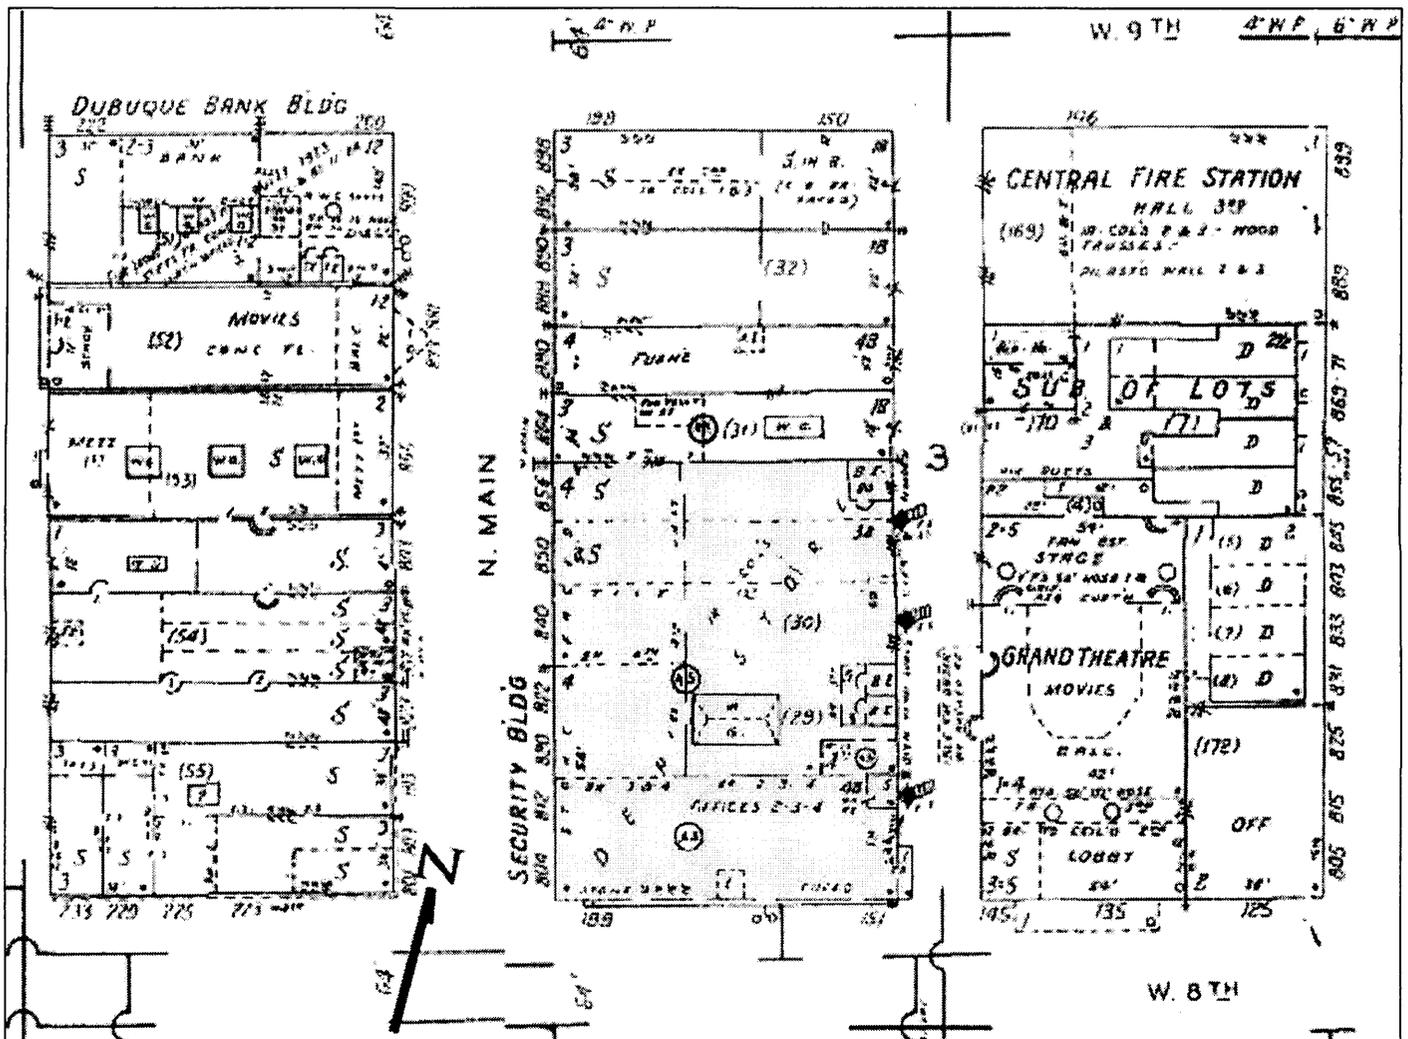
Figure 23: 1909/50 Sanborn Fire Insurance Map
Security Building is shaded gray

An external heating plant was built across the alley to the northeast of the Security Building on land that had been acquired by the landowners sometime prior to 1886. Thomas Stampfer asked the City Council to approve the construction of a steam tunnel from the plant to his building in July 1946. The fourth floor was completely infilled in 1959-60 based on plans prepared by Des Moines architects Wetherell and Harrison. The land and building were finally joined in unified ownership on September 18, 1994, when Security Partners, L.P., originally titled Security Building Partnership, purchased the land.
