**HISTORIC RESOURCES INVENTORY
BUILDING AND STRUCTURES**

**STATE OF CONNECTICUT
CONNECTICUT HISTORICAL COMMISSION**

1. BUILDING NAME (Common)		(Historic)	
Private Residence		Thomas Harrison House	
2. TOWN, CITY	VILLAGE	COUNTY	
Branford		New Haven	
3. STREET AND NUMBER (and/or location)			
23 North Harbor Street		Map D8, Block 2, Lot 8.1; .14 acres

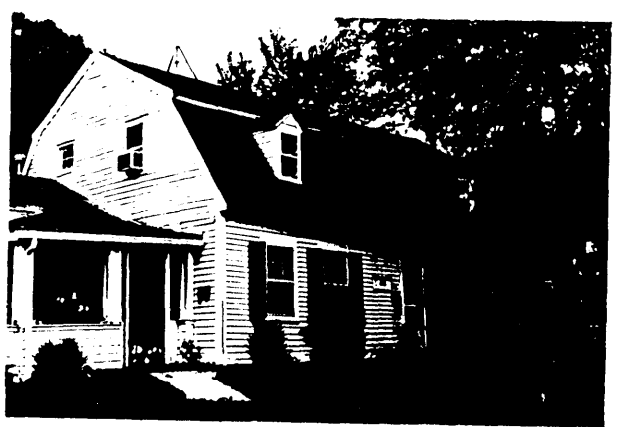
Southeast Corner

Constructed on a rectangular plan with its ridge parallel to the street, this structure has a gambrel roof with a brick center chimney set back of the ridge. The house has a five-bay facade with two gabled dormers at the second story and six-over-six sash at most windows. The gable ends have four windows except where modified by the one-story ell which extends to the south. The exterior is finished with clapboards on all sides; trim is extremely simple.
