National Register of Historic Places Registration Form

Historic name: Main Street Commercial Historic District

City or town: Middletown State: Ohio County: Butler

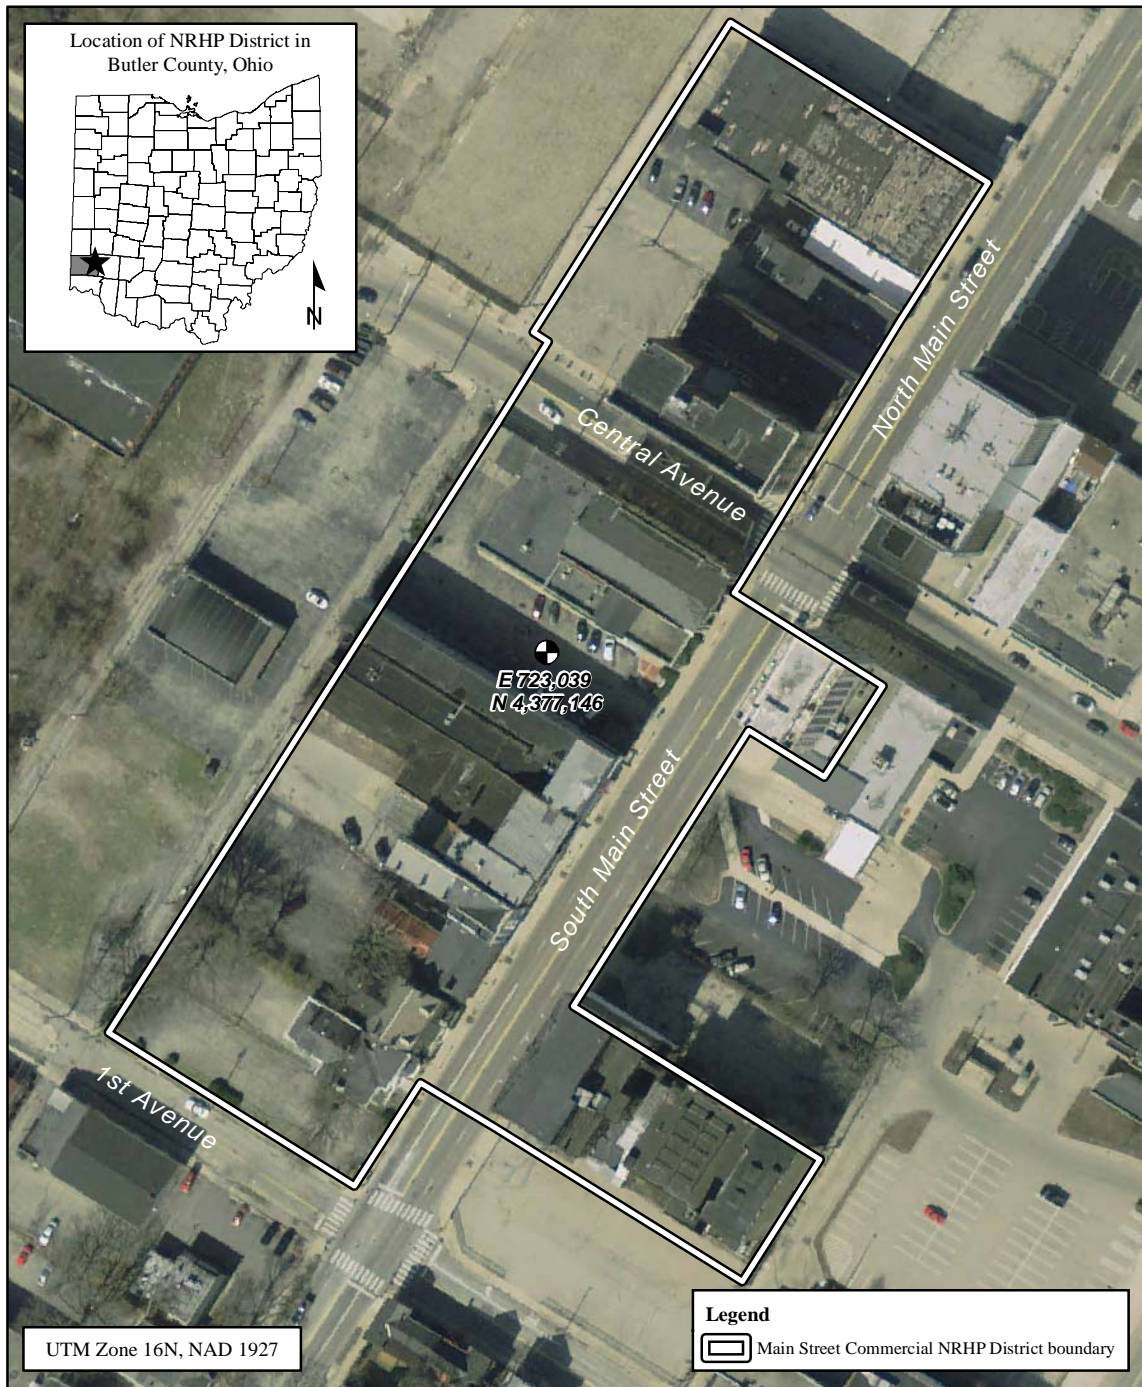
Figure 2. Aerial photograph showing the Main Street Commercial Historic District in Middletown, Ohio

The Main Street Commercial Historic District is centered on the intersection of Main Street and Central Avenue in Middletown, Ohio (Figures 1, 2, and 3). The city of Middletown is located in northeastern Butler County with a small portion of the city extending into northwestern Warren County. The city occupies approximately 26 square miles and is located approximately half way between Cincinnati and Dayton. As of 2010, the population of the city was 48,694 (US Census Bureau 2013). The city is located along the eastern bank of the Great Miami River. The two primary streets in the city are Central Avenue (east-west) and Main Street (north-south) which intersect approximately a half mile east of the Great Miami River. North and South Main Street are separated by Central Avenue. Originally called Third Street, Central Avenue was renamed "Central" in 1923 because it had become the primary commercial corridor for the downtown area. Many prominent citizens of Middletown constructed domestic residences along South Main Street, while many commercial buildings were constructed at the intersection of Main Street and Central Avenue. The residential area of South Main Street and the commercial buildings in the southern portion of the Main Street Commercial Historic District are included within the South Main Street Historic District (NR# 78002015). The South Main Street Historic District was listed on the National Register in 1978, and consists of 76 contributing buildings, one contributing object, and four non-contributing resources. Eight buildings located along South Main Street contribute to both the South Main Street Historic District, and the Main Street Commercial District (Figure 4).

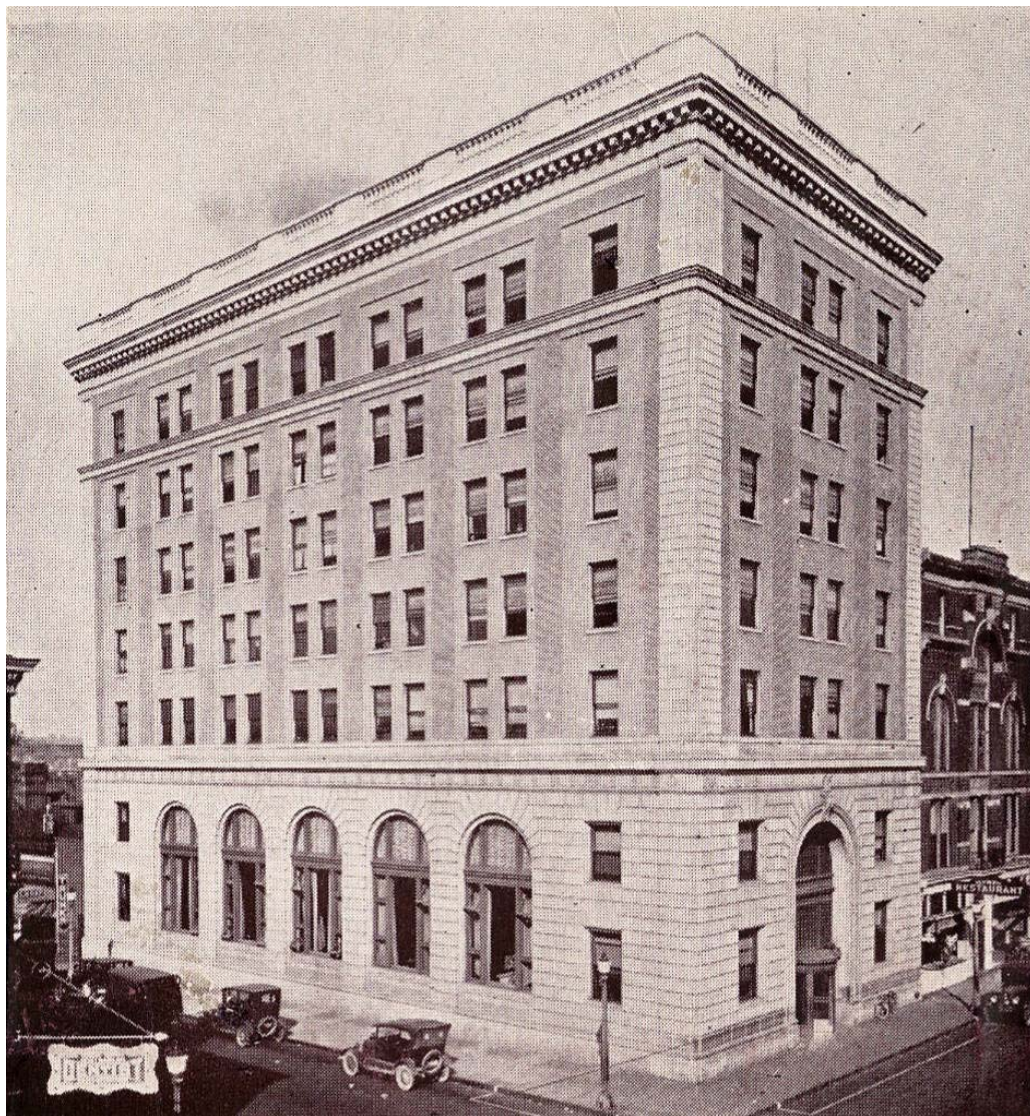
Figure 5. Ca. 1923 photograph showing the First and Merchants National Bank Building and the Masonic Temple in the Main Street Commercial Historic District in Middletown, Ohio, looking northwest
Source: George C. Crout Collection, MidPointe Library System, Middletown, Ohio

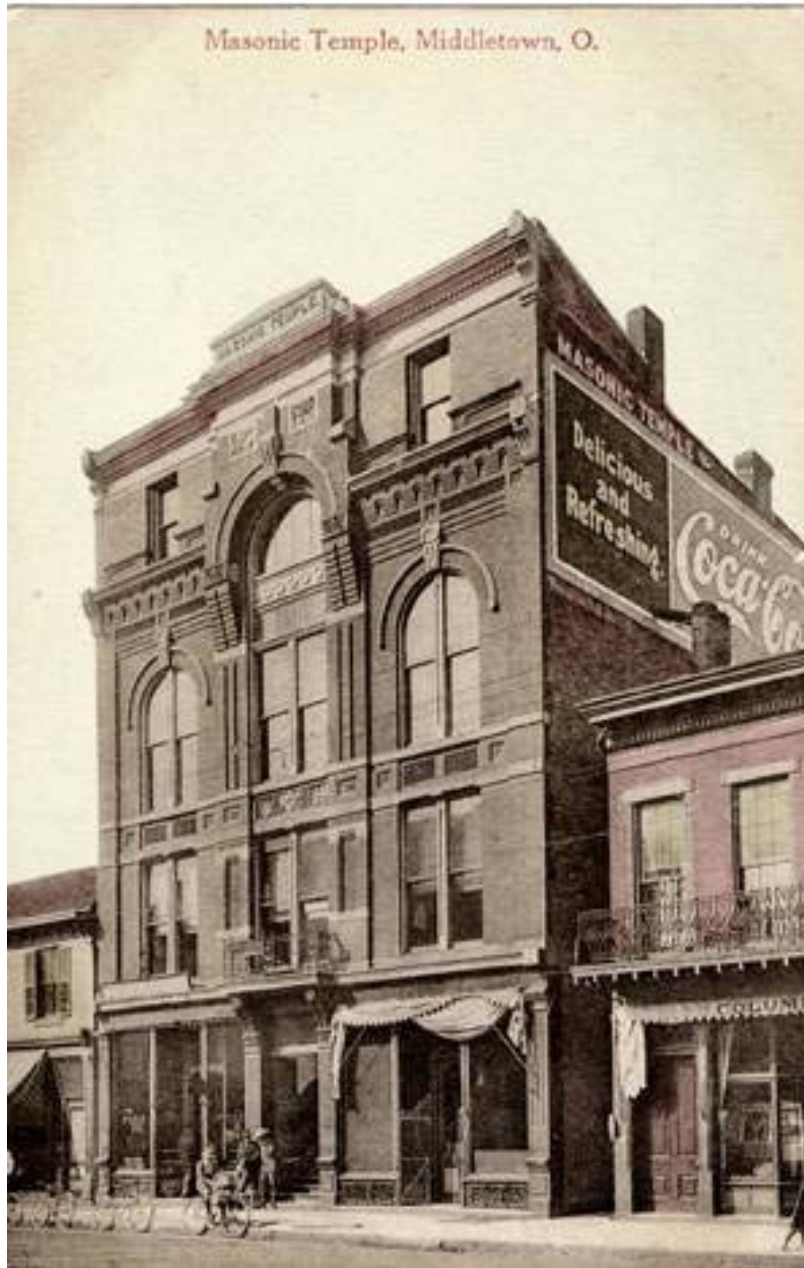
Figure 7. Ca. 1915 photograph postcard showing the Masonic Temple prior to the construction of the First and Merchants National Bank Building in the Main Street Commercial Historic District in Middletown, Ohio, looking southwest

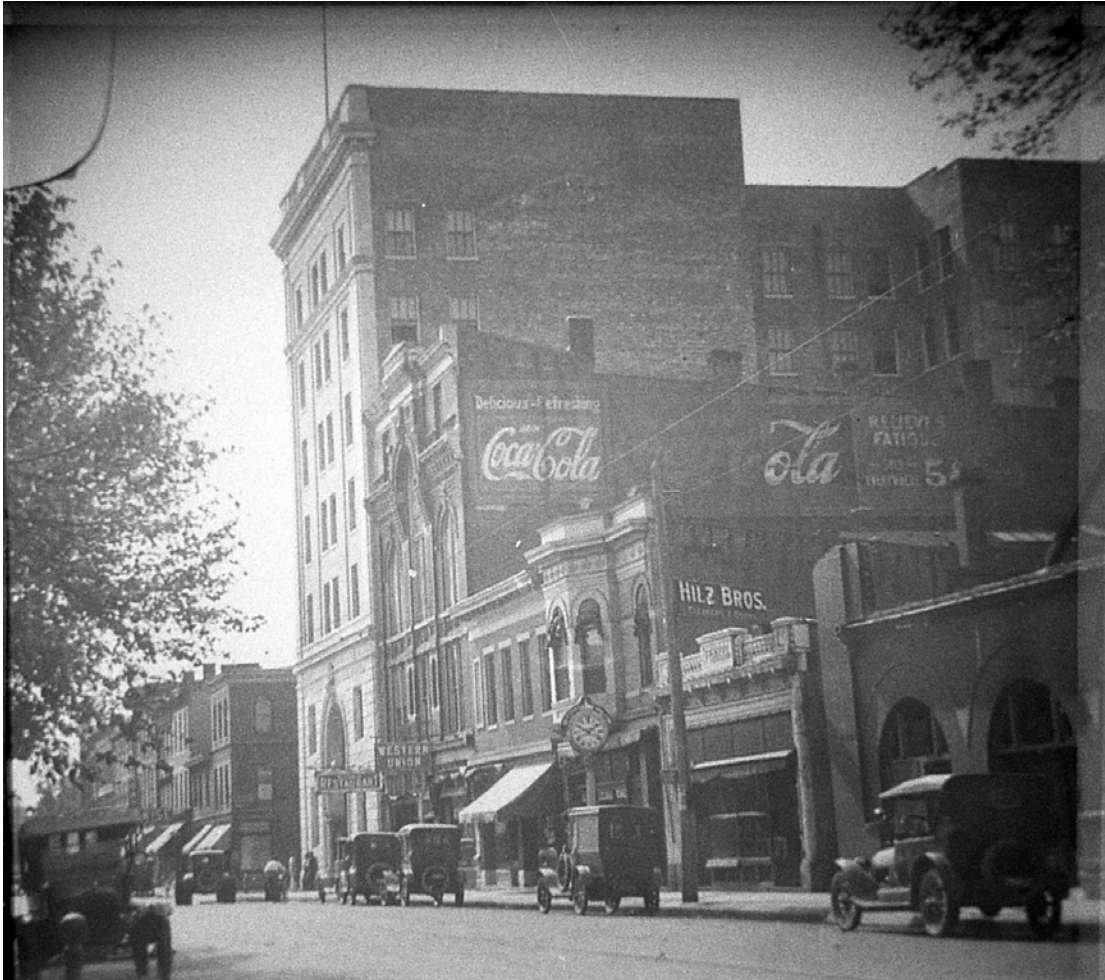
Figure 8. Ca. 1924 photograph of the west side of North Main Street in the Main Street Commercial Historic District in Middletown, Ohio, looking southwest

Figure 8. Ca. 1924 photograph of the west side of North Main Street in the Main Street Commercial Historic District in Middletown, Ohio, looking southwest

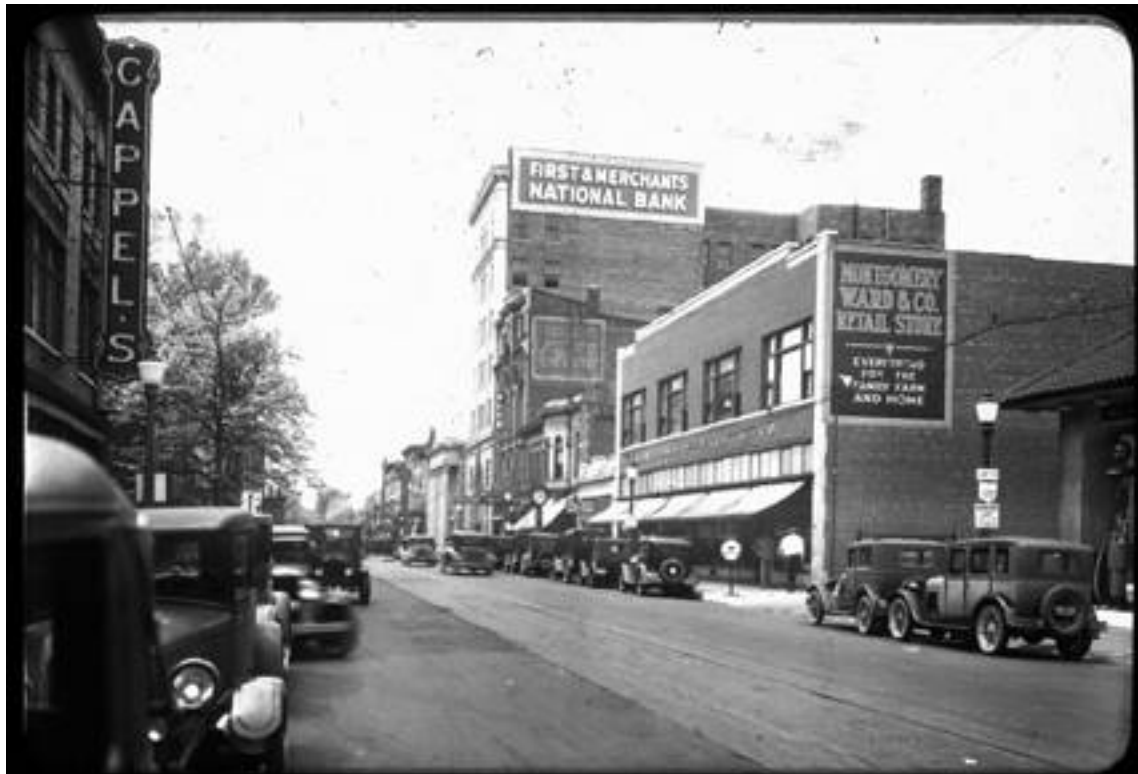
Figure 9. Ca. 1929 photograph of the west side of North Main Street in the Main Street Commercial Historic District in Middletown, Ohio, looking southwest
Source: George C. Crout Collection, MidPointe Library System, Middletown, Ohio

elevation has been in-filled by cream-colored bricks. A ca. 1929 photograph shows that the first story was originally a series of show windows utilized by the department store (Figure 9). The four window openings in the second story of the east (front) elevation have been in-filled by concrete block. In addition, the parapet on this elevation has been topped by concrete block, replacing a basic white cornice (Figure 9). The north (side) elevation is now blind because three small windows have been in-filled by brick. The west (rear) elevation maintains its utilitarian appearance with exposed vent work and a cargo door. The façade has experienced a lot of in-fill and alterations. Because of the extent of these alterations, the former department store building lacks architectural and historical integrity and does not contribute to the Main Street Commercial District.

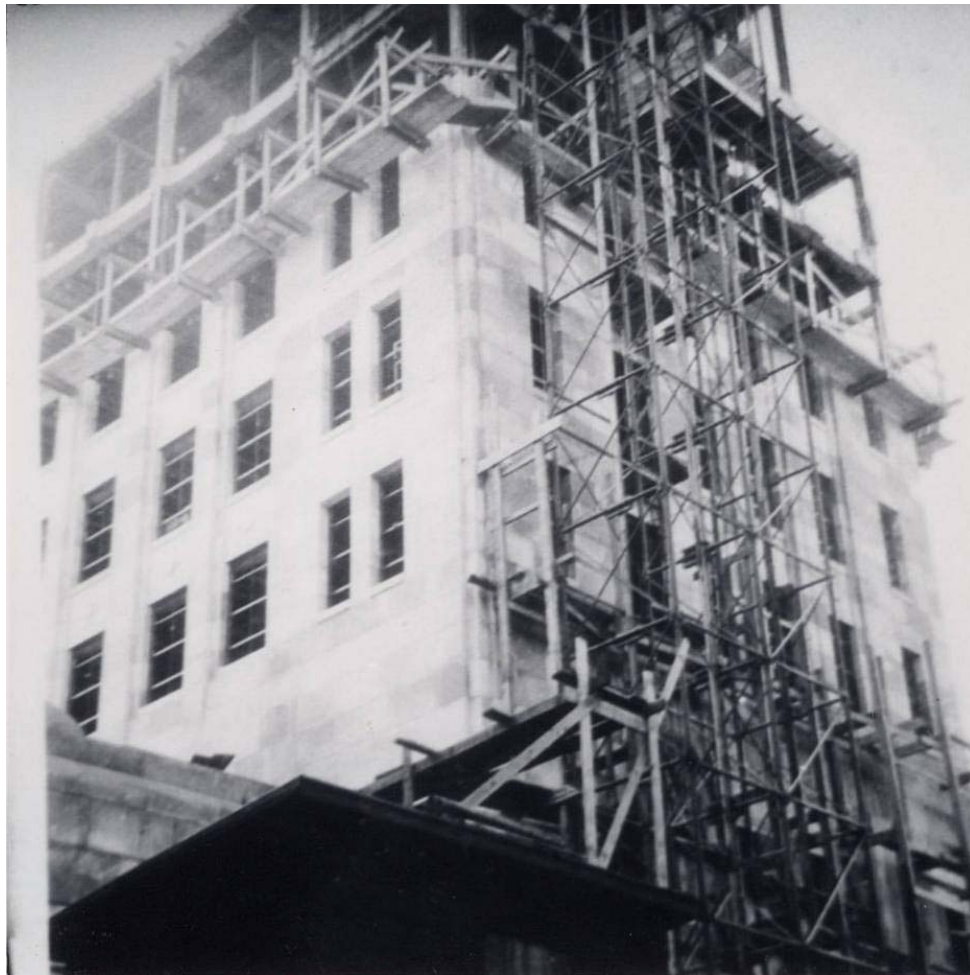
Figure 10. 1930 photograph of the Middletown Building and Deposit Association Building being constructed in the Main Street Commercial Historic District in Middletown, Ohio, looking southwest
Source: George C. Crout Collection, MidPointe Library System, Middletown, Ohio

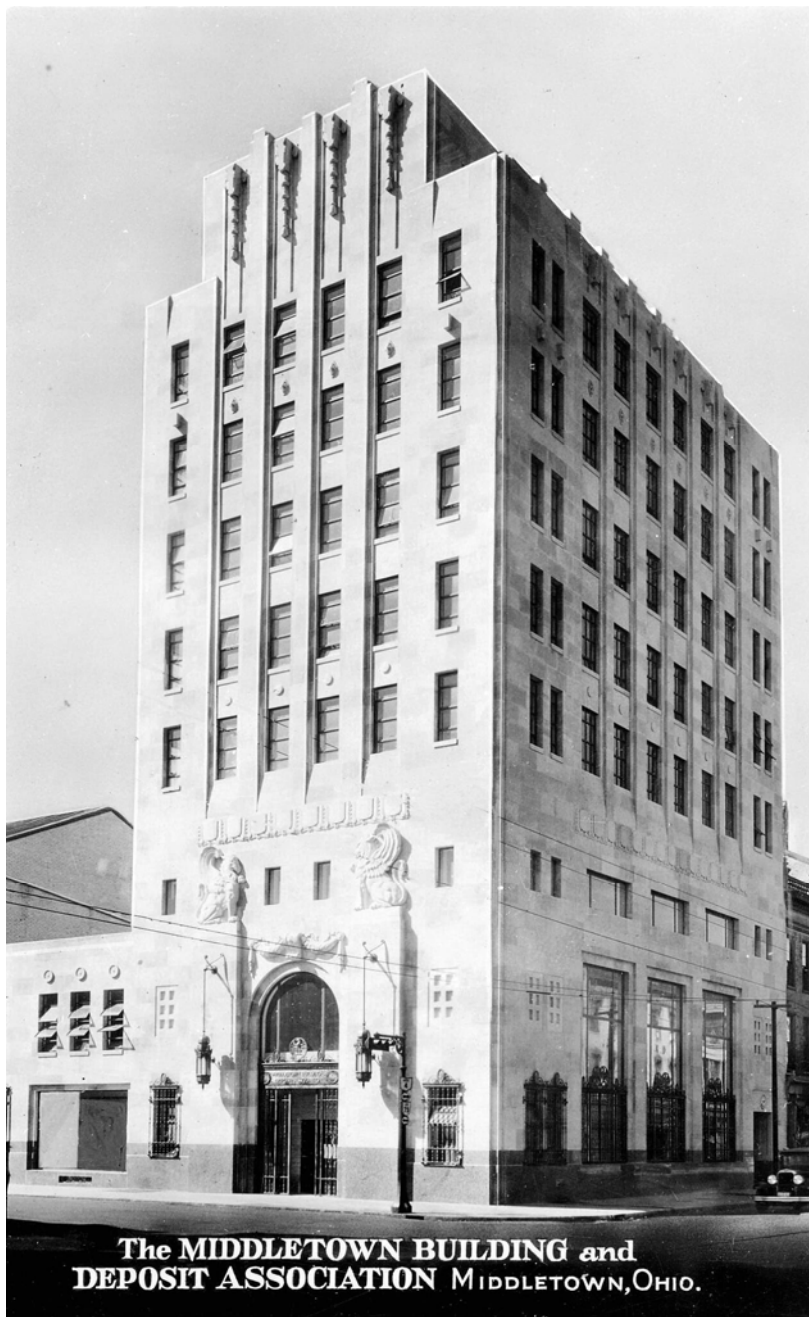
Figure 11. Ca. 1940 postcard photograph of the Middletown Building and Deposit Association Building in the Main Street Commercial Historic District in Middletown, Ohio, looking southeast

replaced by modern metal-frame windows, and the main entrance has been altered by replacing a smaller entrance protected by a wrought-iron gate with the current paired metal-frame modern business doors and metal-frame sidelights (Figure 11 and Photo 20). The remaining portions of the building remain unaltered. Despite these alterations, the former Middletown Building and Deposit Association building overall retains architectural and historical integrity, and is one of the few examples of Art Deco architecture in Middletown. This building contributes to the historical and architectural significance of the Main Street Commercial Historic District.

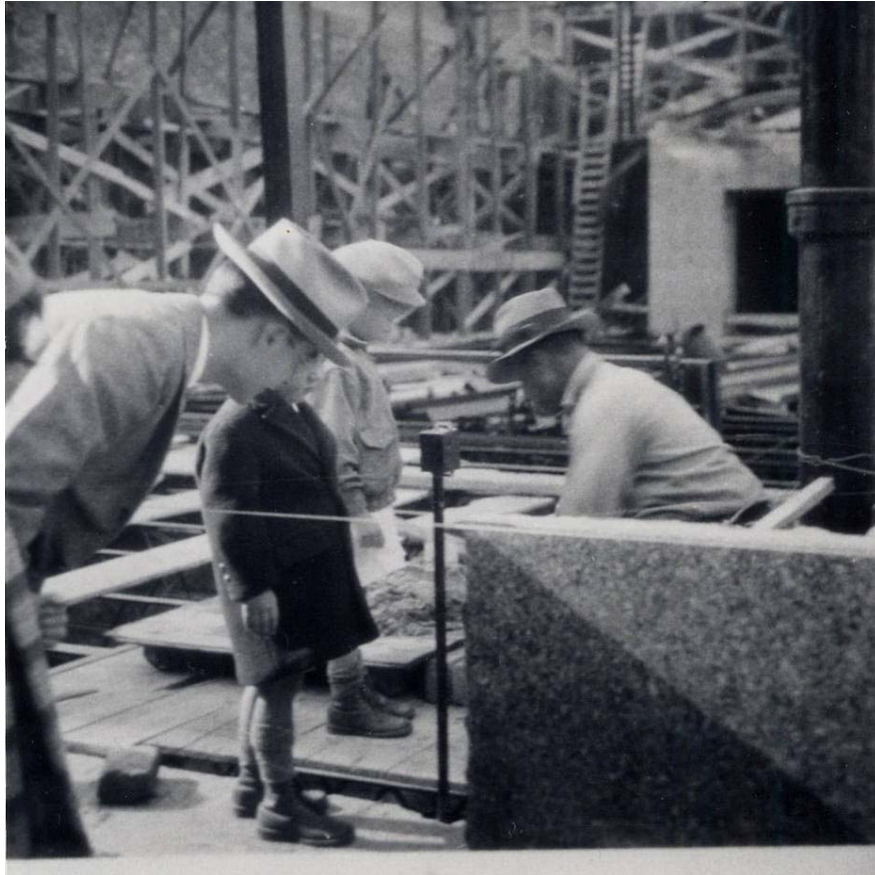
Figure 12. 1928 photograph of the laying of the cornerstone for the Oglesby-Barnitz Bank and Trust Company Building being constructed in the Main Street Commercial Historic District in Middletown, Ohio
Source: George C. Crout Collection, MidPointe Library System, Middletown, Ohio

2 South Main Street – The former Oglesby-Barnitz Bank and Trust Company building was designed by the architectural firm of Walker and Weeks out of Cleveland, Ohio (Johannesen 1999:163). The building was constructed in 1928 by contractor Ed Frisch under the direction of bank president W. O. Barnitz (Crout 2000; Figures 12, 13, 14, and 15; Photos 23 and 24). The two-story bank building's main façade is on the east elevation and fronts onto South Main Street. The north (side) elevation fronts onto Central Avenue. The building has a Neo-Classical Revival style of architecture with a large pedimented portico and entablature supported by six large concrete Corinthian columns resting on a marble paneled base on the south elevation (Photo 26). The pediment extends above the roofline and features dentil detailing and a circle window. The main entrance has modern metal and glass doors, with a concrete Neo-Classical broken-pediment surround adorned with an urn decoration (Photo 25). The windows on this elevation are metal frame replacement three-over-three windows with concrete headers supported by ornate concrete scroll brackets. The north (side) elevation has five large windows comprised of six larger center panes flanked by smaller side lights. This elevation is embellished by eight Corinthian pilasters. Elaborate scroll architectural details highlight the areas between the tops of the pilasters. A cornice with dentil ornamentation extends along the roofline of this elevation as well. A one story addition with a Neo-Classical revival style wraps around the south (side) and west (rear) elevations of the building. In 1963, several buildings south of the bank building were demolished to make way for this addition and to provide additional parking areas for the expanded customer services (Crout 2000). The visible portions of the south and west elevations of the main building above the one-story addition are blind and lack any architectural ornamentation. Historic photographs show that the main portion of the building has experienced little alteration, with the exception of the replacement of the large windows on the north elevation (Figures 13, 14, and 15). Despite the altered windows, the building retains a high level of architectural and historical integrity and contributes to the Main Street Commercial Historic District.

- Figure 12. 1928 photograph of the laying of the cornerstone for the Oglesby-Barnitz Bank and Trust Company Building being constructed in the Main Street Commercial Historic District in Middletown, Ohio

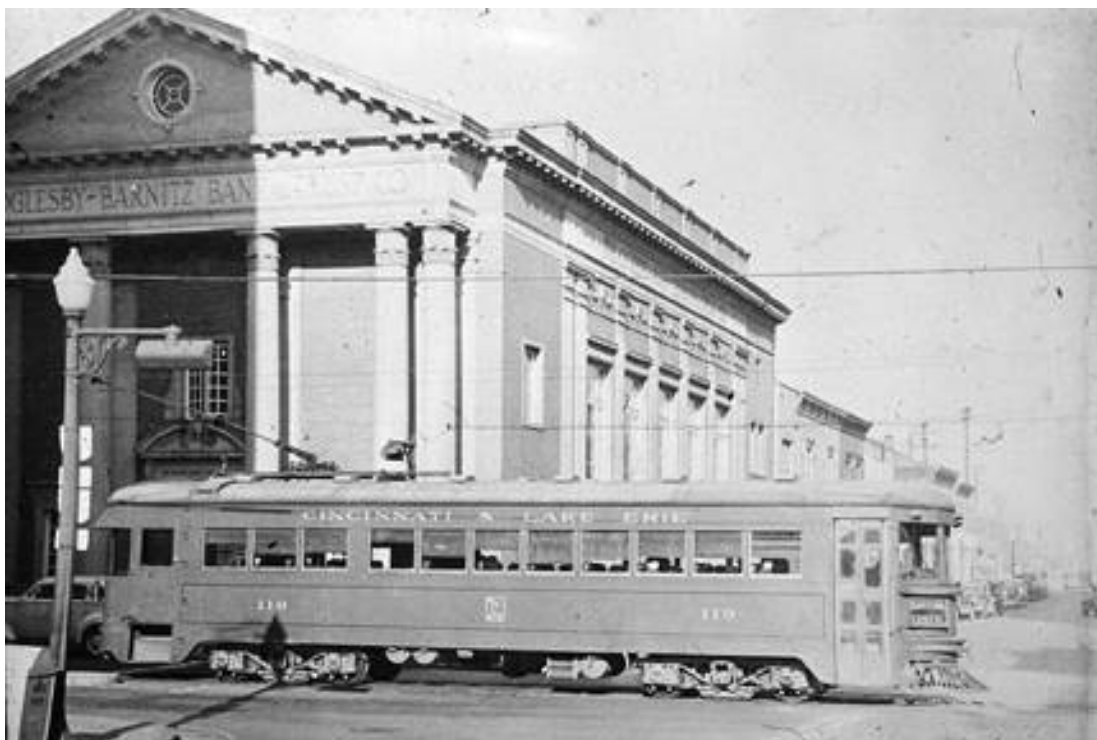
Figure 14. Ca. 1930 photograph of the Cincinnati & Lake Erie Railroad Company’s electric interurban car 119 passing of the Oglesby-Barnitz Bank and Trust Company Building in the Main Street Commercial Historic District in Middletown, Ohio, looking southwest
Source: George C. Crout Collection, MidPointe Library System, Middletown, Ohio

had shut down (Crout 1960:99). The horse-drawn cars were replaced by electric interurban cars (Figure 14).

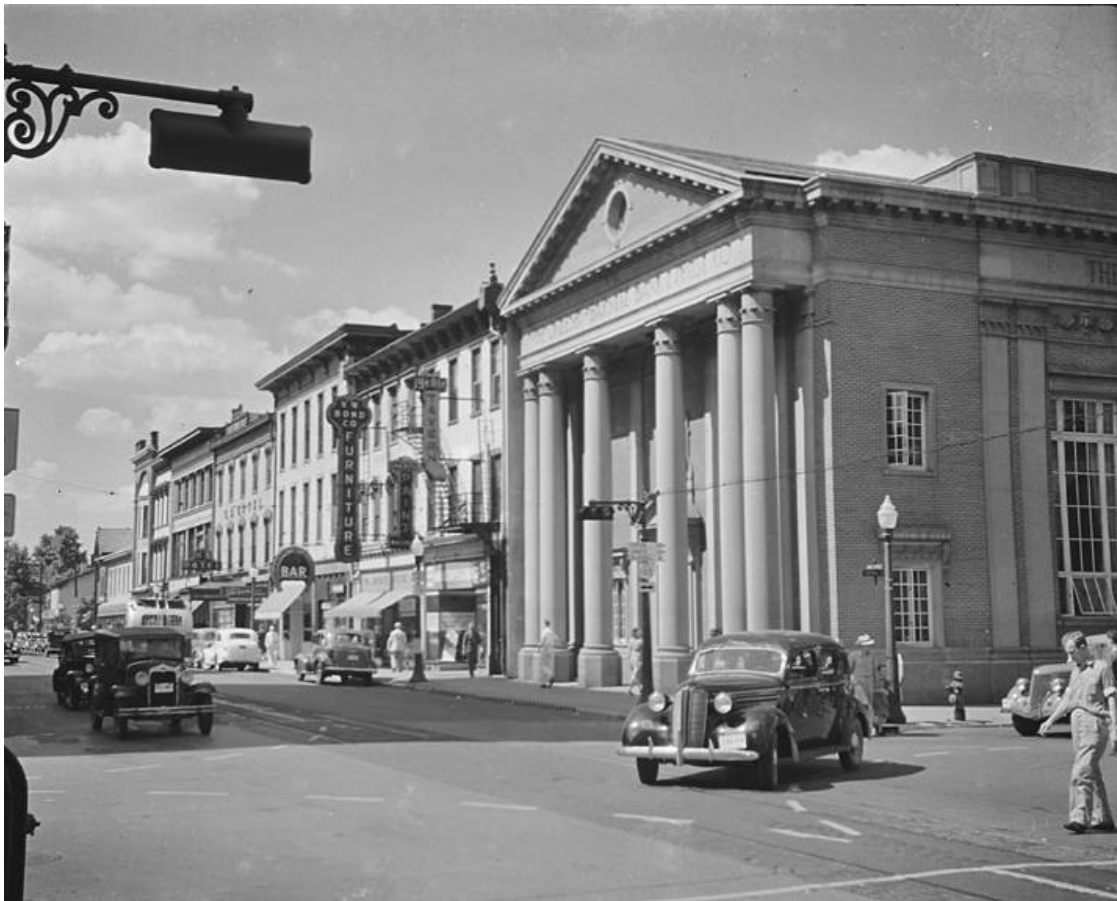
Figure 15. Ca. 1938 photograph of the west side of South Main Street in the Main Street Commercial Historic District in Middletown, Ohio, looking southwest
Source: George C. Crout Collection, MidPointe Library System, Middletown, Ohio

- Figure 15. Ca. 1938 photograph of the west side of South Main Street in the Main Street Commercial Historic District in Middletown, Ohio, looking southwest

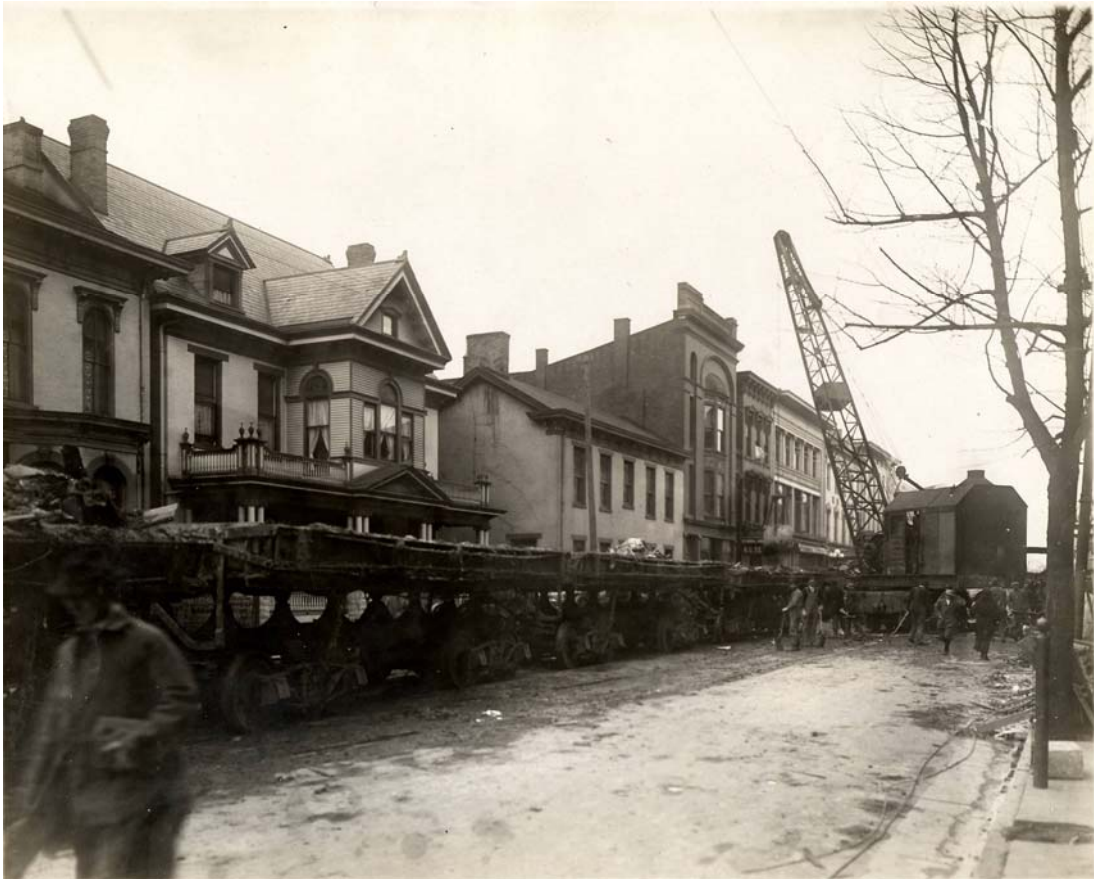
Figure 17. 1913 photograph of the clean up following the Great Flood of 1913 showing the west side of South Main Street in the Main Street Commercial Historic District in Middletown, Ohio, looking northwest
Source: George C. Crout Collection, MidPointe Library System, Middletown, Ohio

days, a total of six to eleven inches of rain had fallen on the state. The ground was quickly saturated and the rivers began to rise. The Great Miami River, along the west side of Middletown, quickly topped its banks and spilled into Middletown. Historic photographs, taken on March 25, 1913, show the extent of the flood damage with water reaching near the top of the first story of the commercial buildings along Main Street and Central Avenue near the river. The Middletown business community was devastated by the flood, but clean-up began almost immediately. ARMCO supplied railroad equipment, adapted to utilize the street car lines along Main Street and Central Avenue, to assist with the clean up, and Middletown gradually began to recover, thanks in large part to the railroads being able to swiftly remove debris while bringing new construction materials into the city (Figure 17) (Crout 2000).

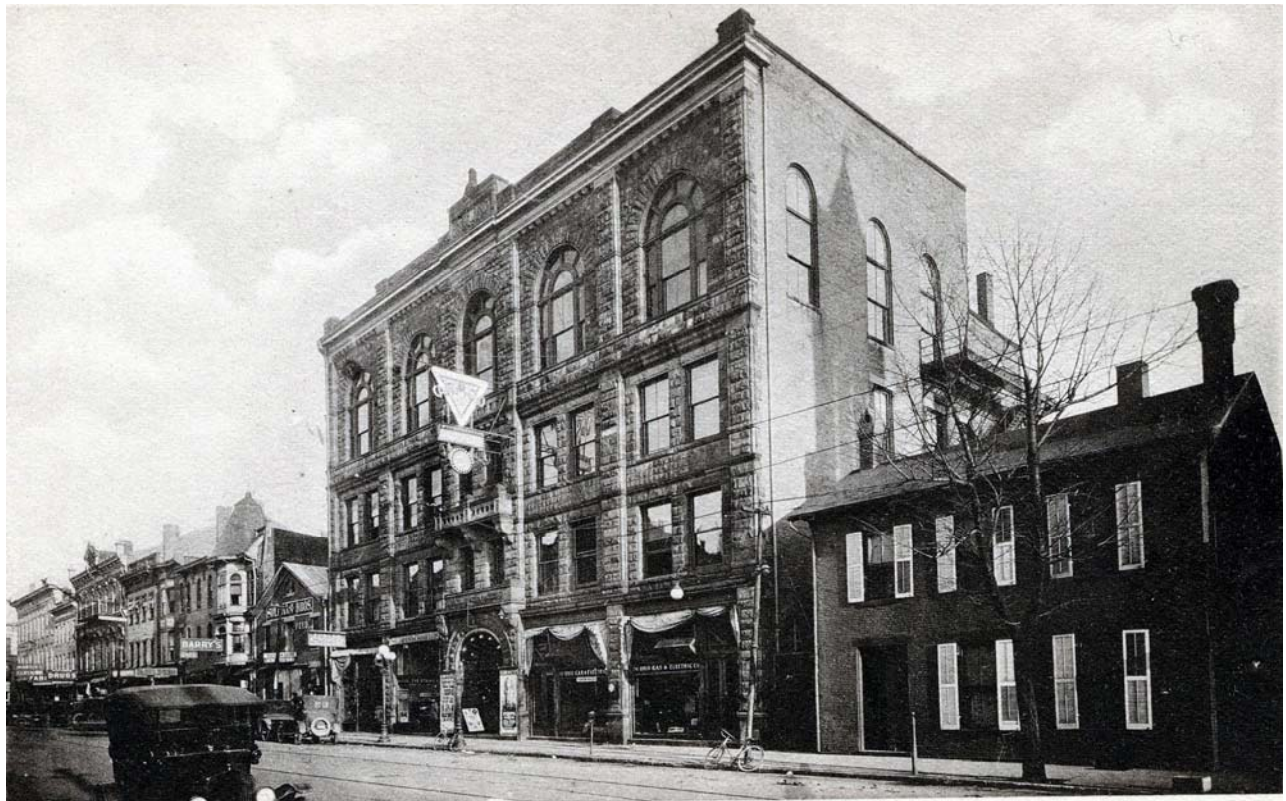
Figure 18. Ca. 1920 photograph of the east side of South Main Street in the Main Street Commercial Historic District in Middletown, Ohio, looking northeast

- Figure 18. Ca. 1920 photograph of the east side of South Main Street in the Main Street Commercial Historic District in Middletown, Ohio, looking northeast

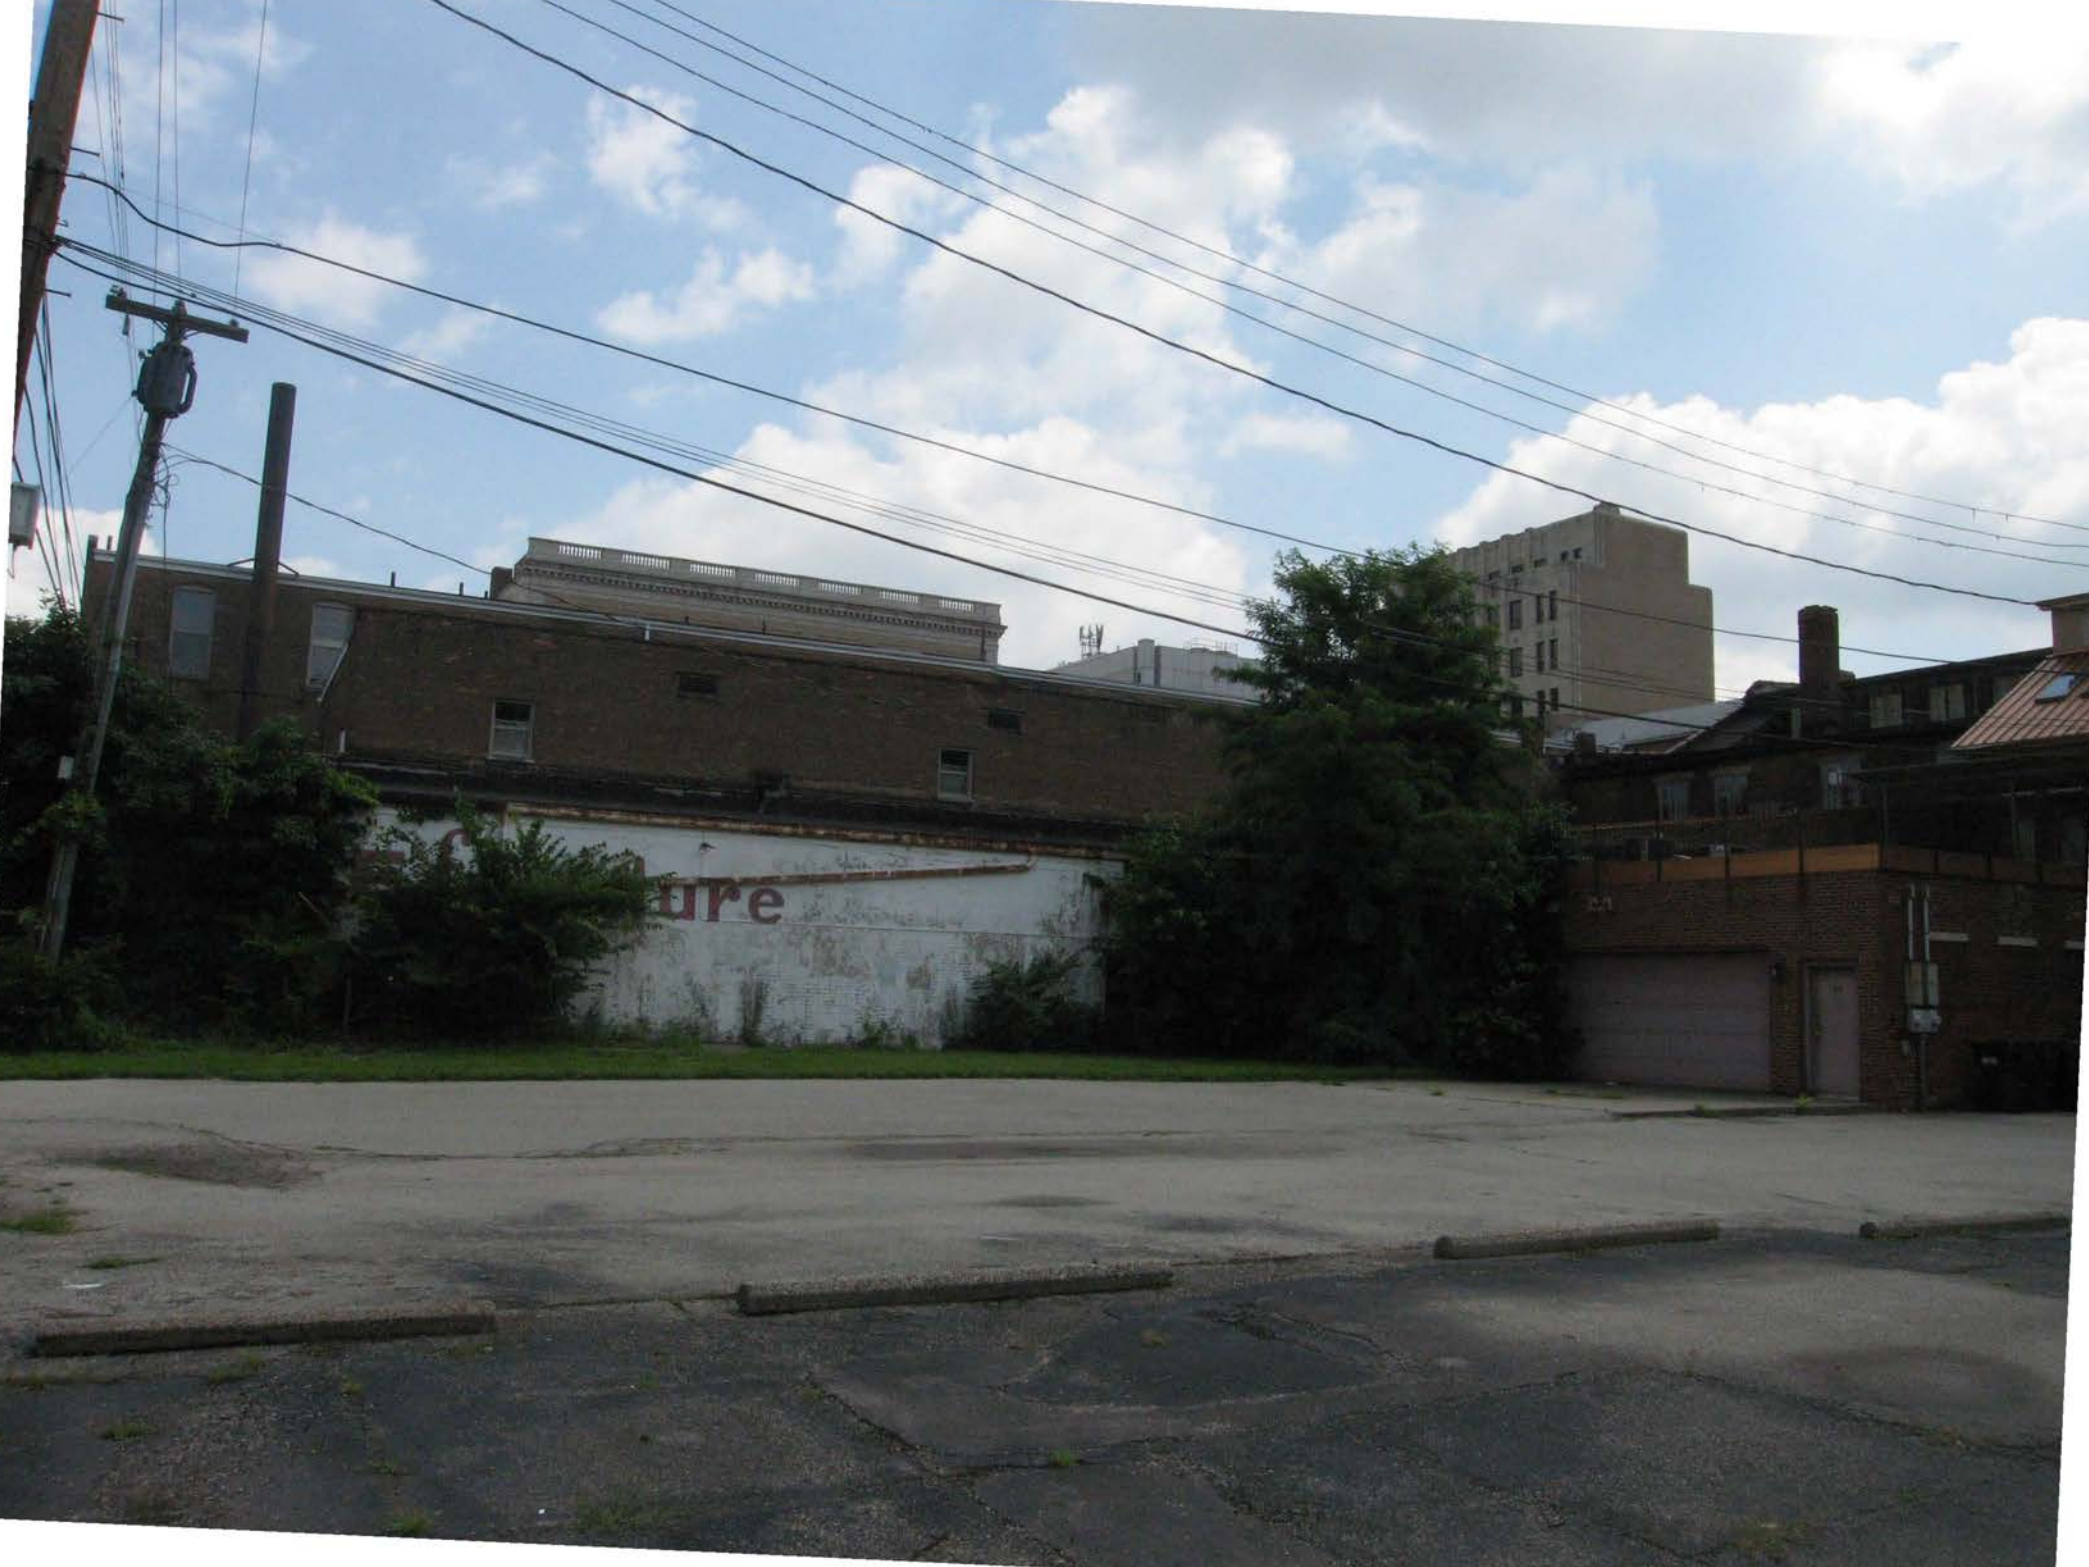
The central building is a three-story red brick structure. The top floor features three windows with decorative grey lintels and sills. The middle floor has four windows, with the leftmost one partially obscured by an adjacent building. The ground floor consists of a storefront with a door on the left and a large window on the right, all framed in grey. The building is topped with a decorative cornice.

The building on the left is a light-colored brick structure. It features a blue awning over a ground-floor entrance and a decorative archway above a window on the upper floor.

The building on the right is a light-colored brick structure. It has a white awning over a ground-floor window and a large window on the upper floor with a decorative frame.
