NATIONAL REGISTER OF HISTORIC PLACES
REGISTRATION FORM

historic name MAY-STRINGER HOUSE

**MAY-STRINGER HOUSE
Brooksville, Hernando County, Florida**

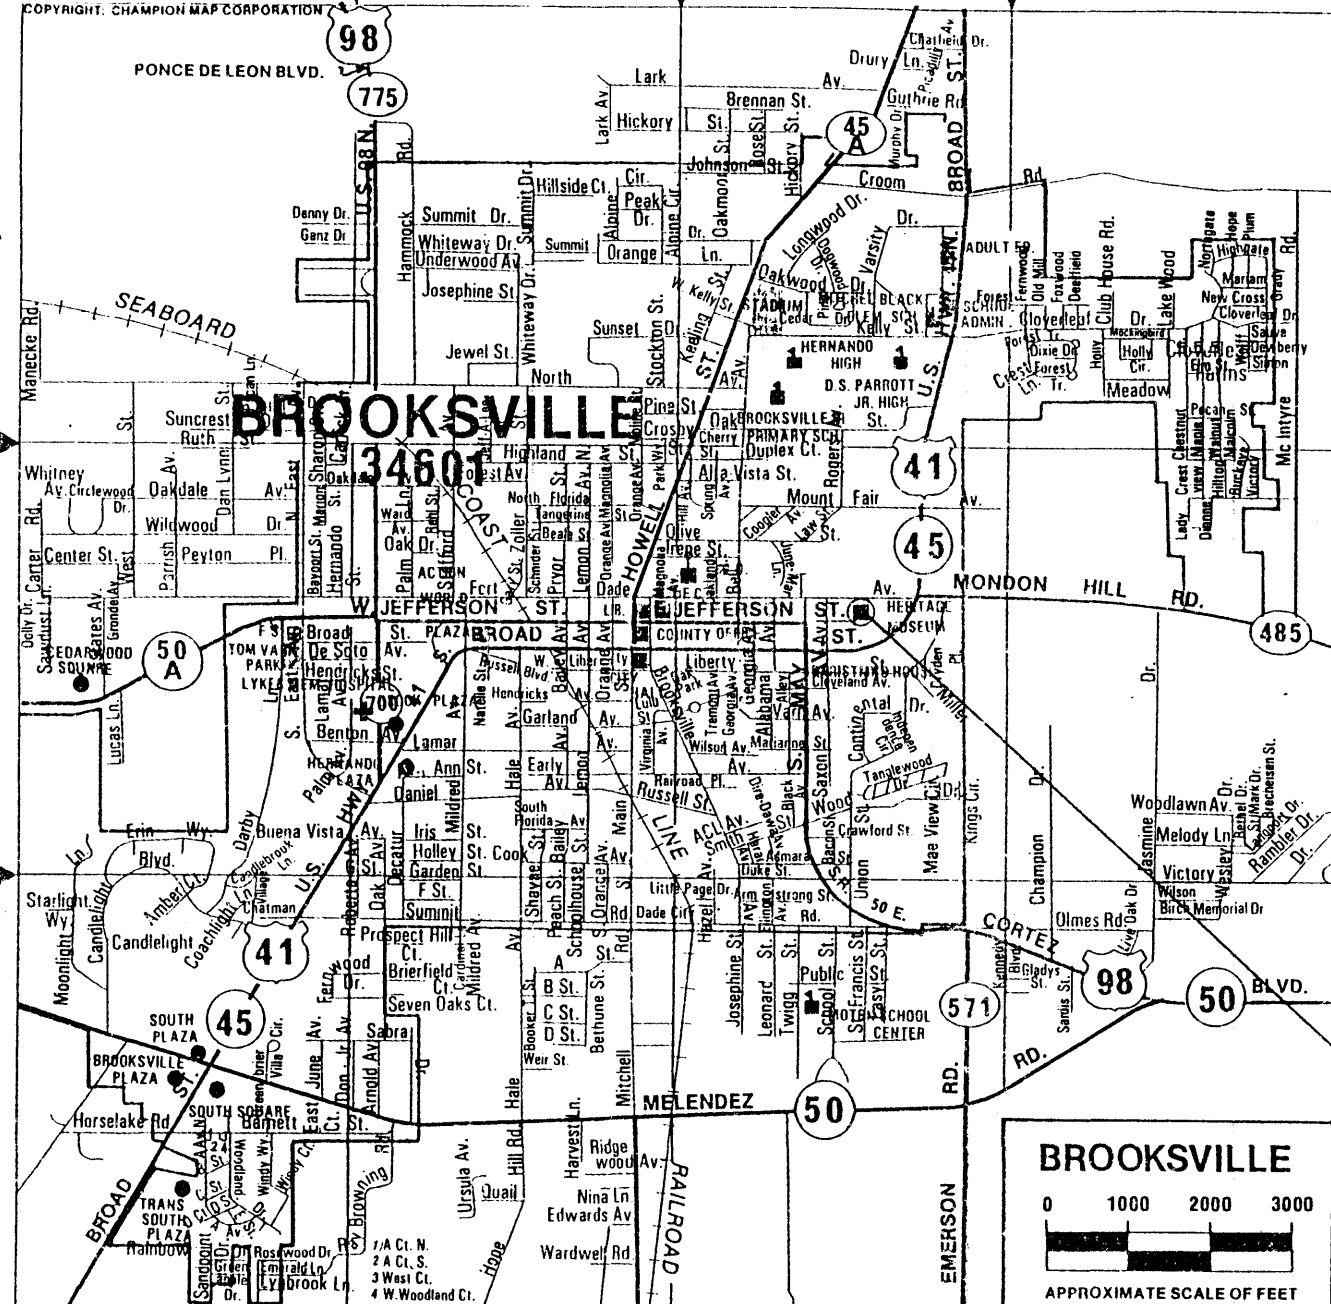
TAX MAP

The boundary of the May-Stringer House is shown as the bold line on the accompanying Hernando County tax map which has a scale of 1 foot to 300 feet. The legal description is Saxons Addition to the Town of Brooksville, all of Block 2, recorded in Plat Book 3 at page 1.
