KING COUNTY HISTORIC SITES SURVEY
Inventory Sheet

NAME				
Historic				
Common Ma	sonic Lodge Buildir	og (Kirledone Lan	Site	No.
LOCATION -		2.707		
Number & Stree	t 700 Market S	Street		for Publication
City or Town	Kirkland	_	Zip_	98033
Incorporated	X Unincorporated ·	_ Community name		
	District 2	Community Planning	District Market	Street Corridor
	ive District 45	Zoning B-C (Comm	unity Business)	
County Council	District 3	_ Shoreline Environm	ent <u>Urban</u>	
CLASSIFICATION				
CATEGORY	OWNERSHIP	STATUS	PRESENT	USE
District	Public	X_Occupied .	Agriculture	Museum
XBuilding(s)	XPrivate	Unoccupied	<u>x</u> Commercial	Park
Structure	Both	Preservation	Educational	Private
Historic Site		Work in Progress	Entertainment	Residence
Arc. Site	ACCESSIBLE	Threatened by:	Government	Religious
 Object	XYes Restricted	Demolition	Industrial	Scientific

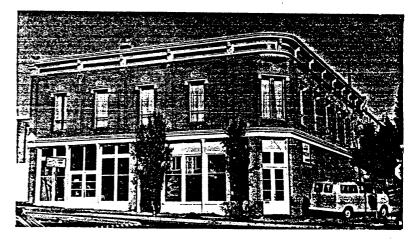
This is a two story rectangular brick building with a flat roof. The building measures $54' \times 79'$ with the southwest corner cut at a 45° angle to create a corner entrance. The exterior brick is laid in the common bond pattern.

The wall design on the street level west facade is alternate brick piers and 8" round, cast iron columns one story in height. The window and door treatments are typical storefront with large wood sash windows with transoms and doorways without decoration. There is frieze and cornice molding above the window transoms at the second floor level terminating at the northwest and southeast corners in a decorative bracket and triangular ornament. The second floor west facade is given a pier effect by the use of vertical sections of raised brick at regular intervals between the tall rectangular windows. Original double hung windows have been replaced with aluminium frame windows. Above these windows is a plaster entablature head topped by scrolls flanking a triangular ornament.

There is a continuous decorated metal parapet with dentils, brackets and wide paneled frieze crowning the building, terminating at the northwest and southeast corners in a decorative bracket similar to those mentioned previously. Below the frieze are several rows of brick corbeling. The decorative parapet and frieze form a smooth curve around the angled corner of the building. Just below the frieze at this point is a plaster conch shell decoration. The corner has recessed nine foot wooden double doors at the street level.

The building originally had a full basement. Years of dampness and partial collapse of the north retaining wall made it necessary to fill the basement in 1954 with 15,000 yards of pea gravel. A concrete floor was poured over the gravel and has proved to be a successful solution. The first floor level is rented to small businesses.

The second story is used exclusively by the Masons and has been altered to accomodate large meetings. Interior partitions have been removed and the roof has been partially replaced. The exterior has remained unchanged and is well maintained.
