NATIONAL REGISTER OF HISTORIC PLACES  
INVENTORY -- NOMINATION FORM

Dortch Plantation

The Dortch Plantation is a functional and historic farm complex located near Scott, Arkansas. It is comprised of farm buildings, 975 acres of cotton and soybean fields and pasture, (32) and a portion of a horseshoe-shaped lake (31). The plantation includes the site of a plantation church (29) which was removed a few years ago. A lone "mule-cooling tree" (27) still stands in the fields. An underground silo (28) lies along the southern boundary of the plantation. Two modern equipment sheds, a mobile home, and two modern residences are intermingled among the historic structures and sites. Most of the structures, both the historic and the modern, are located alongside two dirt roads in the northern half of the plantation.

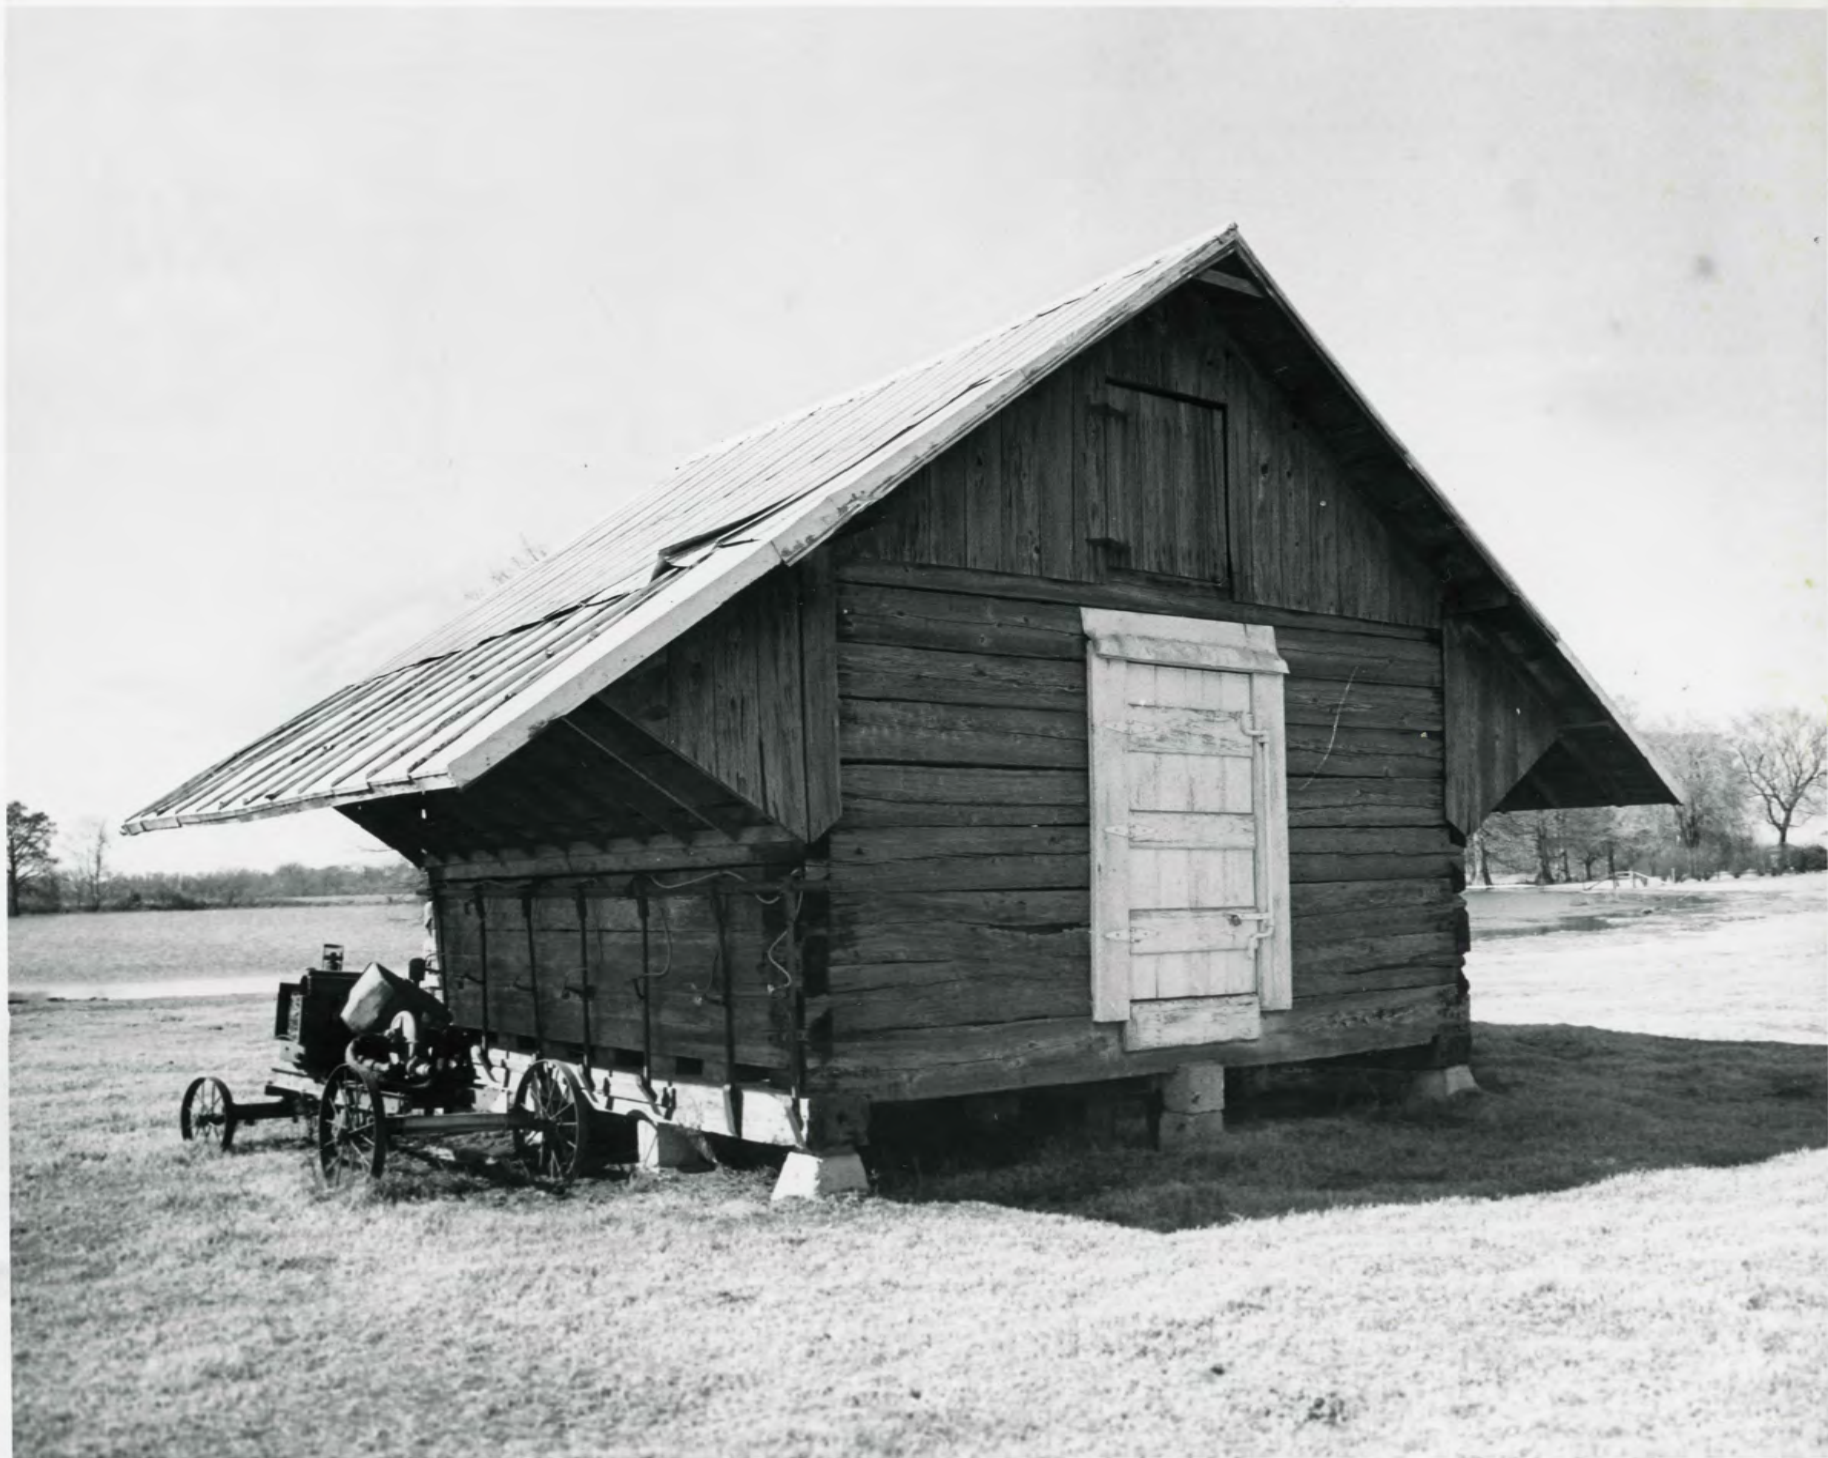
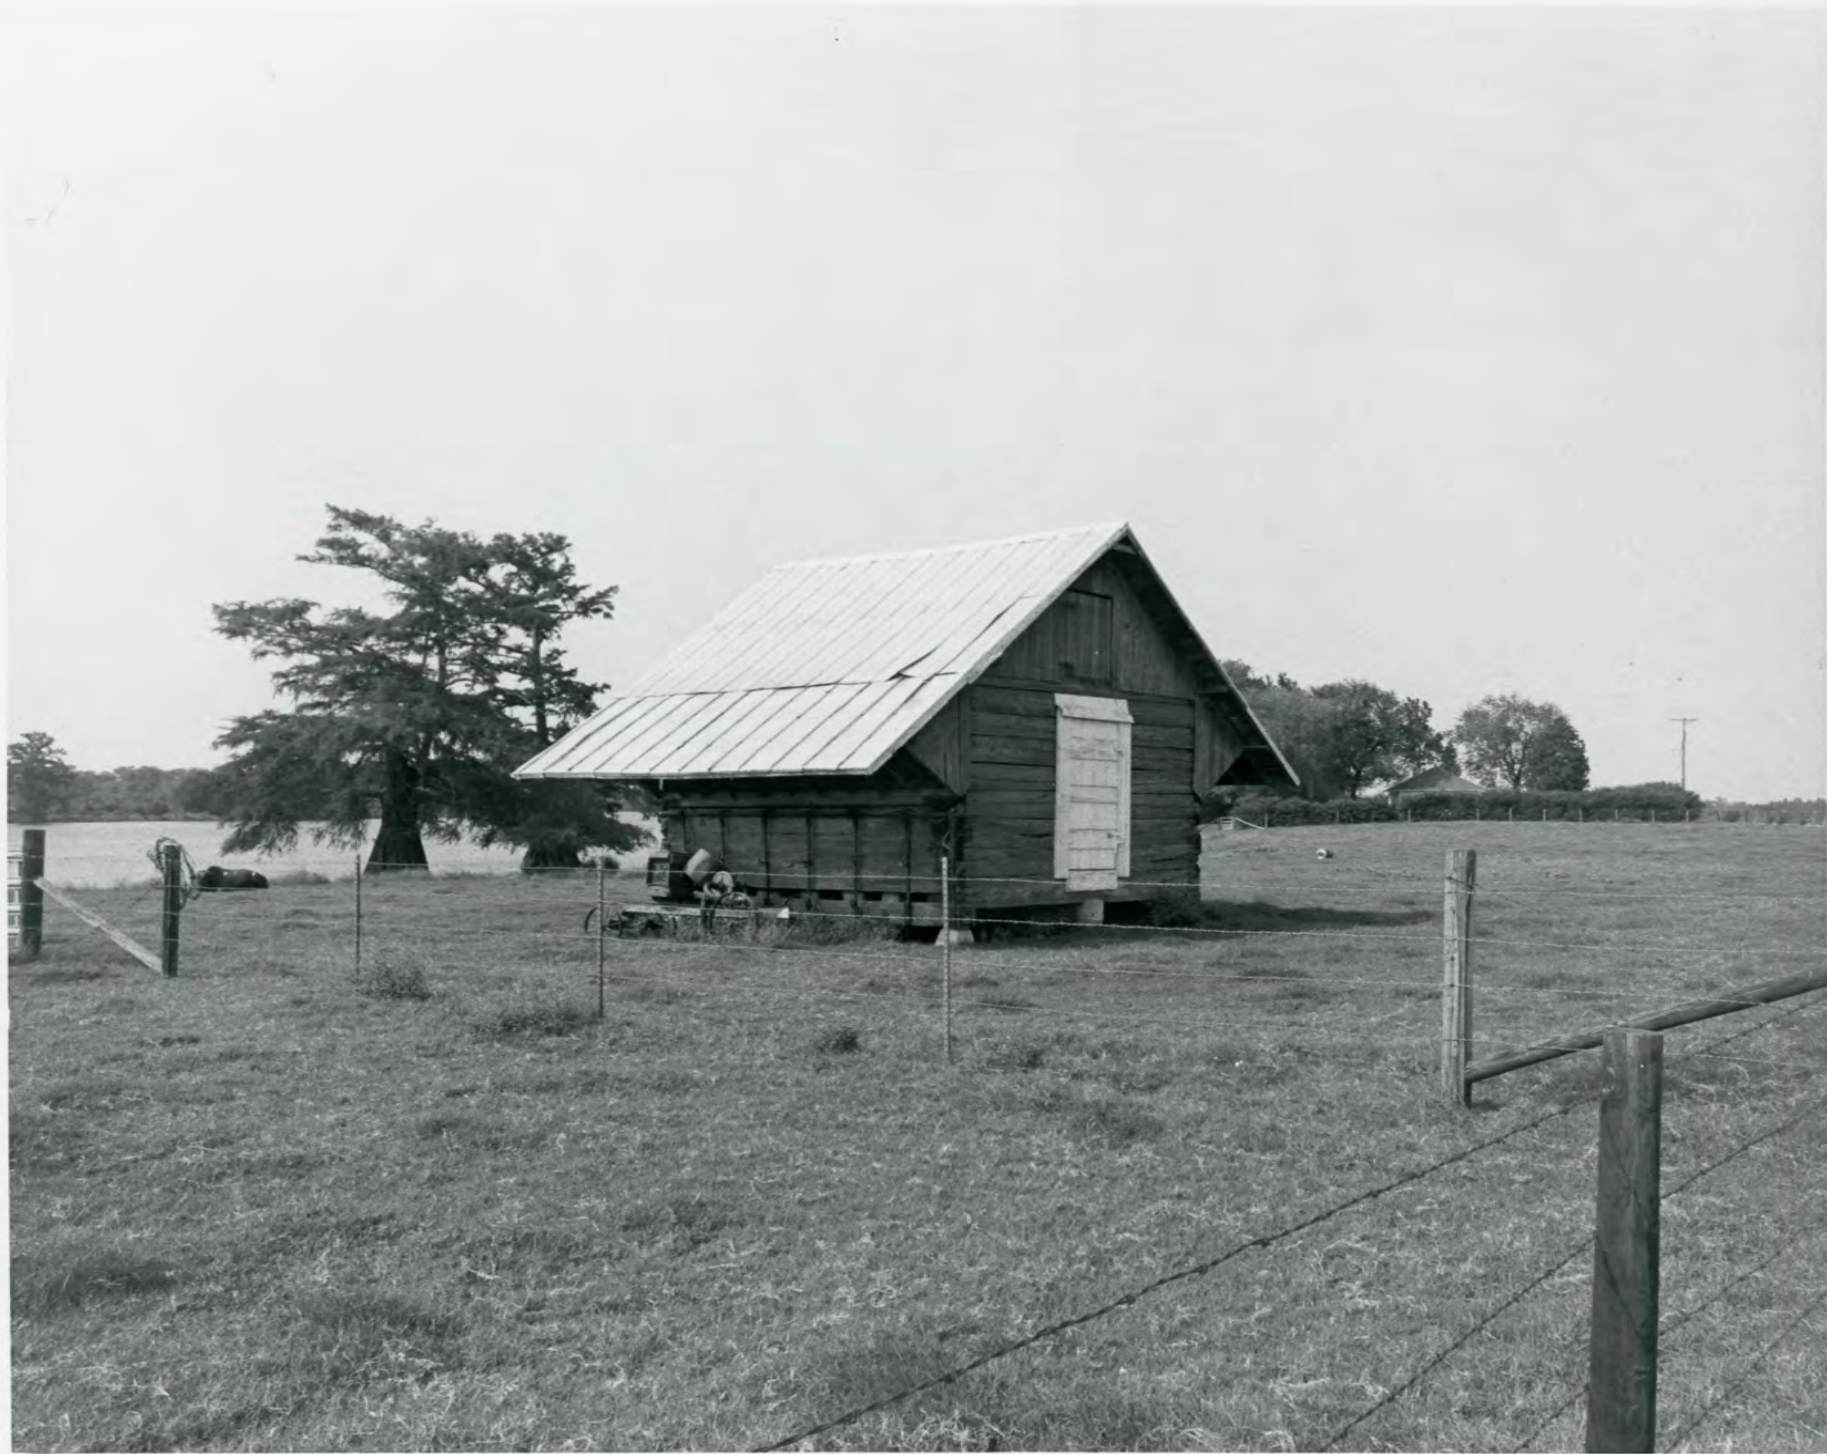
1. Dortch Plantation
2. Scott, Arkansas
3. March, 1979
4. Jack Doss
5. Arkansas Historic Preservation Program
6. #9; Corn Crib; viewed from the southeast
7. photo # 8

5. Corn crib - 1888. Notch-end cypress logs (flattened), no nails - has complete integrity except for sheet metal roof and door.
6. Original house - Now in two parts, both used. House built soon after Civil War - moved to make way for Marls gate - mule hostler lived in part right across from mule barn and gear room. Black worker lives in one of the parts.

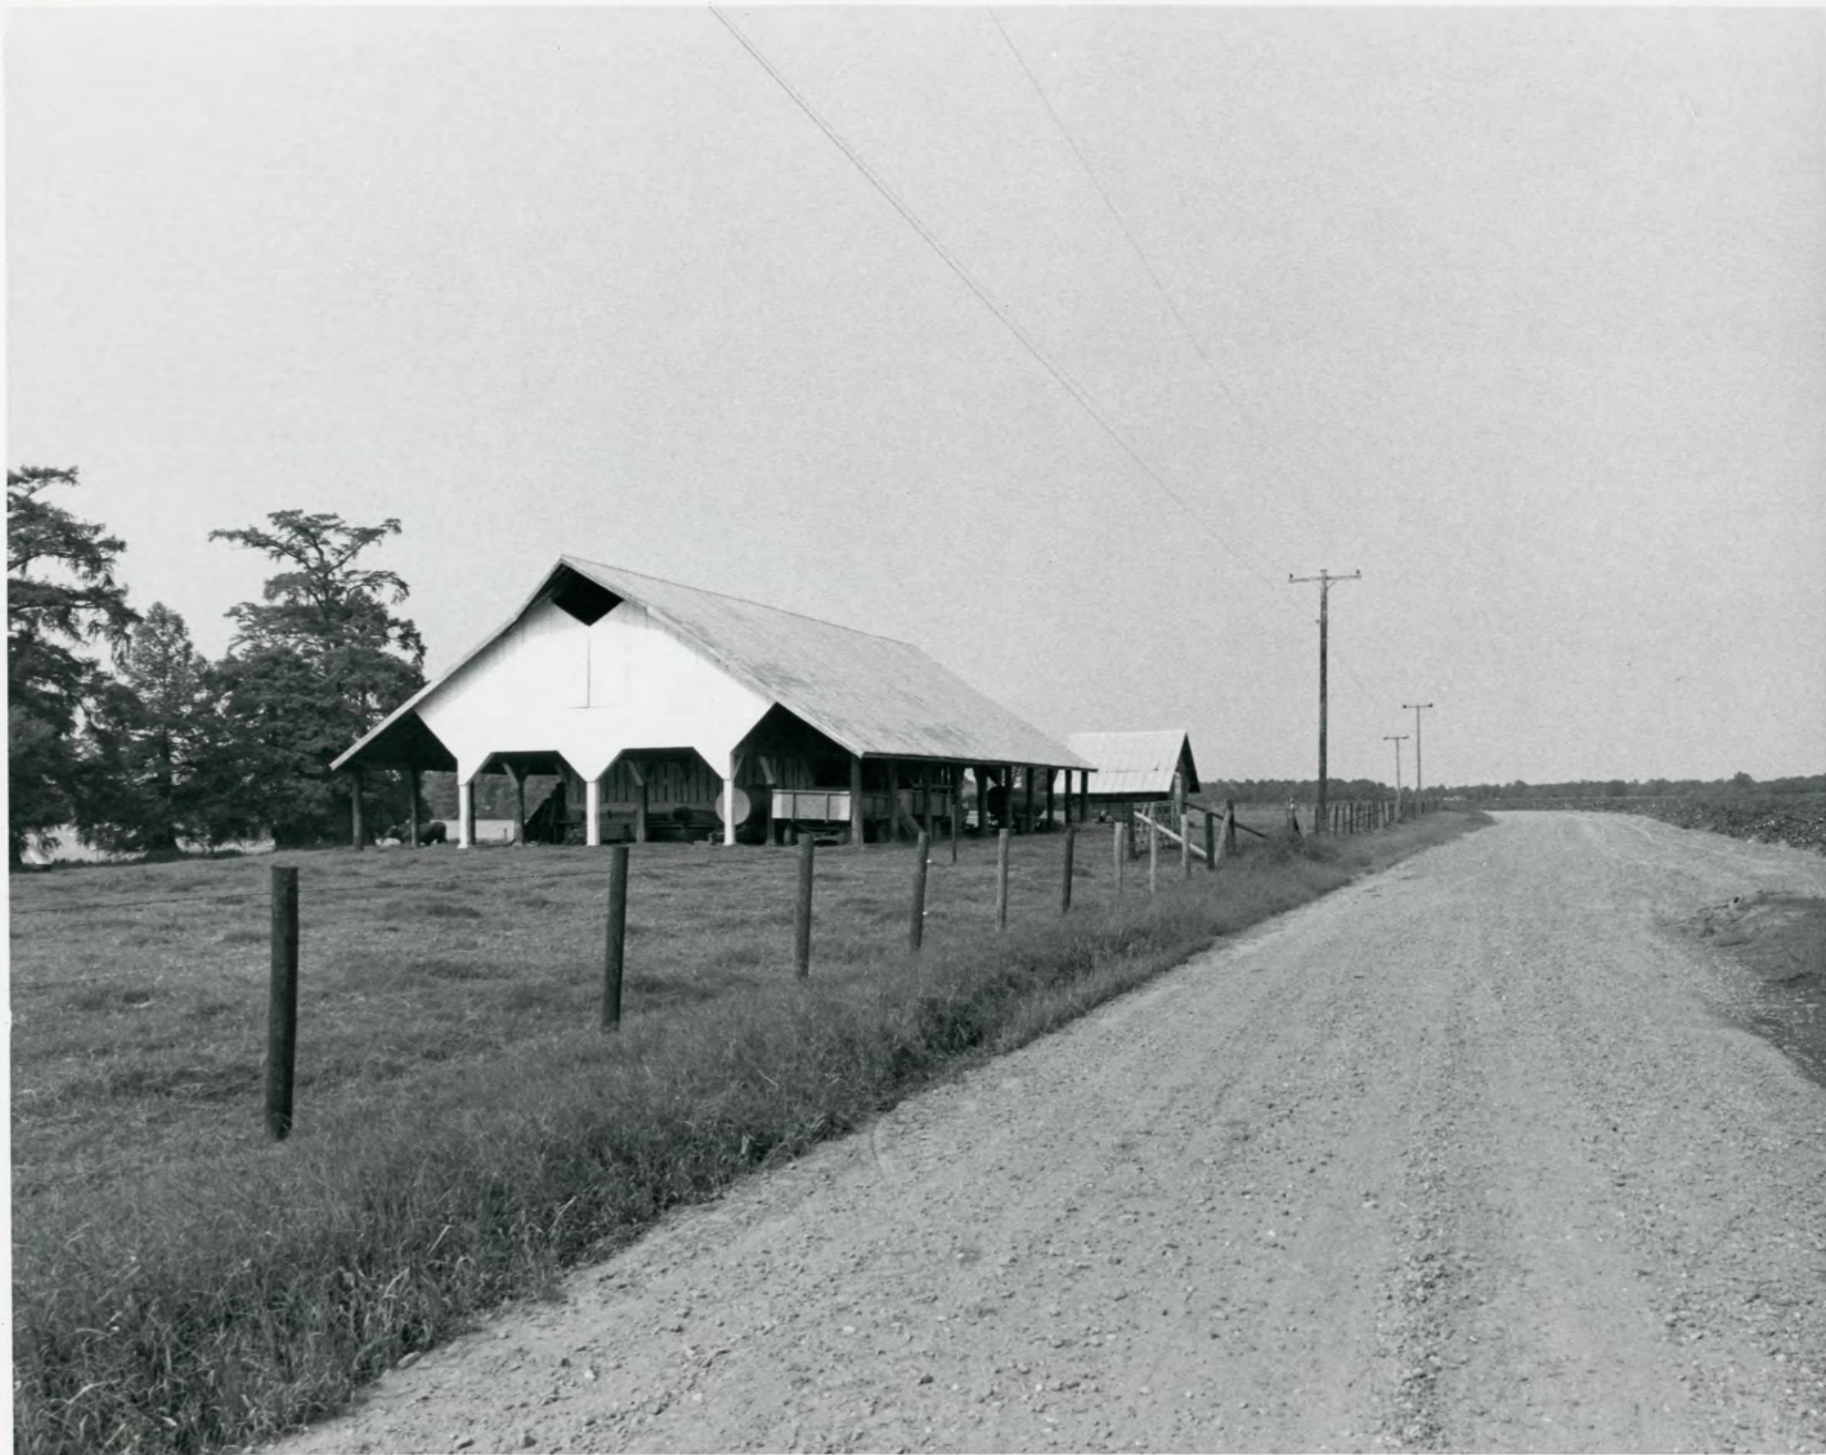
1. Dortch Plantation
2. Scott, Arkansas
3. March, 1979
4. Jack Doss
5. Arkansas Historic Preservation Program
6. # 10; mule barn
7. photo #10

Just south of the corn crib is the mule barn (10), which was constructed in 1940. The barn is a huge, two-storey structure. It features a wide, gabled roof. The covering is of corrugated metal. The roof rests on wooden poles spaced around its perimeter. A second row of poles, which are inset from the gable-ends, provide added support for the roof. Even further inset from the perimeter is an enclosed, rectangular section in the center of the barn. The gabled ends of the barn comprise four bays each; the side elevations have nine bays each. The mule barn is in an excellent state of repair.

Not far from the gear room the mule barn (10) is located. Hay for the mules was stored here, and it was here that the mules were fed. The mules also came to this huge structure to escape the rain and snow. The present mule barn was built in 1940 to replace an earlier one, which was destroyed in 1939 by a tornado. The new barn is on the site of the old one.

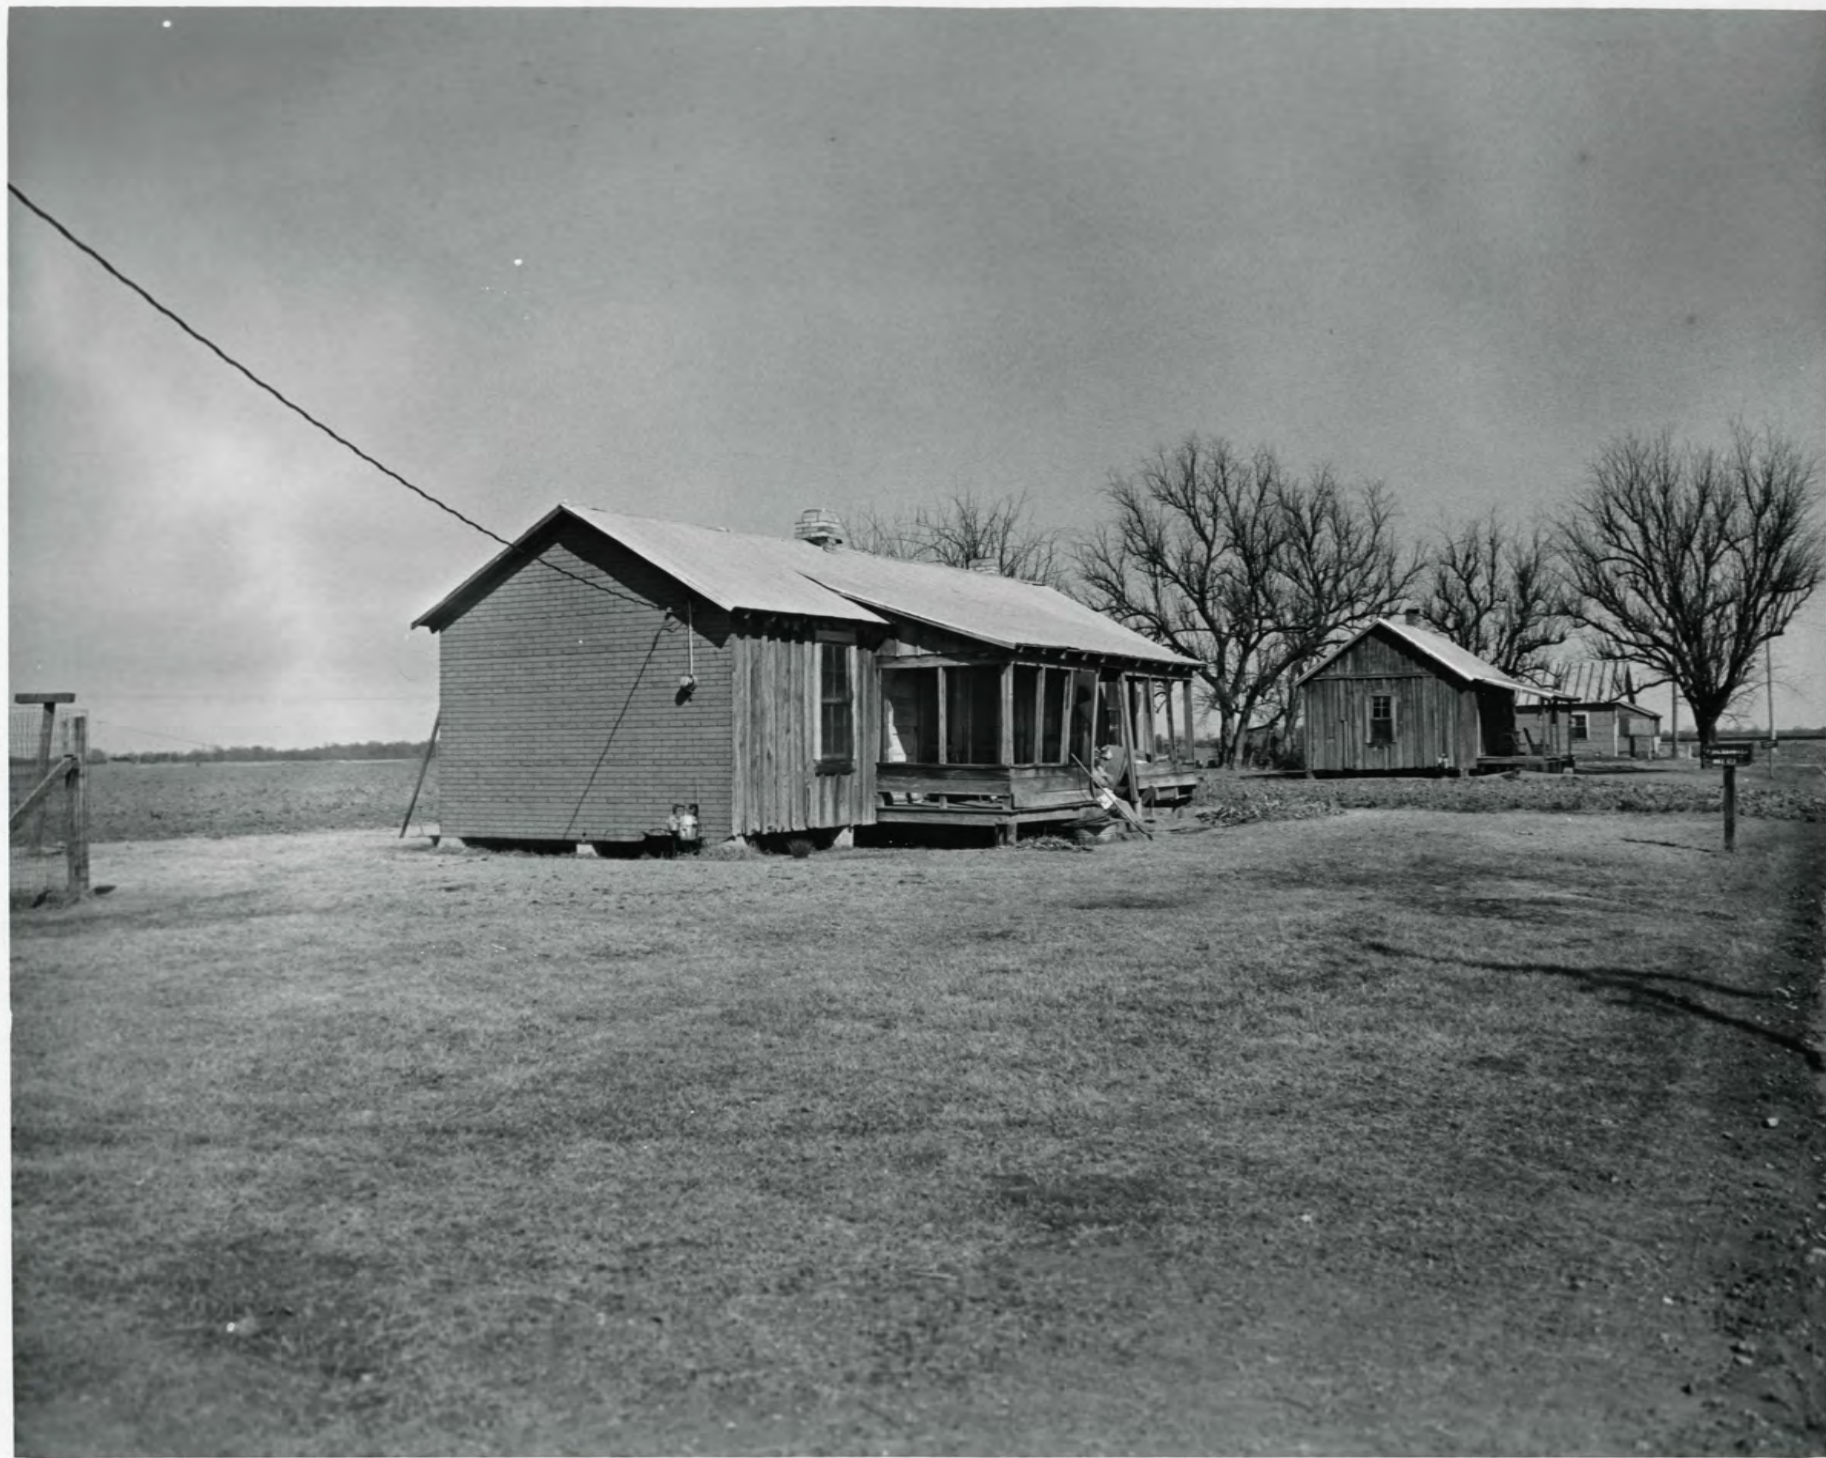
1. Dortch Plantation
2. Scott, Arkansas
3. March, 1979
4. Jack Doss
5. Arkansas Historic Preservation Program
6. #15,16,17; Tenant houses; viewed from the  
west-southwest
7. photo # 16

1. Commissary - ca. 1900. In excellent condition - now used as warehouse.
2. Two groups of tenant houses. Structurally sound - cypress - 1920's - some covered with asphalt (brick pattern) siding - unimpressive appearance.

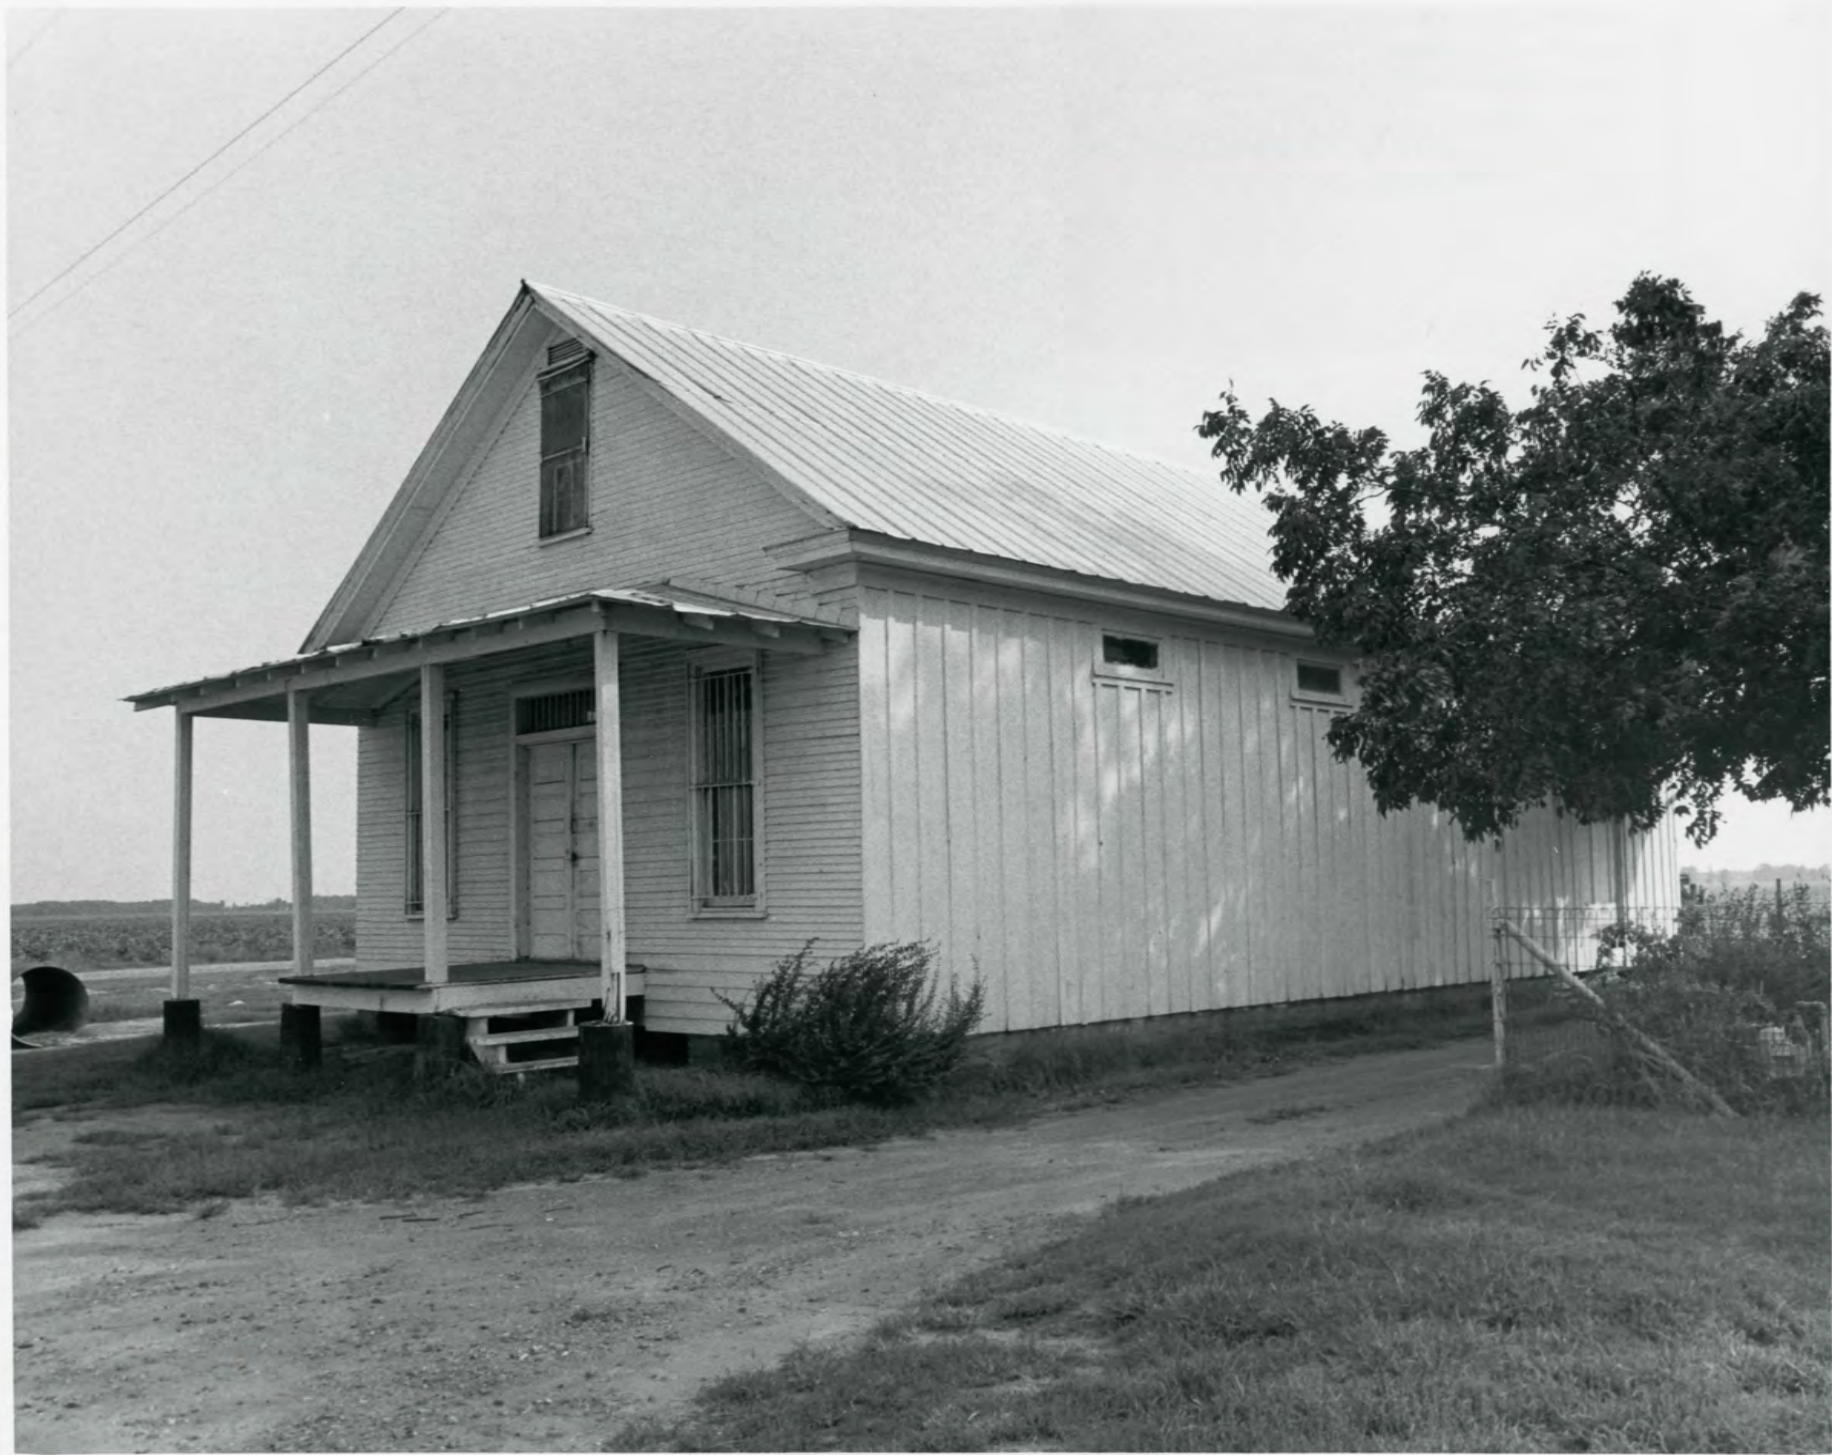
1. Dortch Plantation
2. Scott, Arkansas
3. March, 1979
4. Jack Doss
5. Arkansas Historic Preservation Program
6. #19; Commissary
7. photo #19

The historic plantation commissary (19) is very sturdy and in an excellent state of repair. The commissary was built c. 1900. Rectangular shape and gable roof give a basic simplicity to the building. Adornment is provided by boxed cornices with returns and by lites over a double-leaf entrance on the facade. The facade is the north gable-end elevation. It features a hip-roofed porch and a trabeated window on each side of the entry. The sides of the commissary are covered with board-and-batten; the facade is covered with weather-boarding and novelty-siding.

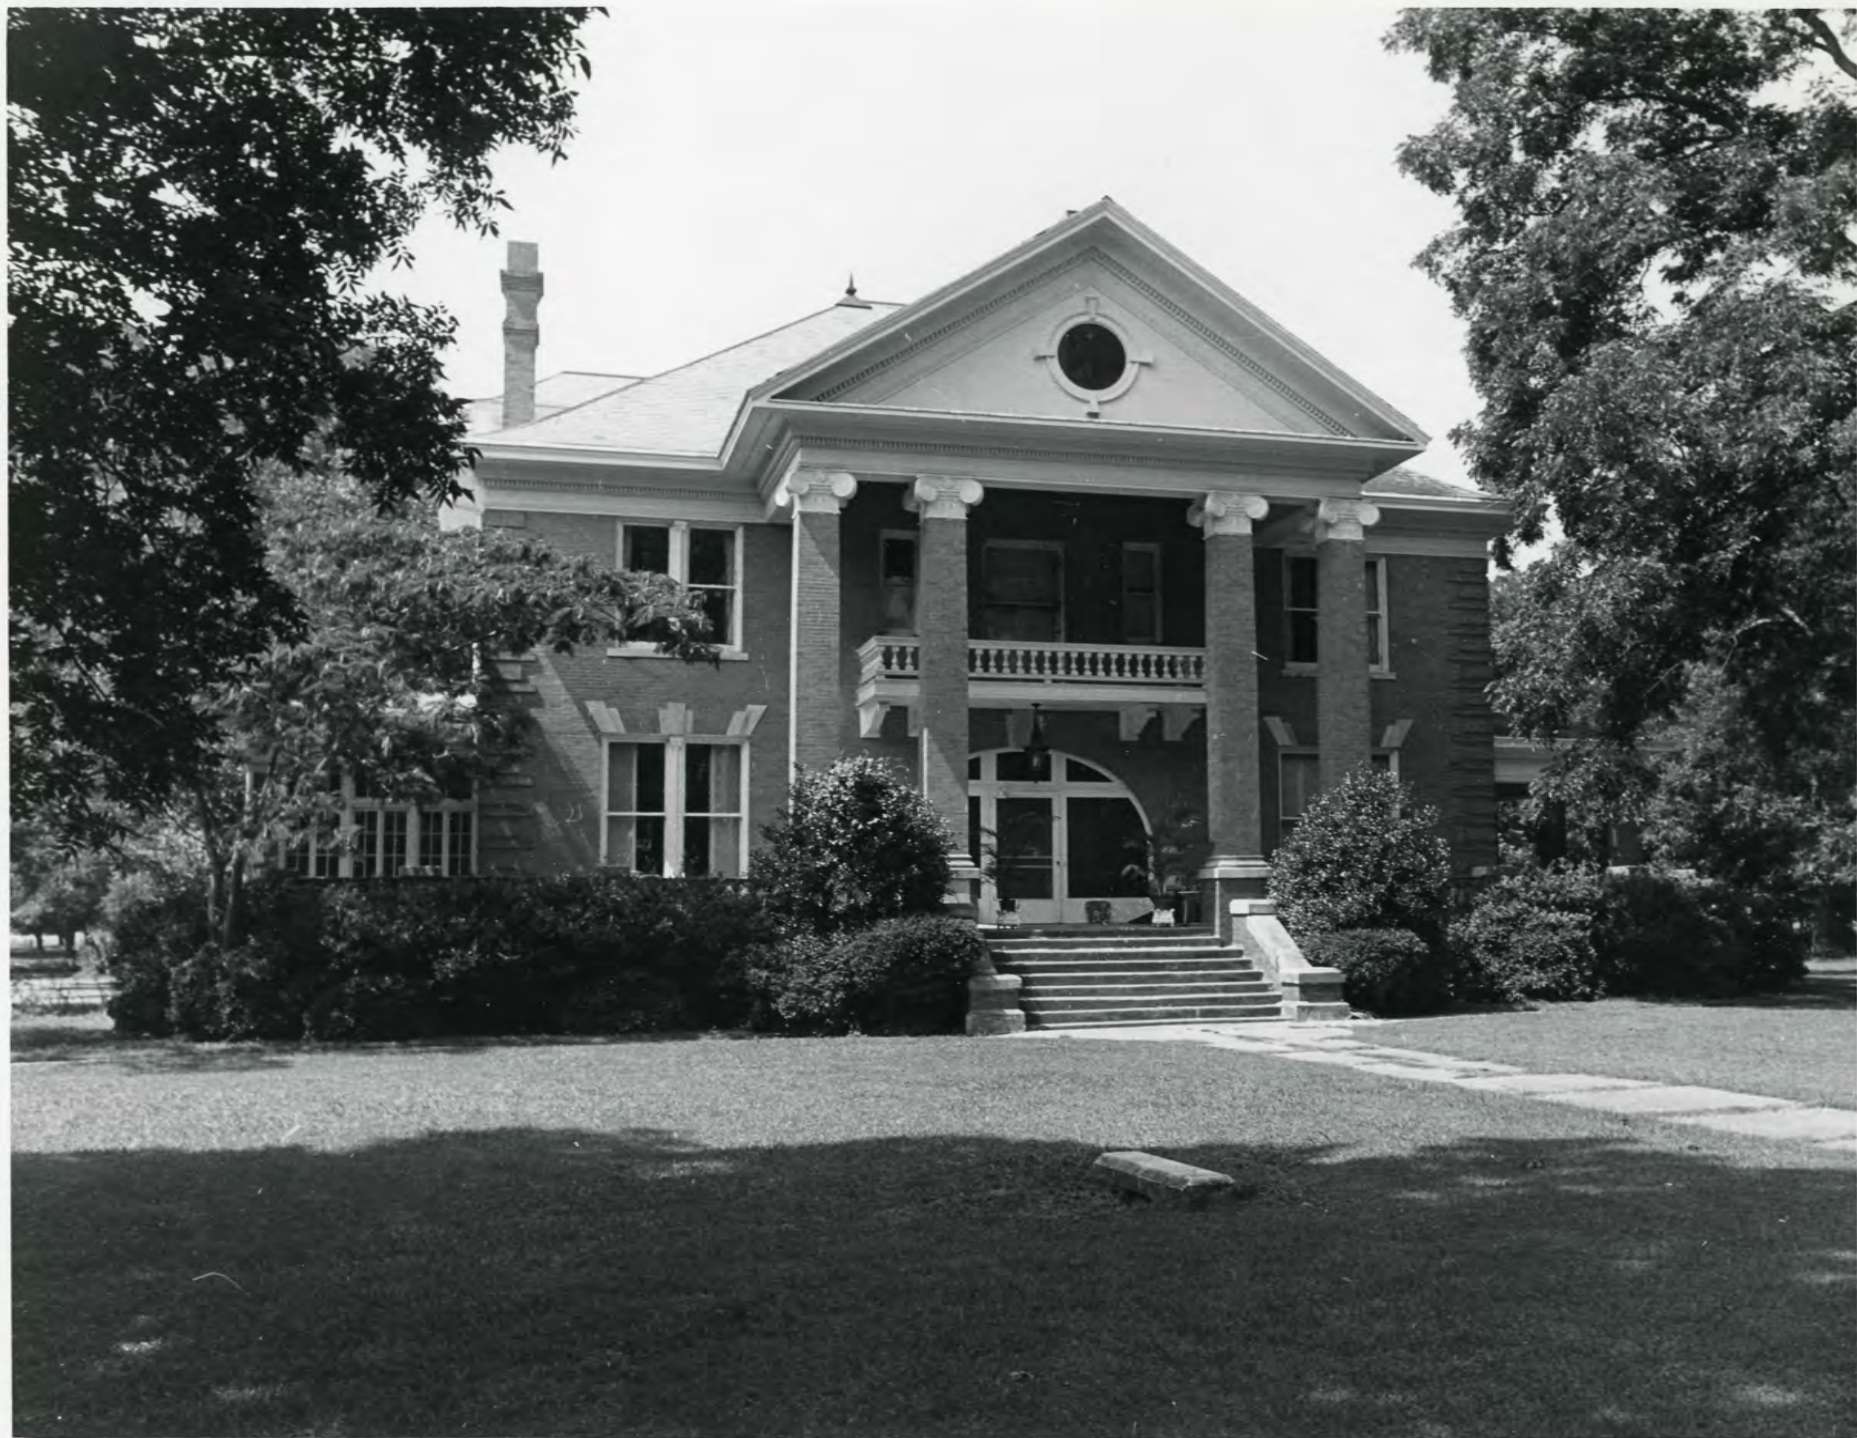
1. Dortch Plantation
2. Scott, Arkansas
3. March, 1979
4. Jack Doss
5. Arkansas Historic Preservation Program
6. #23; Marlsgate
7. photo #21

One of the historic buildings is enormously more imposing than any other structure on the plantation. The building is Marlsgate (23), the residence of three generations of the Dortch family for 75 years. It is presently the home of William P. Dortch III, one of the two owners of the plantation. Marlsgate was individually entered on the National Register in 1975. It was designed by the prominent architect, Charles L. Thompson. The 1904 construction cost was \$33,000.

Marlsgate is grand in both scale and design. Its height encompasses 2½ storeys, and its expanse comprises 20 rooms of living space. A full basement lies beneath the superstructure. The grandness of design is suggested by the two-storey portico, a second-storey balcony, and fourteen-foot-high ceilings. Marlsgate reflects the lifestyle of the Dortches as a wealthy farm family at the turn-of-the-century.

The full-sized, two-storey portico has four square, brick columns. Ionic capitals crown the four columns. This grand portico dominates the facade of the house. Dentil work, which ornaments the cornice, is also utilized in the pediment of the portico. Located in the center of the pediment is an oeil-de-boeuf window. A second-storey balcony projects over the entry; it features urn-shaped balusters. Support for the balcony is provided by heavy paired brackets. The single entry is set into a wide, arched opening. The arch is defined by brickwork and is capped by a keystone, which is centered above the door. The keystone contains the intertwined initials of William and Nettie Dortch. Paired windows flank the entry; they are unusual in their use of cut stone and brick in the window heads. Upper, paired windows have simple trim. The railing on the portico is cast concrete; it is molded on the grounds. The facade is symmetrically balanced by two projecting one-storey wings, one on either elevation.

Marlsgate is crowned with a high, hipped roof. Dormers, each with double windows, project from the east and west elevations of the roof. Two finials project from the ridge of the roof. A dentiled cornice extends around the house.

The unusually thin bricks of which the house is constructed were made in St. Louis. An interesting feature of the bricks is that they extend around the corners. The corners of the main wing of the house are highlighted by cut-stone quoins.

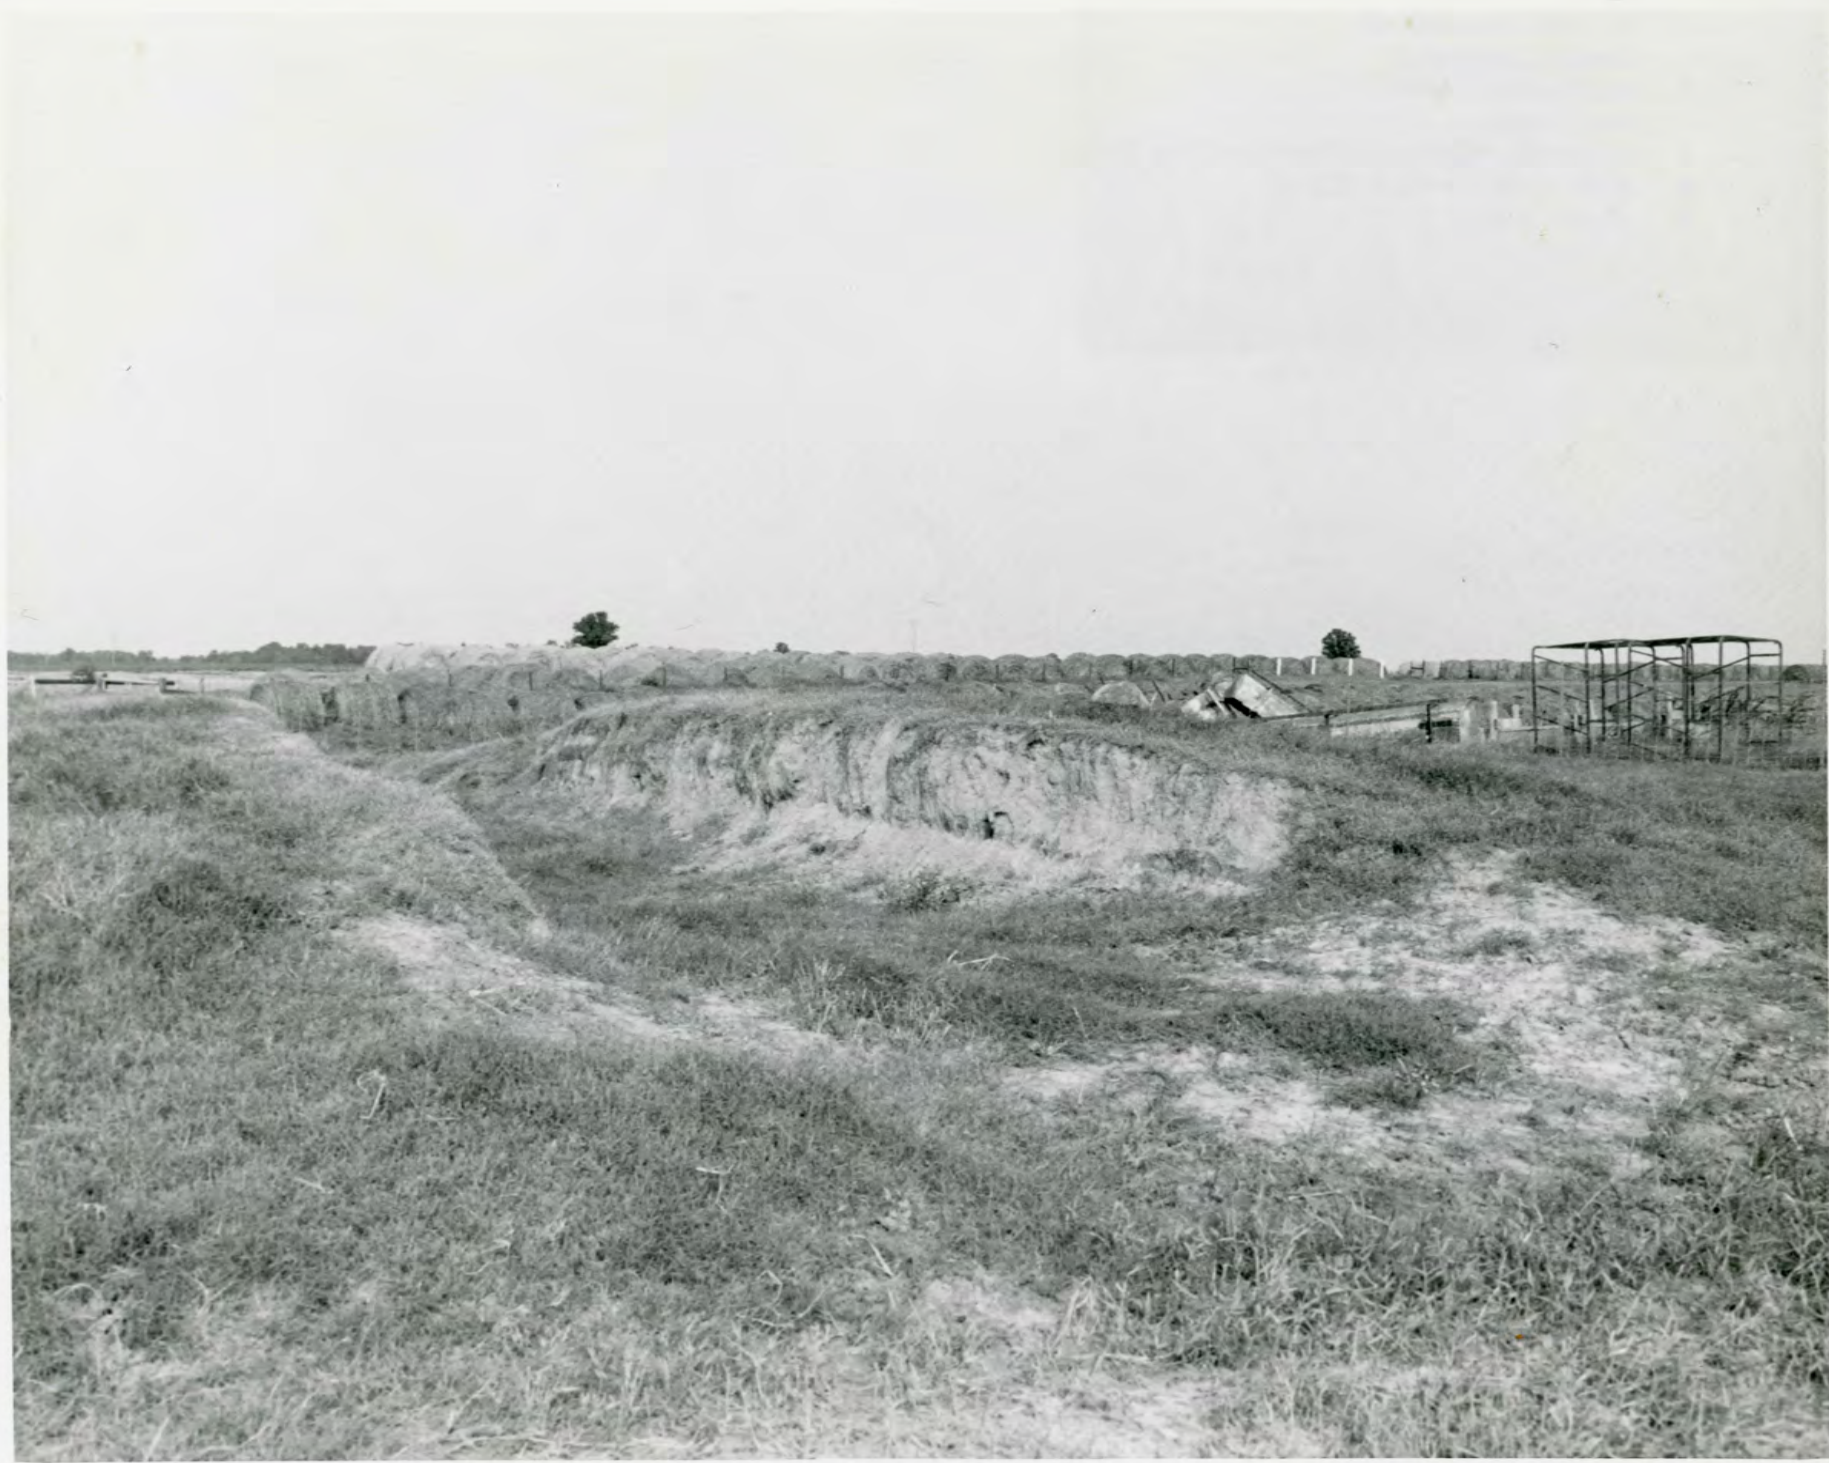
1. Dortch Plantation
2. Scott, Arkansas
3. March, 1979
4. Jack Doss
5. Arkansas Historic Preservation Program
6. #28; underground silos
7. photo # 24

10. Two underground silos - built 1935. Agri teacher at Scott public school told Bill Dortch's father about the idea. First such silos in the country - dirt floor.
