# National Register of Historic Places Registration Form

historic name Record, E.C. and M.I., Homestead

street & number 8 Bean Road

city or town Buckfield

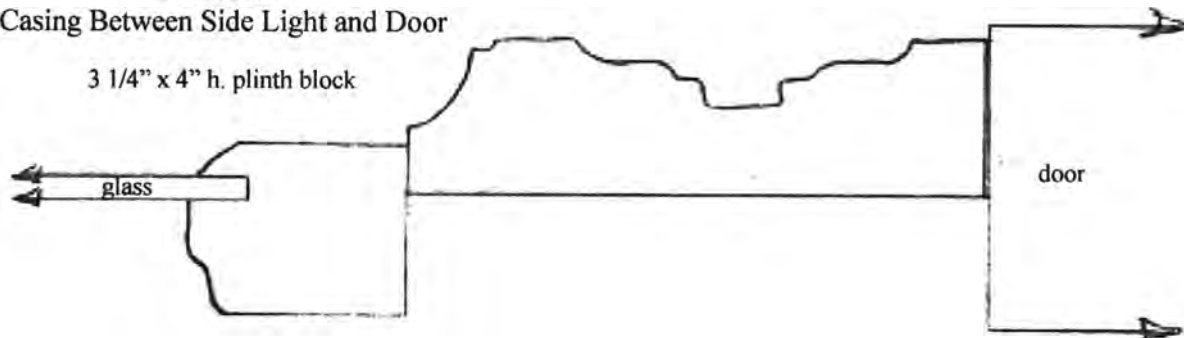
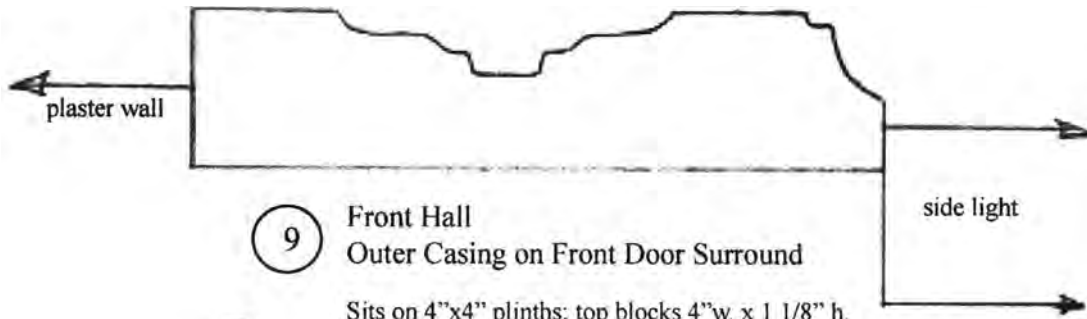
Front Hall  
Casing Between Side Light and Door

3 1/4" x 4" h. plinth block

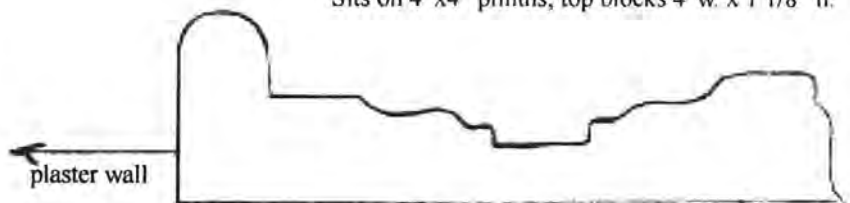
9

Front Hall  
Outer Casing on Front Door Surround

Sits on 4"x4" plinths; top blocks 4"w. x 1 1/8" h.

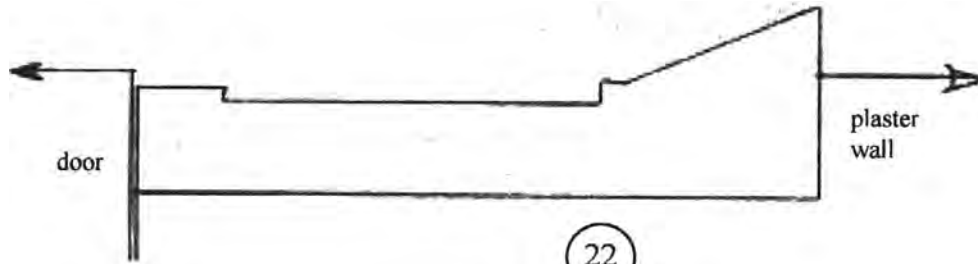
22

Middle Back Room  
Door and Window Trim

(mitered at corners)

In this 7' 10" x 13' 4" room, the doors and window have a very simple Greek Revival style trim (22) composed of flat stock posts and lintel with mitered backband molding at the outer edge. The window was relocated in the 1950's. The current owner replaced the c. 1950's flat stock trim on the window with trim to match the original on the doors in the room. The 6 1/2" high base board is flat stock. The door to the north parlor is a later addition, as described in the North Parlor description, and has simple flat stock trim. The original door opening to the entry hall has been in-filled with cupboard doors above two drawers. The use of period hardware helps these alterations to blend in well with the original fabric, however, the particle board sides and bottom of the drawer boxes (visible when pulled out) makes clear that they are recent additions. There is a door to the cellar stairs located between the original door to the entry and the door to the south parlor. This door is not in use but is still functional, opening onto the landing at the top of the stairs. The stairs are currently accessed from a door in the south parlor, which opens onto the same landing. It appears that this was originally a closet under the stairs and the stairs to the cellar were added later. The floor is pine, which has been sanded and finished with polyurethane. The original plaster ceiling remains.

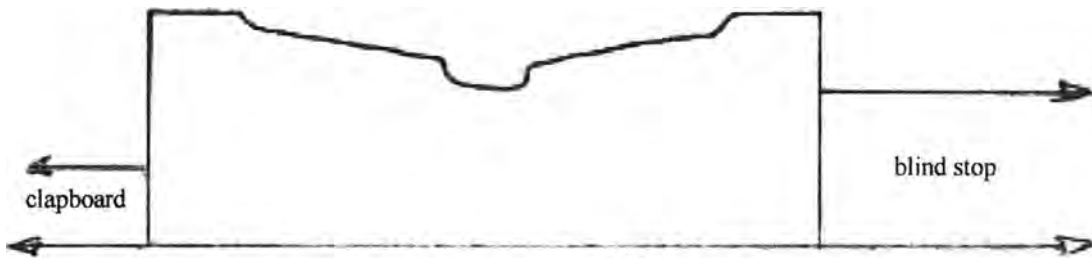
23

Exterior Window

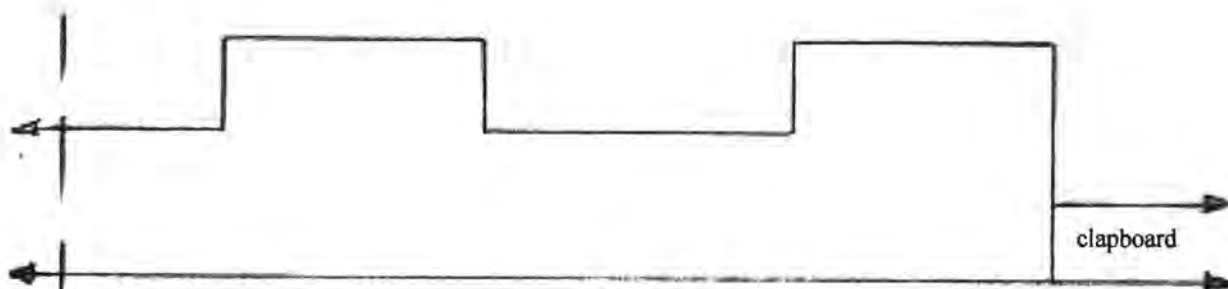
24

Exterior Corner Pilaster

The west façade of the E. C. Record Homestead is a classic five-bay Greek Revival style composition. The recessed central entry and wide corner pilasters are its most noticeable features. The four windows on the façade are trimmed with a relatively simple 4 3/8" wide molding (23)<sup>4</sup> and smooth-faced square corner blocks. The window sills are 2" thick. Louvered shutters were historically used on the windows and portions of their hinge pintles remain in the blind stops. Photos show that these were removed by the mid-1940s. Some of the shutters are stored in the second story of the barn. The corner pilasters are 13" wide with four simple applied vertical battens that effectively create the feeling of a fluted pilaster (24). The pilaster bases are very simple, with a flat rectangular cap atop a plain plinth, approximately 10" tall and slightly wider than the pilasters above. At the tops of the pilasters, the three "flutes" terminate in pointed gothic arches, an interesting detail on a strongly Greek Revival façade. Several inches below the pointed arches, a horizontal rectangular

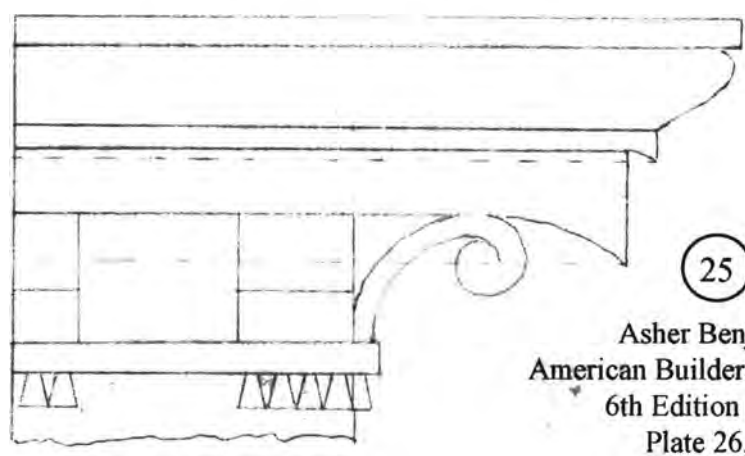
25

Asher Benjamin  
American Builders Companion  
6th Edition (1827)  
Plate 26, D.

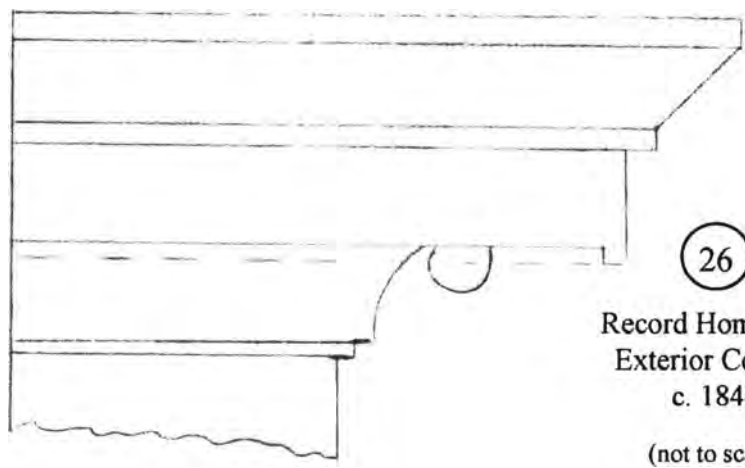
26

Record Homestead  
Exterior Cornice  
c. 1844  
(not to scale)

fillet creates a band across the pilaster, where an astragal would terminate the flutes and create the neck at the top of a correct Classical column or pilaster. Here the "neck" contains the gothic arches. Above the gothic arches, a simple capital is formed of rectangular and angled elements below a bullnosed abacus. The façade has a three-part entablature with wide moulded frieze board, and overhanging soffit and a moulded cornice. The simple angled crown molding at the top of the composition incorporates an integral gutter (which has been roofed over). The entablature wraps the corners to create short cornice returns above the pilasters on the gable ends of the house. Sketch #25 illustrates an exemplary cornice for a Greek Revival entablature, illustrated in Asher Benjamin's 1827 book *The American Builder's Companion*, below it is the simplified version of the same cornice used on the Record Homestead (26).

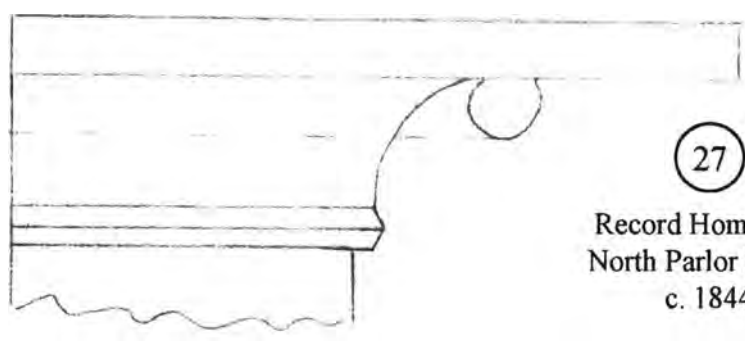
27

Record Homestead  
North Parlor Mantle  
c. 1844  
(not to scale)

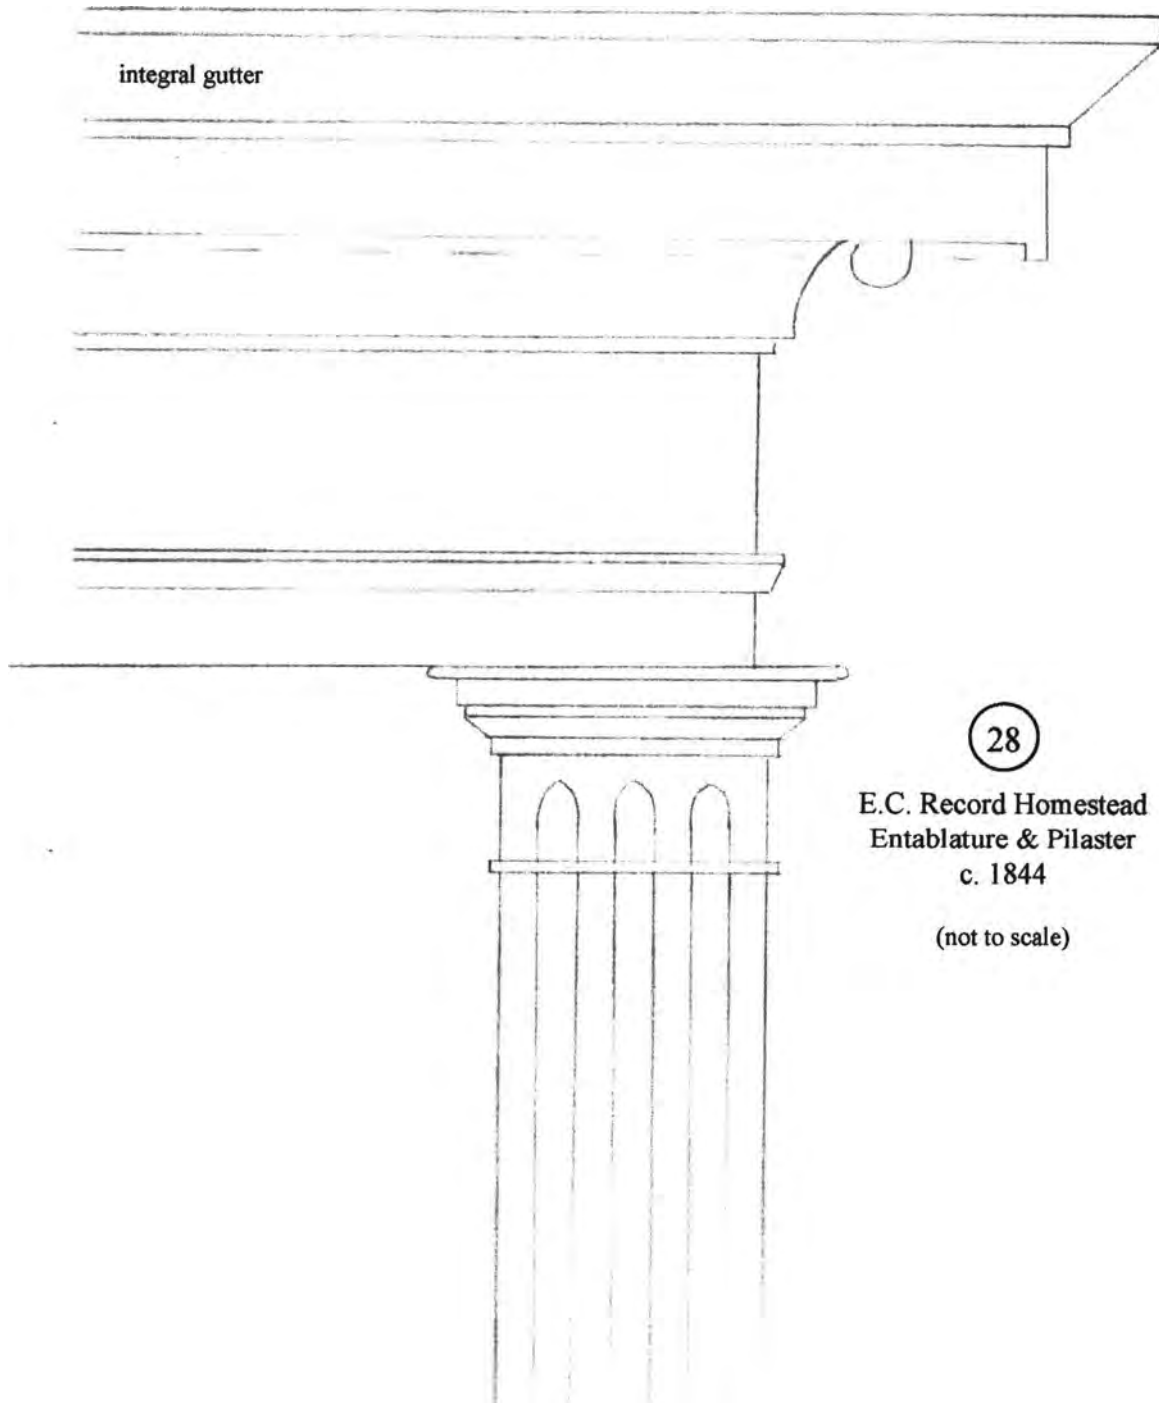
28

E.C. Record Homestead  
Entablature & Pilaster  
c. 1844

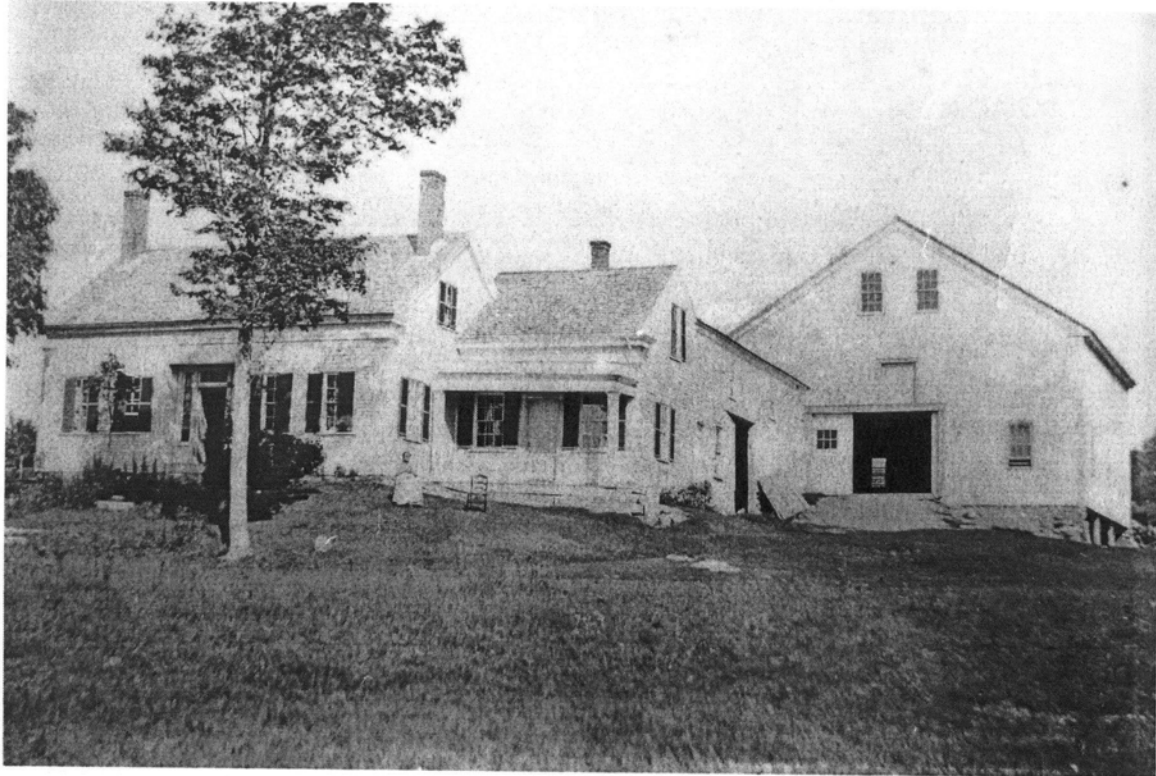
Figure 32: Looking northeast at west (front) façade and south elevations of Ezekiel & Mariam Record Homestead. Collection of owners, c. late 19<sup>th</sup> century.

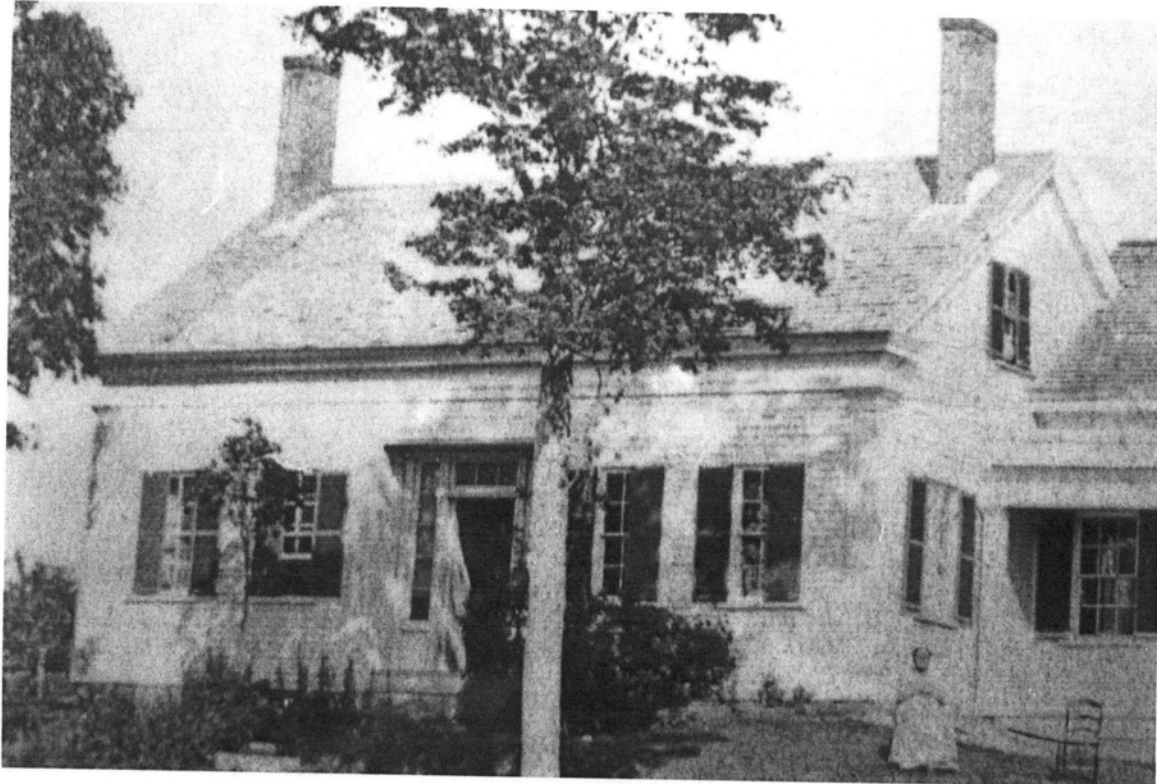
Figure 33: Detail, looking northeast at west (front) façade of Ezekiel & Mariam Record Homestead. Collection of owners, c. late 19<sup>th</sup> century.

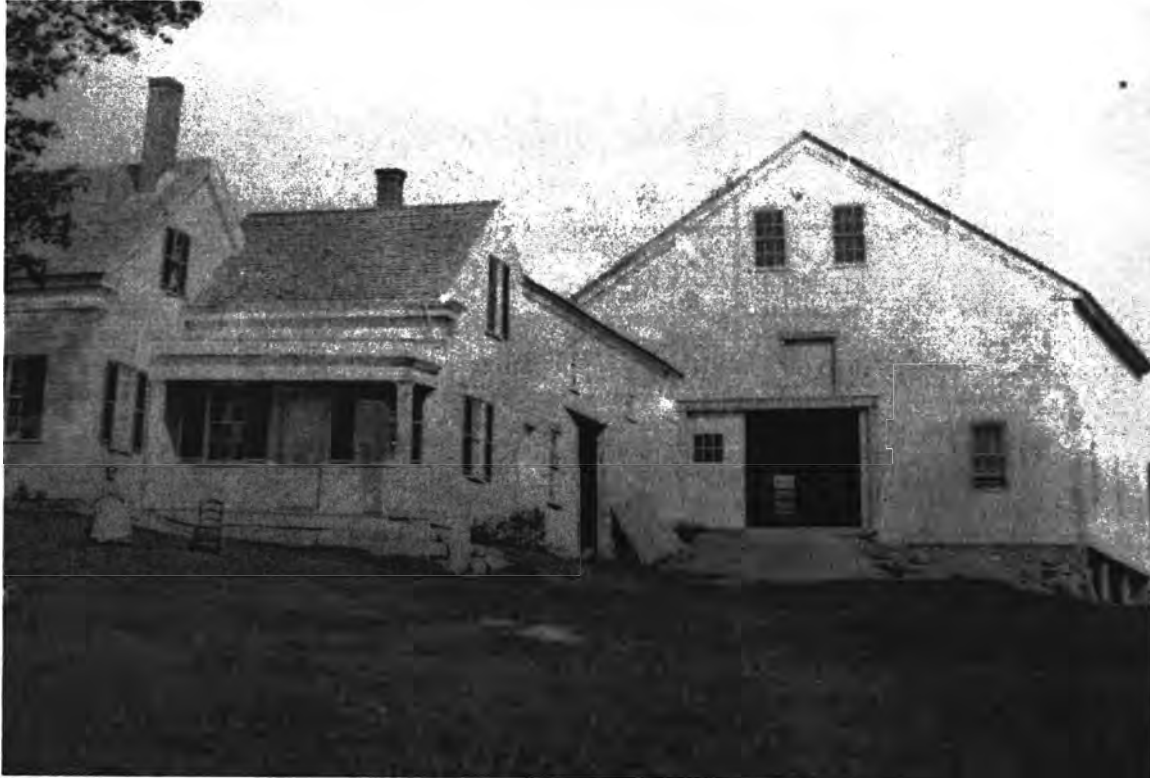
Figure 34: Detail, looking northeast at south elevations of Ezekiel & Mariam Record Homestead. Collection of owners, c. late 19<sup>th</sup> century.

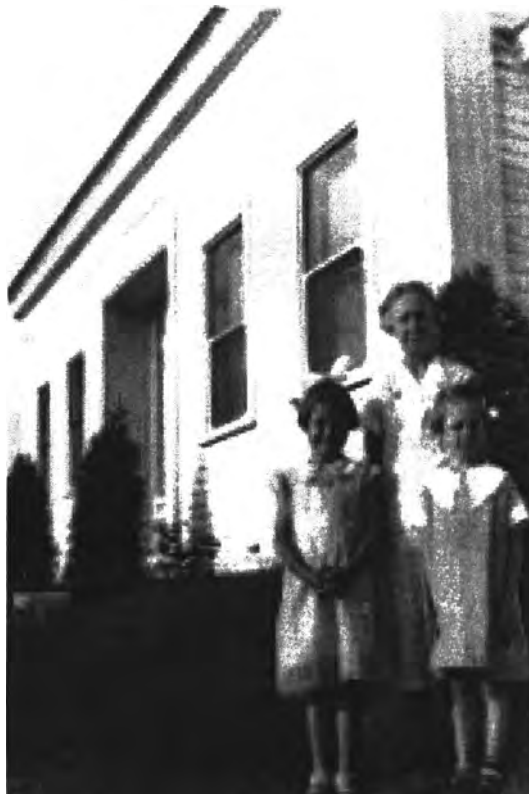
Figure 36: Looking northeast at west (front) façade and south elevations of Ezekiel & Mariam Record Homestead. Collection of owners, c. 1940s.

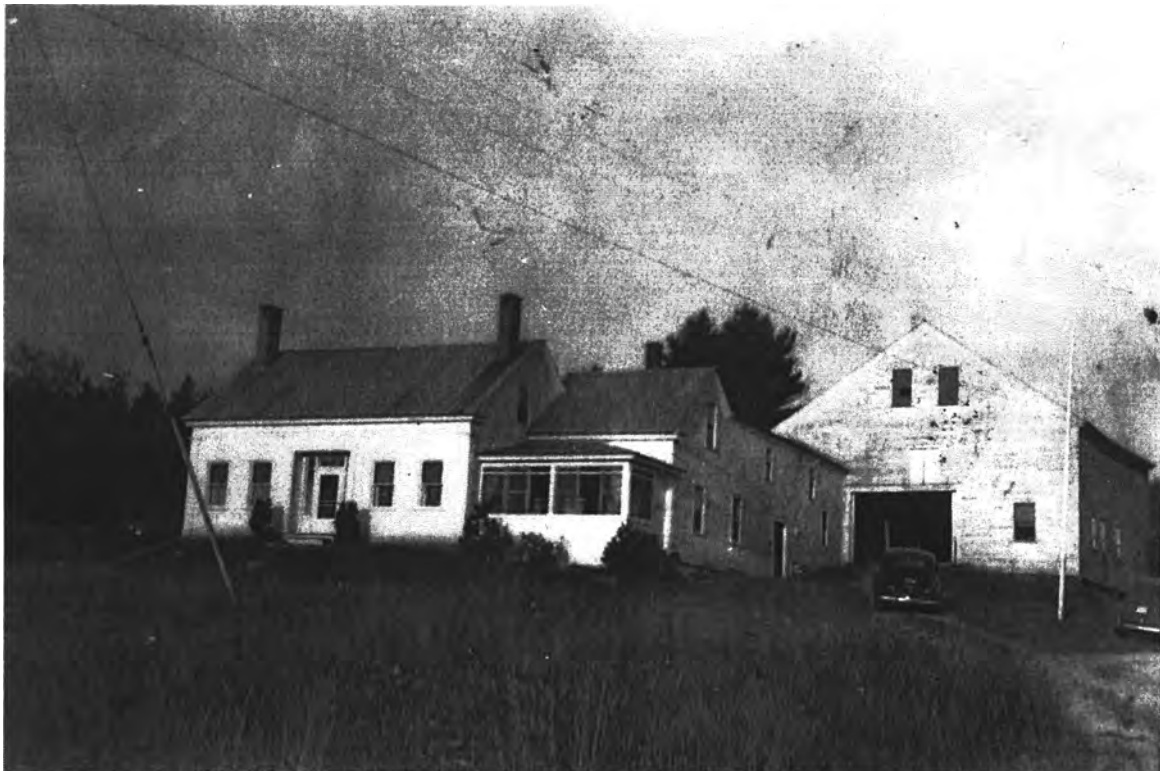
Figure 37: Detail, looking northeast at west (front) façade of Ezekiel & Mariam Record Homestead. Collection of owners, c. 1940s.

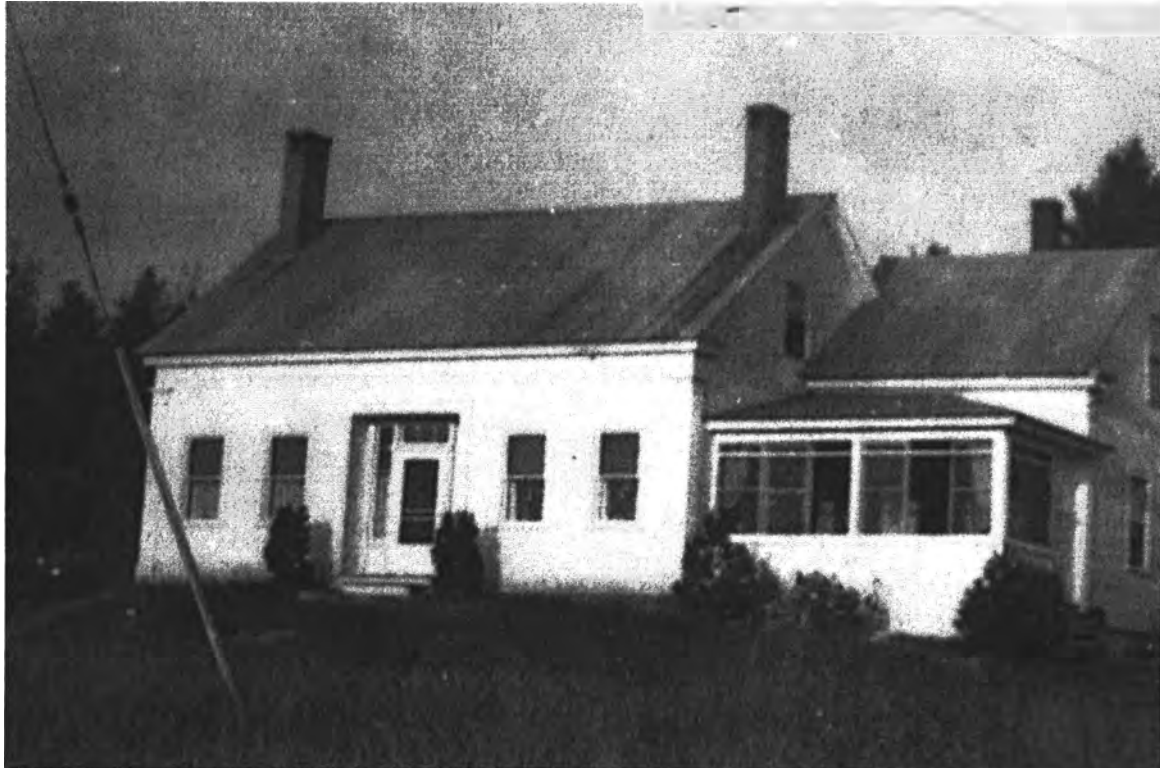
Figure 38: Looking northeast at west (front) façade of Ezekiel & Mariam Record Homestead. Collection of owners, 1940s.

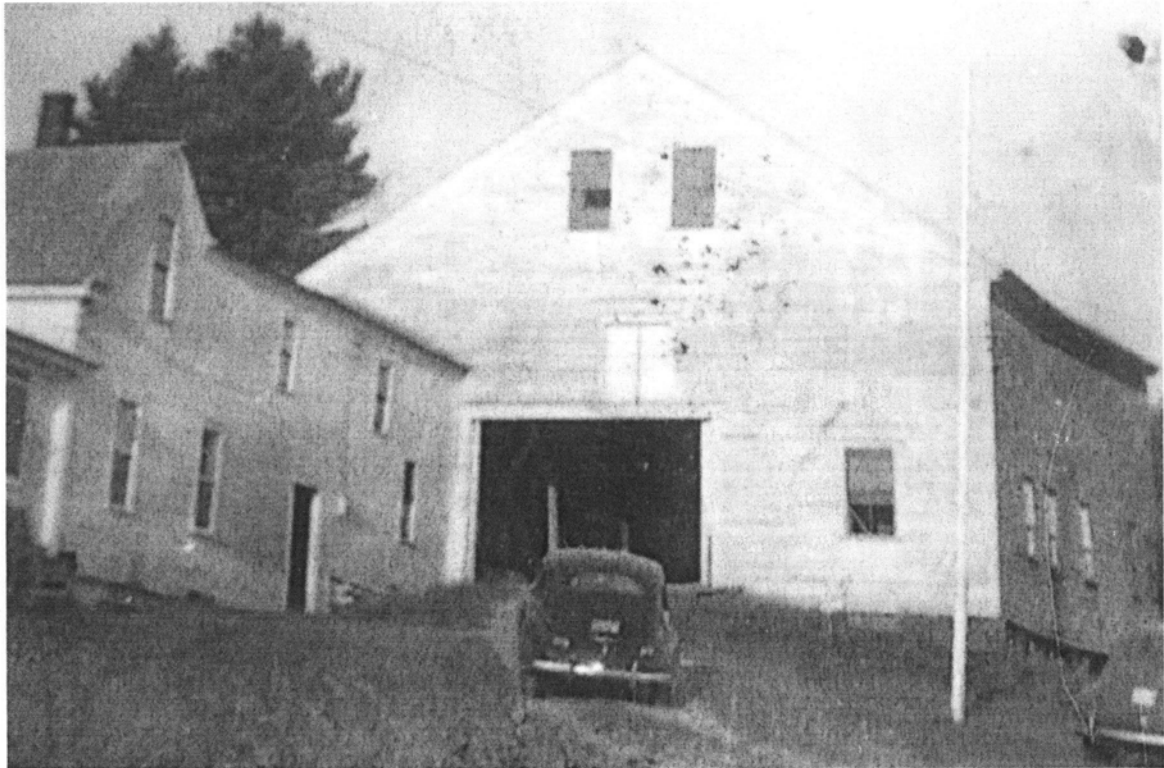
Figure 39: Detail, looking northeast at Ezekiel & Mariam Record Homestead and barn. Collection of owners, c. 1940s.
